ABC Herron Tree LLC  
P.O. Box 64  
Gold Bar, WA 98251  
425-293-2443  
mountainredd@comcast.net

September 19, 2025

RE: Property Owner: Jill Schlosser  
Site Address: 4822 103<sup>rd</sup> PI SW, Mukilteo, WA 98275  
Parcel#:00650500005500  
Lot Size: 0.26 acres

## Tree Assessment Matrix

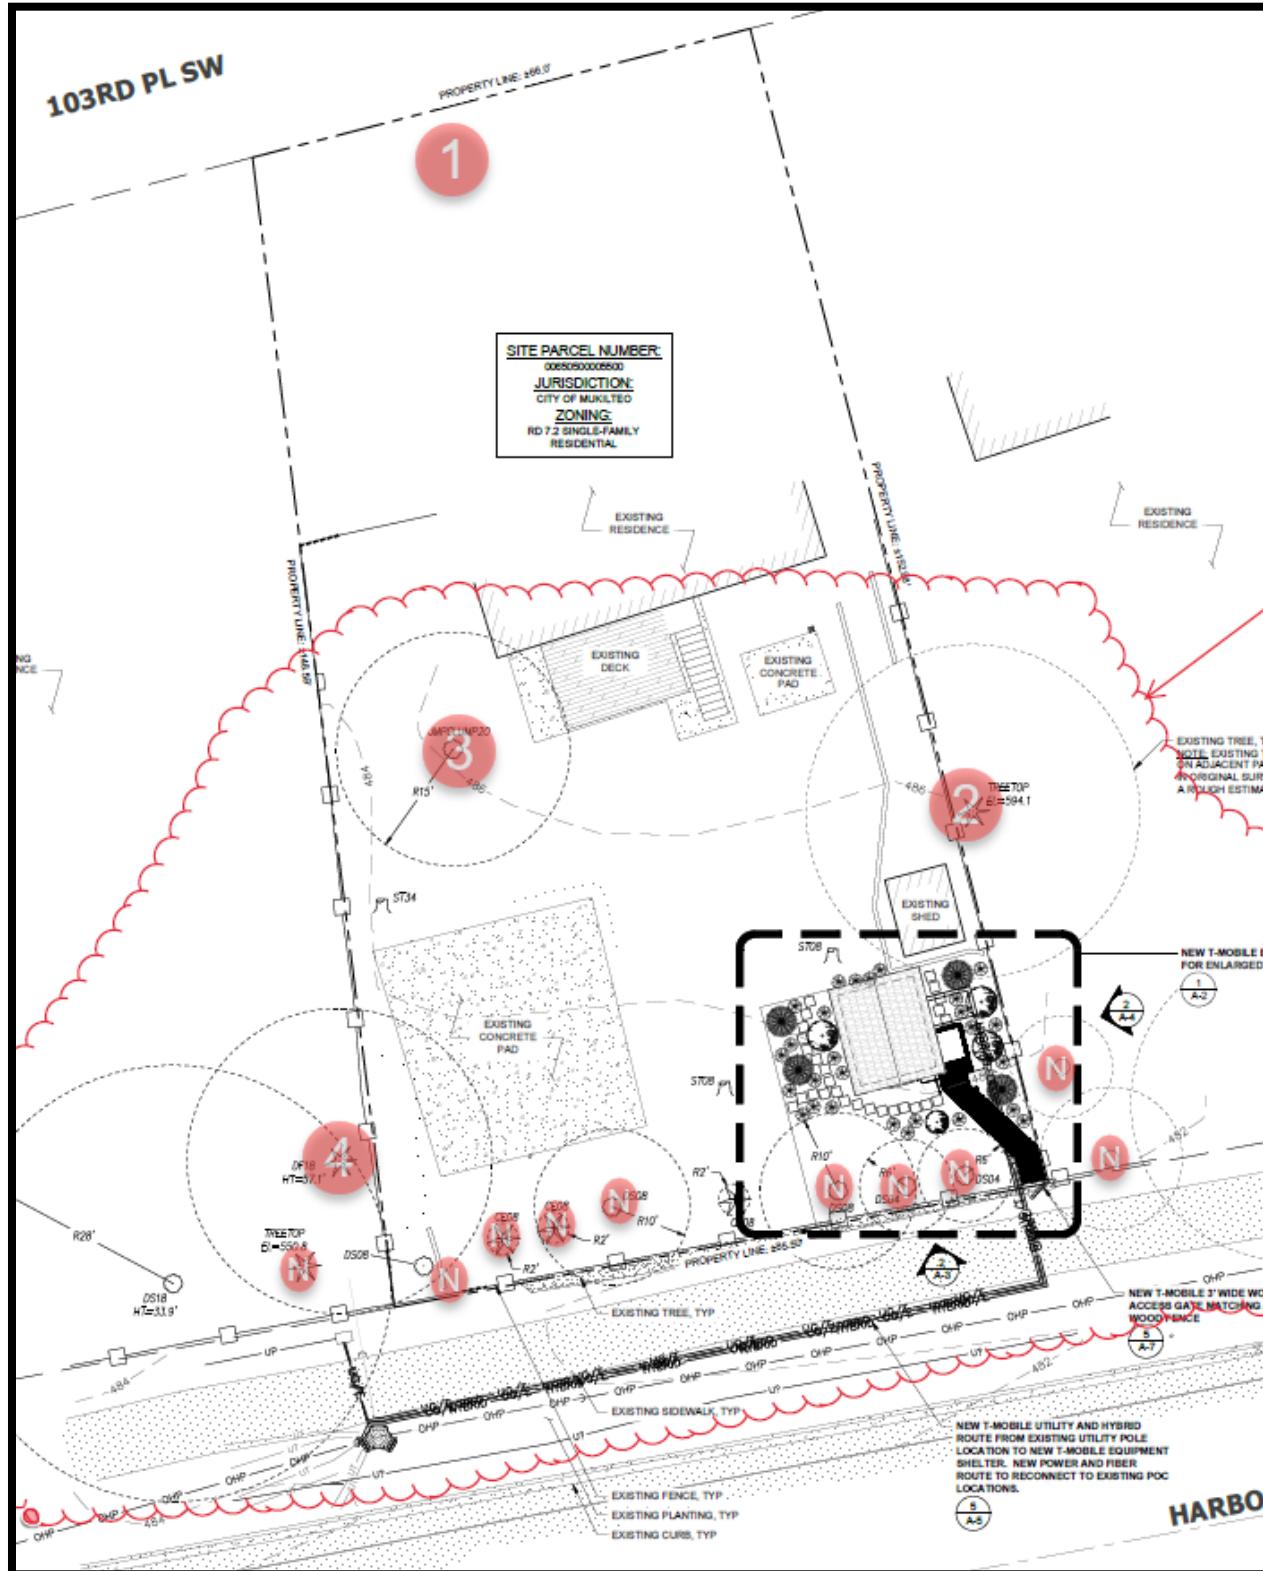
**Site Map Figure 4** (for visual use only, not to be used as a survey) This is a detail from a site plan dated 4/28/25. Trees indicated coordinate numerically with the Tree Assessment Matrix. Trees marked "N" are non-significant trees per city code.

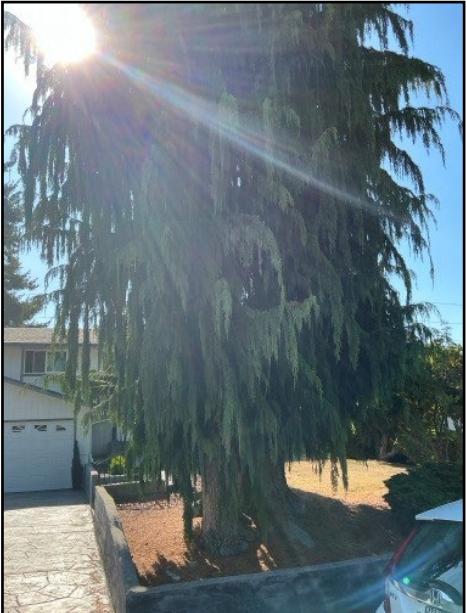
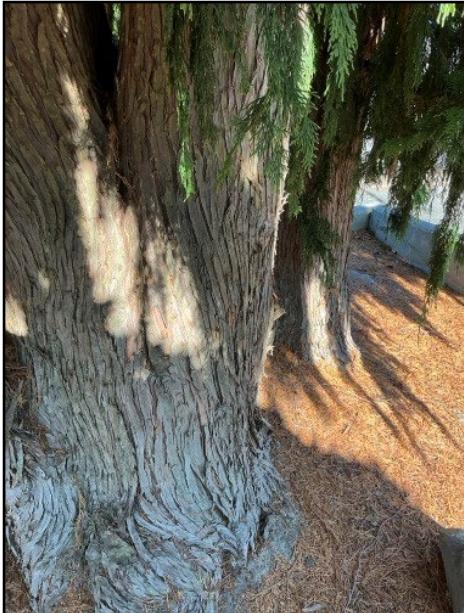
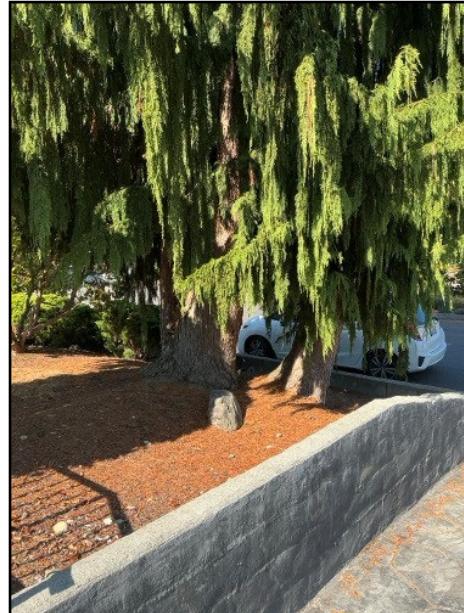
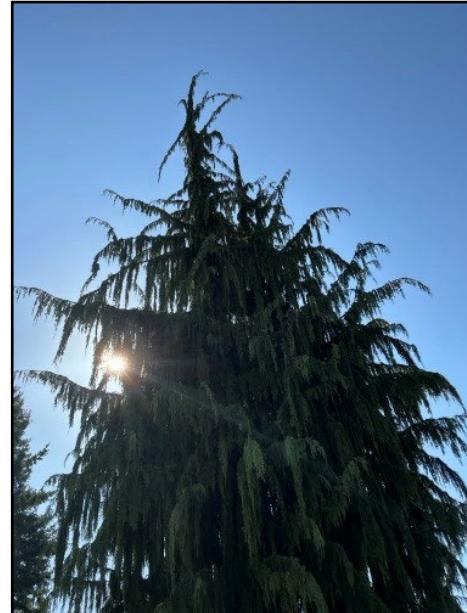
Tree	Species	DBH (in)	Drip (ft)	CRZ (ft)	Condition	Structure	Risk	Pres. Value	Recommendations
1	Alaska yellow cedar <i>Callitropsis nootkatensis</i>	26.7	8.0	26.7	4 Good	4 Good	N/A	N/A	Tree Inventory
Notes/Defect	This tree has multiple stems and is an adjusted DBH.

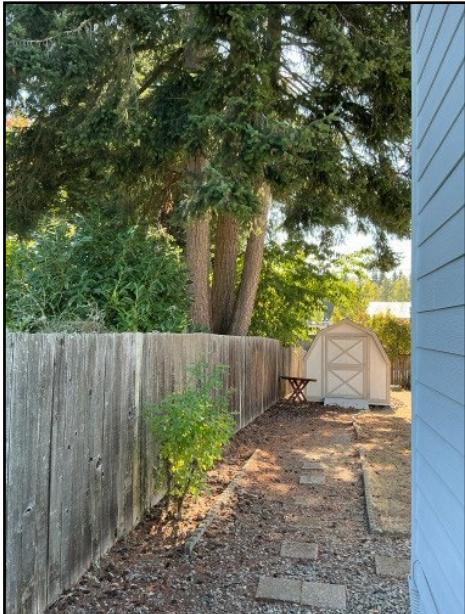
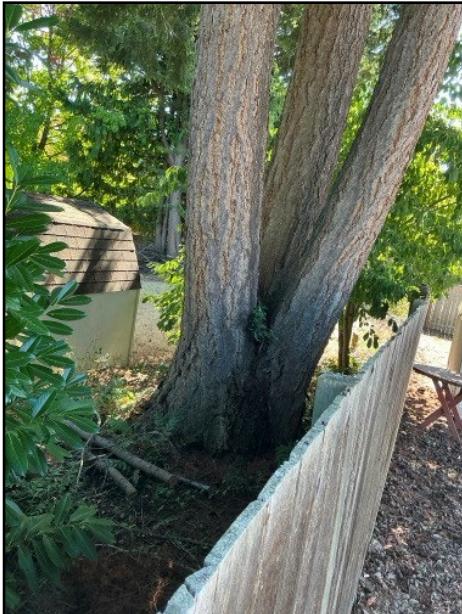
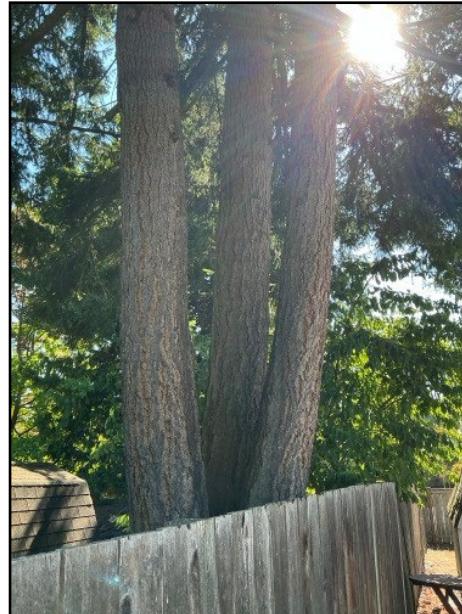
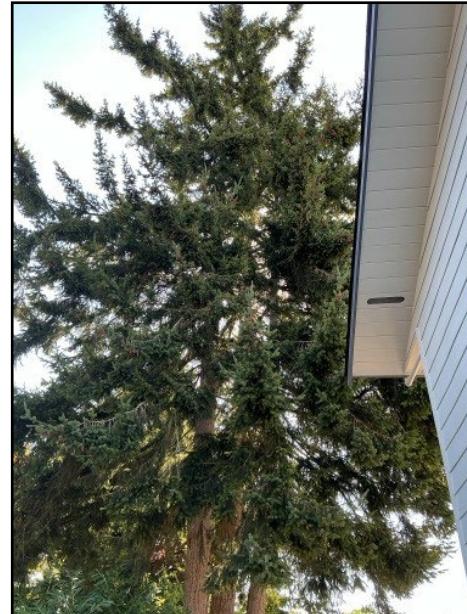
Tree	Species	DBH (in)	Drip (ft)	CRZ (ft)	Condition	Structure	Risk	Pres. Value	Recommendations
2	Douglas fir <i>Pseudotsuga menziesii</i>	34.6	25.0	34.6	4 Good	4 Good	N/A	N/A	Tree Inventory
Notes/ Defect	This tree has multiple stems and is an adjusted DBH. This is an offsite tree on the property to the east at 4814 103rd PI SW. The drip line of this tree over extends the fence by 17 feet to the west.

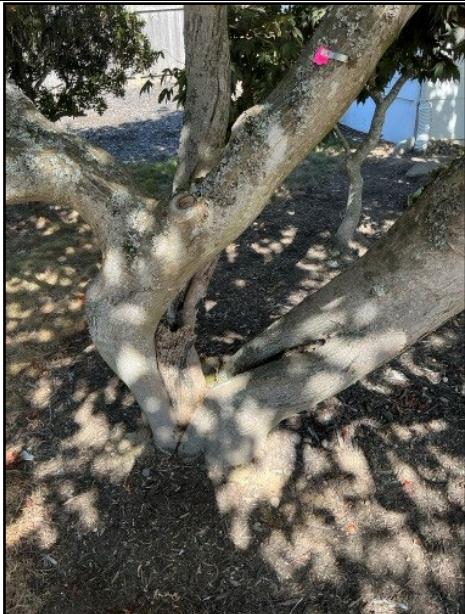
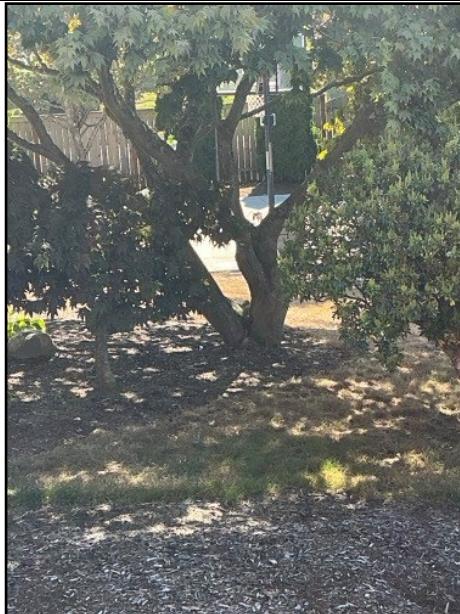
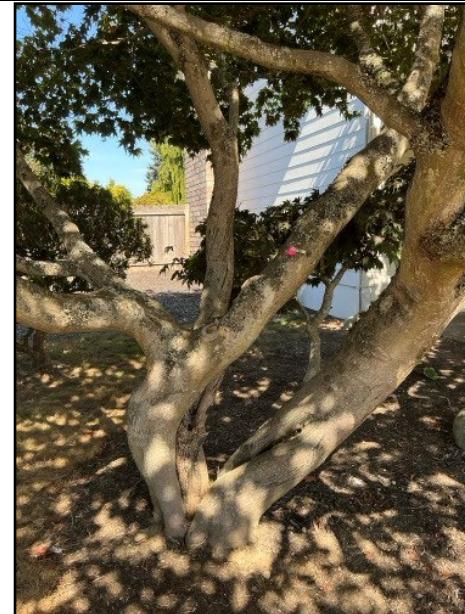
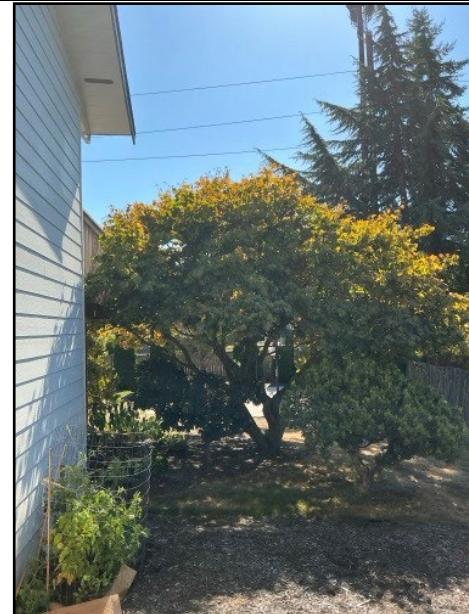
Tree	Species	DBH (in)	Drip (ft)	CRZ (ft)	Condition	Structure	Risk	Pres. Value	Recommendations
3	Japanese maple <i>Acer palmatum</i>	14.2	10.0	14.6	4 Good	3 Fair	N/A	N/A	Tree Inventory
Notes/Defect	This tree has multiple stems and is an adjusted DBH.

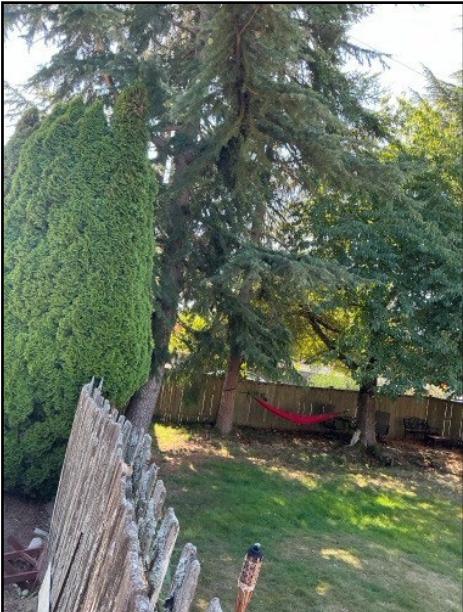
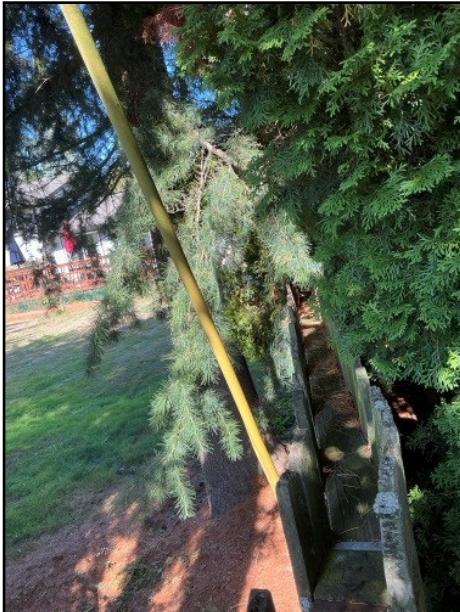
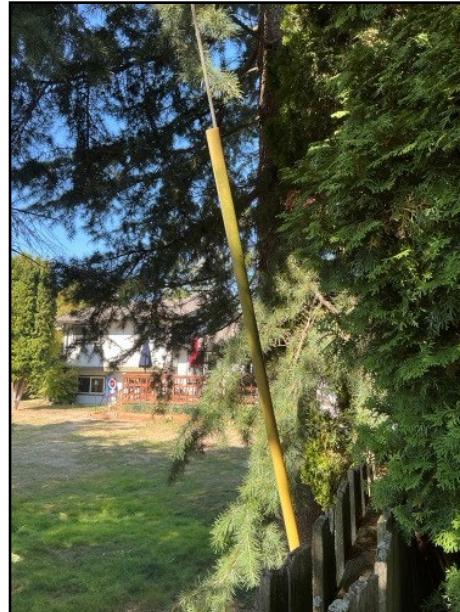
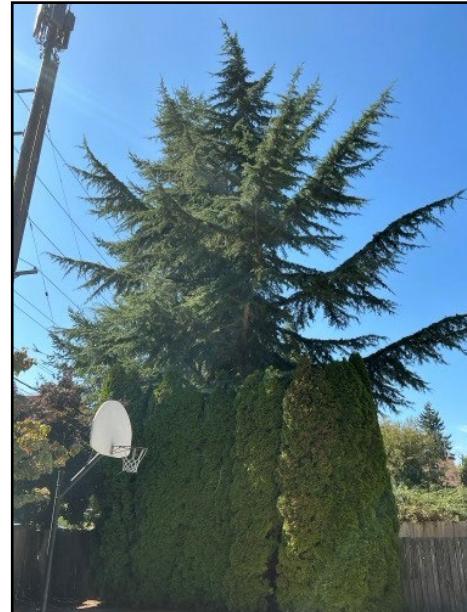
Tree	Species	DBH (in)	Drip (ft)	CRZ (ft)	Condition	Structure	Risk	Pres. Value	Recommendations
4	Deodora cedar <i>Cedrus deodora</i>	18.0	15.0	18.0	4 Good	3 Fair	N/A	N/A	Tree Inventory
Notes/Defect	This tree has multiple stems and is an adjusted DBH. This tree is an offsite tree at 4828 103rd PI SW. This tree over extends the fence line by about 20 feet to the east.

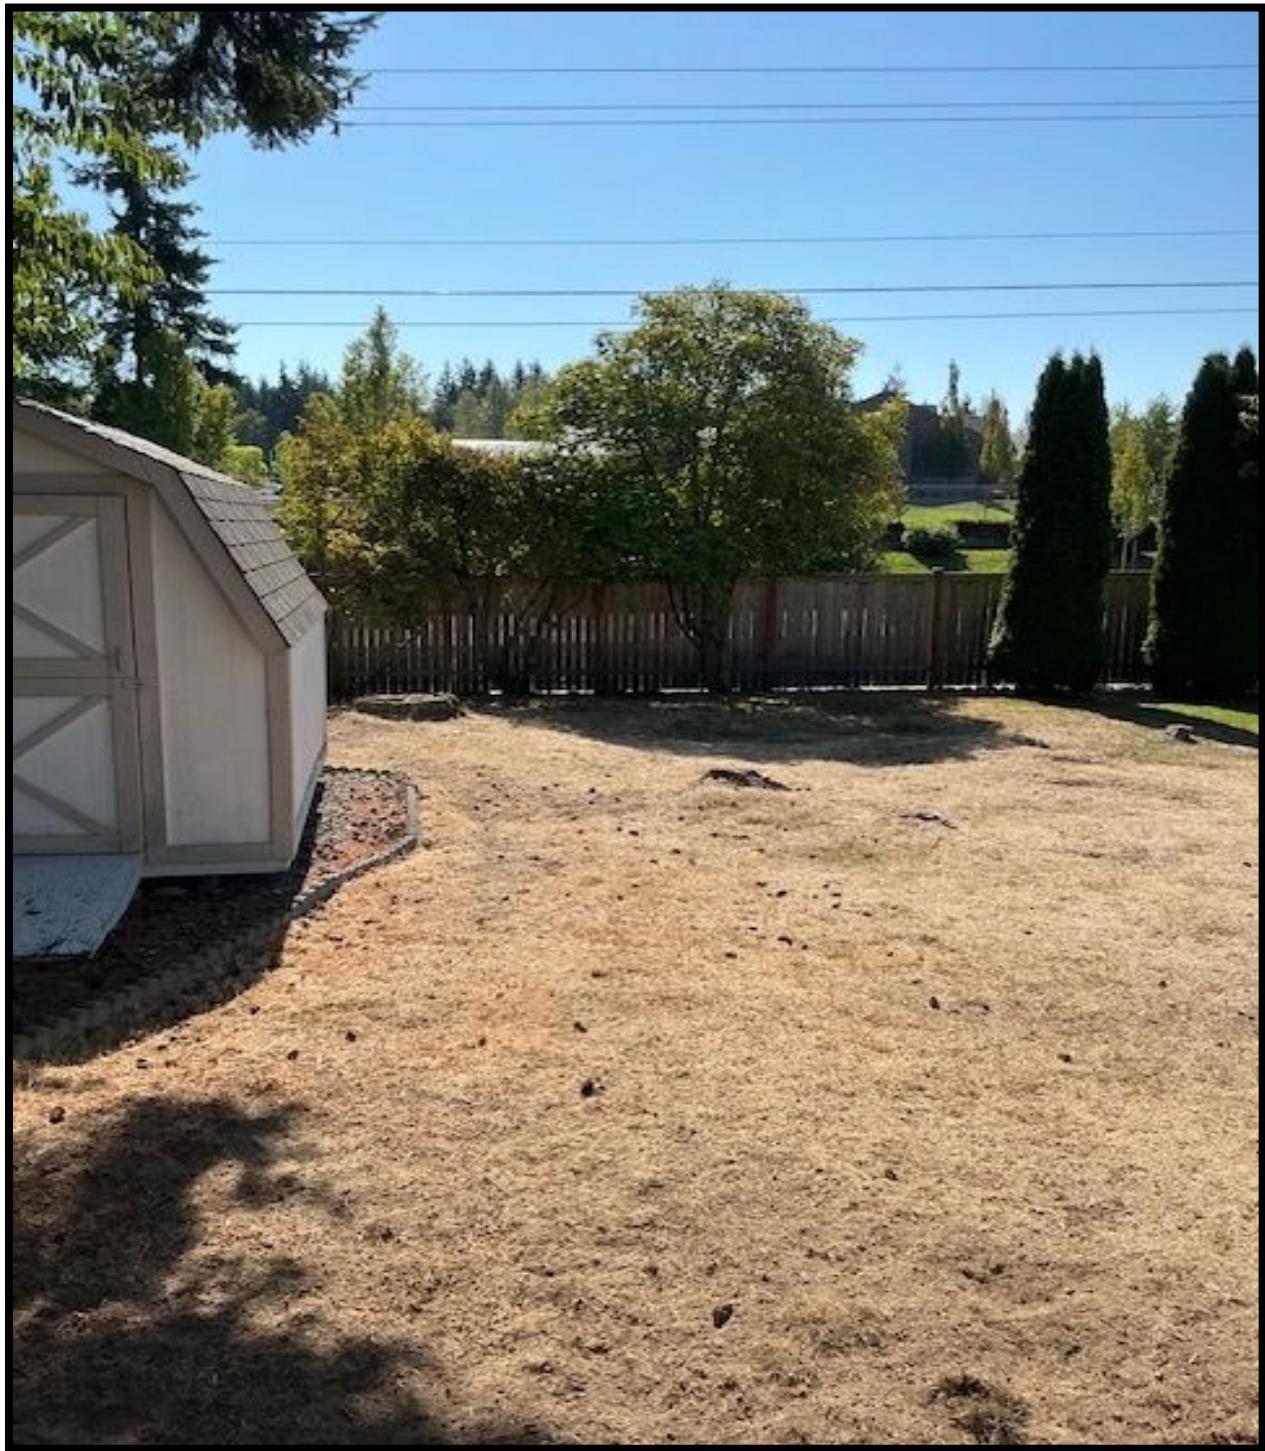
**Photo 1** Figure 6 This photo shows non-significant sized trees in the back of the property that do not meet the description of a regulated tree per MMC 17.08.020.
