**Hawthorne Hall**

**1134 2<sup>nd</sup> Street, Mukilteo, WA**

## **Structural Condition Assessment Report**

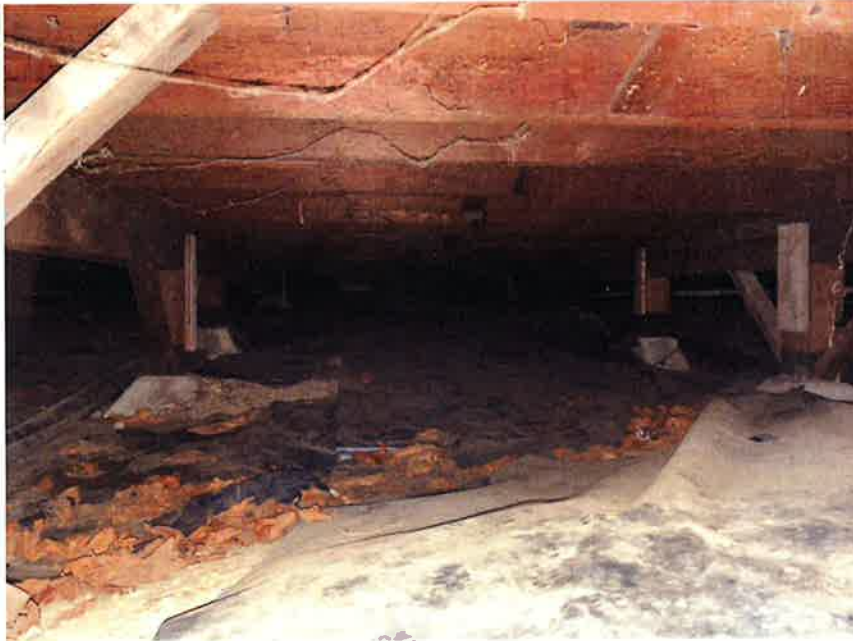
Figure 1: Intermittent Concrete footings w/6x6 Posts

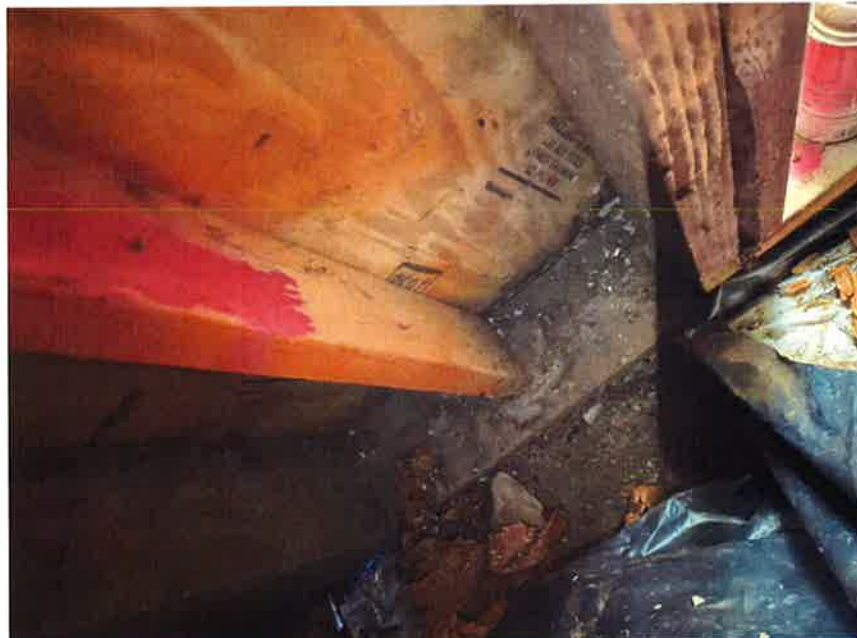
Figure 2: Cripple Wall studs and Sill Plate to the Concrete footing

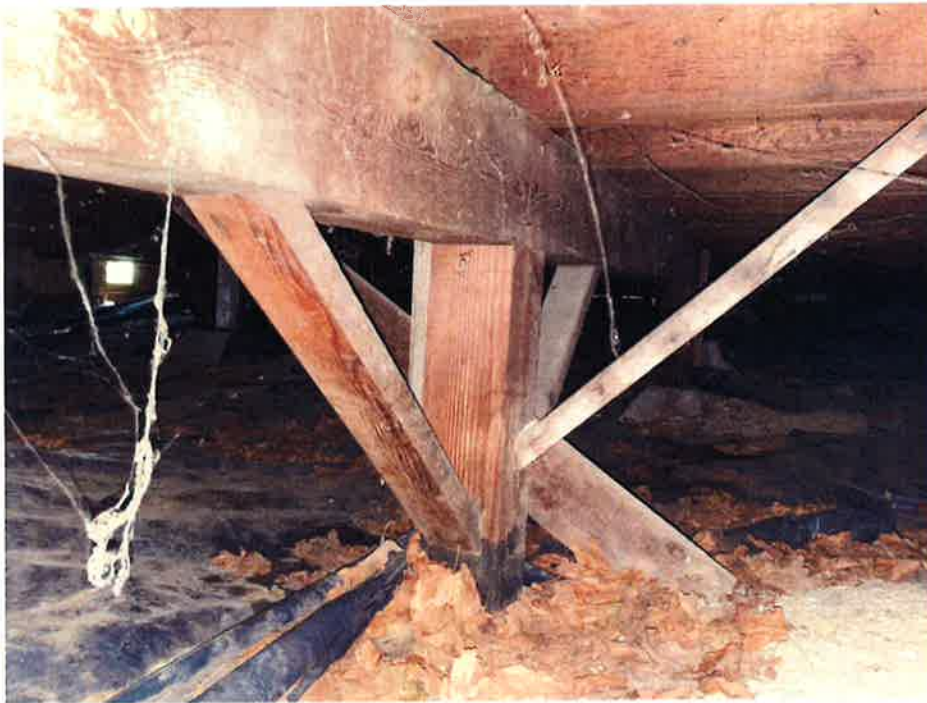
The exterior foundations of Hawthorne Hall are concrete cast in place footings. A 2x4 wood framed cripple wall (Figure-4 in Appendix A) frames the perimeter of the crawlspace below the first floor; at the addition a concrete stem wall frames the exterior of the crawlspace. The interior foundations (Figure-1) are 6x6 posts supported on intermittent, isolated, concrete pad footings that are spaced at 8' on center (O.C.) in both directions, at the north end of the main hall they are spaced at 2' to 4' O.C. All posts are supported laterally with 2x6 kickers (Figure-3) from all four directions.

Figure 3: Intermittent post footing w/ kicker supports

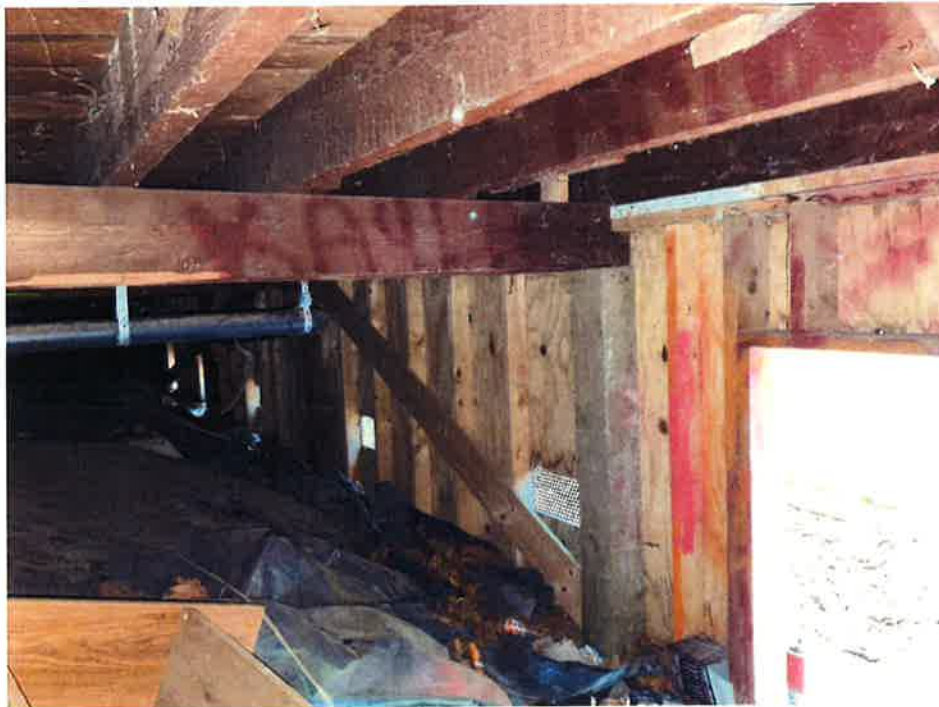
Figure 4: Cripple wall between footings and lower level floor framing

- Add posts and concrete pedestals to the perimeter of the building at 8 feet O.C.. This will reduce the 10 foot spans of the 6x8 beams and provide adequate capacity for the 100 psf live load.
- Add sill anchors to the cripple wall at 24 inches O.C. to provide lateral connectivity to the foundation
- Add hold-downs to the foundation, with ties between the cripple wall and the shear walls above.
- Add positive anchorage between posts in crawlspace and foundation by bolting framing to foundation.
- Add positive connection/brackets between all beams and posts in crawlspace.

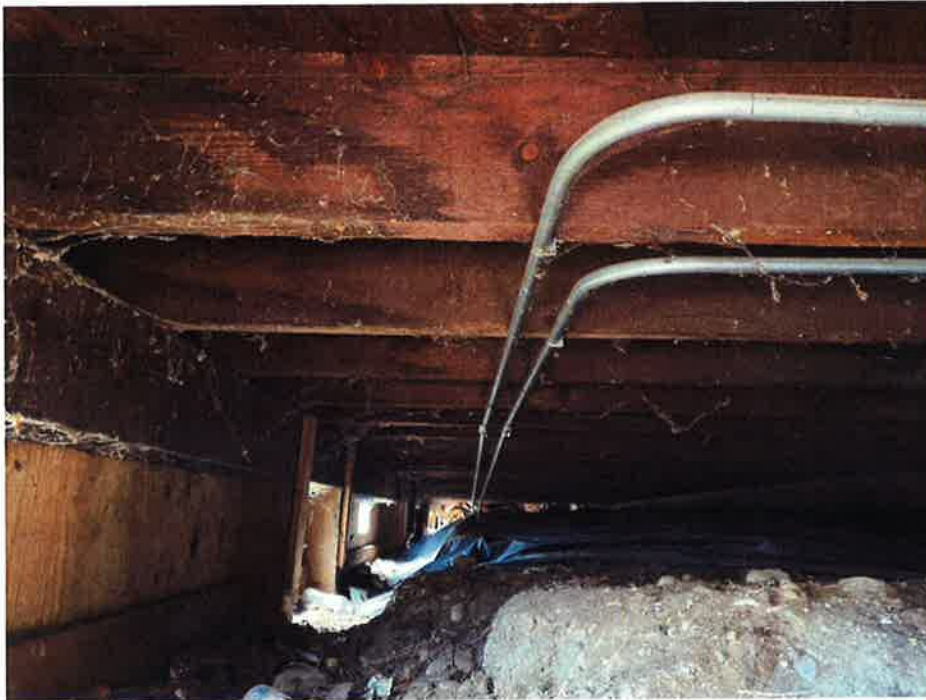
The ground floor joists were found to be adequate for the specified loads. Typical 6x8 floor beams were found to be adequate for the specified loads, however beams with 10 foot spans were found to be deficient. Beams with 10 foot spans had a demand to capacity ratio of about 1.5, meaning the loads on the beam were 1.5 times the capacity of the same beam. Second story floor joists were also found to be deficient with a demand to capacity ratio of about 1.3.

Figure 5: Lower level floor joists with floor beams

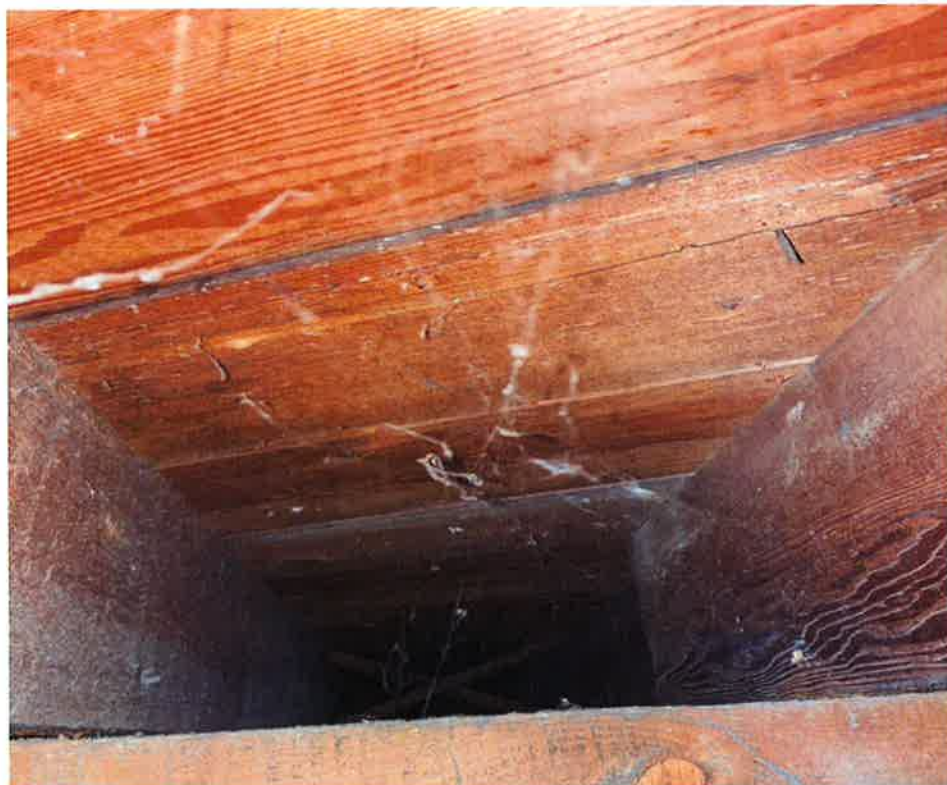
Figure 6: Floor Sheathing – 1x decking

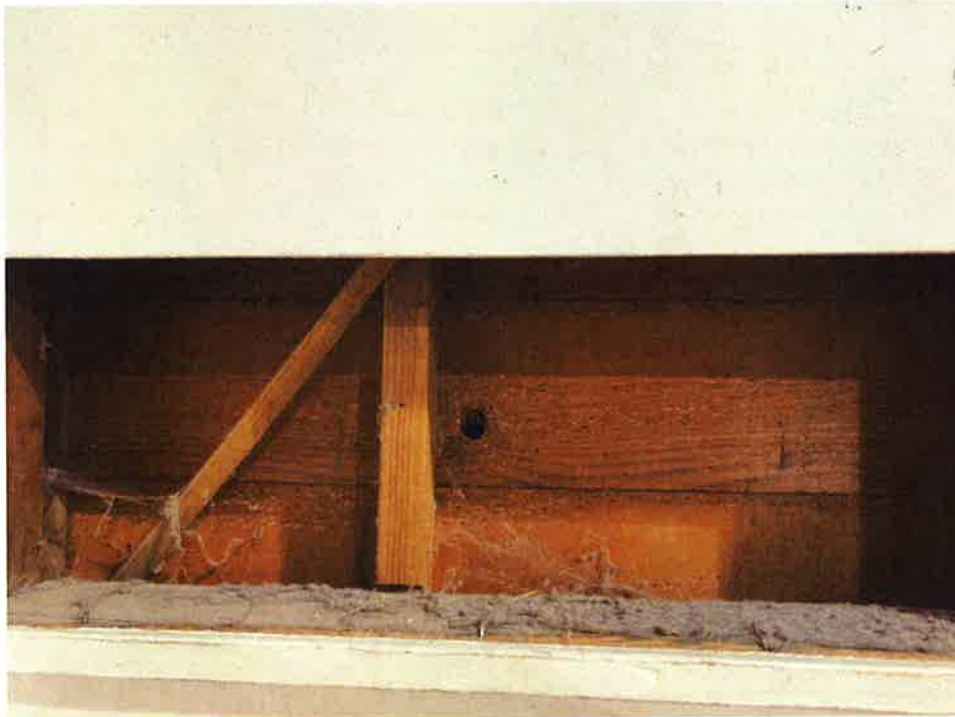
Typical wall framing for both interior and exterior walls is 2x6 framing at 16 inches O.C. (Figure-7). All the walls have 1x6 sheathing on the outside and 1x2 sheathing on the inside; both span horizontally and are attached to the wall studs with a staggered nailing pattern. In select locations, interior sheathing was removed to observe the framing and the sill plates. Generally, the framing appeared to be in good condition. In localized areas of the second floor of the west wing, some signs of minor water intrusion were observed with no signs of decay in the wood. The framing was not observed to be bolted to the foundation and appeared to have no hold-downs for the shear walls. All the windows on the north wall of the main hall had been removed and closed with plywood permanently.

The proximity to the water and the position on the slope of a hill create a high wind condition for the structure. The existing wall framing was found to be deficient for the wind loads, with a demand to capacity ratio of about 1.5.

Figure 7: Wall Farming – Wall studs w/ exteriors 1x decking as sheathing

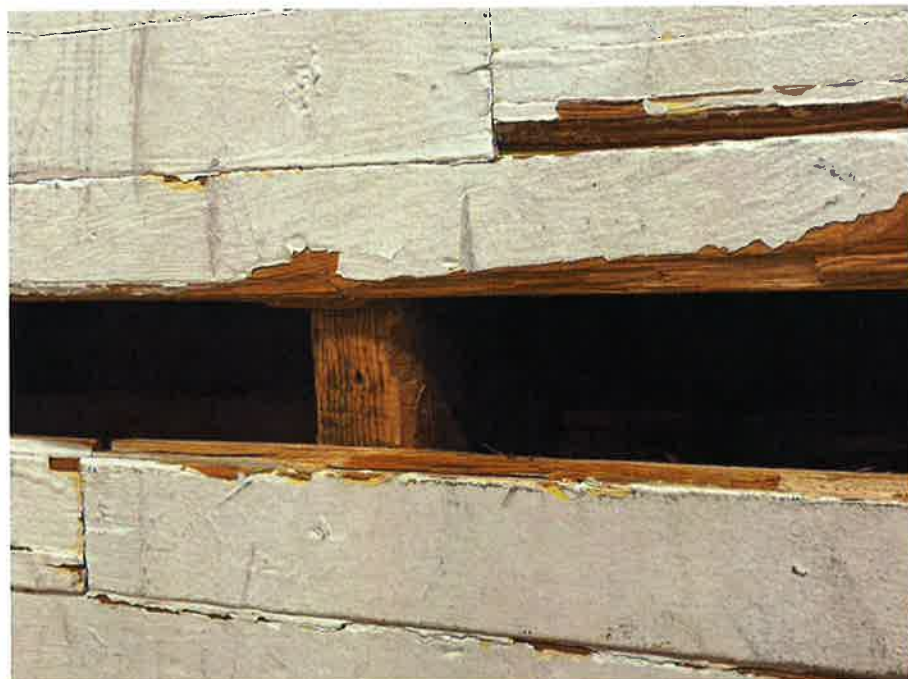
Figure 8: Wall Studs w/ Interior 1x decking

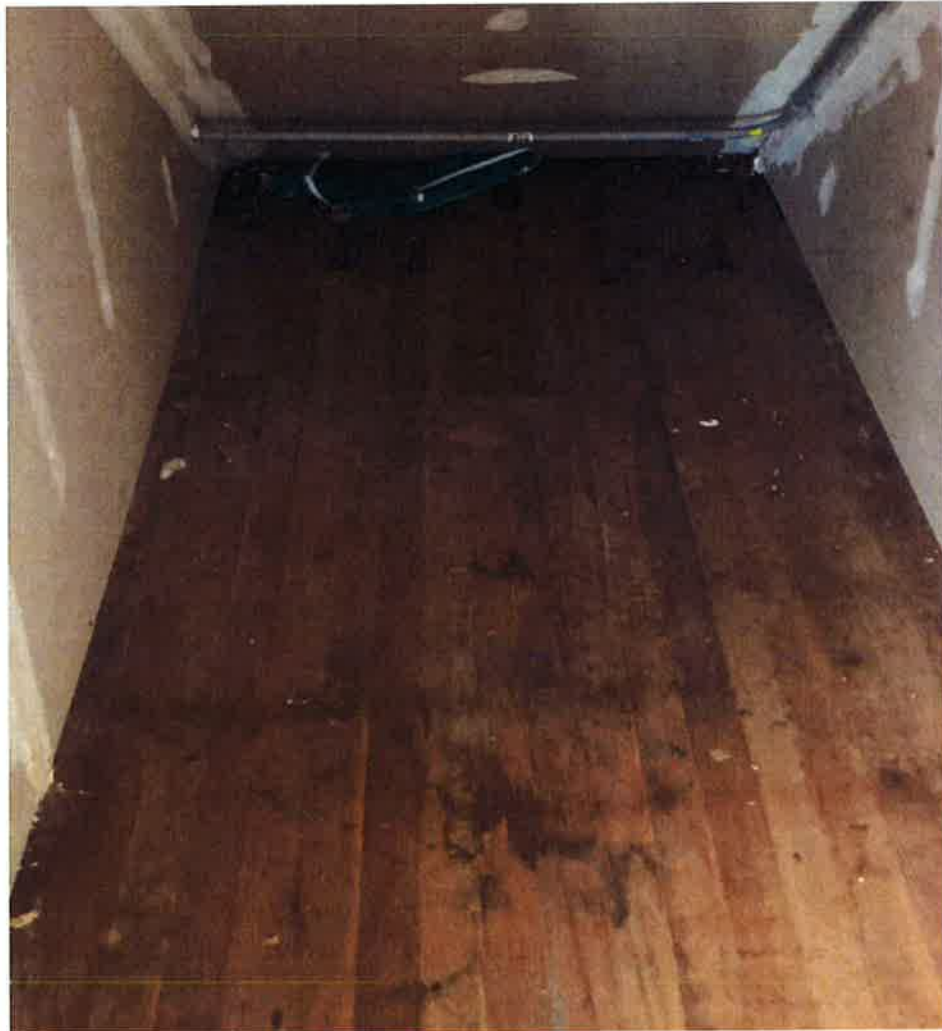
Figure 9: Upper Level Floor Framing – 1x decking over 2x12 floor joists

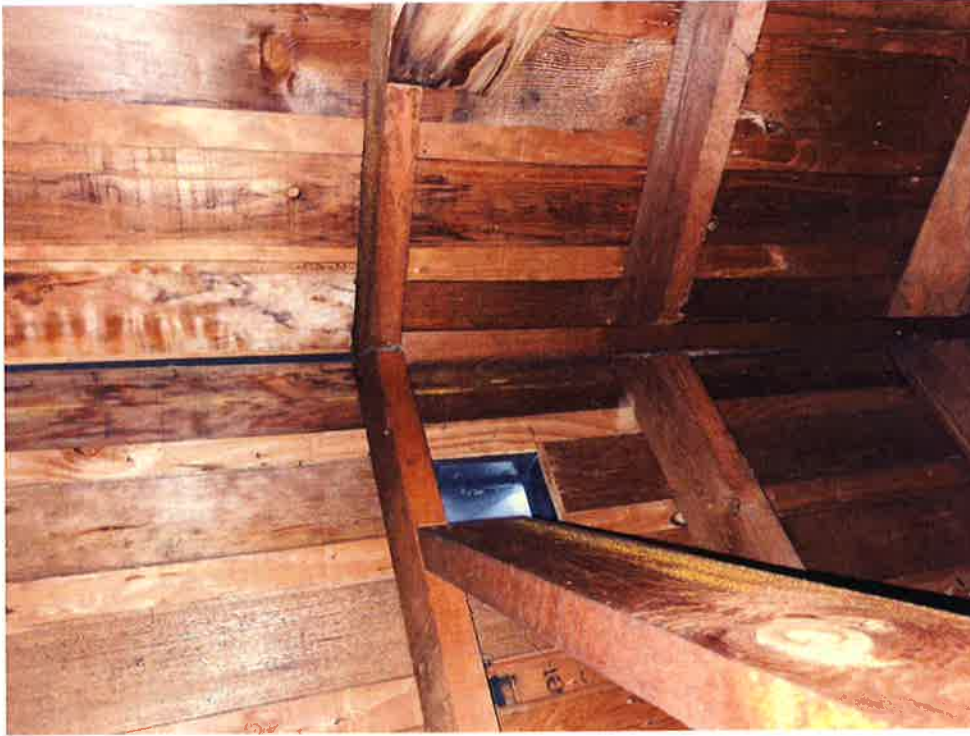
The lateral resisting system for the building consists of a plywood roof diaphragm (Figure-10) over the entire roof which is sheathed with ½ plywood and all the exterior walls which are sheathed with 1x6 decking (Figure-7). The forces are then transmitted down through the exterior shear walls by anchorage of the sill plates to the concrete foundations. Our analysis indicates that both in the longitudinal and transverse directions, the demands on the end shear walls and anchorages have demand to capacity ratios higher than 1.0 and therefore we recommend upgrades.

Figure 10: Roof Sheathing – 1x decking under 1/2" plywood.

- Add straps at joints and openings on the roof diaphragm.
- Add blocking and light gauge clips along perimeter of roof to attach roof diaphragm to shear walls.
- Add plywood sheathing (15/32 inch minimum) with rigid nailing pattern (4 inch minimum) at all exterior walls to increase lateral capacity.
- Add hold-downs at the end of each shear wall.
- Anchor hold-downs to foundation with posts and straps at cripple wall.
- Provide seismic anchorage of shear walls to sill plates and sill plates to the foundations meeting seismic requirements of latest building codes.
- Strap chimney to building and reduce chimney heights above roof.

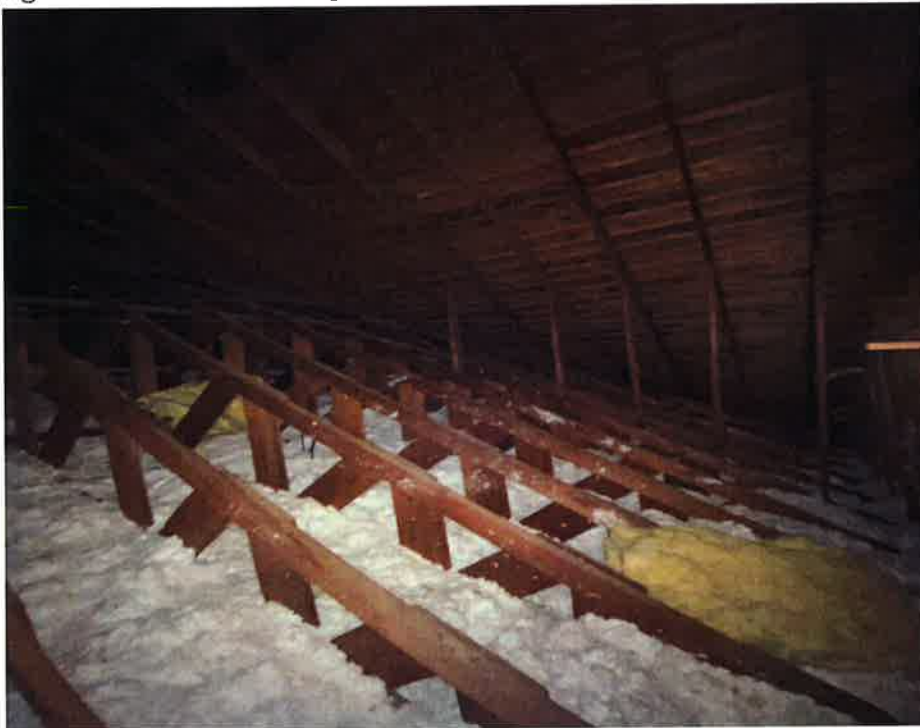
Figure 11: Roof Framing – Truss A w/ Over framing & vertical supports

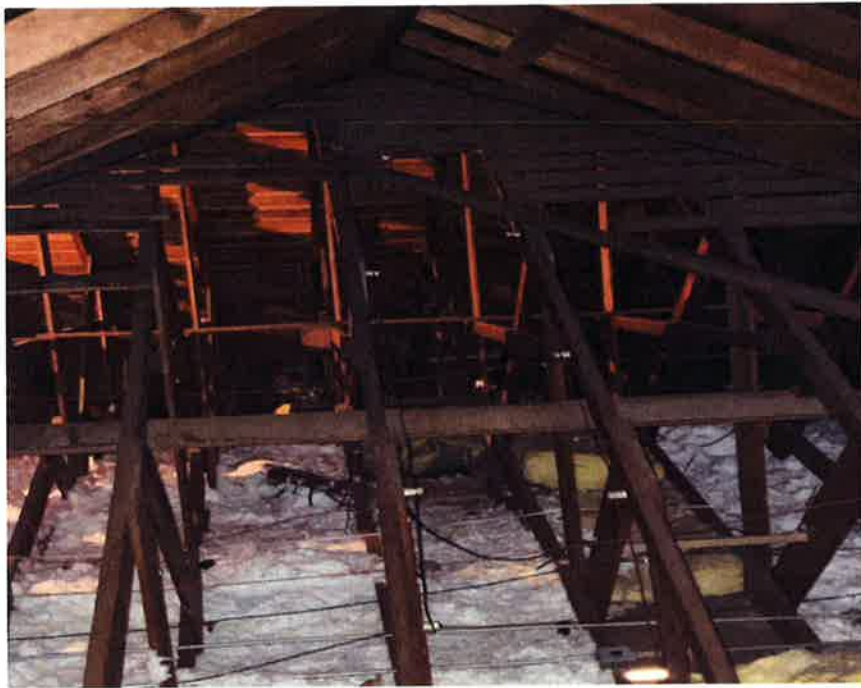
The trusses in the main hall (Truss Type A and B) were found to have a demand to capacity ratio of about 1.5. The critical members are the 1x web members. Additionally, the top chord of Truss B was found to have a demand to capacity ratio of 1.3.

Figure 12: Roof Framing – Truss A

- Truss Types A and B – brace all 1x web members to limit the span length to 5 feet.
- Truss Type B – sister a 2x6 rafter next to the top chords (8 trusses).
- Truss Type C – add 2x6 rafters at 24 inches O.C. at truss tails on south side and at roof rafters at dormer on north side.
- Add clips for uplift anchorage at all trusses.
- At several locations – replace or sister damaged rafter tails at the eaves (approximately 70 percent of rafter tails)

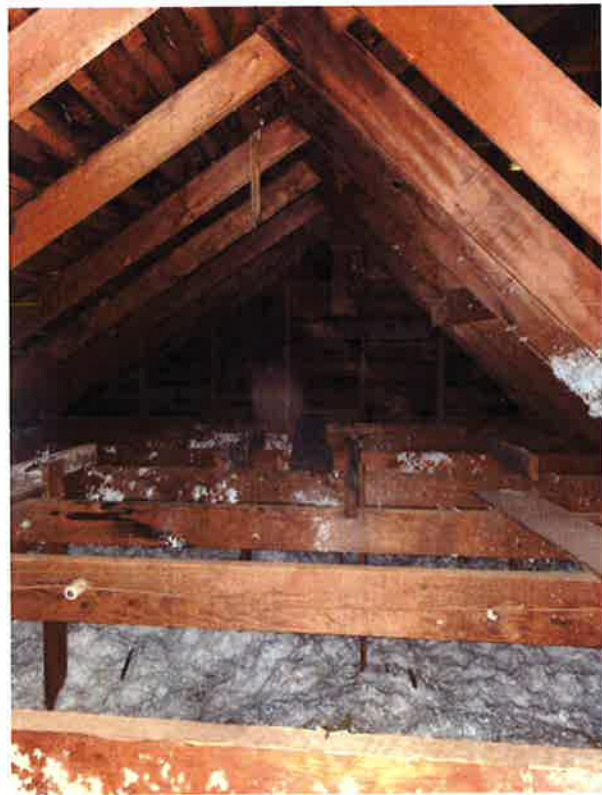
Figure 13: Roof Framing – Truss B

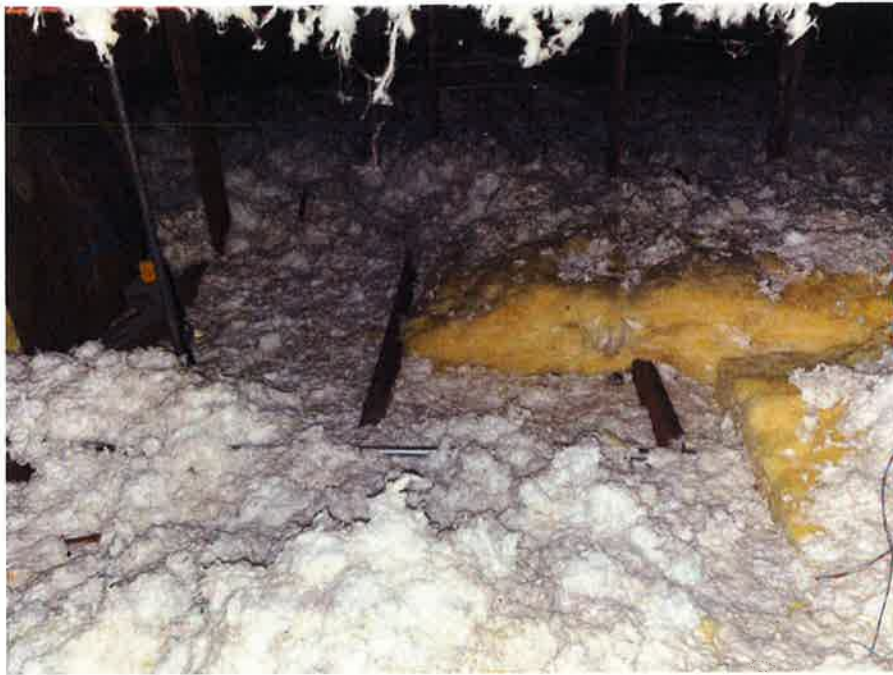
Figure 14: Roof Framing – Ceiling Joists under Truss B

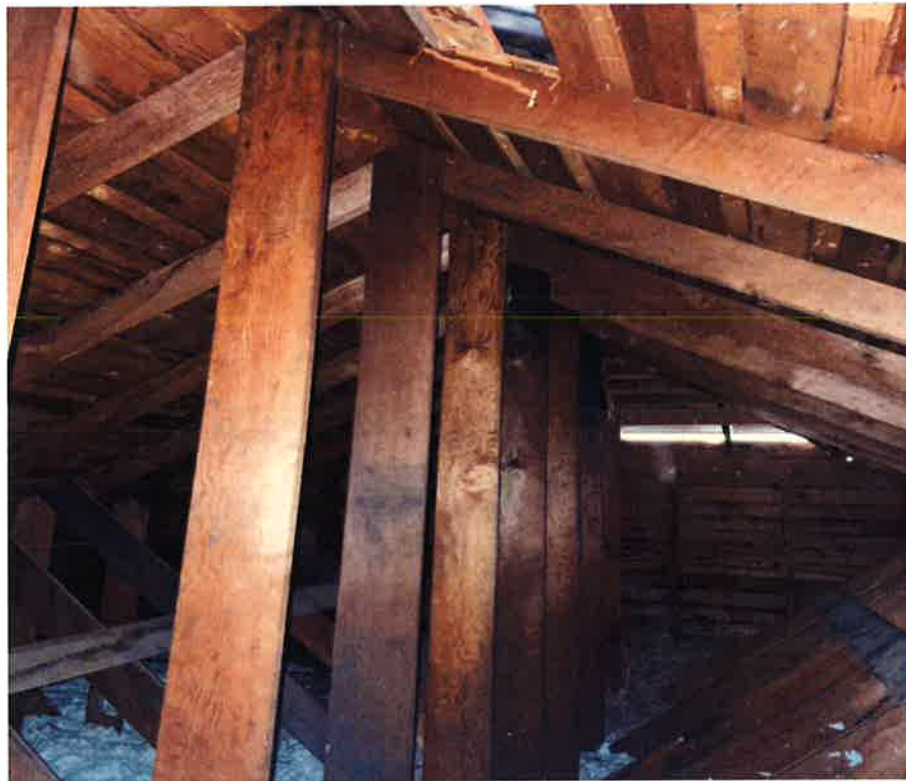
The trusses at the west wing (Truss Type C) were found to be deficient with a demand to capacity ratio of about 1.6. The rafters at the north end of this segment were found to be deficient with a demand to capacity ratio of about 1.5. The lack of support for the south intermediate bearing wall on the second floor (as discussed above) creates the sag in the roof as well as strength deficiencies.

Figure 15: Roof Framing – Truss C w/ 1x10 Web Members

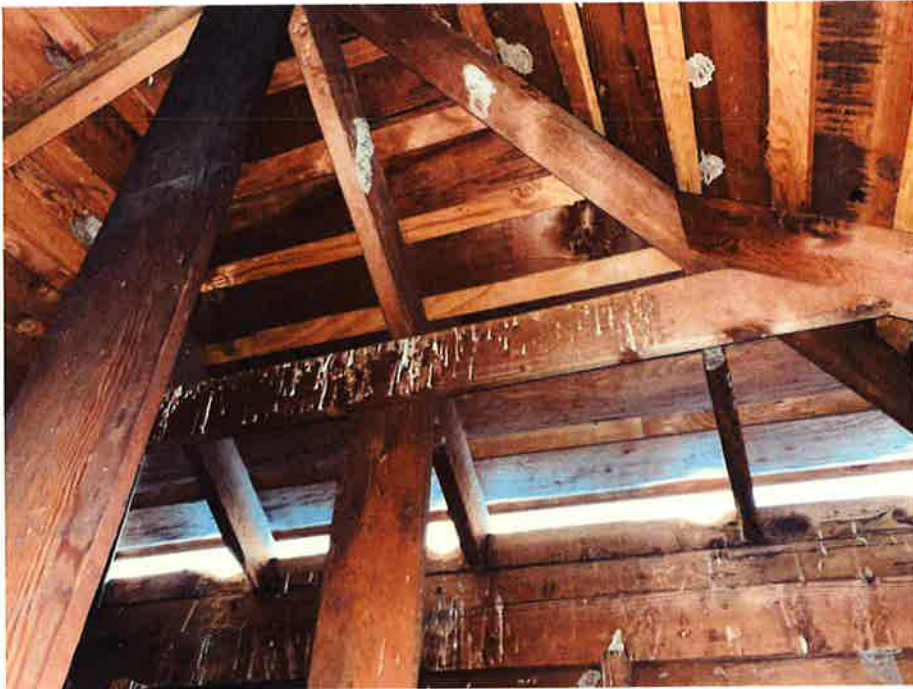
The roof is sheathed in 1/2-inch plywood and 1x decking which has been added after the original construction. There is a jerkinhead roof (Figure-15) at each end of the building; the jerkinhead roof features 2x6 framing in good condition. In several locations, the rafter tails have decayed and were sistered with new rafter tails (Figure-16) especially on the southwest side. All other roof and ceiling framing appeared to be in good condition with no signs of decay or distress.

Figure 15: Roof Framing – Truss C Dutch Gable End

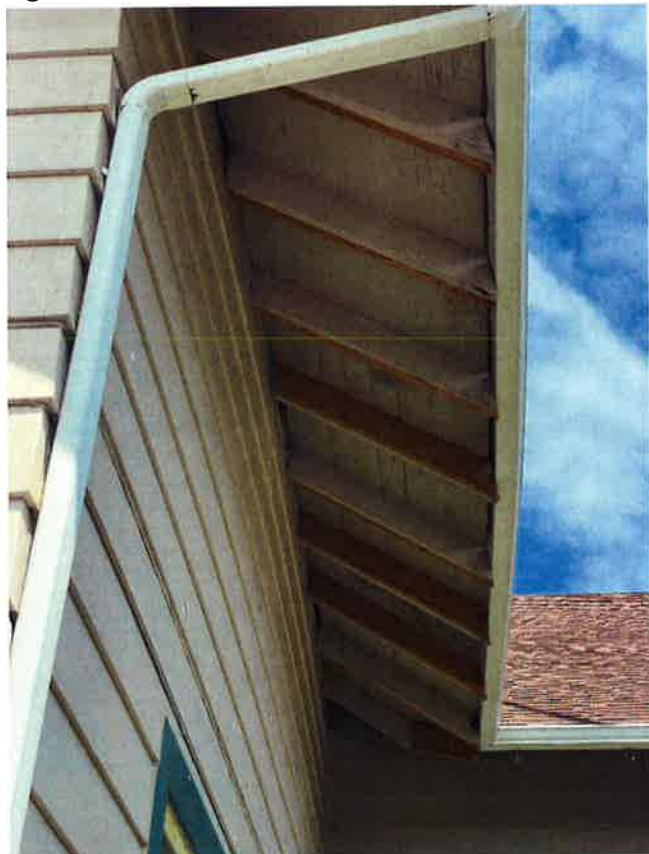
Figure 16: Roof Framing – Rafter Tails Failure and Sistered with new ones

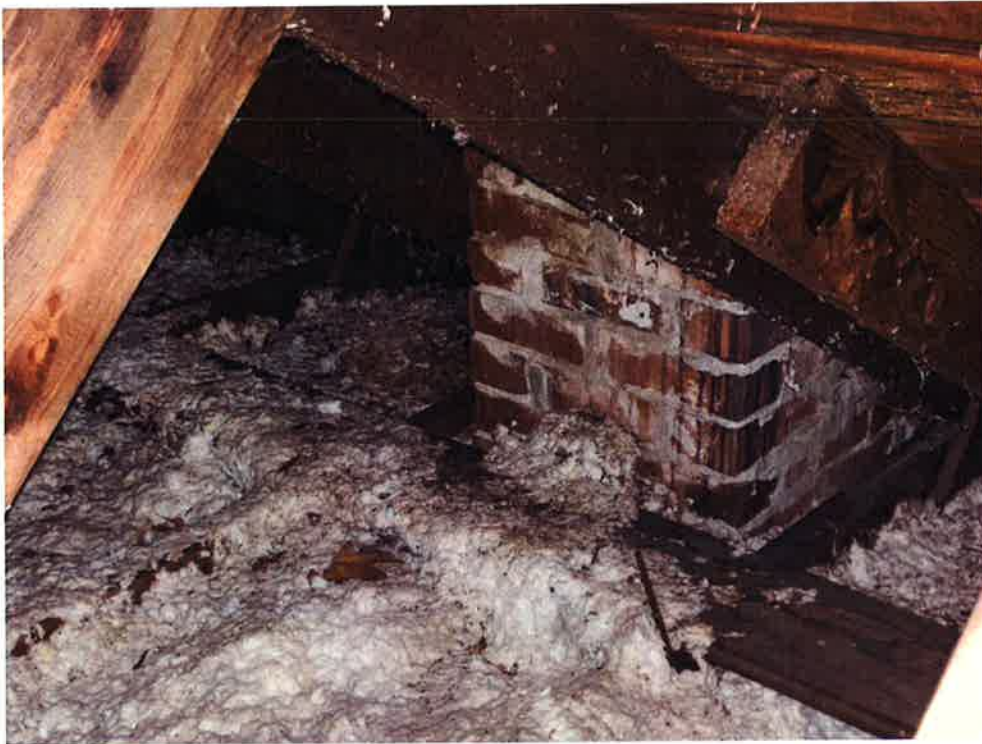
- Flexible Couplings – No flexible couplings on fire suppression or gas piping.
- Emergency Lighting – Not properly anchored/braced.
- Masonry Chimneys – No proper anchorage for masonry chimneys at each floor level.
- Suspended Equipment – Equipment suspended does not have adequate lateral bracing to accommodate free swing without causing any damage.
- Electrical Equipment – Not laterally braced to the structure.
- Fluid/Gas Piping – Does not have flexible couplings.

Figure 17: Chimney – No lateral bracing
