AMERICAN GEOSERVICES

Geotechnical Evaluation Report

Parcel#28040300203200, Mukilteo, Snohomish County,
Washington

Reference: Landslide Evaluation Report, Parcel # 28040300203200, Mukilteo, Snohomish County, WA

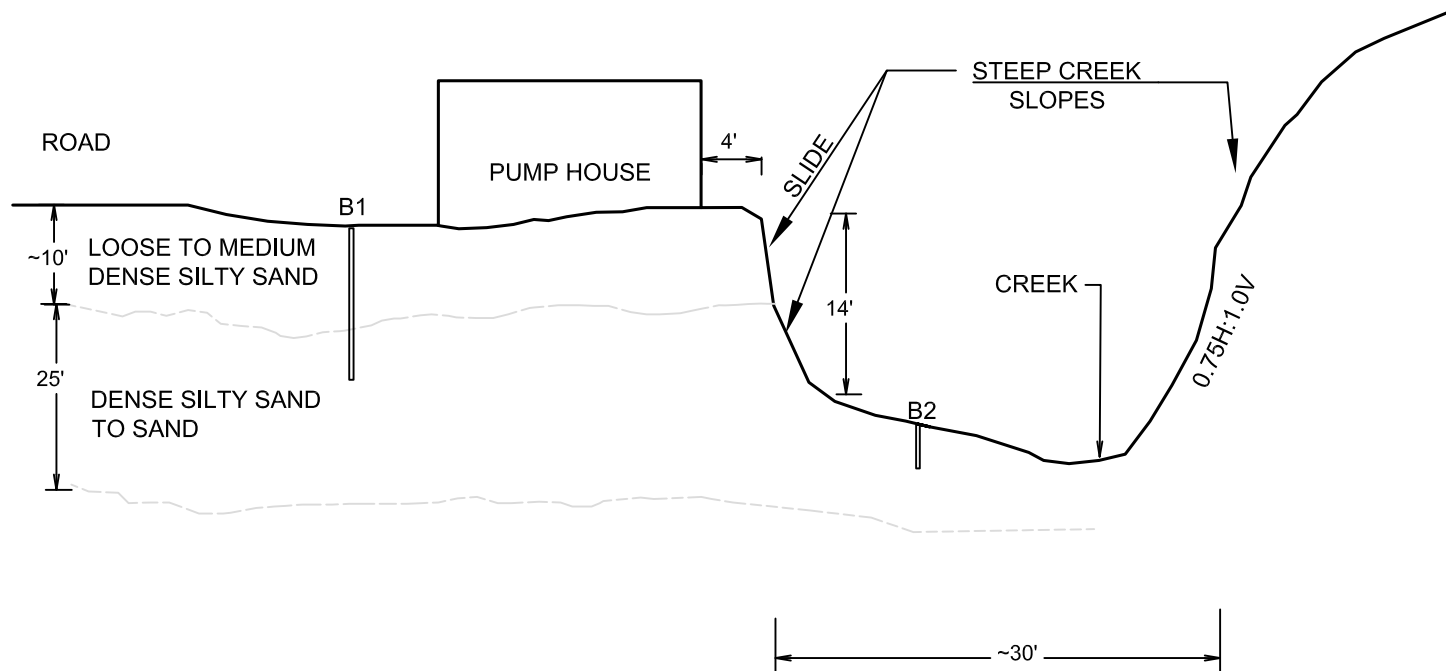
FIGURE 2B: GENERALIZED
CROSS-SECTION

See Figures 2A and 2B for surface conditions and a generalized cross-section of the site. See attached photographs included in an appendix for further details on the surficial site conditions.
