# **GEOSPECTRUM CONSULTANTS, INC.**

November 27, 2017

**SUBJECT: GEOTECHNICAL RECONNAISSANCE**  
Residential Property Development  
Snohomish County Parcel No. 00408600400  
100XX 63<sup>rd</sup> Place West  
Mukilteo, Washington  
Project No. 17-114-01

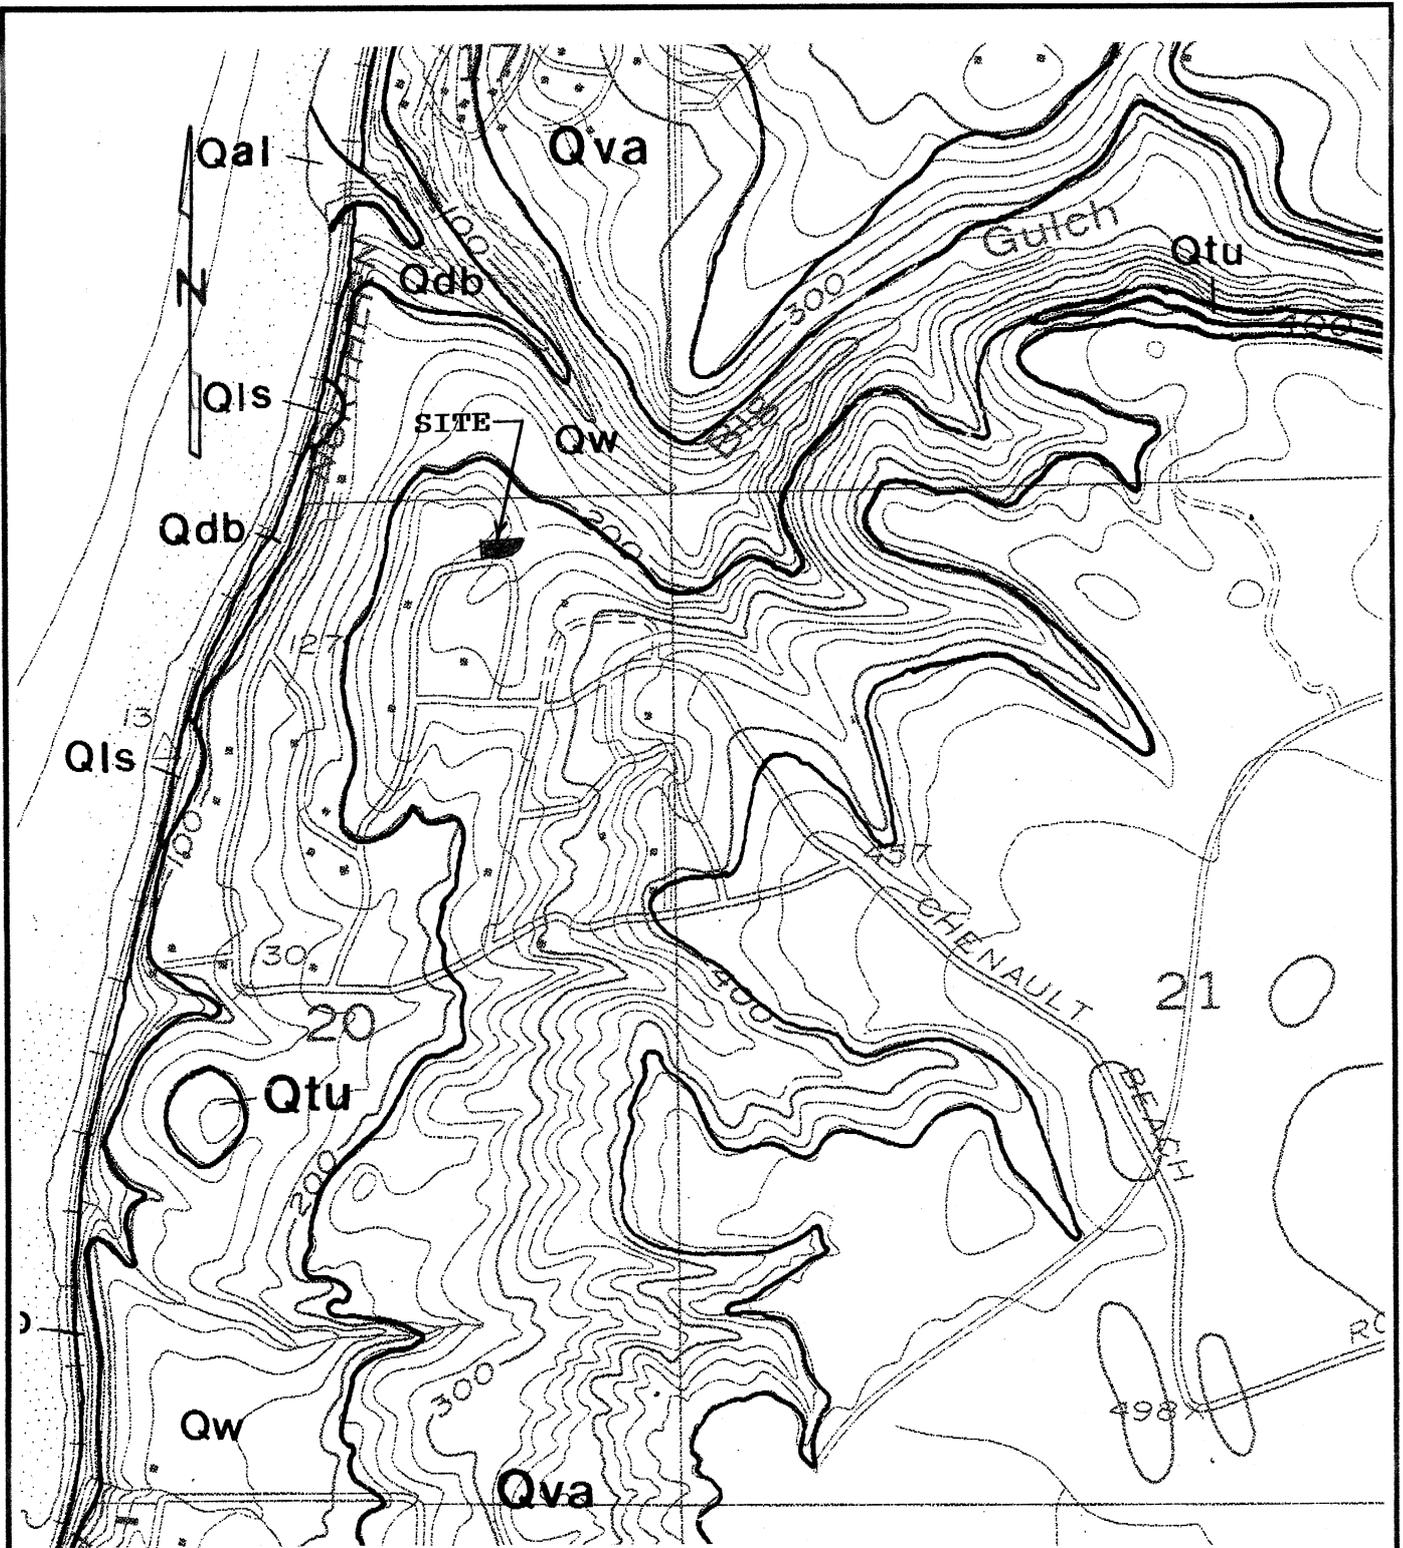
The referenced geologic map of Figure 1 indicates the site to expose advance outwash (Qva) soils deposited during the advance of the Vashon glaciation, the last glacial advance into the Puget Sound area, approximately 13,000 to 16,000 years ago. The referenced map describes the Qva soils as mostly sand and gravel deposits but fine grained sand and silt deposits are common in lower part of the unit. Based on the soils observed on the site and the fact that the site lies within the lower part of the mapped limits of Qva deposits shown on the referenced map, it is our opinion that the natural subsoils underlying the subject property are fine grained sand and silt Qva deposits.

Slope Stability: The City of Mukilteo landslide hazard map provided to us indicates the site is mapped within a "Moderate" landslide hazard area. The geologic map of Figure 1 indicates no mapped landslides within the site vicinity but the topography of Figures 2 and 3 and our own observations indicate that the site does contains steep to very steep slopes within the central and northeastern area of the lot. Therefore the lot is considered to be a Geologic Sensitive Area and development must comply with the regulations presented in Chapter 17.52A of the Mukilteo Municipal Code (MMC).

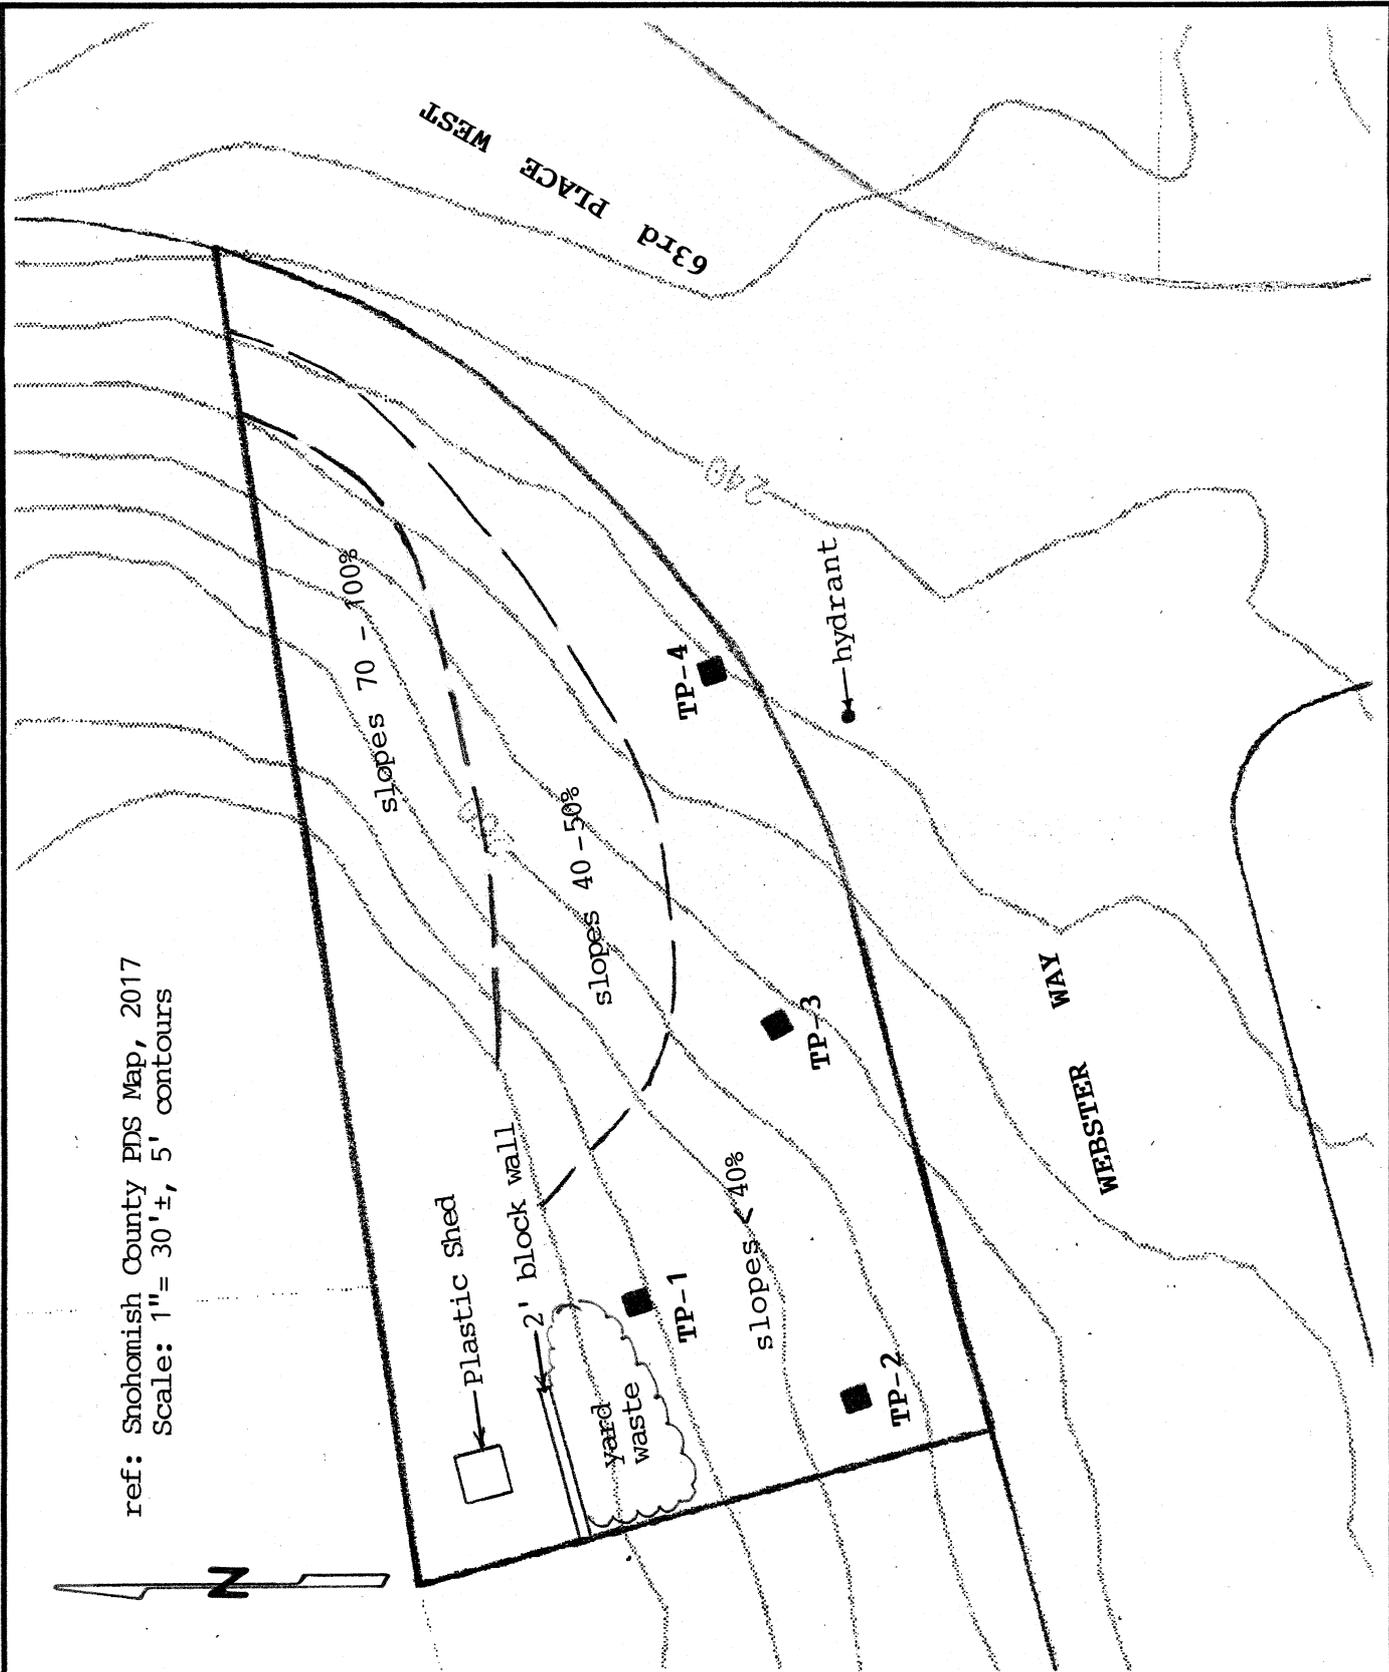
Proj. No.17-114	Date 11/17	Figure 3
-----------------	------------	----------

Figure 3 shows that the subject lot includes a relatively flat lying area in the northwest corner above moderately sloped areas to the southwest and steep to very steep slopes in the northeast area. Based on the topography of Figure 3, the subject property has about 35+ feet of elevation difference across the lot from the NE corner to the NW corner. The topography shown on Figure 3 and our own supplemental measurements indicates gradients of the subject lot range from moderate slopes of about 25 to 35 percent along the west side increasing to steep to very steep slopes of 40 to 100+

We also noted a plastic storage shed and a 2 ft high landscape block wall in the relatively flat lying area above the slope at the NW corner of the lot as shown in Figure 3 as well as a thick layer of yard waste debris near the top of slope in the NW corner also shown on Figure 3.

Subsurface conditions were explored by four test pits excavated within the subject lot at the approximate locations shown on Figure 3. More detailed descriptions of the subsurface conditions encountered at each test pit as well as laboratory test results are presented in Appendix A.

slope areas is a lateral boundary as approximately shown on Figure 3. Considering that the boundary with the steep slope area is lateral, in our opinion development related site disturbance of the moderately sloped area may extend to the edge of the steep slope area provided the disturbed areas are stabilized after construction, but we recommend that structure foundations be set back at least 10 feet from the edge of the steep slope area or greater as required for temporary construction excavations per our recommendations in this report. Therefore for "Reasonable Use" provision considerations for the subject lot our recommended minimum steep slope buffer would be zero and our recommended minimum buffer setback would be 10 feet.

With regard to the potential for shallow surface failures, it is our opinion that the potential for shallow failures within the western moderate gradient area of the lot area is low but potential for shallow failures within the central steep slope area (gradients 40% to 50%) is moderate and the potential for shallow failures within the northeastern very steep slope area (gradients 70% to 100%) is high. The risk of shallow slope failures will generally be greatest during periods of heavy rainfall and/or seismic loading conditions. Reduction or elimination of the apparent Marmot population on the lot will reduce the disturbance of the shallow slope soils and reduce water infiltration into the shallow soils which will reduce the potential for shallow slope failures. Removal of the yard waste debris is also recommended to reduce the slope load.

Slope Buffers and Structure Setbacks: We do not recommend development or disturbance of the steep to very steep slope areas of the site. Development should be limited to the moderately sloped areas of the subject lot (slope gradients less than 40%) which are generally in the western 1/3 of the lot and along the southern boundary as shown in Figure 3. In general to minimize development risk, structures should be set back from the top and toe of steep to very steep slopes as far as possible within the constraints of the development plans.
