Arborist Report

December 2019

Mietzner Mukilteo, LLC

7902 44th Ave. W
Mukilteo, WA

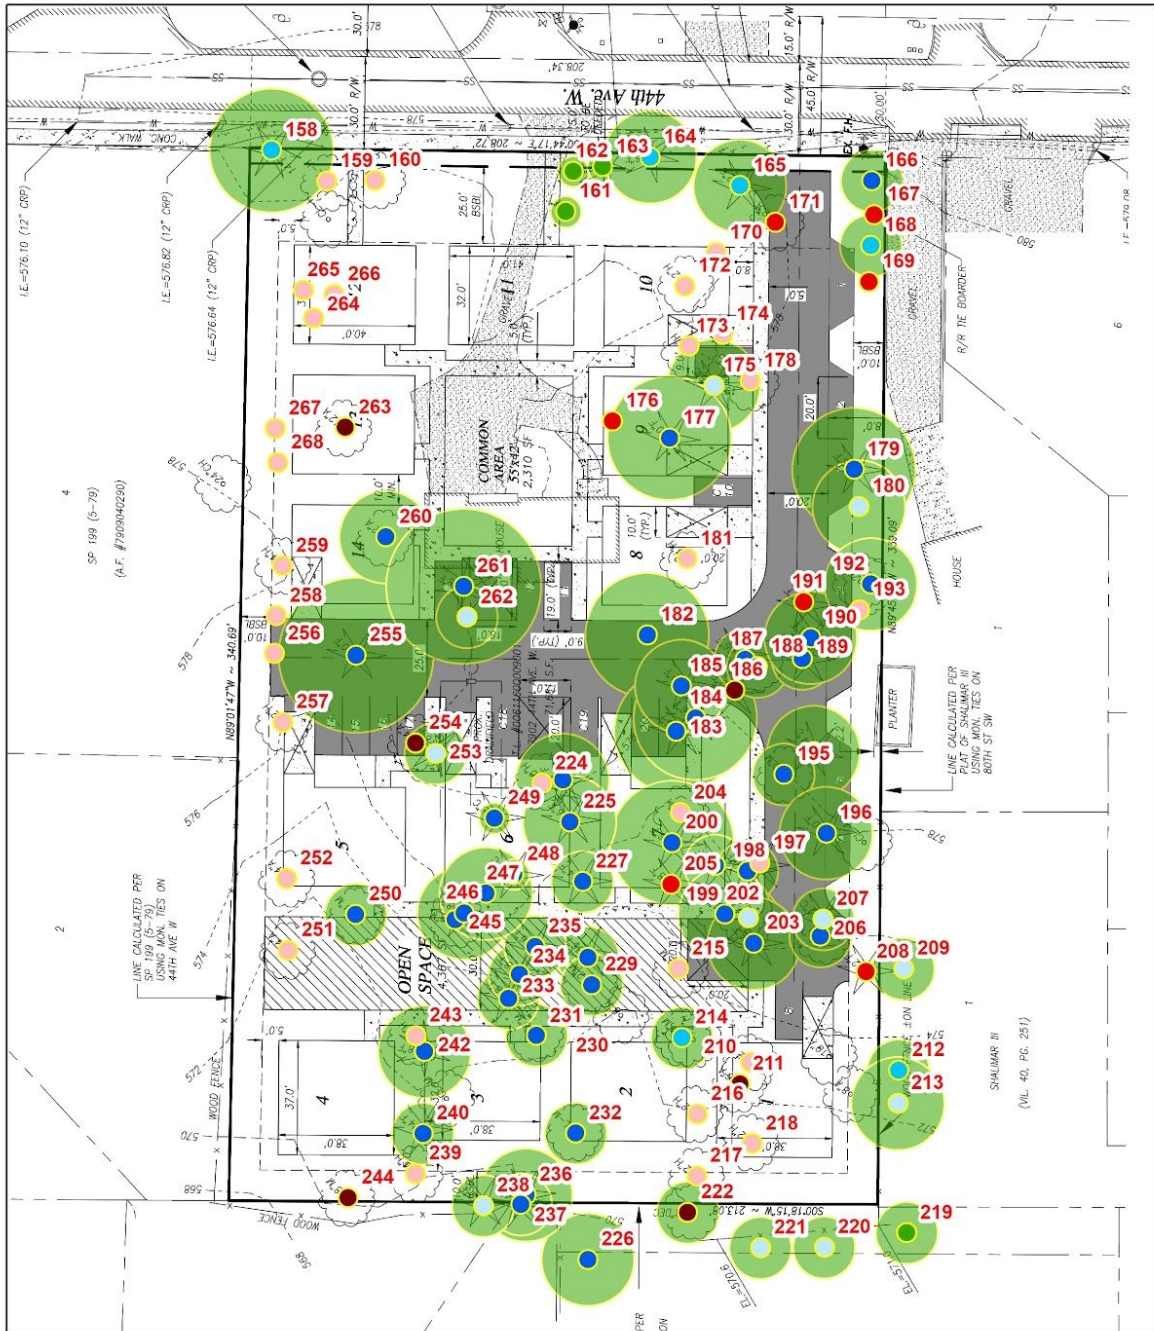
Map 1. Site map showing tree id number, TPZ, and average canopy dimensions.

ID	Owner	Species	DBH (in)	Height (ft)	Avg. Canopy Radius (ft)	SRZ Radius (ft)	Condition	Preservation Priority	Maintenance Task	Maintenance Detail(s)	Observations
158	Client	Douglas-fir (Pseudotsuga menziesii)	43	120	20	4	Fair	2	Priority 2 Prune	Crown Clean, Raise	Large Deadwood (+3"), Overhead Utilities, Poor Structure
159	Client	Holly, English (Ilex aquifolium)	9	20	5	4	Fair	4	Priority 3 Removal	Invasive	Onesided, Codominant Stem, Poor Structure
160	Client	Holly, English (Ilex aquifolium)	12	20	5	4	Poor	4	Priority 3 Removal	Invasive	Narrow Crown, Small Deadwood (-3"), Poor Structure, Sapsucker
161	Client	Arborvitae (Thuja spp.)	12	15	5	4	Poor	3	No Priority		Small Deadwood (-3"), Codominant Stem, Compacted Soils, Lean, Topped, Hedge
162	Client	Arborvitae (Thuja spp.)	8	15	5	4	Poor	3	No Priority		Small Deadwood (-3"), Codominant Stem, Compacted Soils, Lean, Topped, Hedge
163	Client	Arborvitae (Thuja spp.)	14	15	5	4	Poor	3	No Priority		Small Deadwood (-3"), Codominant Stem, Compacted Soils, Lean, Topped, Hedge

164	Client	Douglas-fir (Pseudotsuga menziesii)	43	120	15	4	Poor	3	Priority 2 Prune	Crown Clean, Raise	Large Deadwood (+3"), Narrow Crown, Poor Structure, Broken Limbs, Vines

ID	Owner	Species	DBH (in)	Height (ft)	Avg. Canopy Radius (ft)	SRZ Radius (ft)	Condition	Preservation Priority	Maintenance Task	Maintenance Detail(s)	Observations
165	Client	Douglas-fir (Pseudotsuga menziesii)	46	120	15	4	Fair	2	Priority 2 Prune	Crown Clean, Raise	Large Deadwood (+3"), Narrow Crown, Poor Structure, Broken Limbs, Vines
166	Client	Alder, Red (Alnus rubra)	22	55	10	4	Poor	3	Priority 1 Prune	Reduce	Large Deadwood (+3"), Onesided, Poor Structure, Broken Limbs, Vines, Trunk Decay, Lean, Codominant Stem, Included Bark
167	Client	Cherry (Prunus spp.)	12	50	10	4	Poor	4	Priority 2 Removal	Remove	Large Deadwood (+3"), Onesided, Poor Structure, Broken Limbs, Stressed, Trunk Decay, Lean
168	Client	Cherry (Prunus spp.)	14	50	10	4	Poor	3	Priority 2 Prune	Crown Clean	Large Deadwood (+3"), Onesided, Poor Structure, Broken Limbs, Stressed, Trunk Decay, Lean
169	Client	Cherry (Prunus spp.)	14	50	10	4	Critical	4	Priority 2 Removal	Remove	Large Deadwood (+3"), Onesided, Poor Structure, Broken Limbs, Stressed, Trunk Decay, Lean

170	Client	Holly, English (Ilex aquifolium)	9	20	5	4	Poor	4	Priority 3 Removal	Invasive	Narrow Crown, Small Deadwood (-3"), Poor Structure, Codominant Stem
171	Client	Cherry (Prunus spp.)	16	50	10	5	Very Poor	4	Priority 2 Removal	Remove	Large Deadwood (+3"), Onesided, Poor Structure, Broken Limbs, Stressed, Trunk Decay, Lean, Codominant Stem

ID	Owner	Species	DBH (in)	Height (ft)	Avg. Canopy Radius (ft)	SRZ Radius (ft)	Condition	Preservation Priority	Maintenance Task	Maintenance Detail(s)	Observations
172	Client	Holly, English (Ilex aquifolium)	13	20	5	5	Very Poor	4	Priority 3 Removal	Invasive	Narrow Crown, Small Deadwood (-3"), Poor Structure, Codominant Stem, Vines
173	Client	Holly, English (Ilex aquifolium)	10	20	5	5	Very Poor	4	Priority 3 Removal	Invasive	Narrow Crown, Small Deadwood (-3"), Poor Structure, Codominant Stem, Vines
174	Client	Holly, English (Ilex aquifolium)	10	20	5	5	Very Poor	4	Priority 3 Removal	Invasive	Narrow Crown, Small Deadwood (-3"), Poor Structure, Codominant Stem, Vines
175	Client	Cedar, Western-red (Thuja plicata)	33	100	15	5	Fair	2	Large Tree Routine Prune	Structural Prune	Large Deadwood (+3"), Narrow Crown, Poor Structure, Onesided, Root Collar Buried
176	Client	Douglas-fir (Pseudotsuga menziesii)	51	120	15	5	Very Poor	4	Priority 2 Removal	Remove	Large Deadwood (+3"), Narrow Crown, Poor Structure, Broken Limbs, Vines, Suppressed, Stressed

- Tree protection fencing shall be installed outside the dripline of all neighboring significant trees where their canopies extend onto the subject property. Maintenance for neighboring trees was recommended but will not be completed by the client.
- All of the English holly were recommended for removal (29 trees)
- Fourteen (14) trees are recommended for removal based on condition. These trees are poor candidates for preservation.
- Site plans should be adjusted according to the updated tree data to achieve the optimal retention rate of 25%.
- Pruning is recommended for the retained trees prior to the installation of tree protection fencing.
- Trees will be selected for preservation based on construction impacts to the root zone once development plans have been finalized.
