## **CRITICAL AREA STUDY & MITIGATION PLAN**

**MUNDORF – 8<sup>TH</sup> ST**  
**MUKILTEO, WA**

*Wetland Resources, Inc. Project #16233*

July 21, 2017

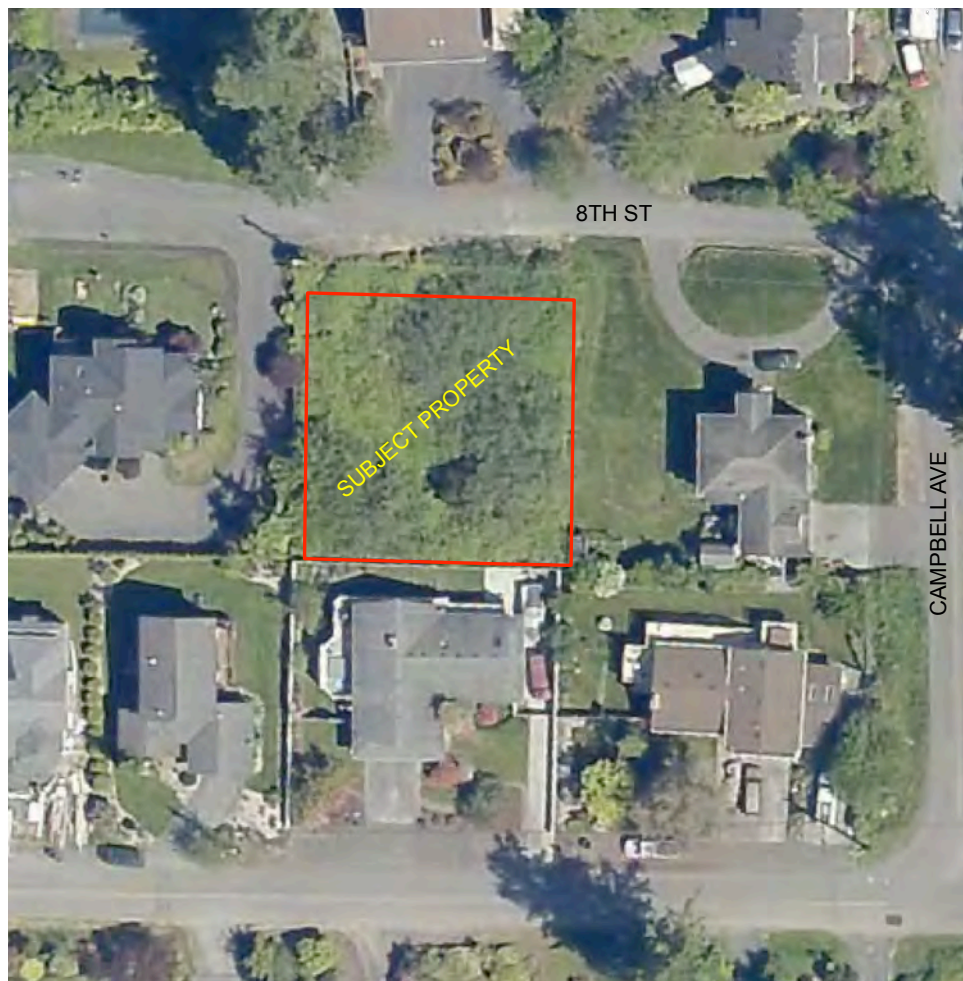
**Figure 1:** Aerial view of the subject property

The 0.23-acre subject property is further located as a portion of Section 4, Township 28N, Range 04E, W.M. The subject site is square in shape and is comprised of one tax parcel. The tax identification number for the subject site is 00527503900500. The intent of this document is to characterize all identified critical areas and buffers in the vicinity of the subject property, assess potential impacts associated with the applicant's development proposal, and provide mitigation adequate to compensate for all proposed impacts.

Access to the subject property is from the north via 8<sup>th</sup> St. The property is undeveloped, and no buildings or foundations were found. A stormwater pipe was located onsite near the southeast corner of the subject property. This pipe is presumed to be a point discharge from the neighboring property's French drain. Surrounding property use can be described as single-family residential development.

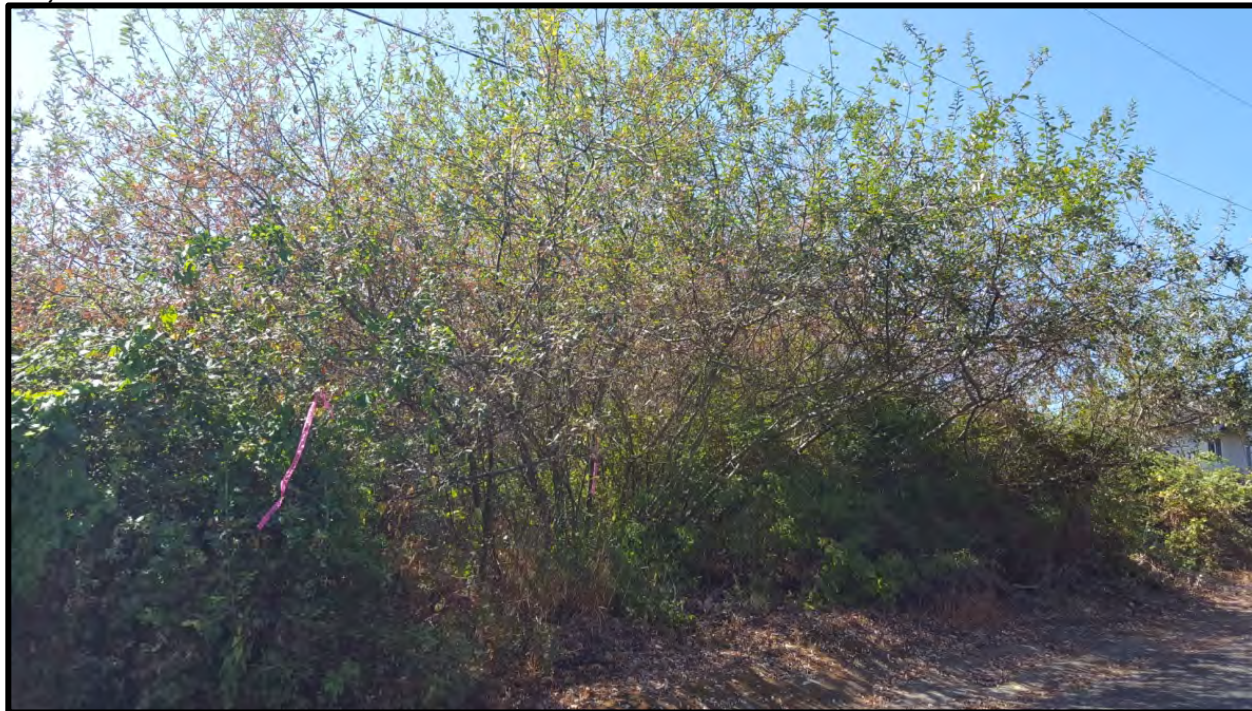
Wetland A is a sloped feature located on the eastern side of the subject site. Dominant vegetation within the wetland includes Sitka willow (*Salix sitchensis*), Himalayan blackberry (*Rubus armeniacus*), Nootka rose (*Rosa nutkana*), and creeping buttercup (*Ranunculus repens*). Soils within the wetland are generally very dark grayish brown (10YR 3/2) sandy clay loam with dark yellowish brown (10YR 4/6) redoximorphic features. Soils sampled in the northern portion of the wetland contain a sublayer of dark gray (10YR 4/1) sandy loam with strong brown (7.5YR 5/8) redoximorphic features. These soil characteristics are consistent with the Redox Dark Surface (F6) and Depleted Below Dark Surface (F7) hydric soil indicators listed in the 2010 Regional Supplement. Soils were saturated at 10 inches below the surface following a long period without rainfall, during our August 2016 site visit (A total of 0.40 inches of precipitation total for the month of August). Additionally, the geomorphic position and sparsely vegetated areas within the interior of the wetland meet secondary indicators for wetland hydrology.

The dominant species rate “facultative” or wetter, indicating that a hydrophytic vegetative community is present in the areas mapped as wetland.

Field observations indicate that the area mapped as wetland is flooded, ponded, or saturated long enough during the growing season to develop anaerobic conditions in the upper part of the soils. Therefore, the vegetation, soil, and hydrologic criteria are all met for the on-site wetland.

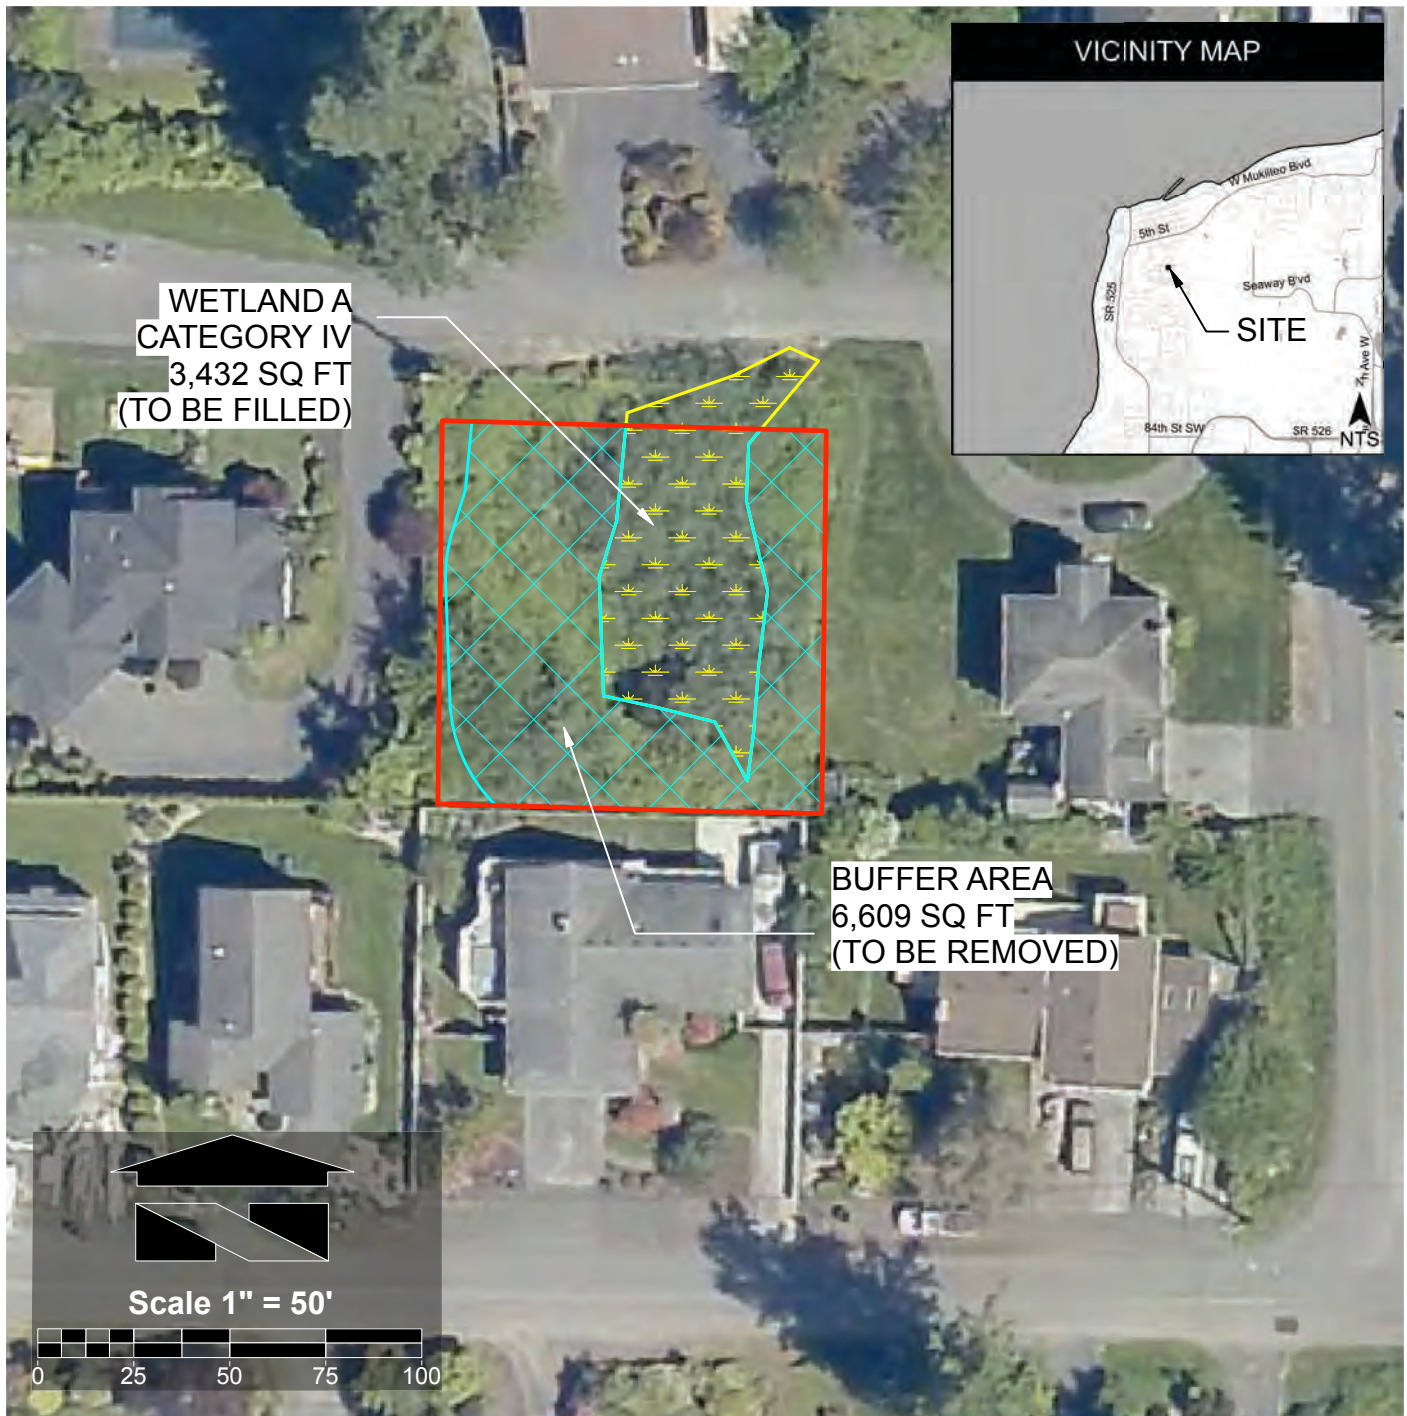
EXISTING CONDITIONS MAP

PORTION OF SECTION 4, TOWNSHIP 28N, RANGE 4E, W.M.
