Small Site Drainage Report Mundorf SFR

8XX 8th St
Mukilteo, WA 98275
Tax ID: 00527503900500

Job No: 19-1024
January 2020

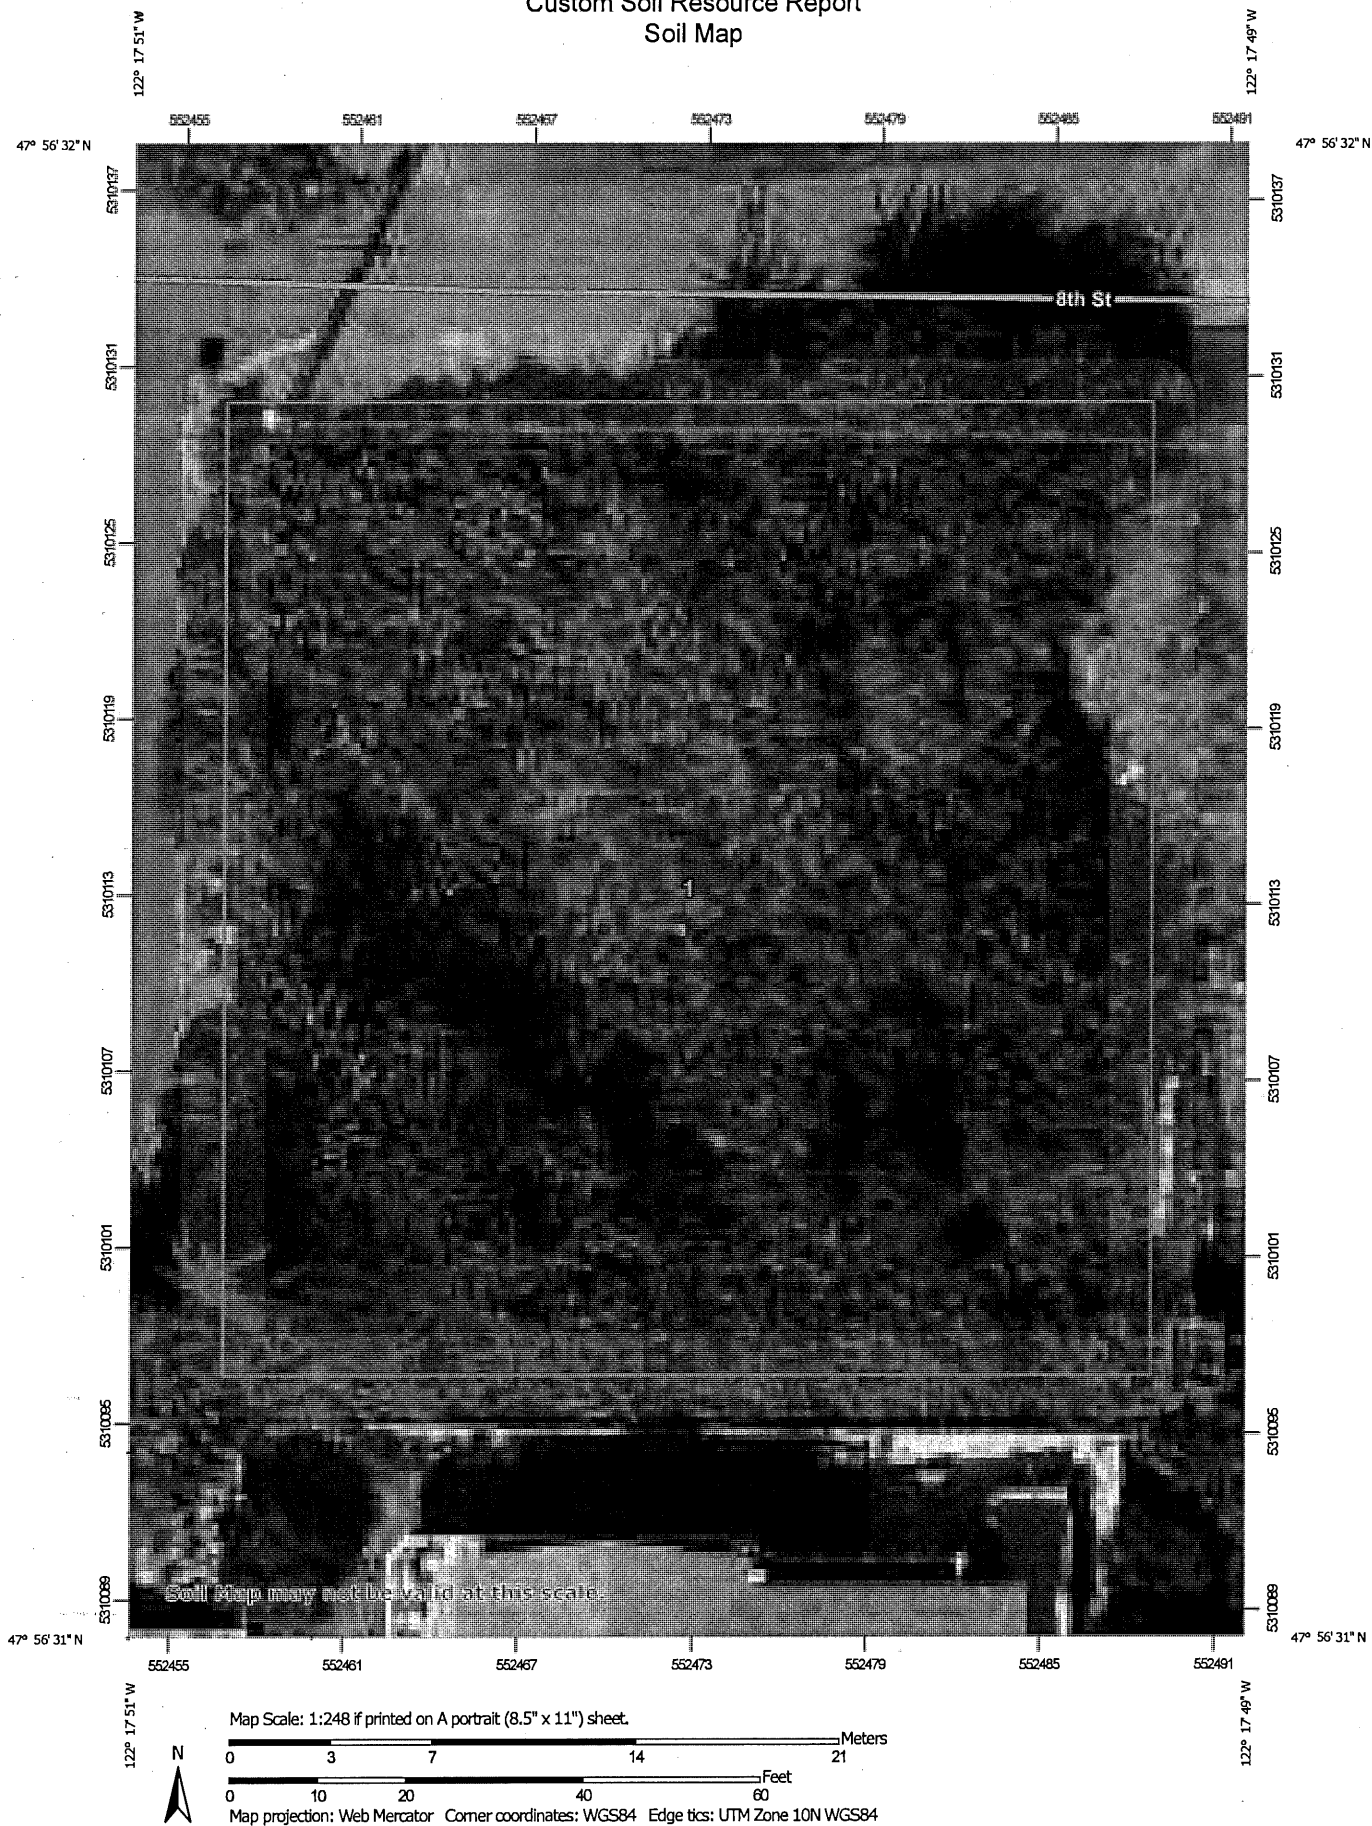
Custom Soil Resource Report Soil Map

1- ALDERWOOD GRAVELLY SANDY LOAM.

The USDA Web-Soil Survey was used to determine the existing soil conditions for the parcel. Refer to Appendix A. The soils are mapped as Alderwood gravelly sandy loam. The general site slopes, in the area of disturbance, are moderate and average approximately 10 percent down to the north. Based on the existing soil information and the setbacks of the proposed improvements from any of the property lines or critical areas there is little potential for erosion or sedimentation during construction, assuming the basic BMPs included in the SWPPP are installed and maintained properly. Refer to Figure 2 for an existing basin map.

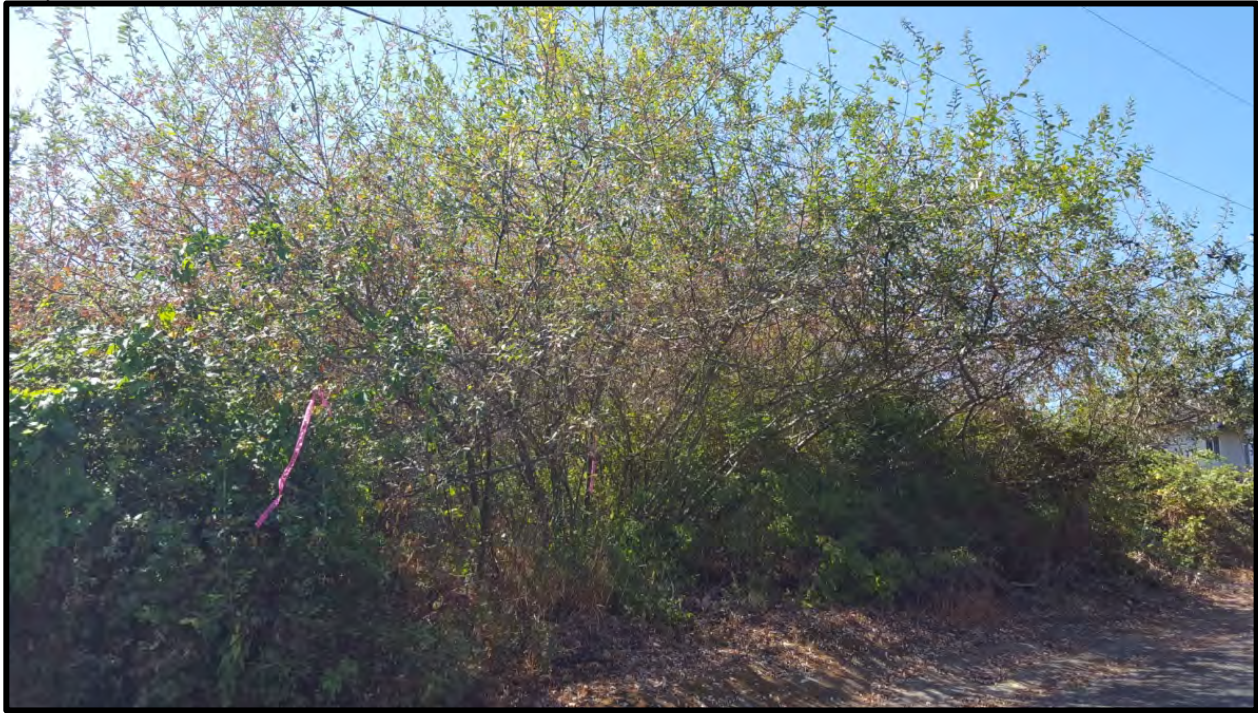
Wetland A is a sloped feature located on the eastern side of the subject site. Dominant vegetation within the wetland includes Sitka willow (*Salix sitchensis*), Himalayan blackberry (*Rubus armeniacus*), Nootka rose (*Rosa nutkana*), and creeping buttercup (*Ranunculus repens*). Soils within the wetland are generally very dark grayish brown (10YR 3/2) sandy clay loam with dark yellowish brown (10YR 4/6) redoximorphic features. Soils sampled in the northern portion of the wetland contain a sublayer of dark gray (10YR 4/1) sandy loam with strong brown (7.5YR 5/8) redoximorphic features. These soil characteristics are consistent with the Redox Dark Surface (F6) and Depleted Below Dark Surface (F7) hydric soil indicators listed in the 2010 Regional Supplement. Soils were saturated at 10 inches below the surface following a long period without rainfall, during our August 2016 site visit (A total of 0.40 inches of precipitation total for the month of August). Additionally, the geomorphic position and sparsely vegetated areas within the interior of the wetland meet secondary indicators for wetland hydrology.

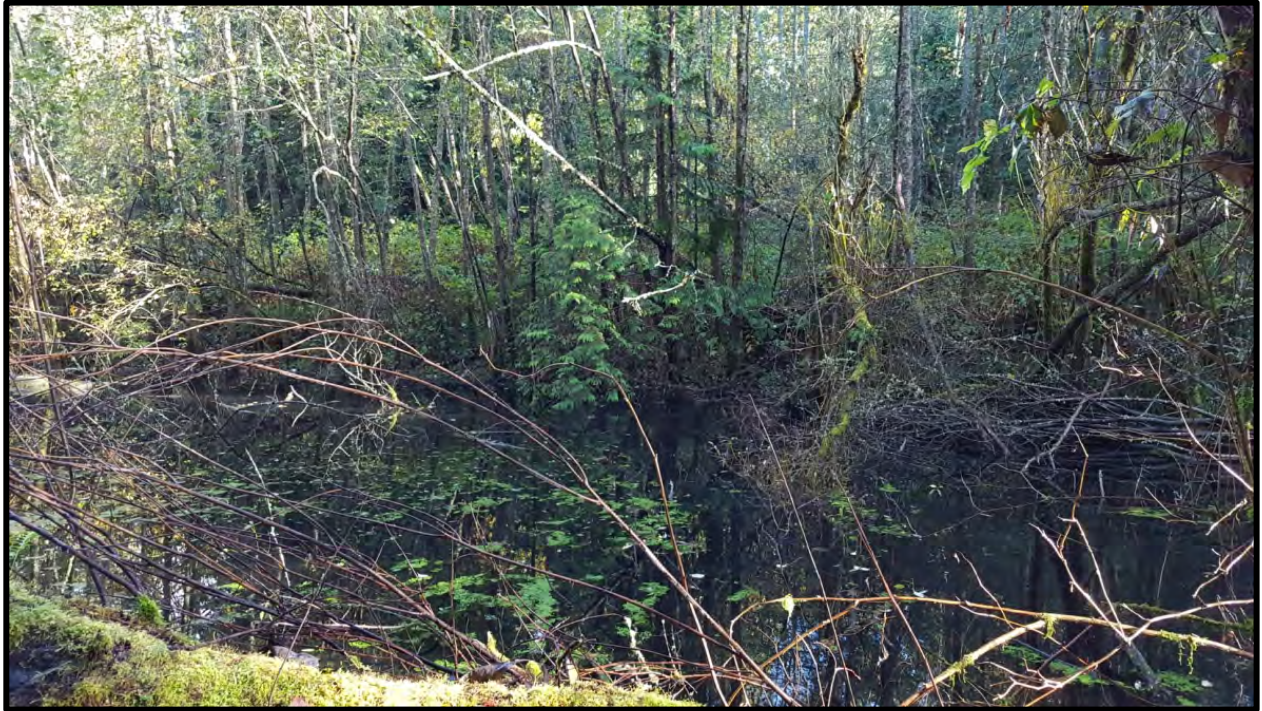
Wetland 2 is a depressional feature located on the eastern side of the Mitigation Site M2: Japanese Gulch/Brewery Creek Headwater Wetlands, and continues off-site to the north. Dominant vegetation within the wetland includes red alder (*Alnus rubra*; FAC), Western red cedar (*Thuja plicata*; FAC), salmonberry (*Rubus spectabilis*; FAC), Sitka willow (*Salix sitchensis*, FACW), Pacific willow (*Salix lucida*, FACW), creeping buttercup (*Ranunculus repens*), and Himalayan blackberry (*Rubus armeniacus*; FAC). Wetland soils from 0 to 6 inches below the surface generally have a Munsell color of black (10YR 2/2) and a sandy clay loam texture. From 6 to 11 inches below the surface, soils have a color of very dark gray (10YR 3/1) and a sandy loam texture, with dark yellowish brown (10YR 4/6) redoximorphic features present on coated sand grains. From 11 to 16 inches below the surface, soils have a color of dark grayish brown (10YR 4/2) and a sandy loam texture, with dark yellowish brown (10YR 4/6) redoximorphic features present on coated sand grains. A restrictive cobble layer was present at 16 inches. These soil characteristics are consistent with the Redox Dark Surface (F6) and Depleted Below Dark Surface (F7) hydric soil indicators listed in the 2010 Regional Supplement. Soils were saturated at the surface, during our October 2016 site visit.

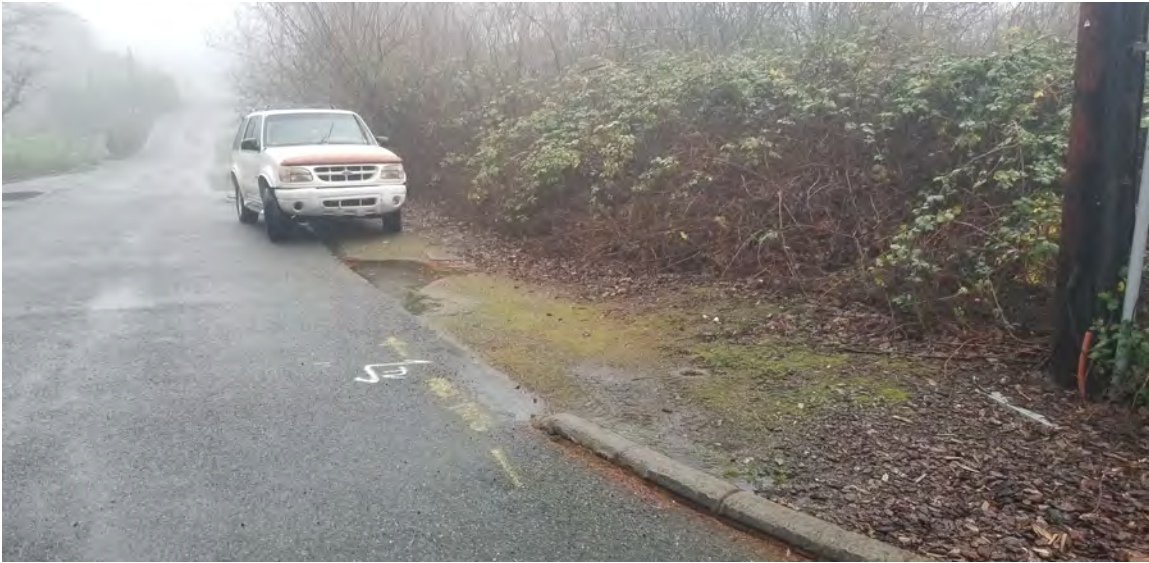
View of edge of 8th St where proposed driveway will take access

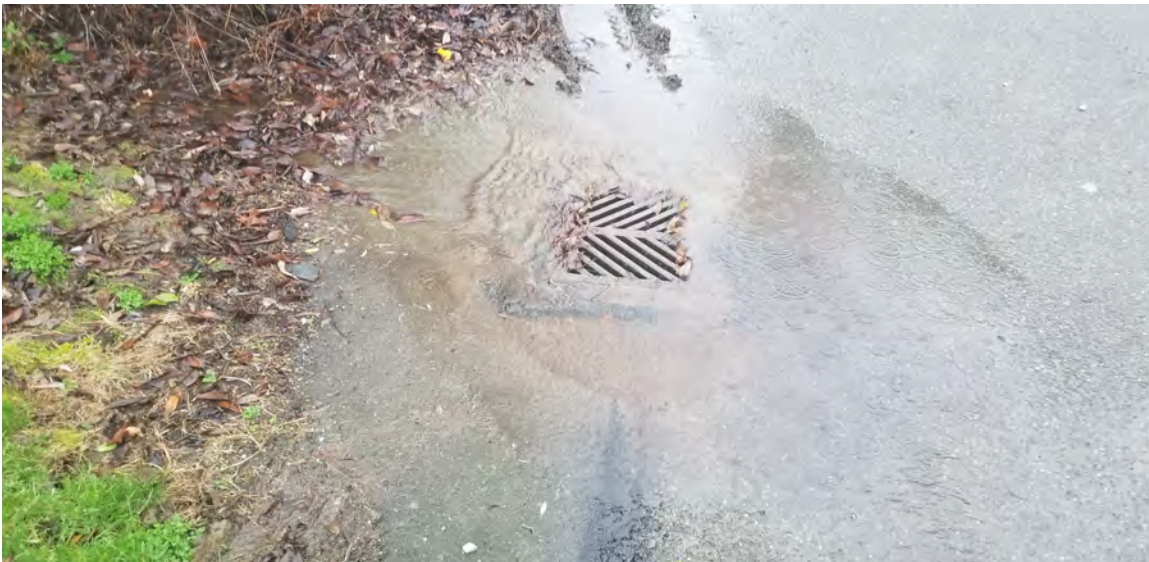
View west of CB north of northeastern property corner (site visit performed during very heavy rain event)

The proposed area of disturbance drains to the north and eventually into the catch basin located north of the northeastern property corner within 8th St. This project will not affect any off-site flows from passing through the site as in the existing condition. Runoff from the proposed impervious surfaces will be dispersed on site via splash blocks, a dispersion trench and sheet flow. By not grading or compacting the majority of the pervious surfaces to remain after construction in the area of disturbance a maximum amount of site runoff from the developed project will be absorbed and naturally infiltrated into the existing on-site soils.

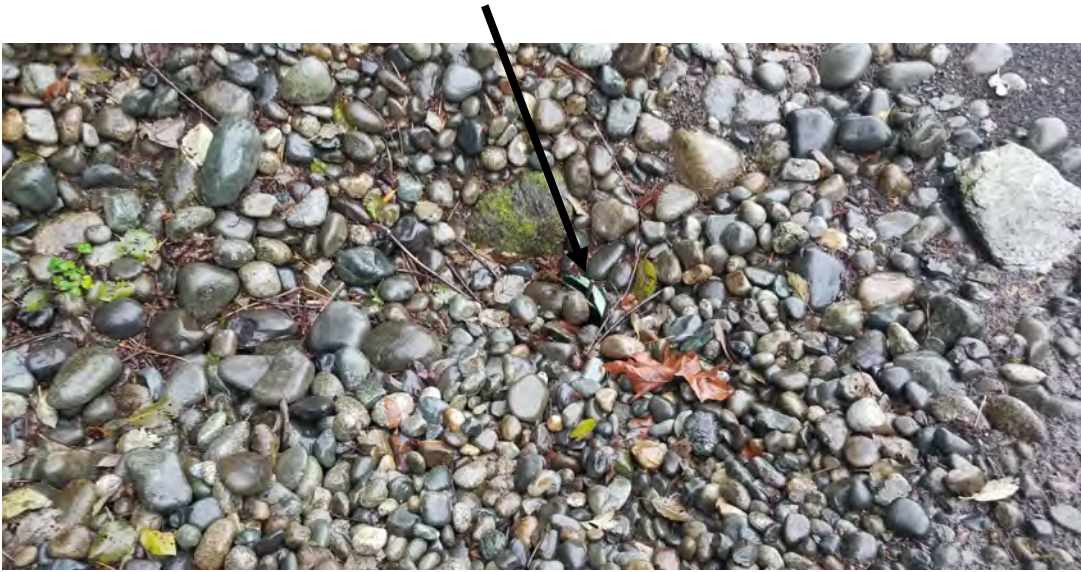
View of buried inlet of small PVC culvert that flows into CB

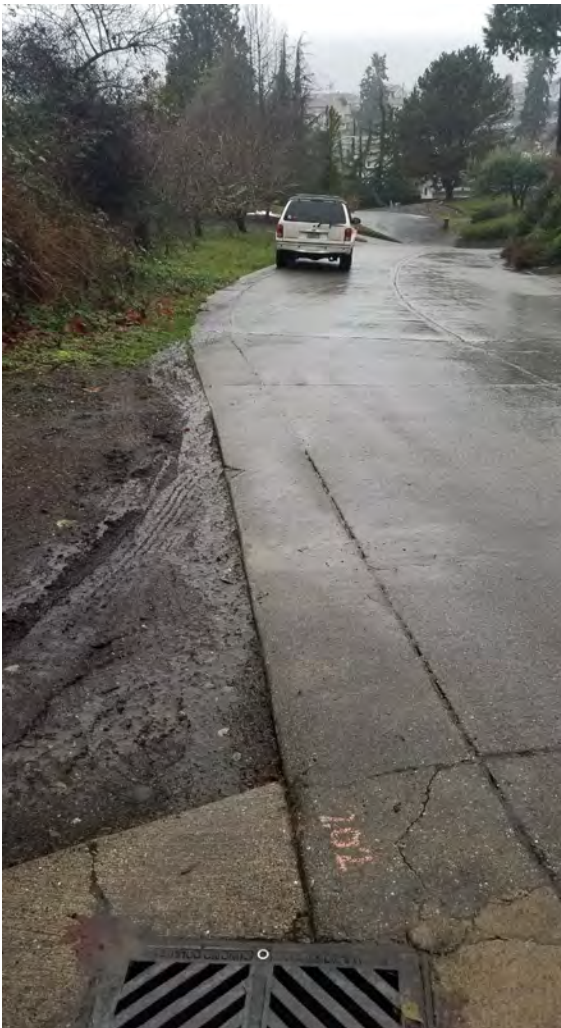
View north of CB at top of private driveway off of Campbell Ave

Runoff from the proposed area of disturbance of the existing site sheet flows over pervious surfaces in a generally northern direction toward the northern property line. Runoff leaves the parcel over the northern property line and flows northeast and into the catch basin within 8th St. Runoff flows north out of the CB under 8th St and discharges into a broad swale on private property. The outfall into this swale could not be observed due to private property boundaries. However, topographic contour lines on the Snohomish County PDS Map Portal indicate that runoff is discharged into this swale in which runoff flows northeast approximately 500 feet. At this point, runoff was observed flowing into a small PVC culvert and into a CB at the top of a driveway off of Campbell Ave. Runoff flows north in this conveyance system approximately 200 feet and into the main conveyance system within Campbell Ave, at which point the downstream analysis was concluded.
