61st PI W Culvert Improvement Project Critical Areas Report

October 2015

The City of Mukilteo is proposing to replace an existing deficient culvert with a new box culvert, improving both stream function and road conditions. The replacement will address current problems with stormwater flooding over the road, road deterioration, and erosion and headcutting downstream of the culvert outfall. The new culvert will not be fish passable, but the project includes improving structural stream conditions along approximately 230 linear feet of stream, including the reach approximately 120 feet downstream that may contain fish.

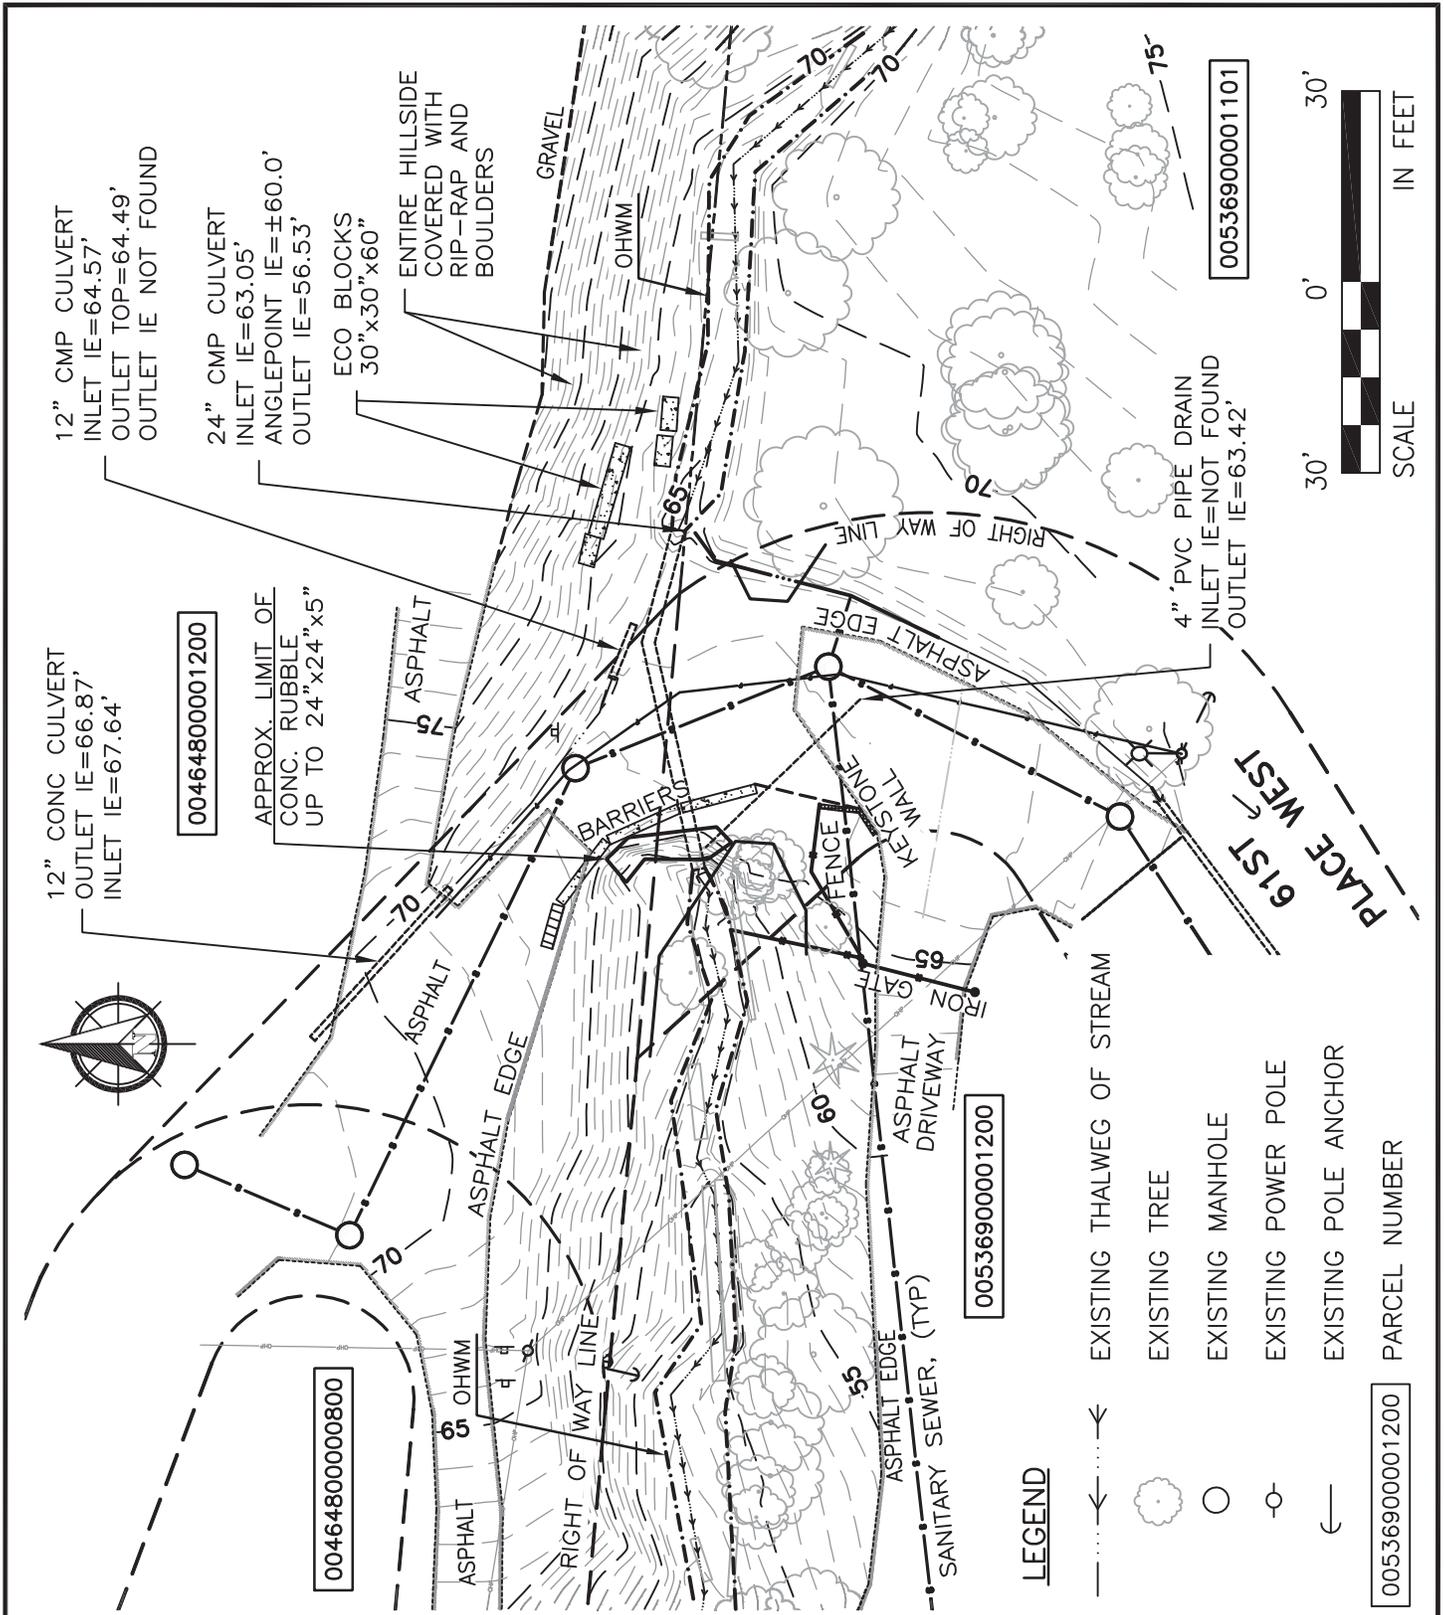
Date: 08/31/2015 Figure 2

Figure: Existing Conditions

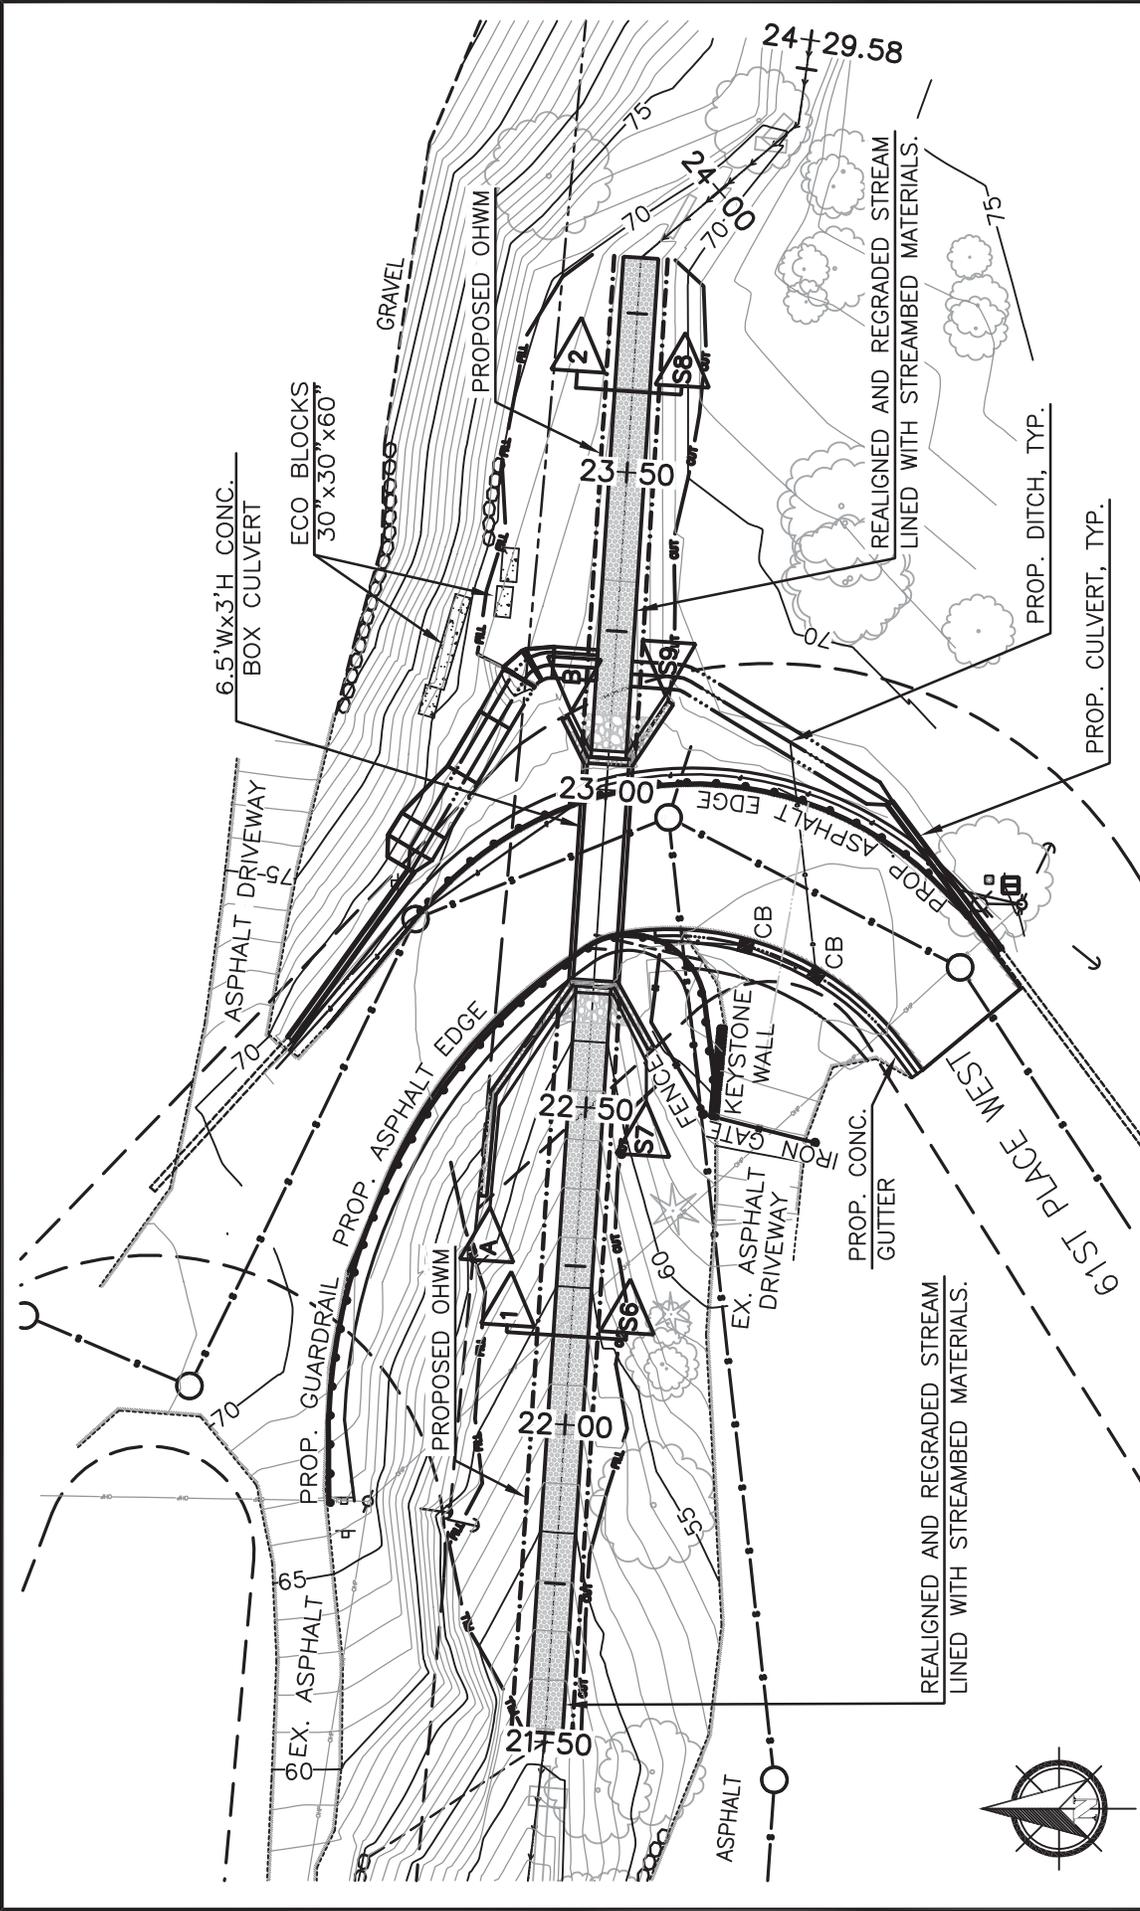
Date: 8/31/2015 **Figure 3**

Proposed Work: Replacement of existing 24" culvert with 3' high by 6.5' wide by 36' long cox culvert

Figure: Proposed Conditions

Figure 3, Proposed Conditions (Appendix A) provides a project overview and additional project plans and details are included in Figures 3 through 9.

Construction of the new culvert, as well as removal of the old culvert, will take place directly in Smuggler's Gulch Creek and its 75-foot critical areas buffer (see Figures 3 through 9). The culvert alignment and stream alignment will be slightly altered and the grade of the creek will be evened out downstream of the culvert outfall. The construction activities will take place when the stream is dry to avoid impacts to the stream's waters. The road will be restored and will not encroach further into the critical areas buffer than the existing condition.

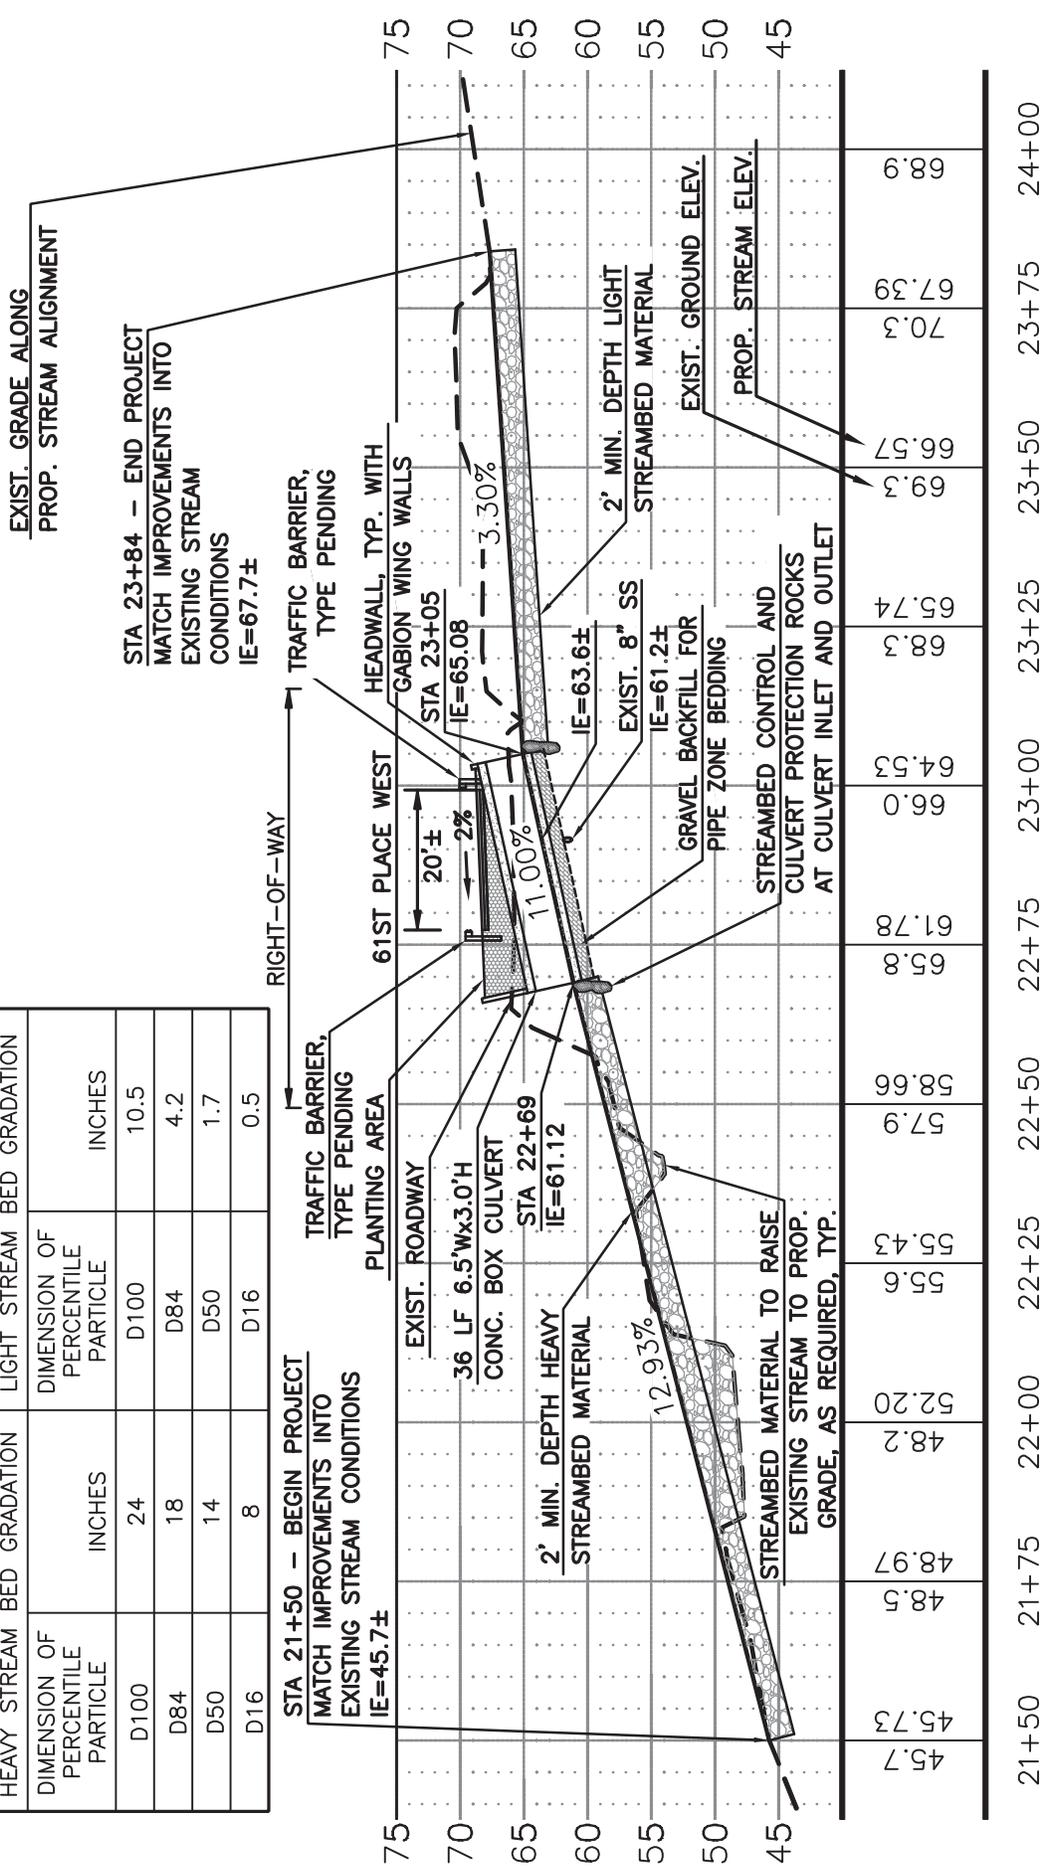
Date: 8/31/2015 Figure 5

Station	45.7	45.73	48.5	48.97	52.20	55.6	55.42	57.9	58.66	65.88	61.78	66.0	64.52	68.3	65.74	69.3	66.57	70.3	67.39	68.8
21+50																				
21+75																				
22+00																				
22+25																				
22+50																				
22+75																				
23+00																				
23+25																				
23+50																				
23+75																				
24+00

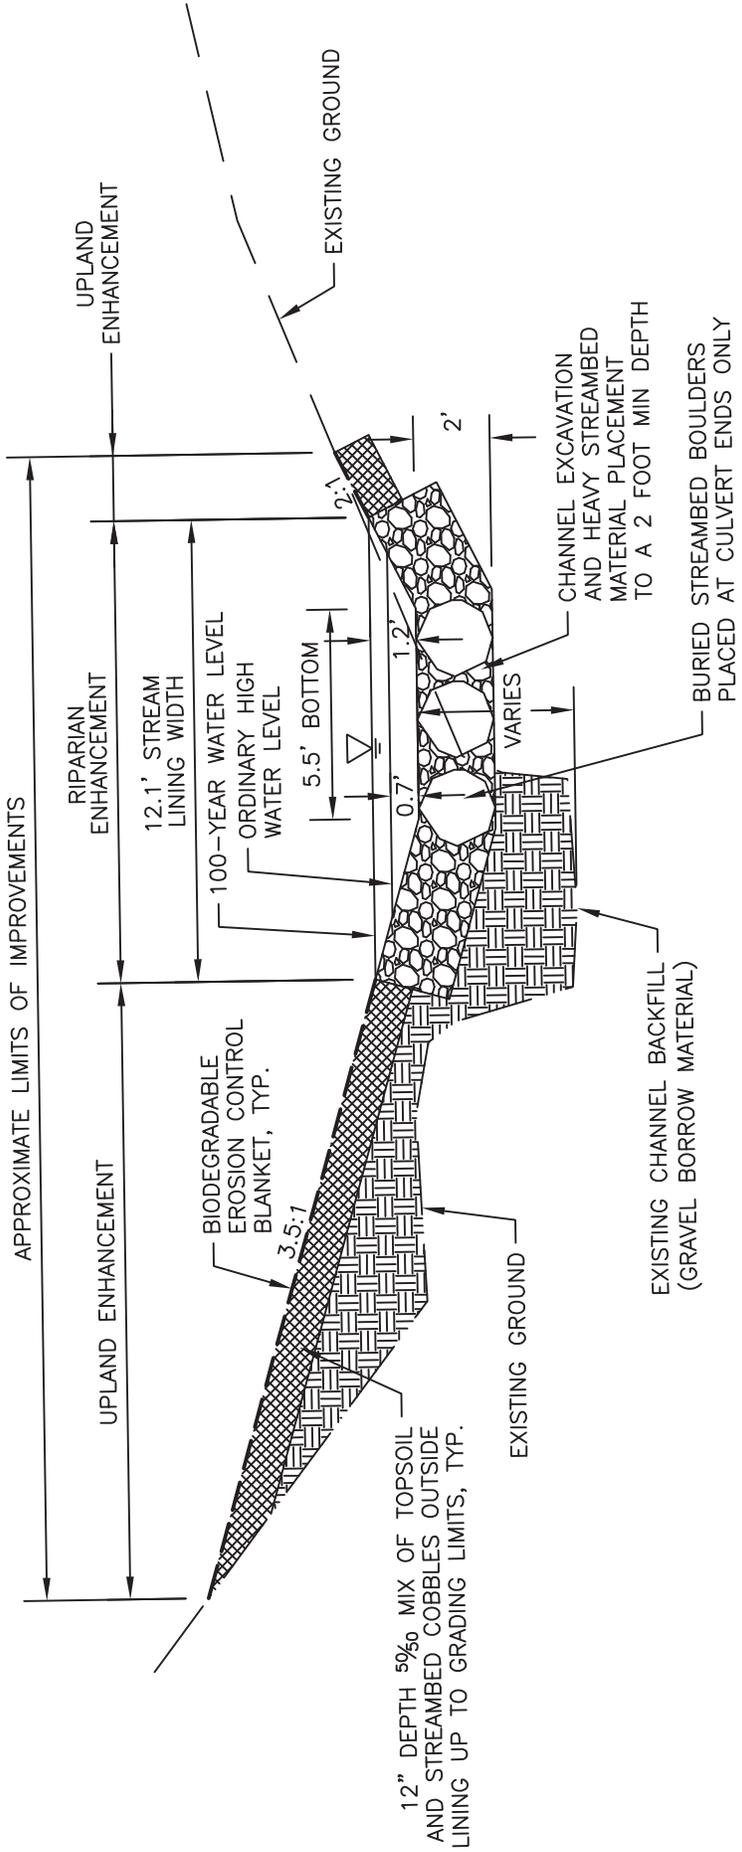
Figure: Downstream Cross Section
Vert. Datum: NAVD88
Location: +47.917019, -122.315146
Scale: NTS
Date: 8/31/2015 **Figure 6**

DOWN STREAM CROSS SECTION DETAIL
DOWNSTREAM OF PROPOSED BOX CULVERT
LOOKING UPSTREAM TO THE EAST
STA 21+50 TO STA 22+70

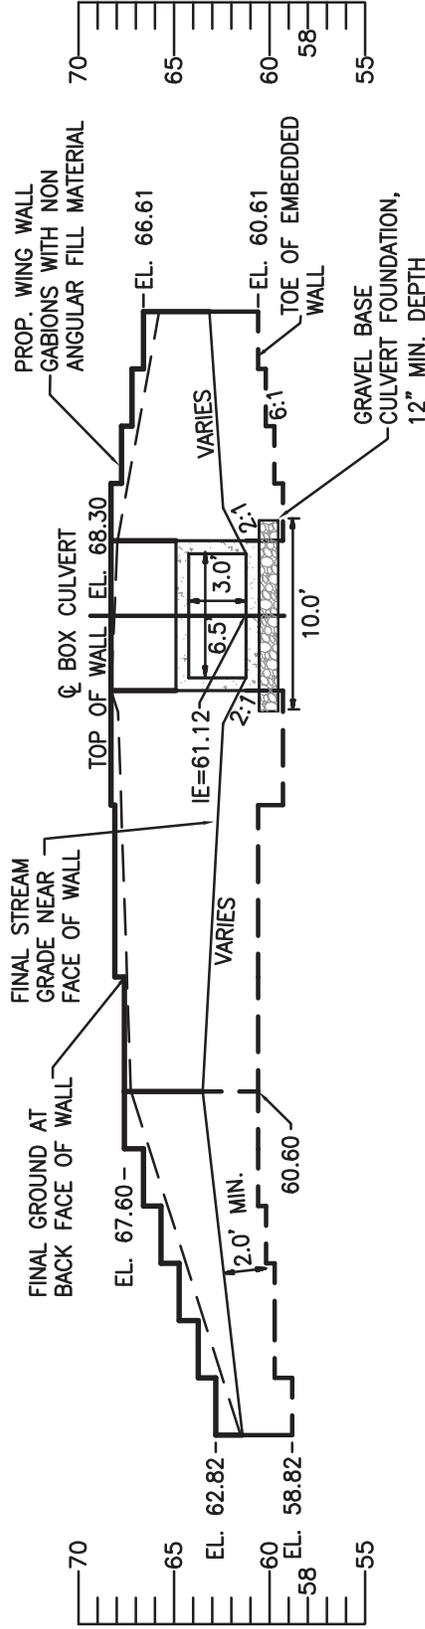
Figure: Downstream Culvert End Cross Section
Vert. Datum: NAVD88
Location: +47.917019, -122.315146
Scale: NTS
Date: 8/31/2015 **Figure 7**

DOWNSTREAM CULVERT END CROSS SECTION DETAIL
 DOWNSTREAM OF PROPOSED BOX CULVERT NTS
 LOOKING UPSTREAM TO THE EAST

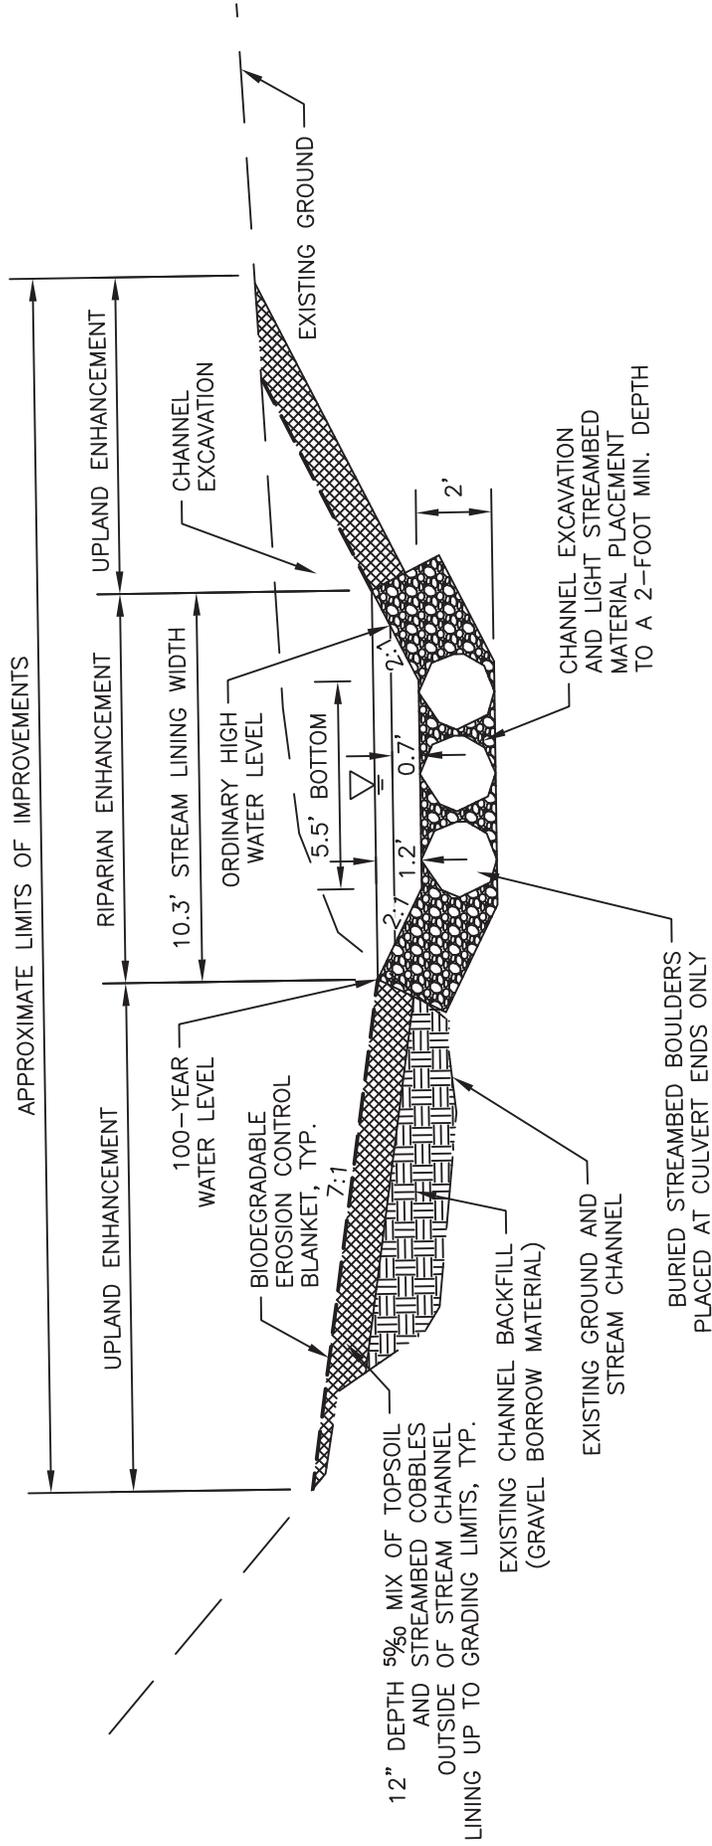
Figure: Upstream Cross Section
Vert. Datum: NAVD88
Location: +47.917019, -122.315146
Scale: NTS
Date: 8/31/2015 **Figure 8**

UPSTREAM CROSS SECTION DETAIL
UPSTREAM OF PROPOSED BOX CULVERT NTS
LOOKING UPSTREAM TO THE EAST
STA 23+06 TO STA 23+84

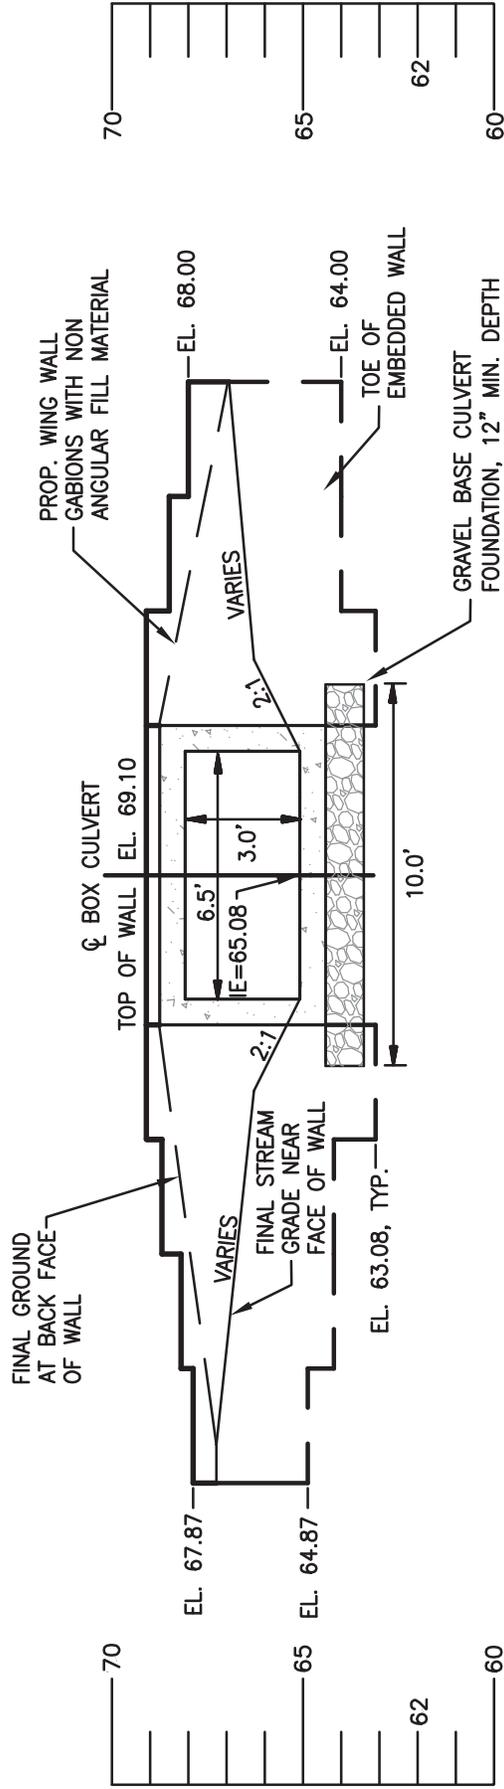
Figure: Upstream Culvert End Cross Section
Vert. Datum: NAVD88
Location: +47.917019, -122.315146
Scale: NTS
Date: 8/31/2015 **Figure 9**

UPSTREAM CULVERT END CROSS SECTION DETAIL
 UPSTREAM OF PROPOSED BOX CULVERT NTS
 LOOKING DOWNSTREAM TO THE WEST

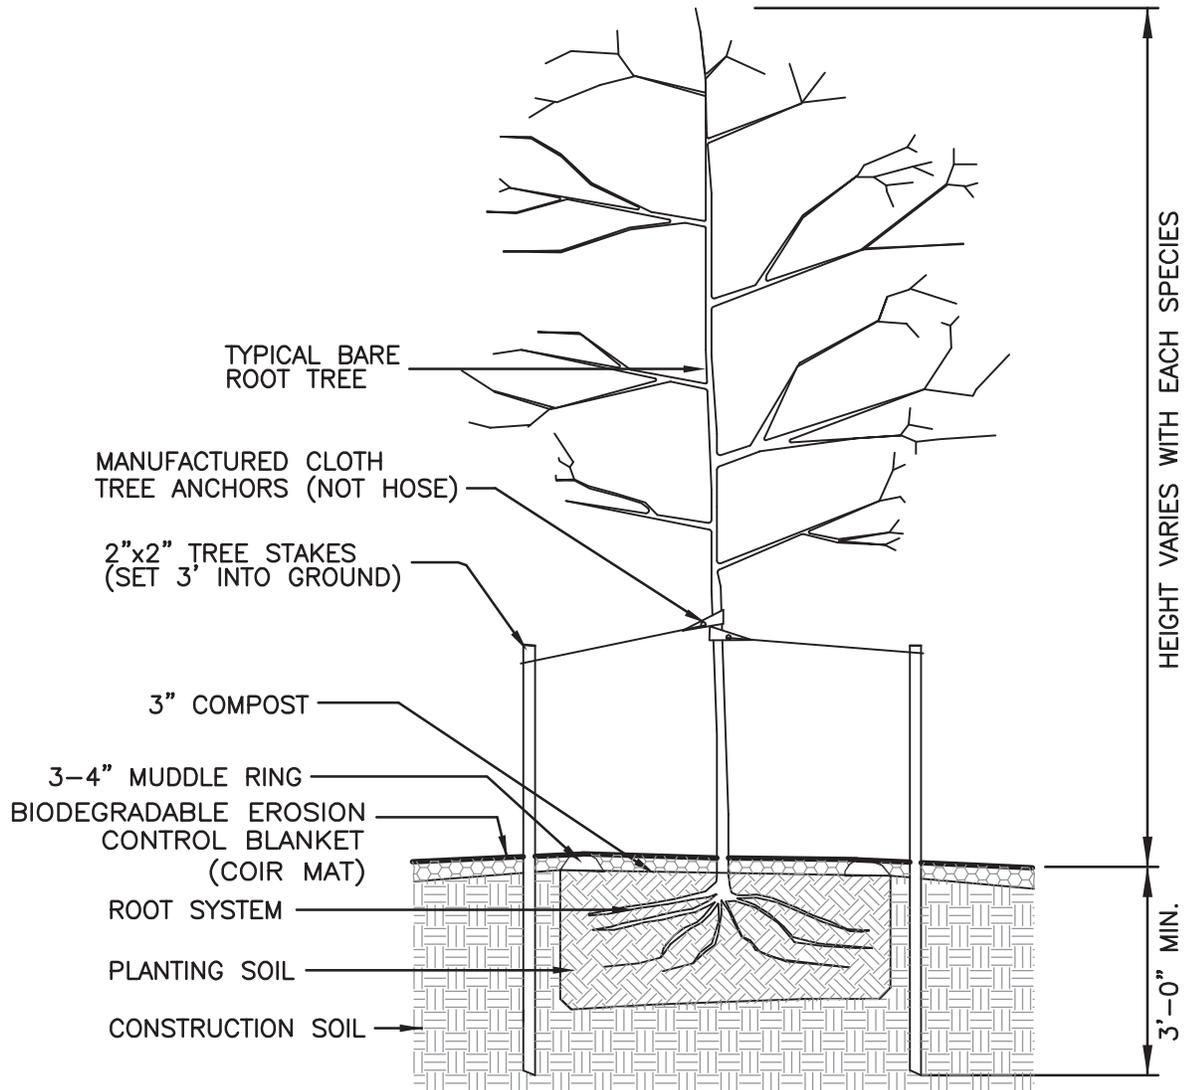
Date: 08/27/2015 **Figure 13**

1. ALL TREES OVER 1-1/4" DIAMETER ARE TO BE STAKED (2 PER TREE).
2. PLANTING PIT SHALL BE DEEP ENOUGH TO ENCOMPASS PLANTING ROOTS WITHOUT BENDING AND PLACEMENT OF FERTILIZER PACKS PER GENERAL NOTES ON SHEET 15 OF 15.

BARE ROOT DECIDUOUS TREE PLANTING DETAIL

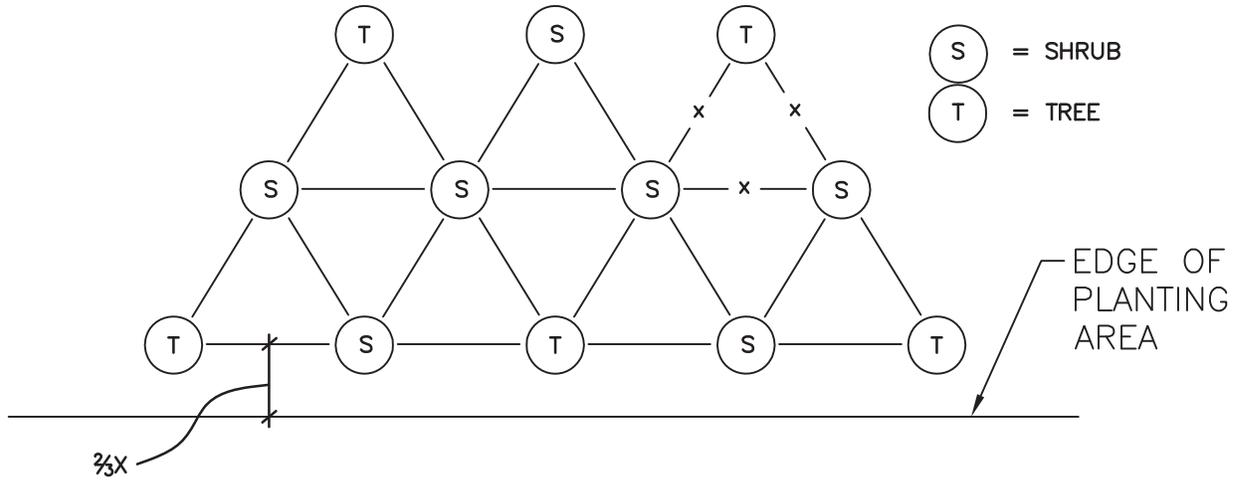
NOTE:
 GROUP LIKE SHRUBS IN GROUPS OF 3, 5 OR 7.
 TREES SHOULD NOT BE PLACED NEXT TO EACH OTHER.

TYPICAL PLANT SPACING DETAIL

X = PLANT SPACING

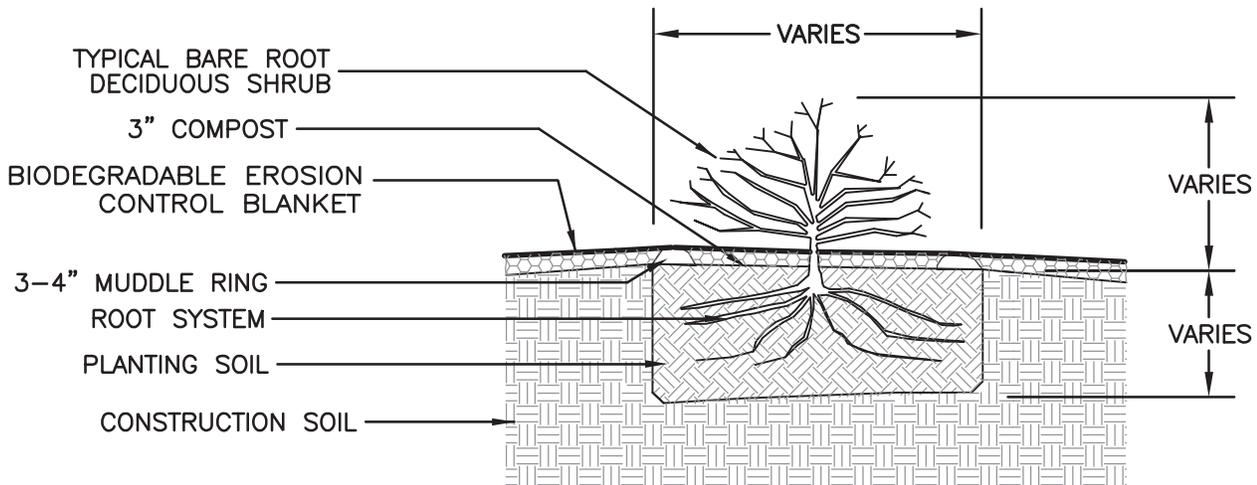
Date: 08/27/2015 Figure 14

BARE ROOT PLANTING DETAIL

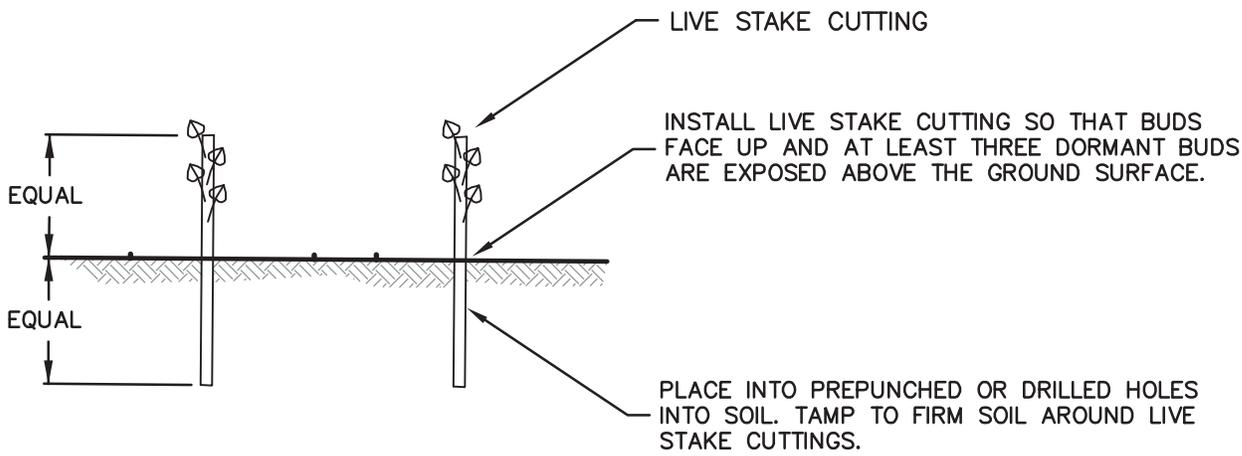
NOTE:
LIVE STAKE CUTTING SHALL BE A
MINIMUM 36 INCHES IN LENGTH.

LIVE STAKE INSTALLATION DETAIL
NOT TO SCALE

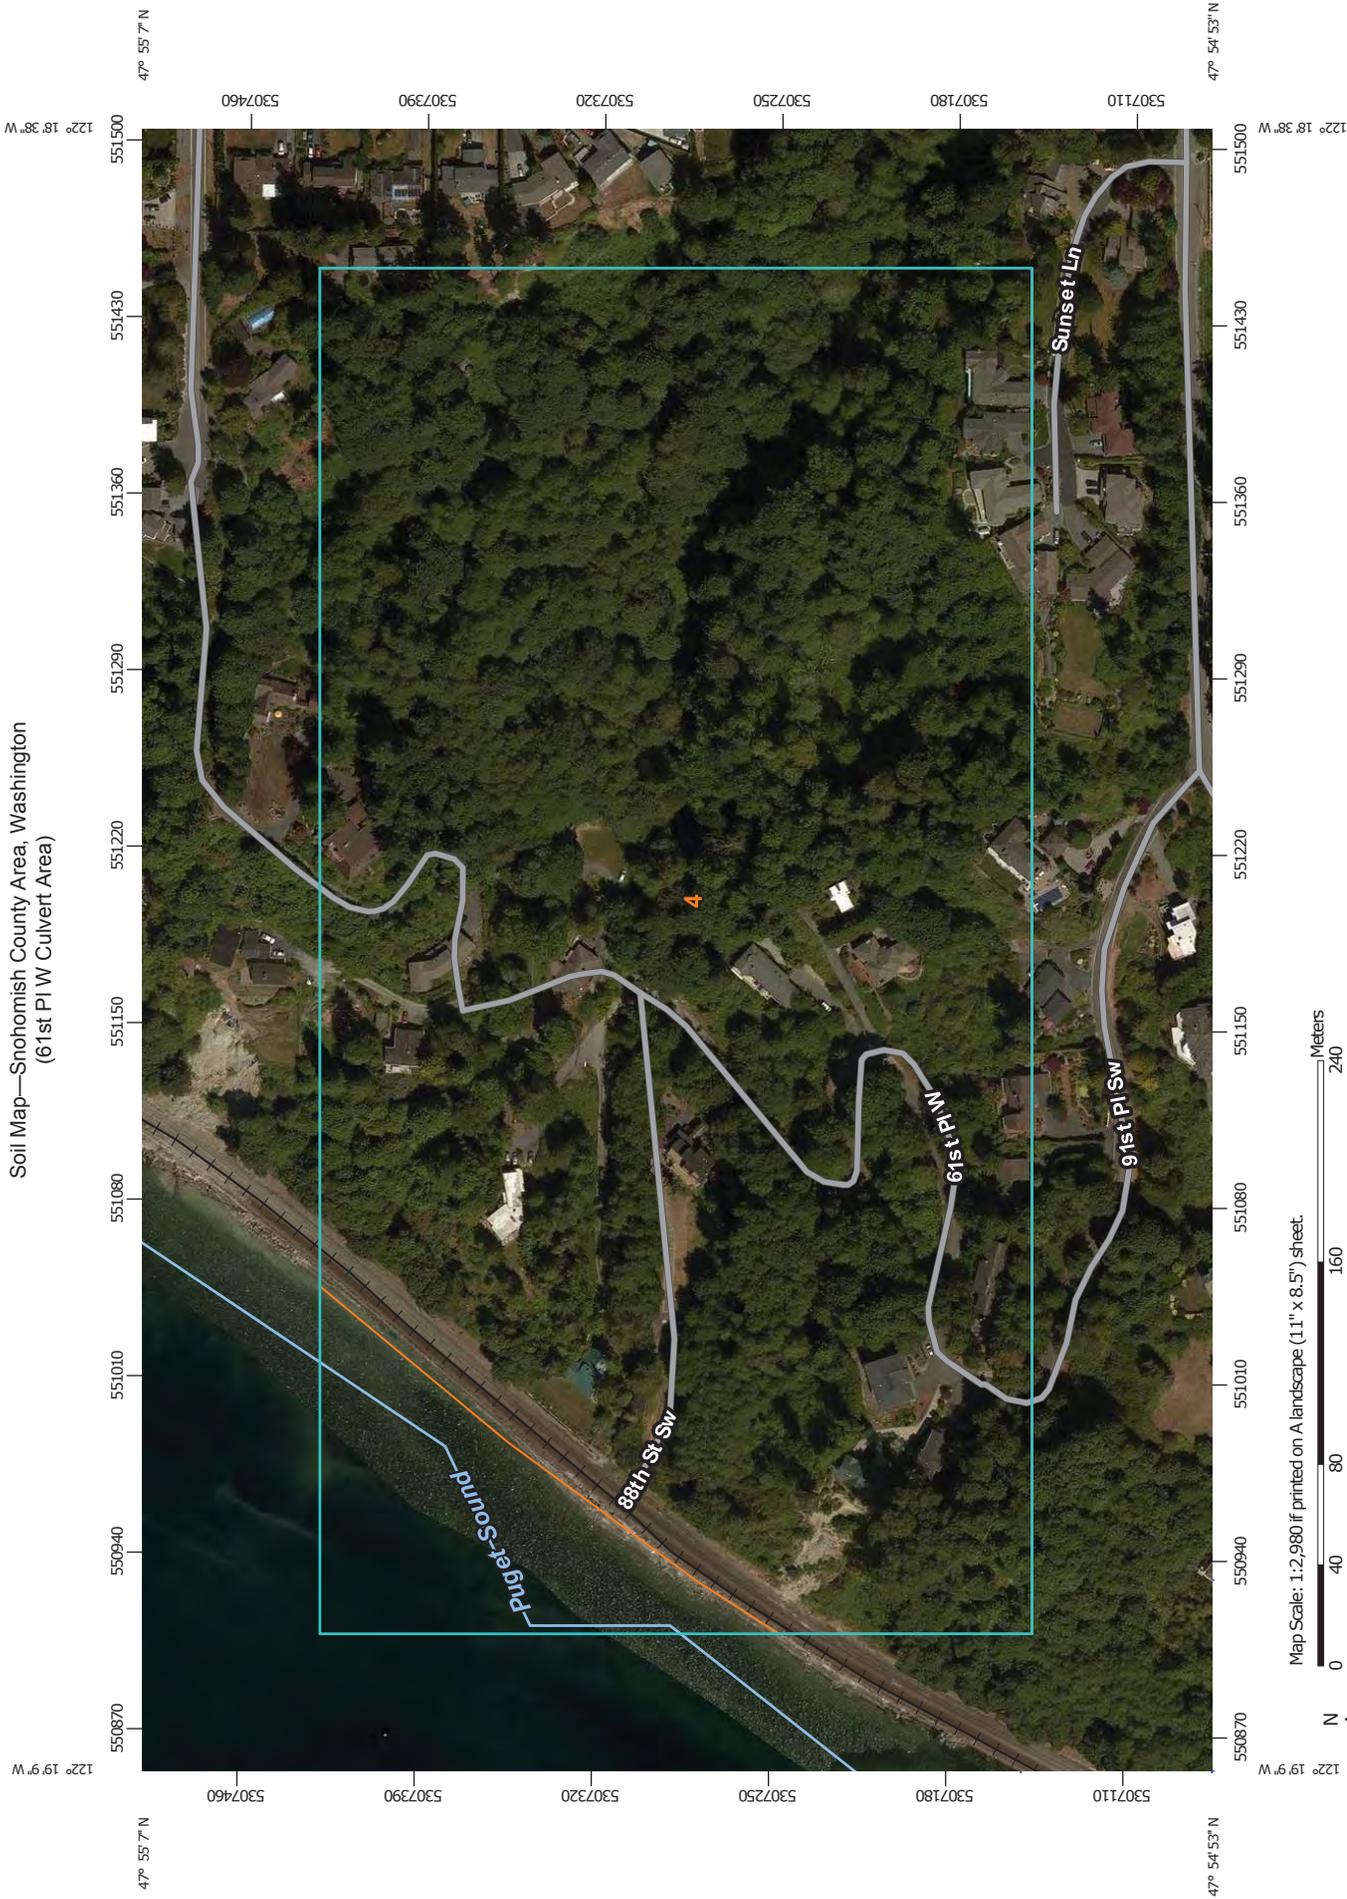
Soil Map—Snohomish County Area, Washington
(61st Pl W Culvert Area)

The USDA Soil Survey for Snohomish County maps all soils around the culvert site and the stream as Alderwood-Everett gravelly sandy loams, 25 to 70 percent slopes. The Alderwood series is made up of moderately well drained soils, which are considered upland soils. Figure 16 shows a map of soils found in the project vicinity.

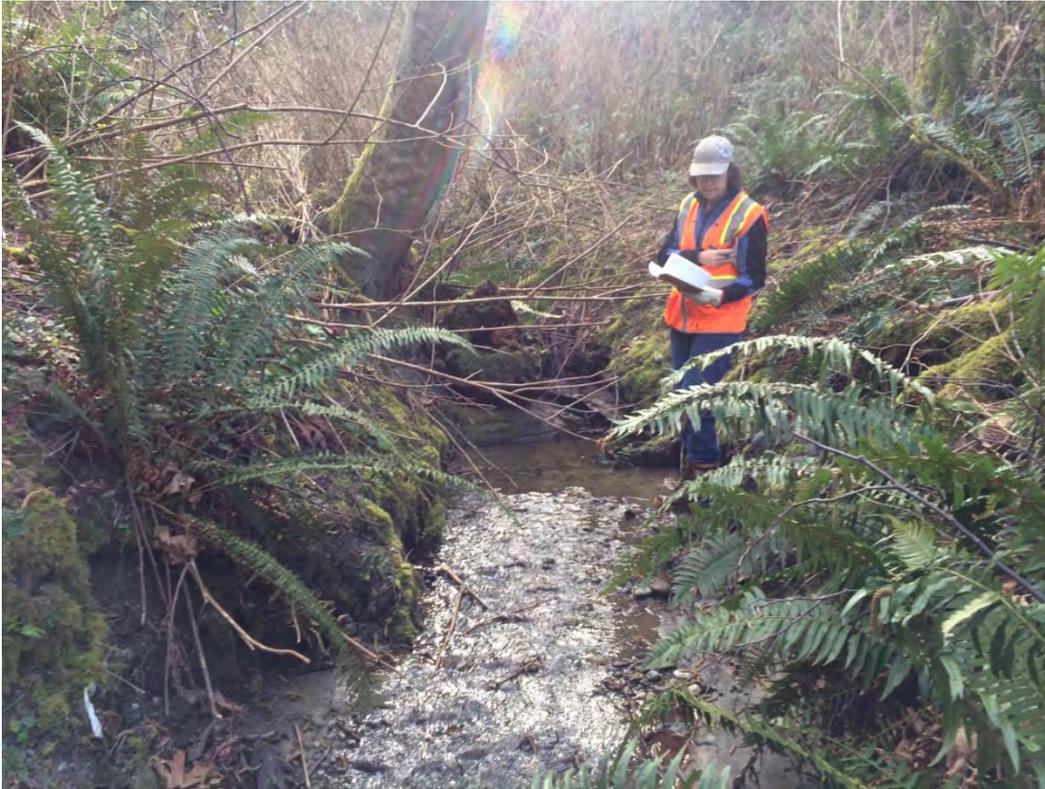
Photo 1. Stream channel about 100 feet upstream of 61st Pl W culvert

The stream upstream of 61st Place West is in a narrow gulch descending through fairly steep terrain. The stream passes through red alder forest (*Alnus rubra*) with scattered western red cedar (*Thuja plicata*) and shrubs such as sword fern (*Polystichum munitum*) and salmonberry (*Rubus spectabilis*); Photos 1, 2 and 3 in Appendix B) and runs adjacent to a residential home with a steep embankment before passing under 61st Place West. The culvert's upper end had some debris partially blocking the entrance during the March 10, 2015 site visit (Photo 4). The lower end is perched about 10 feet above a pool. Stream banks are heavily eroded.

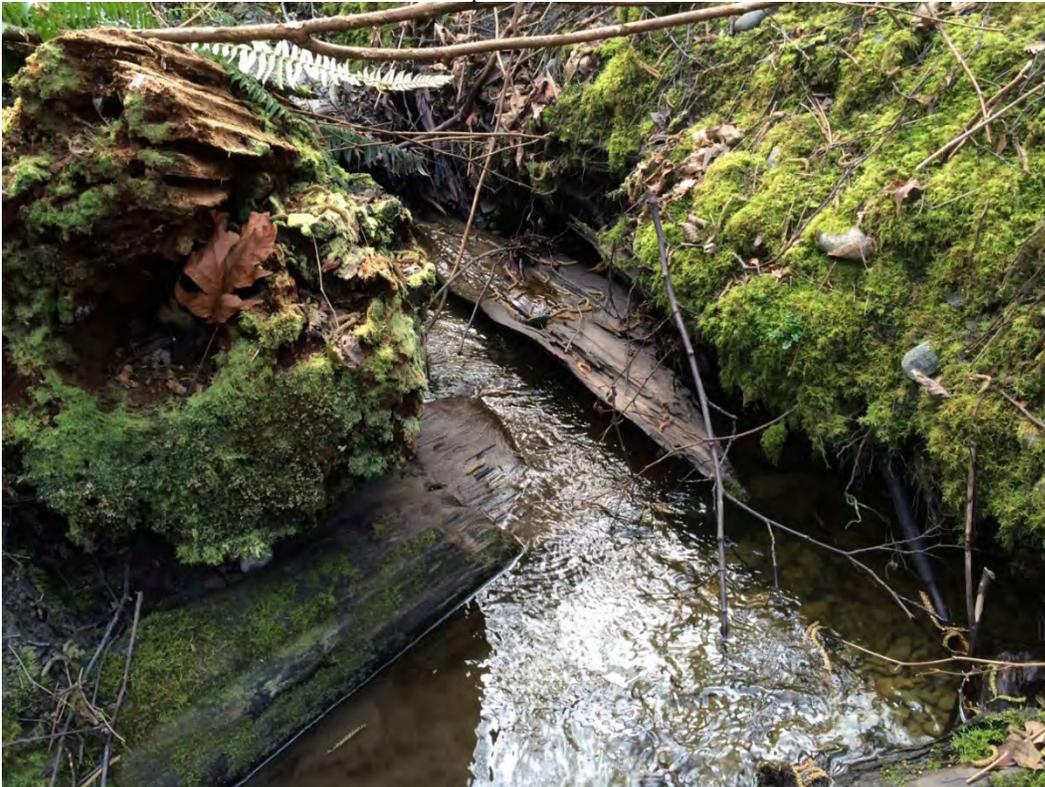
Photo 2. Stream channel about 100 feet upstream of 61st Pl W culvert, showing woody debris in stream

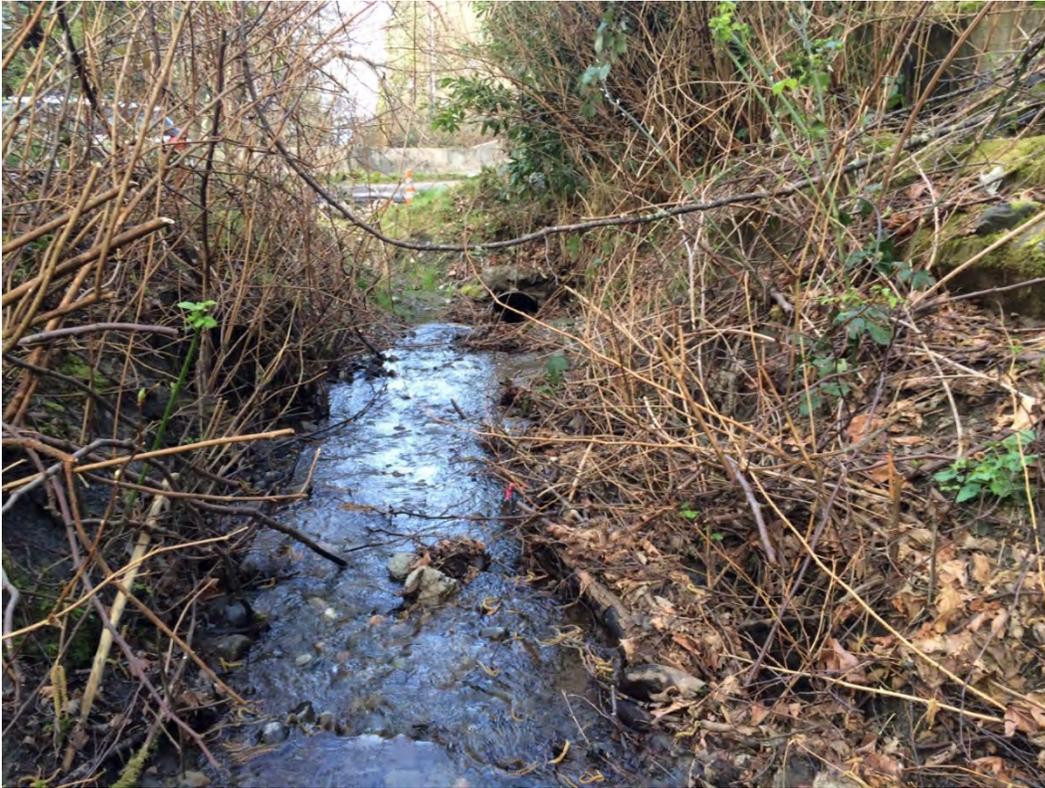
Photo 3. Stream channel at 61st Pl W Culvert, looking downstream at culvert

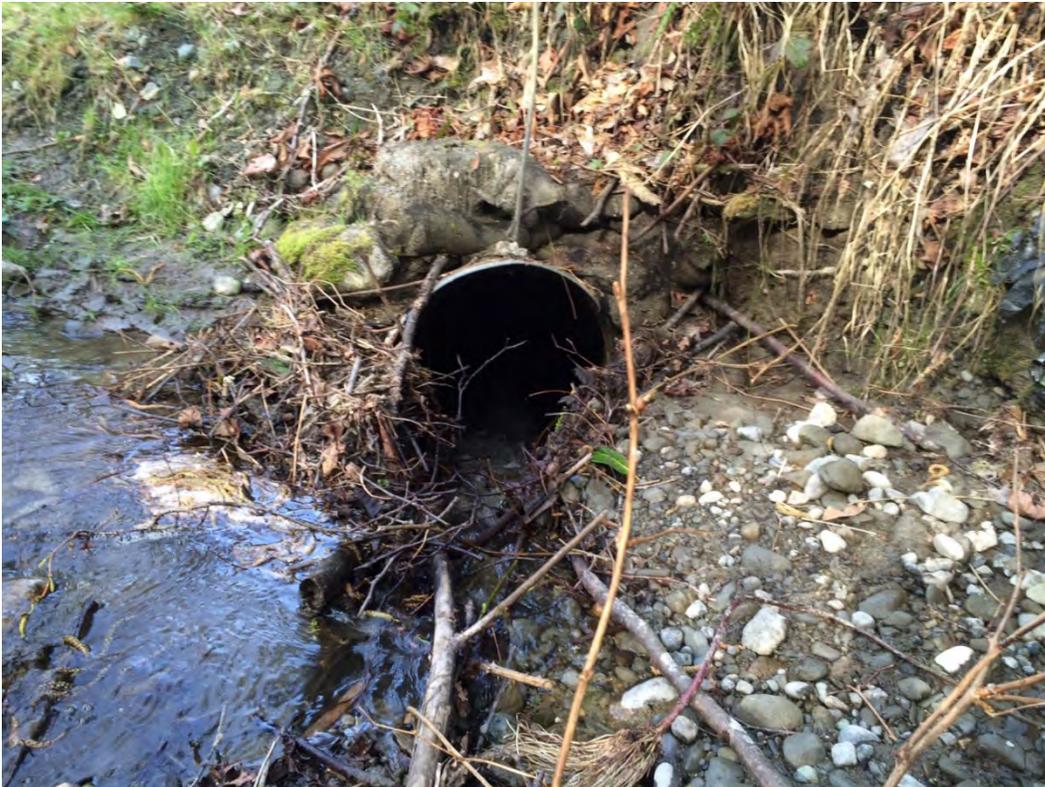
Photo 4. Upstream end of culvert under 61st Pl W

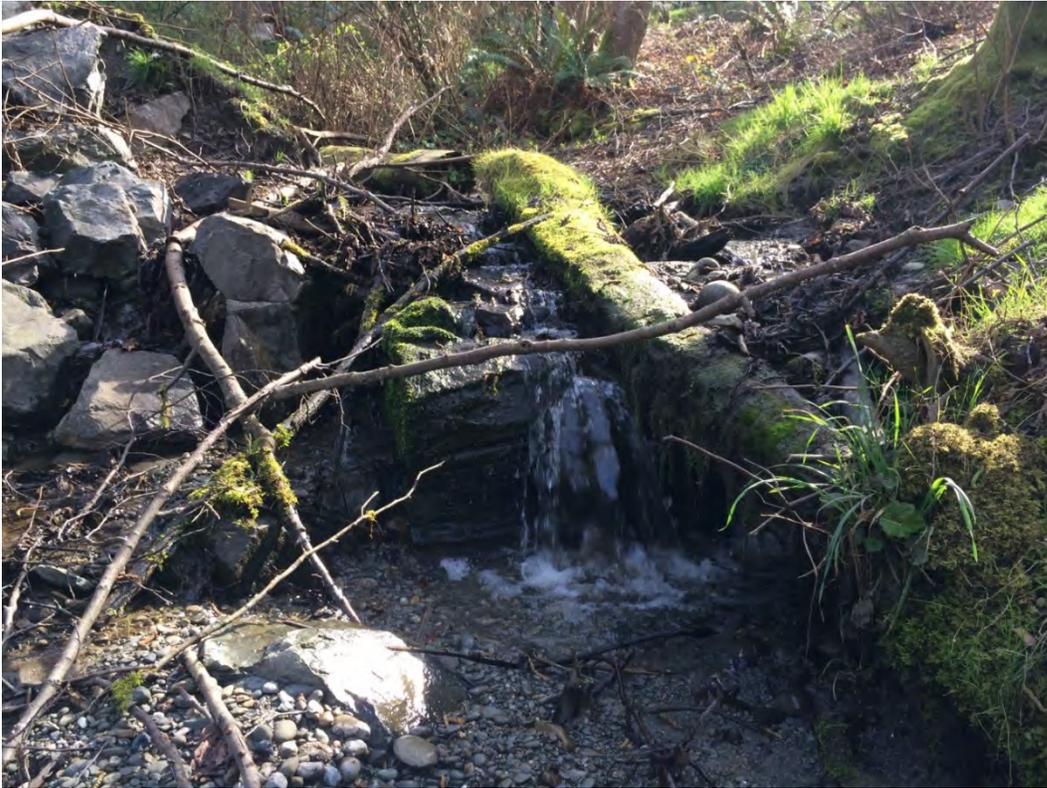
Photo 5. Barrier along stream, downstream of 61st Pl W culvert

Below the 61st Place West culvert, the stream is a riffle run with cascades and an incised channel (Photo 5). The stream runs past a couple of residential homes and runs parallel to 88th Street SW, where a riprap bank along the road extends below the ordinary high water mark (OHWM) of the stream (Photo 6). The stream crosses under 88th Street SW through another culvert (Photos 8 and 9) that is a partial fish-passage barrier due to a perched outlet observed during the March 10, 2015 site visit. Finally, the stream crosses under the railroad tracks via a 36-inch-diameter concrete culvert that does appear fish-passable before entering Puget Sound (Photo 10).

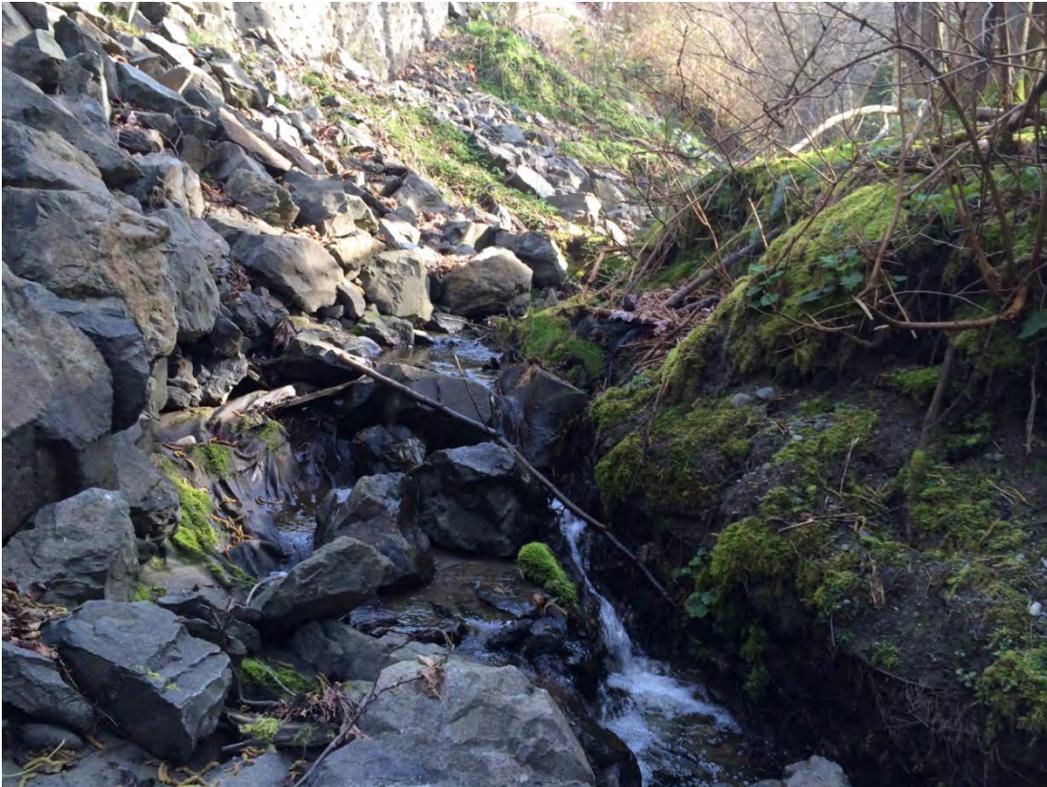
Photo 6. Riprap bank descending into stream, downstream of 61st Pl W culvert
