61st PI W Culvert Improvement Project Critical Areas Report

October 2015

The City of Mukilteo is proposing to replace an existing deficient culvert with a new box culvert, improving both stream function and road conditions. The replacement will address current problems with stormwater flooding over the road, road deterioration, and erosion and headcutting downstream of the culvert outfall. The new culvert will not be fish passable, but the project includes improving structural stream conditions along approximately 230 linear feet of stream, including the reach approximately 120 feet downstream that may contain fish.

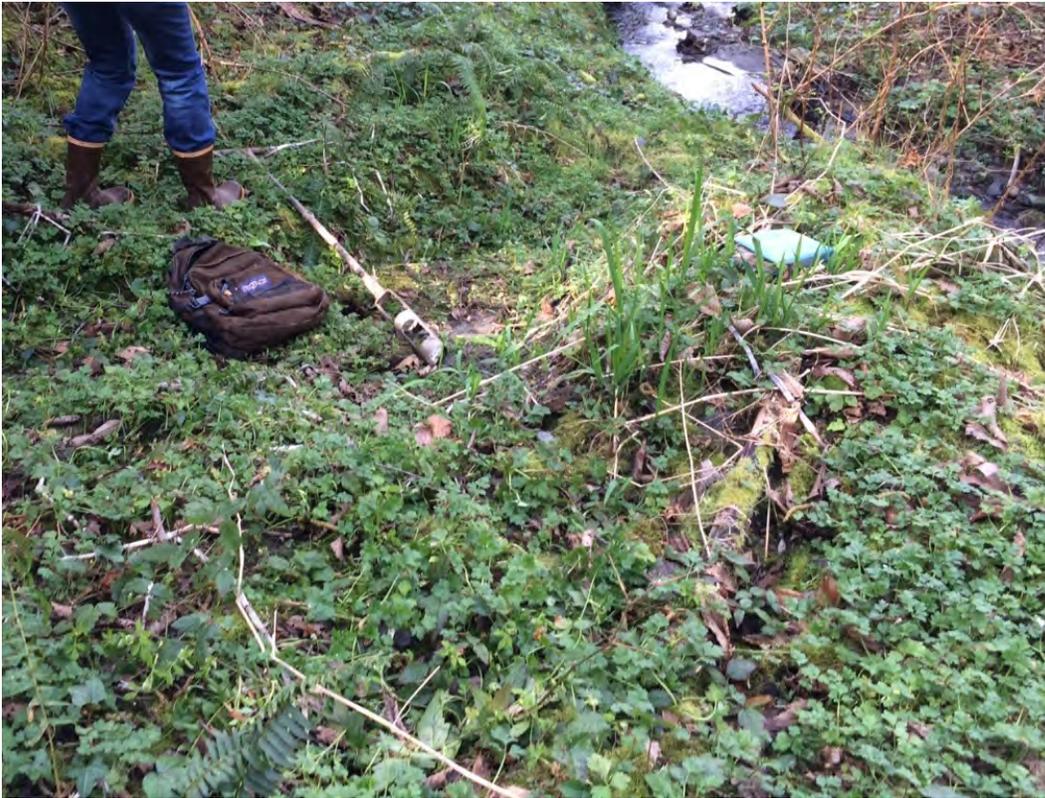
Photo 7. Streambank at site of Test Plot 1

NWEC biologists established one test-plot (TP-1) at the small streamside bench downstream of the 61st Place West culvert and just upstream of the 88th Street SW culvert (Photo 7 in Appendix B). NWEC excavated a test-pit in the center of this bench.

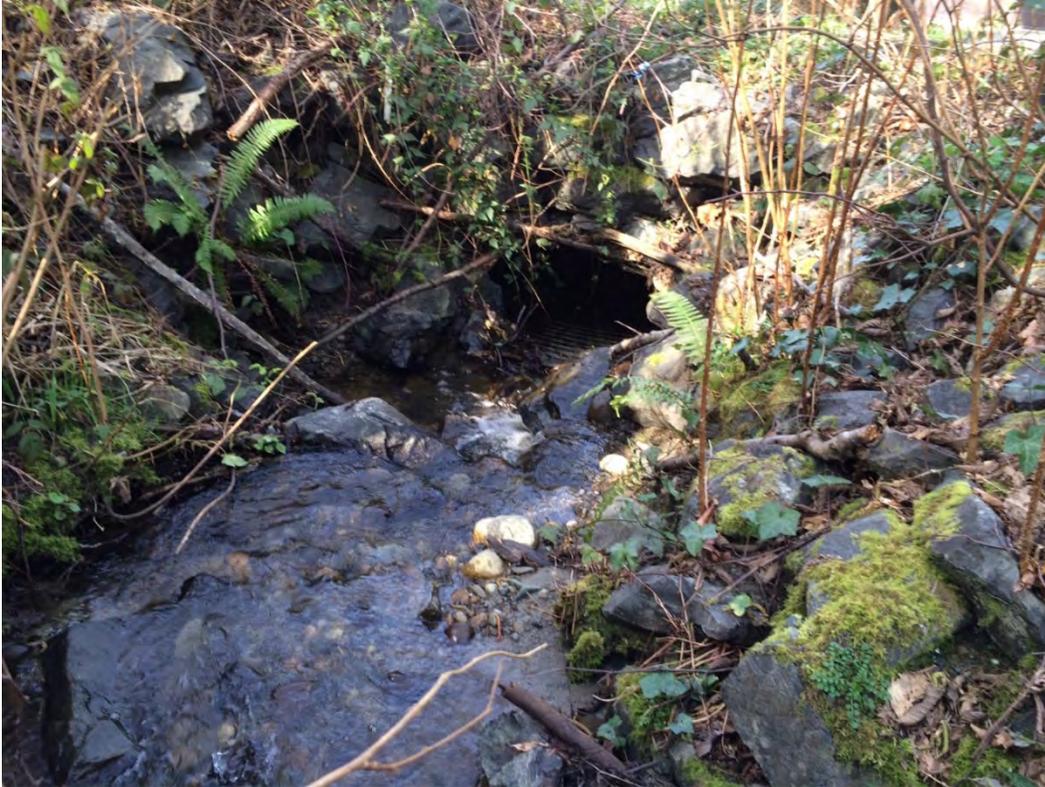
Photo 8. Upstream end of second culvert under 88th Street SW, downstream of 61st Pl W culvert

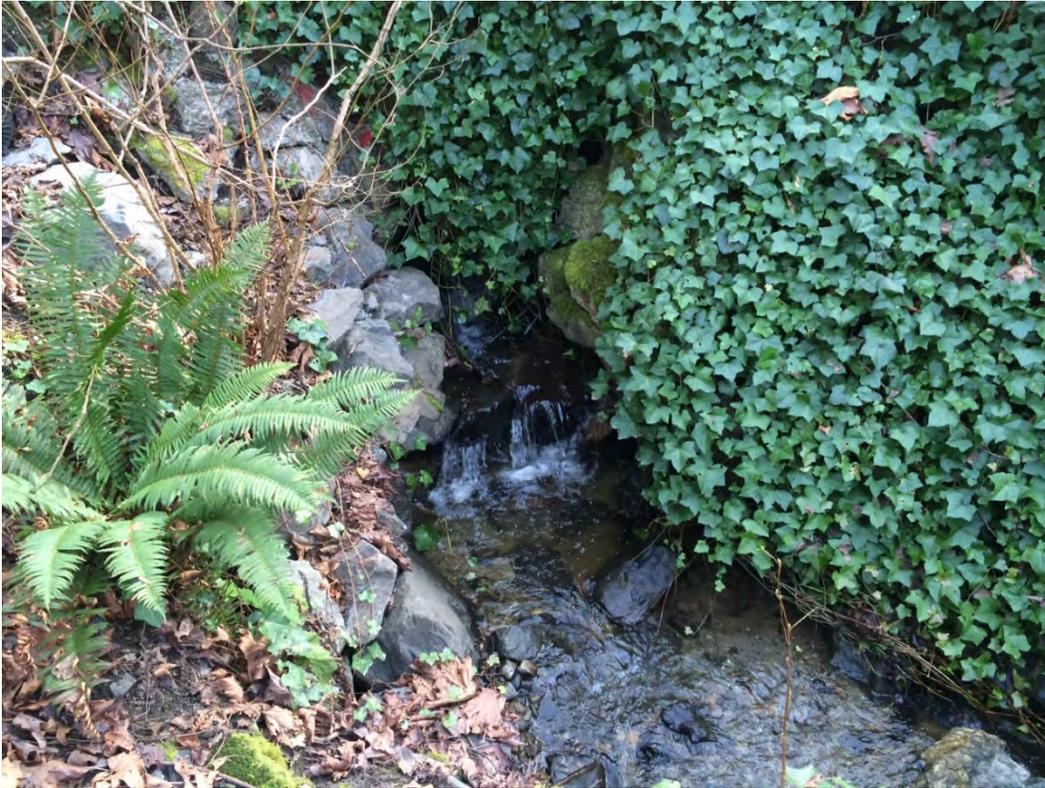
Photo 9. Outlet of second culvert under 88th Street SW, downstream of 61st Pl W culvert

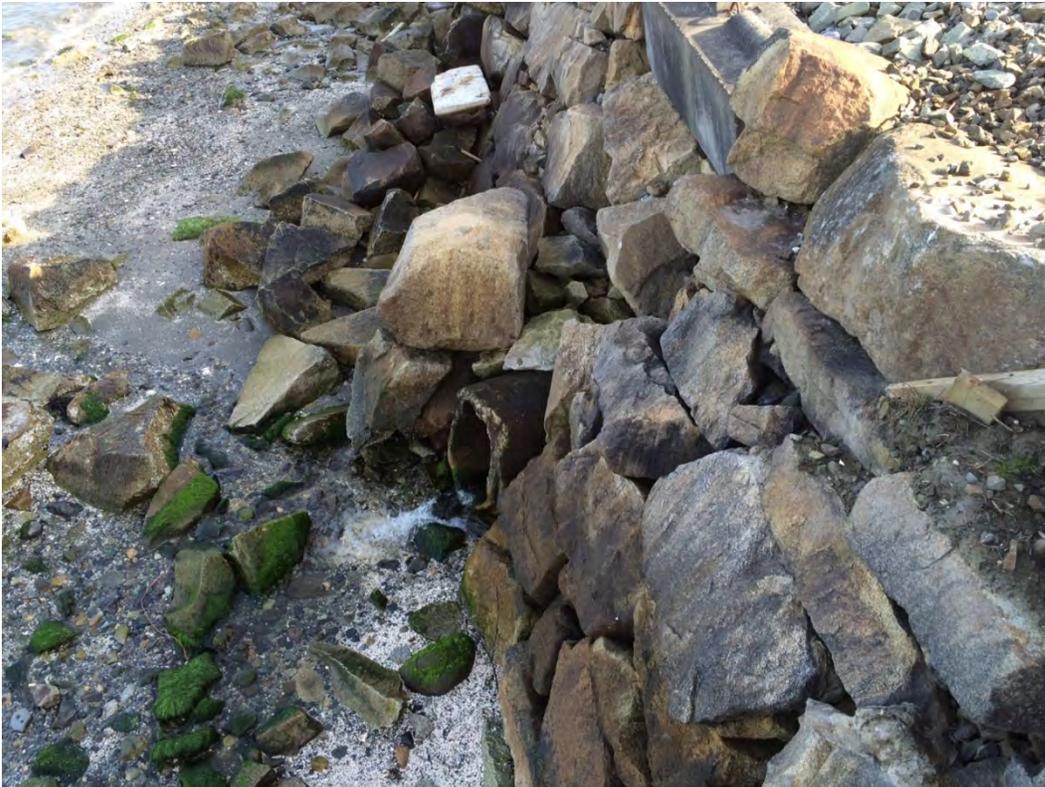
Photo 10. Stream outlet into Puget Sound; concrete culvert under railroad tracks

Below the 61st Place West culvert, the stream is a riffle run with cascades and an incised channel (Photo 5). The stream runs past a couple of residential homes and runs parallel to 88th Street SW, where a riprap bank along the road extends below the ordinary high water mark (OHWM) of the stream (Photo 6). The stream crosses under 88th Street SW through another culvert (Photos 8 and 9) that is a partial fish-passage barrier due to a perched outlet observed during the March 10, 2015 site visit. Finally, the stream crosses under the railroad tracks via a 36-inch-diameter concrete culvert that does appear fish-passable before entering Puget Sound (Photo 10).

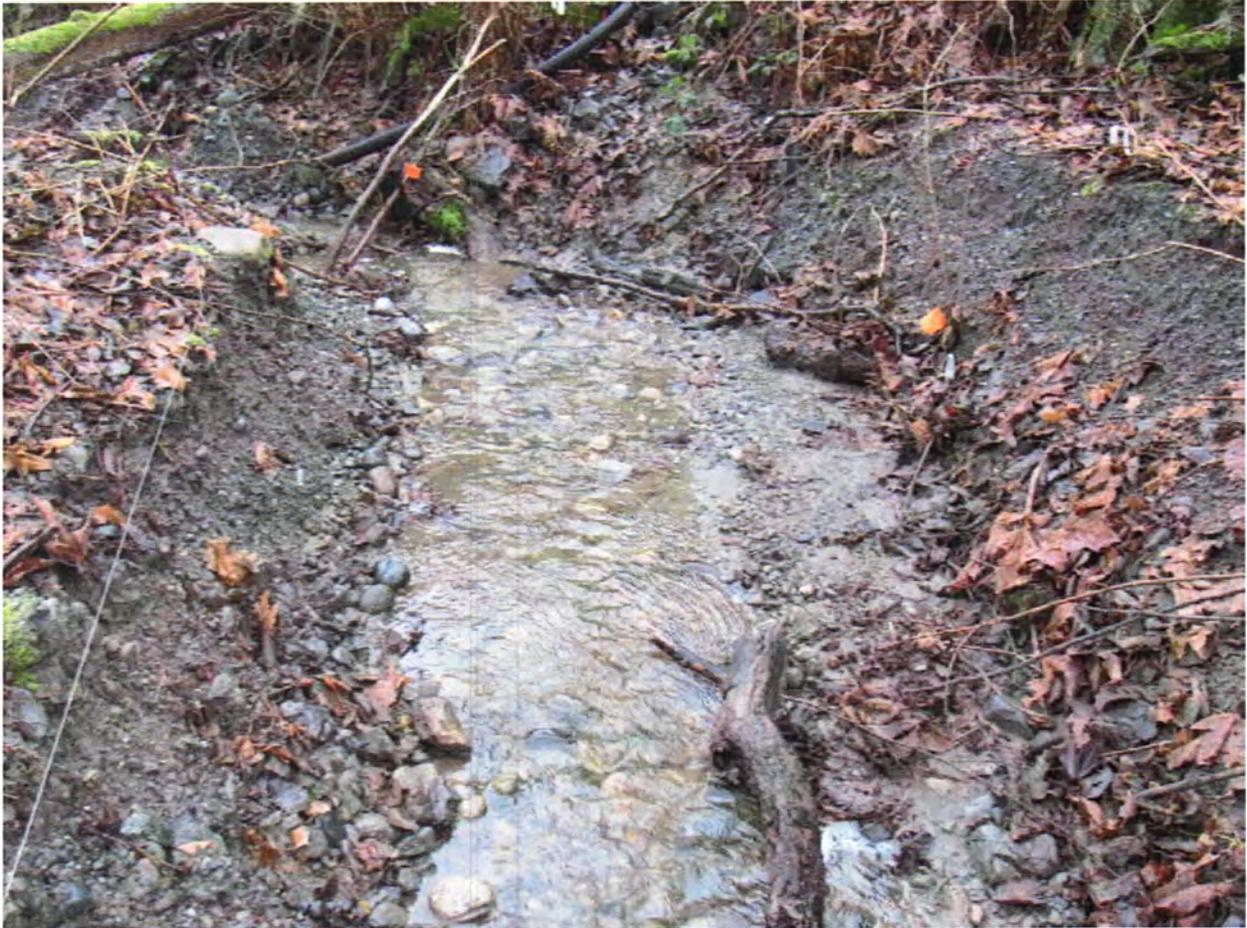
Photo 1: Typical section in lower portion of surveyed reach. Note sediment deposition on either side of channel

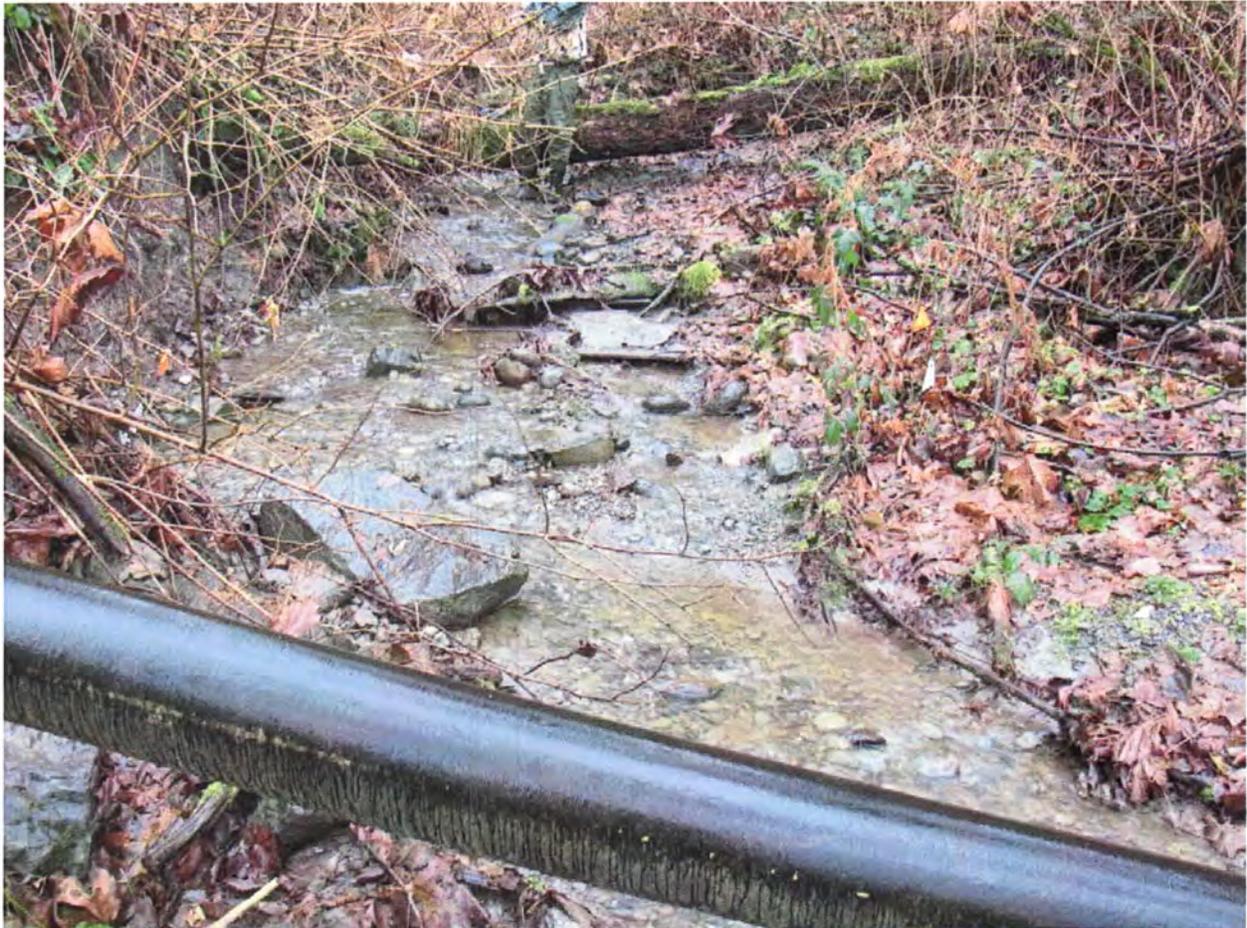
Photo 2: Stream channel with exposed sewer pipe crossing stream in foreground, indicative of historic downcutting and channel incision

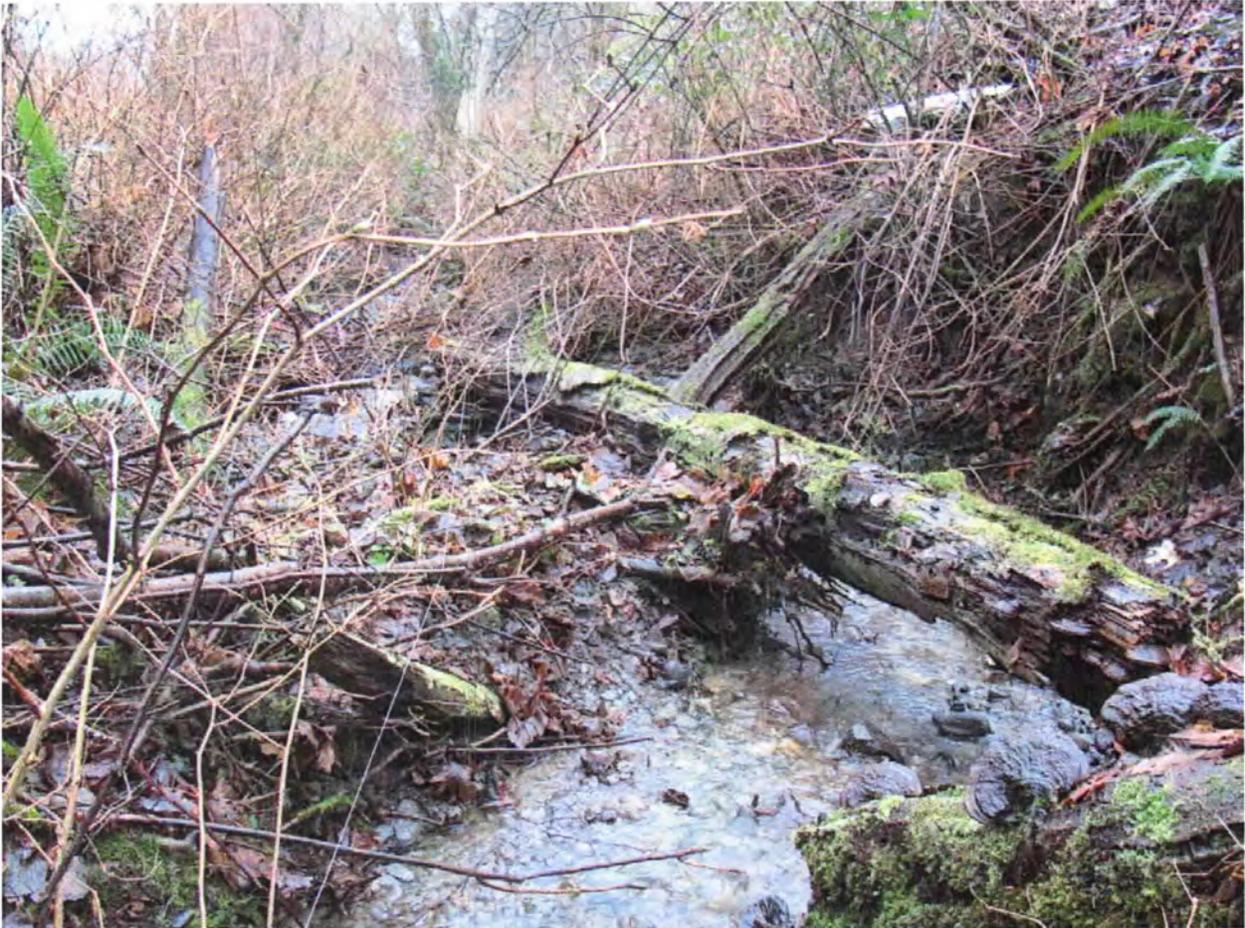
Photo 3: Typical LWD element spanning channel

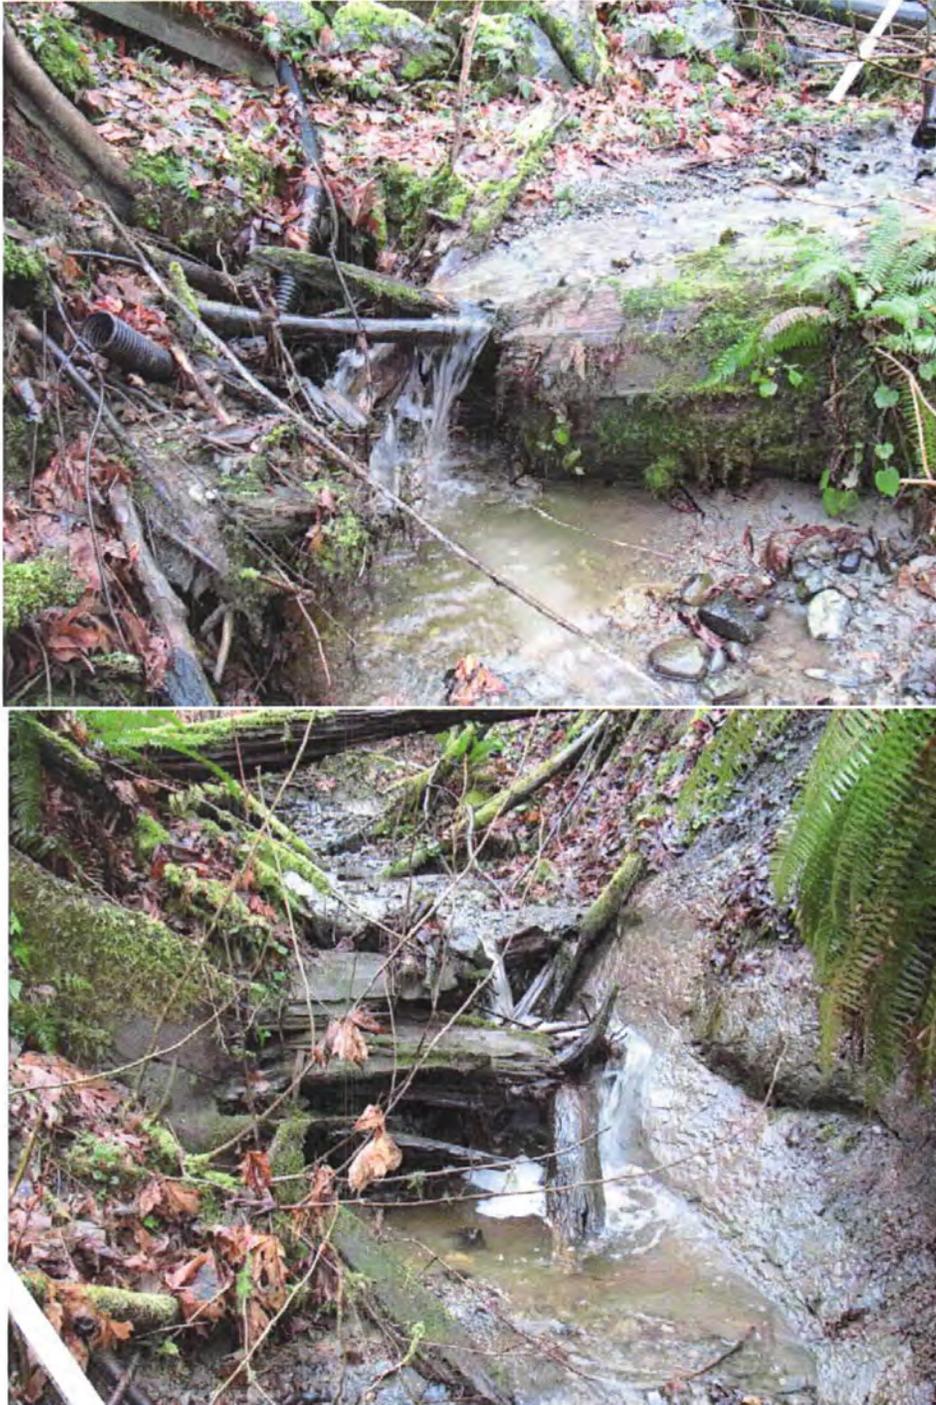
Photo 4: Gradient jumps/drops in system, ranging from 2 to 3 feet in height

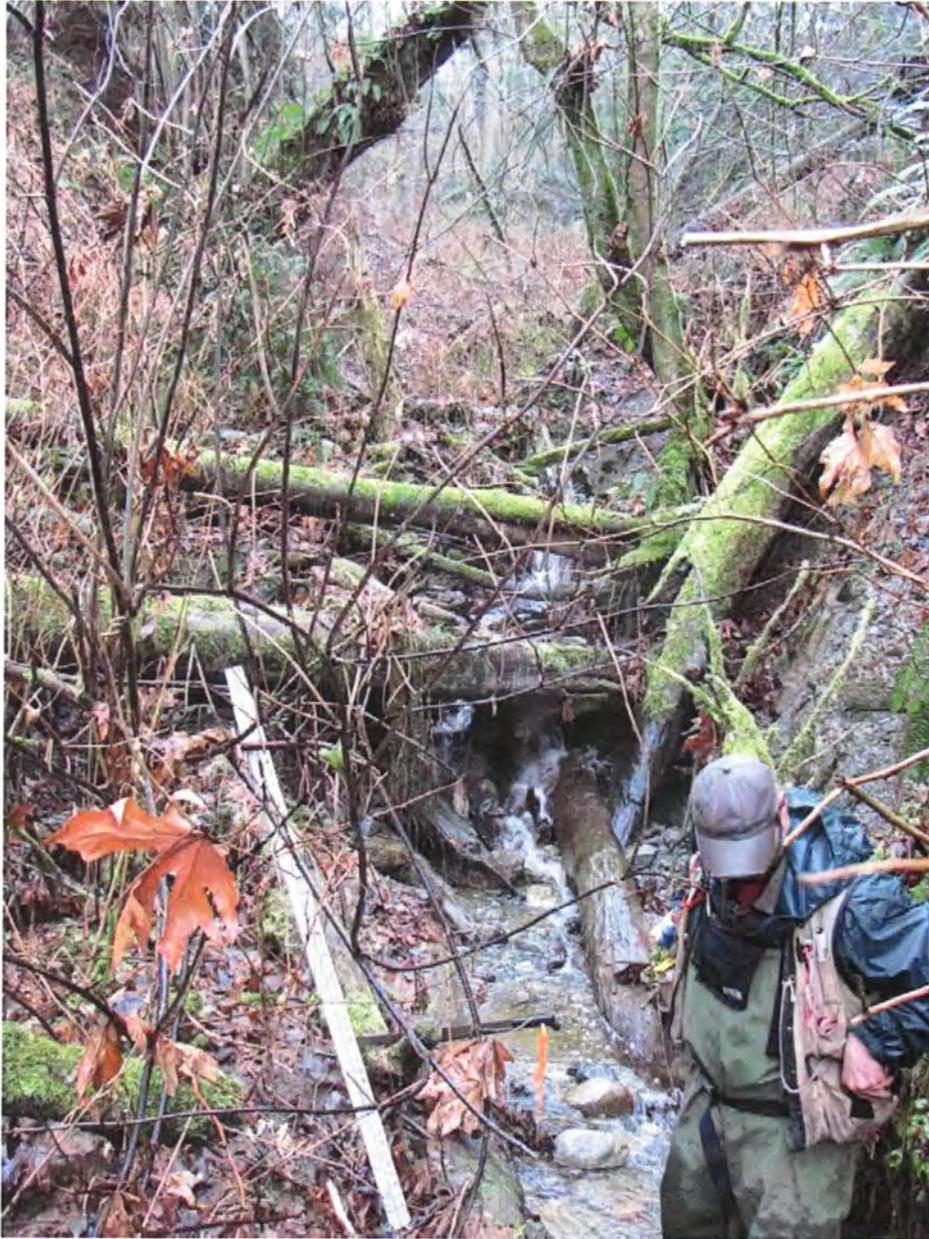
Photo 5: Debris jam and beginning of cascade sequence. Gradient increases to approximately 24% above the jam
