# Big Gulch North

Watershed: Big Gulch  
 Management Category: Targeted Management Strategies  
 Priority: High

Area (acres): 303  
 % Impervious: 23%  
 % Wetland: 0.8%  
 Landscape Position: Plateau

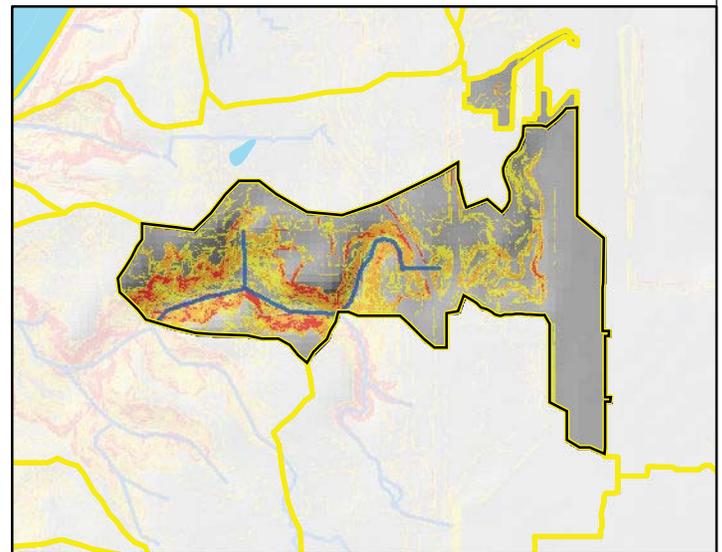
**Drainage**  
 Streams (blue line), Pipe Network (purple line), Wetlands (green hatched), Open Channel Systems (green line), Detention Ponds (Stormwater Facilities) (dark green rectangle)

**Steep Slopes**  
 Moderate (yellow), Steep (orange), Very Steep (red)

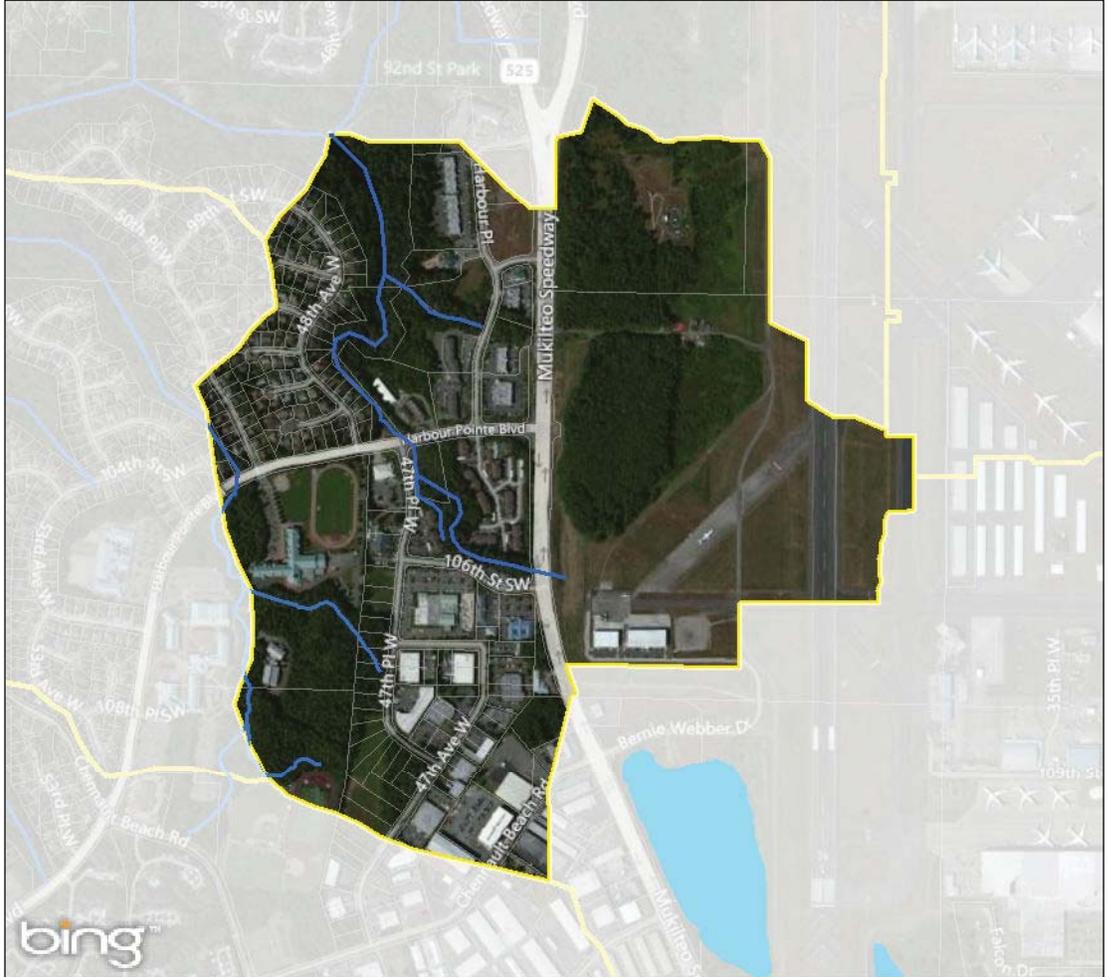
**Drainage**  
 Streams (blue line), Pipe Network (purple line), Wetlands (green hatched), Open Channel Systems (green line), Detention Ponds (Stormwater Facilities) (dark green area)

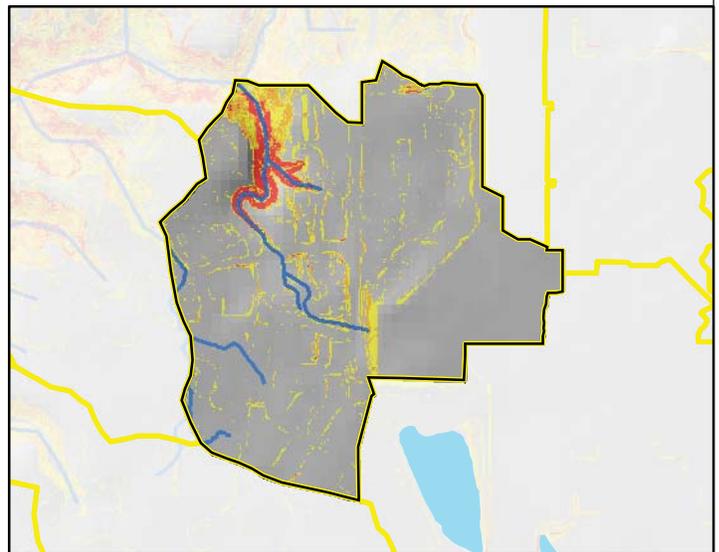
**Steep Slopes**  
 Moderate (yellow), Steep (orange), Very Steep (red)

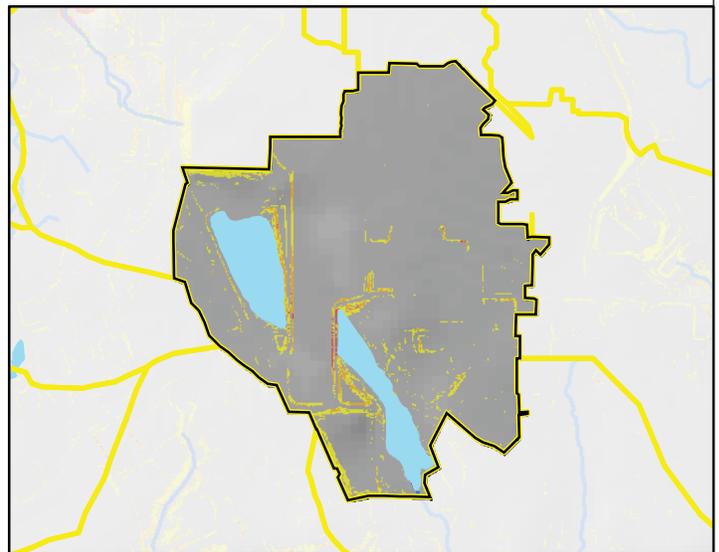
**Drainage**  
— Streams    — Pipe Network    ▨ Wetlands  
— Open Channel Systems    ■ Detention Ponds (Stormwater Facilities)

**Steep Slopes**  
■ Moderate    ■ Steep    ■ Very Steep

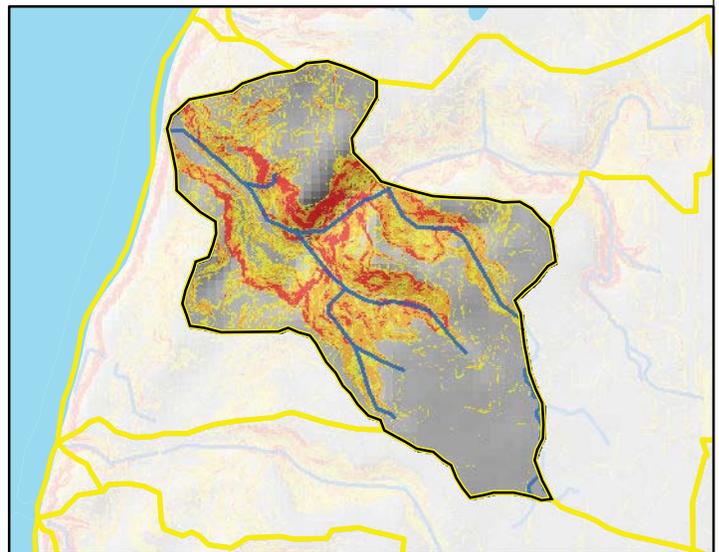
**Drainage**    — Streams    — Pipe Network    ■ Wetlands  
— Open Channel Systems    ■ Detention Ponds (Stormwater Facilities)

**Steep Slopes**    ■ Moderate    ■ Steep    ■ Very Steep

Much of the land in this PAU is located in a well vegetated steep ravine. Use of strategies that infiltrate runoff will be limited/prohibited in these areas due to risks of landslides.

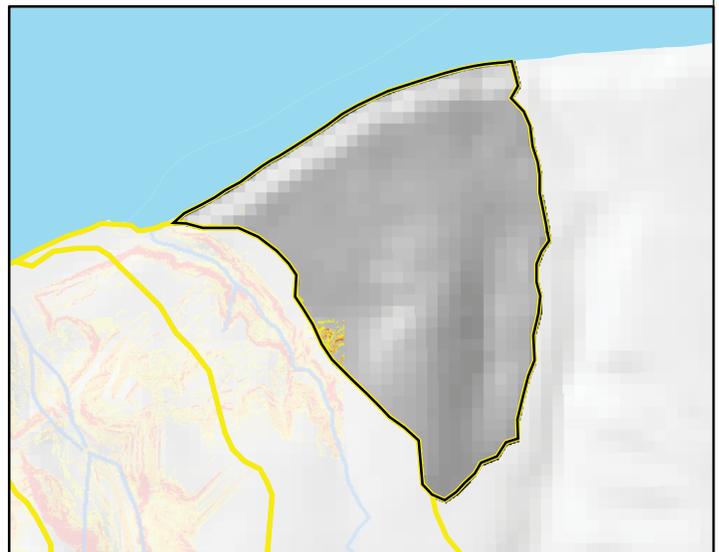
**Drainage**  
 Streams (blue line), Pipe Network (purple line), Wetlands (green hatched area), Open Channel Systems (green line), Detention Ponds (Stormwater Facilities) (dark green area)

**Steep Slopes**  
 Moderate (yellow), Steep (orange), Very Steep (red)

This PAU contains a steep coastal bluff; use of strategies that infiltrate runoff will be limited/prohibited in these areas due to risks of landslides. Approximately 96% of the PAU is residential development; therefore on-site strategies may be most effective.

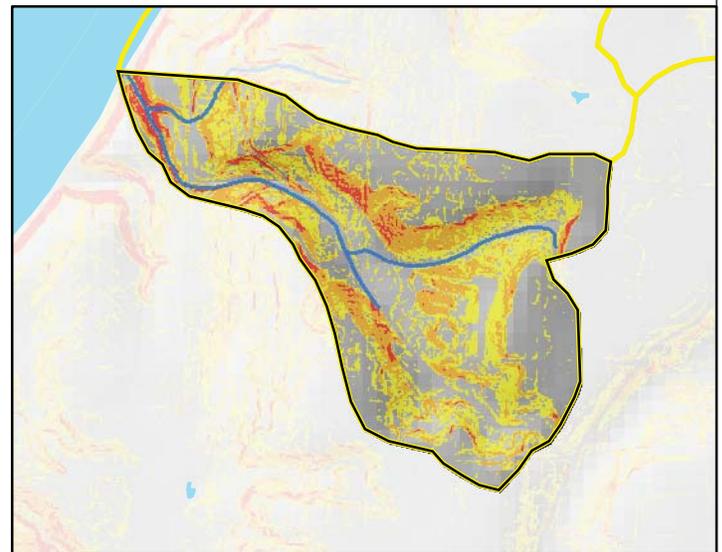
**Drainage** — Streams (blue line) — Pipe Network (purple line) — Wetlands (green hatched) — Open Channel Systems (green line) — Detention Ponds (Stormwater Facilities) (dark green area)

**Steep Slopes** — Moderate (yellow) — Steep (orange) — Very Steep (red)

This PAU contains a steep slope ravine; use of strategies that infiltrate runoff will be limited/prohibited in these areas due to risks of landslides. Approximately 92% of the PAU is residential development; therefore on-site strategies may be most effective.

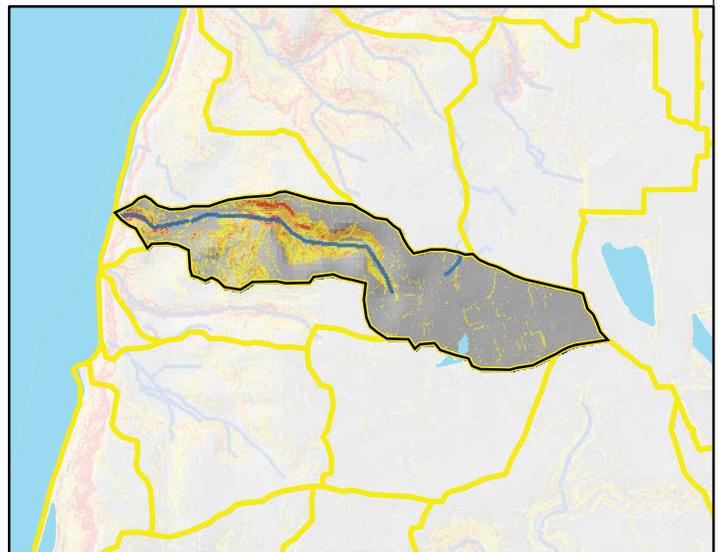
---

Primary Focus: Delivery Process

The lower portion of this PAU contains a steep ravine; use of strategies that infiltrate runoff will be limited/prohibited in these areas due to risks of landslides.
