RE: Revised Critical Area Reconnaissance Report for 9110 53rd Avenue West; Parcel 00611600015900

SITE DESCRIPTION

WETLAND DETERMINATION DATA FORM – Western Mountains, Valleys, and Coast Region

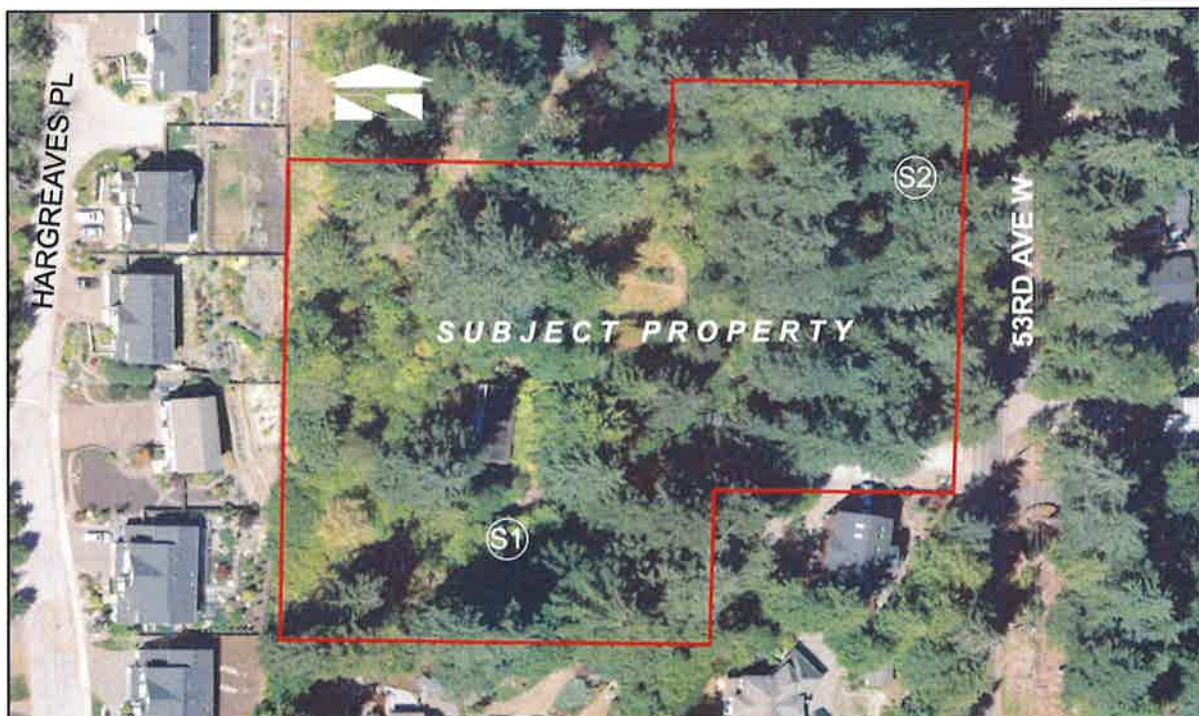
Figure 1 - Aerial photograph of the subject property and data site locations.

The parcel is located in a residential setting, situated between 53rd Ave W and Hargreaves Place, north of Big Gulch Park. A single-family home lies in the northern portion property. Vegetation is generally forested, with an upland species assemblage.

No wetlands, streams or buffers are located on the subject property. No areas on or near the site exhibit the combined positive indicators of hydrophytic vegetation, hydric soils, and wetland hydrology. A depressional area in the eastern portion of the property, adjacent to 53rd Ave W, contains a non-hydrophytic vegetation community and bright, non-hydric soils. Buffers from off-site critical areas do not reach the site.
