RE: Wetland Reconnaissance on vacant land just south of property addressed 9xx Webster Street, Mukilteo, WA 98059; Tax Parcel # 00527504701200

The purpose of this Wetland Reconnaissance is to evaluate if a wetland exists just south of the site. This Wetland Reconnaissance provides findings, photos and conclusions on the formerly delineated offsite wetland (see attached Critical Areas Map by Wetlands & Wildlife for the wetland delineated in 2016 by Wetland Resources, Inc.) beyond the south property line. Wetland boundaries can change over time as they can shrink or increase in area. Since 2016 is more than 5 years ago and because Scott Spooner told me he didn't closely review the offsite wetland area, it made sense for this area to be evaluated based on 2023 conditions.

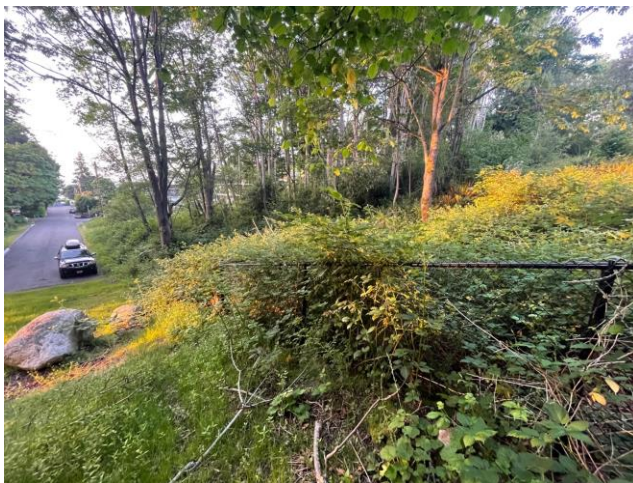
Photo A: Looking north. Webster Street is on left side of photo and depression is left of the black fence. Subject site is in the trees.

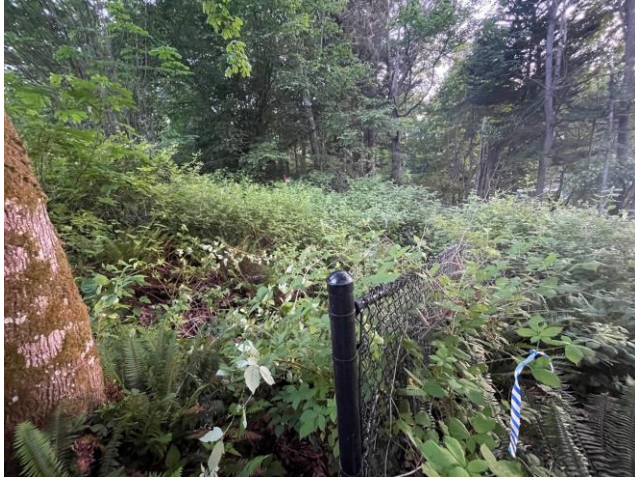
Photo B: SP-1 flag is on the site's south property line on the right side of the photo. SP-2 flag is difficult to see in this photo, but it's left (south) of the fence and in the depression (where the Himalayan blackberry is very dominant). A big leaf maple tree is on the left side of the photo.
