## **TECHNICAL MEMORANDUM**

Date: September 26, 2022  
To: Shelly Henderson; Director of Capital Projects  
Project Name: Mukilteo School District  
Project Number: 220819

### **Re: Mukilteo Elementary School, Wetland and Stream Assessment**

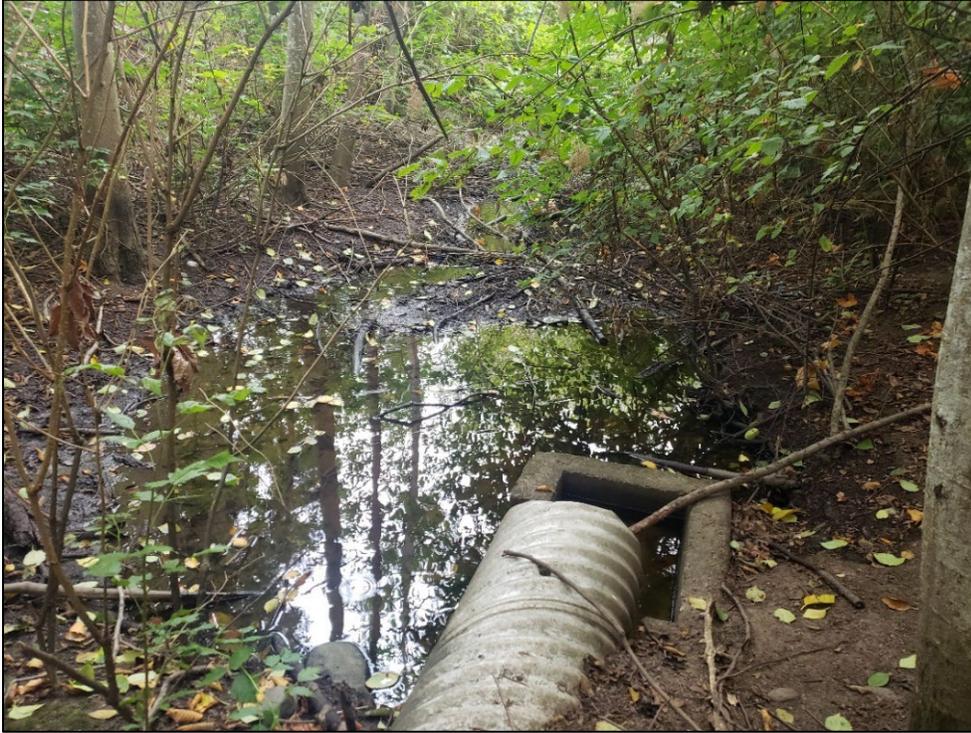
Photo 1. Inlet to stormwater feature via an 18" metal corrugated culvert.

The identified stormwater feature was designed in preparation of Mukilteo Elementary School (see attached grading and drainage plan). The stormwater feature captures drainage via two inlets, a 12" corrugated metal culvert to the east and an 18" corrugated metal culvert to the south (Photo 1). Stormwater is stored in a concave depression, centrally located in the forested property. A concrete weir is located along the northwest and western edge of the stormwater feature, containing stormwater in the concave depression (Photo 2). The stormwater feature has an outlet along western edge via an 18" metal corrugated culvert and overflow structure with debris cage (Photo 3).

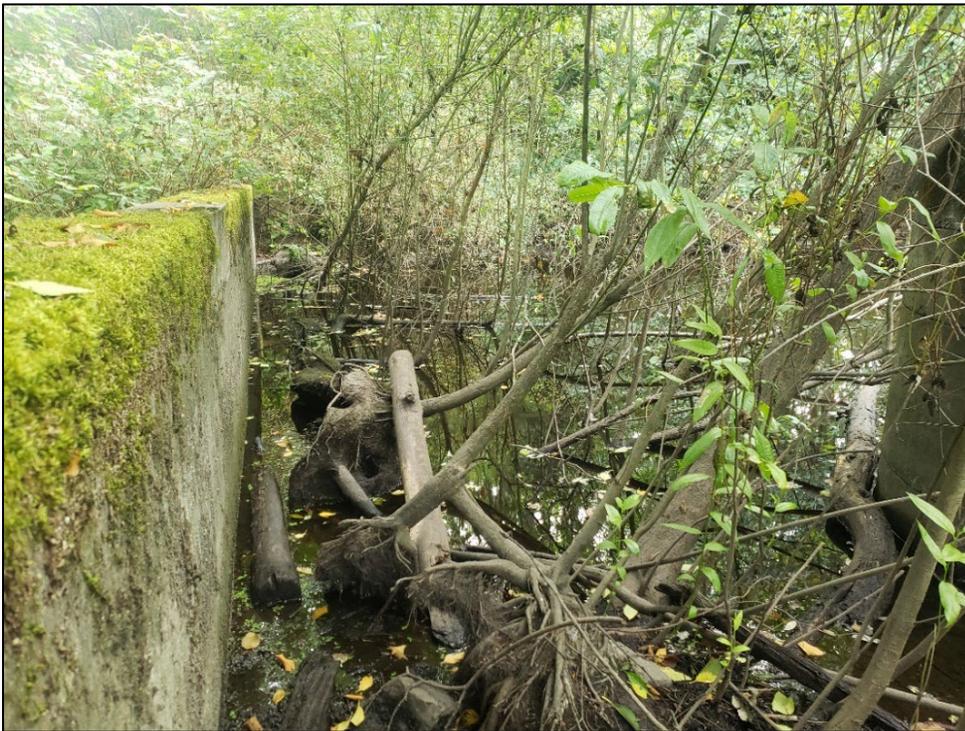
Photo 2. Concrete retaining wall containing stormwater in concave depression.

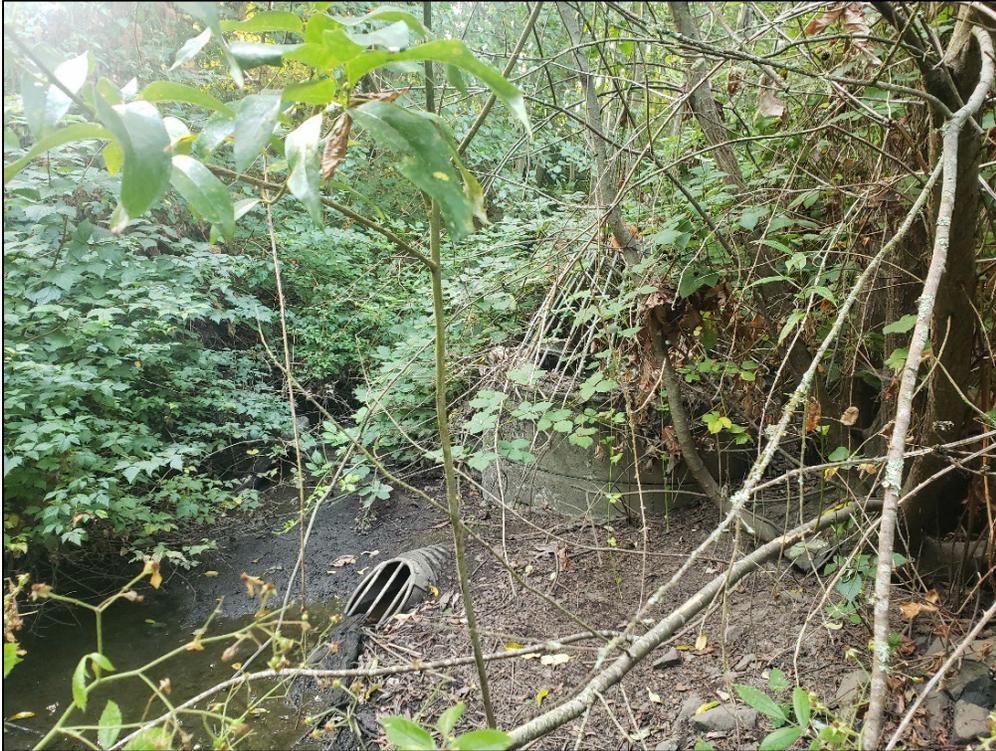
Photo 3. Stormwater feature outlet and overflow structure with bird cage.

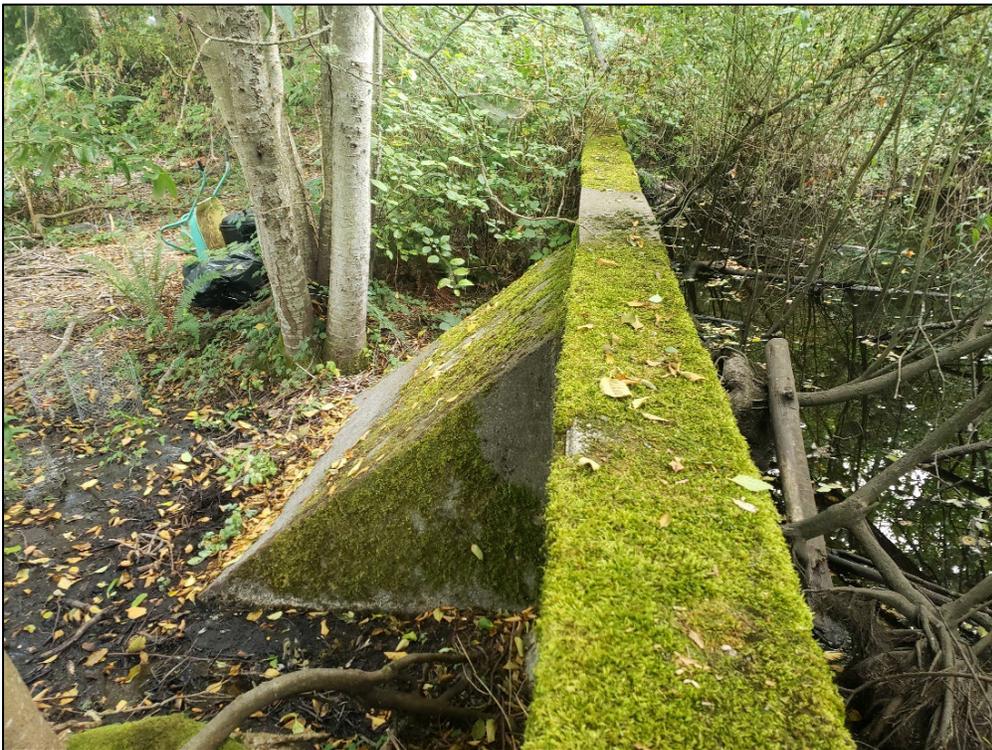
A small area of seepage is located at the base of the retaining wall spillway in a shallow depression (Photo 4). This area meets wetland criteria of hydrophytic vegetation, hydric soils, and wetland hydrology, but is part of the stormwater feature and is not naturally occurring (see DP-3. Immediately downslope of the seepage, non-wetland soils and hydrology are present within the depression. City of Mukilteo GIS identifies a stream downslope of the stormwater feature; however, no evidence bed and bank characteristics, scour, sorted sediments, drainage patterns or other indicators were observed in the vicinity as hydrology is contained in the stormwater feature.

Photo 4. Seepage occurring downslope of the retaining wall and spillway structure, saturated soils noted on left.

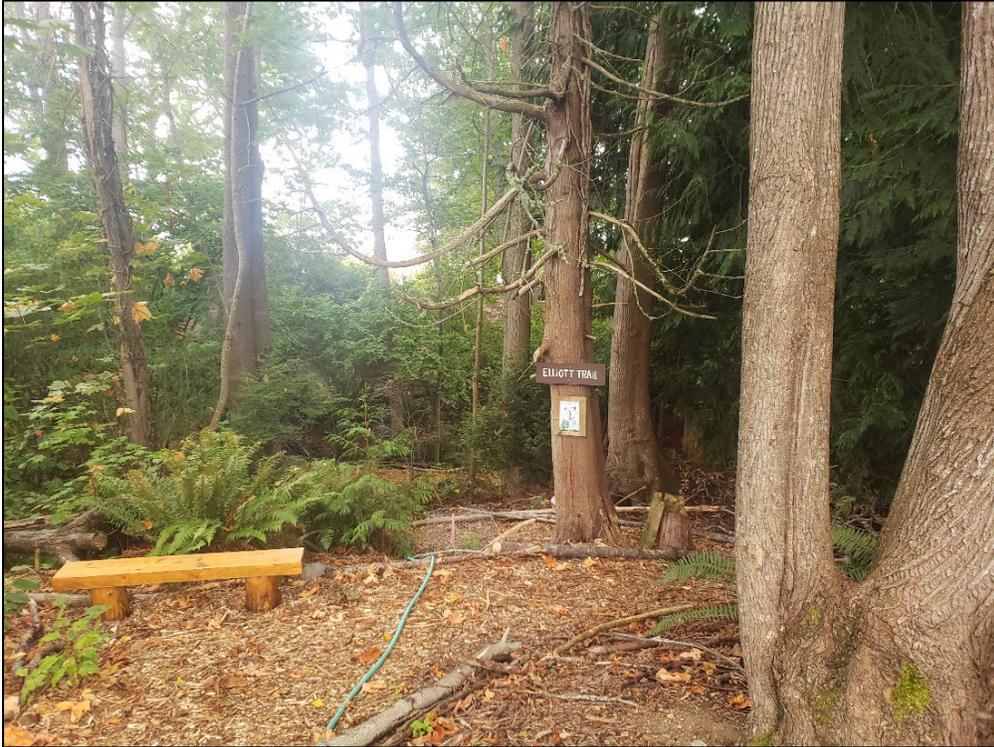
dull Oregon grape (*Mahonia nervosa*), evergreen huckleberry (*Vaccinium ovatum*), and western swordfern (*Polystichum munitum*). The forested property is comprised of several nature trails, active restoration, and used for environmental education (Photo 5).

Photo 5. Nature trails throughout forested upland.

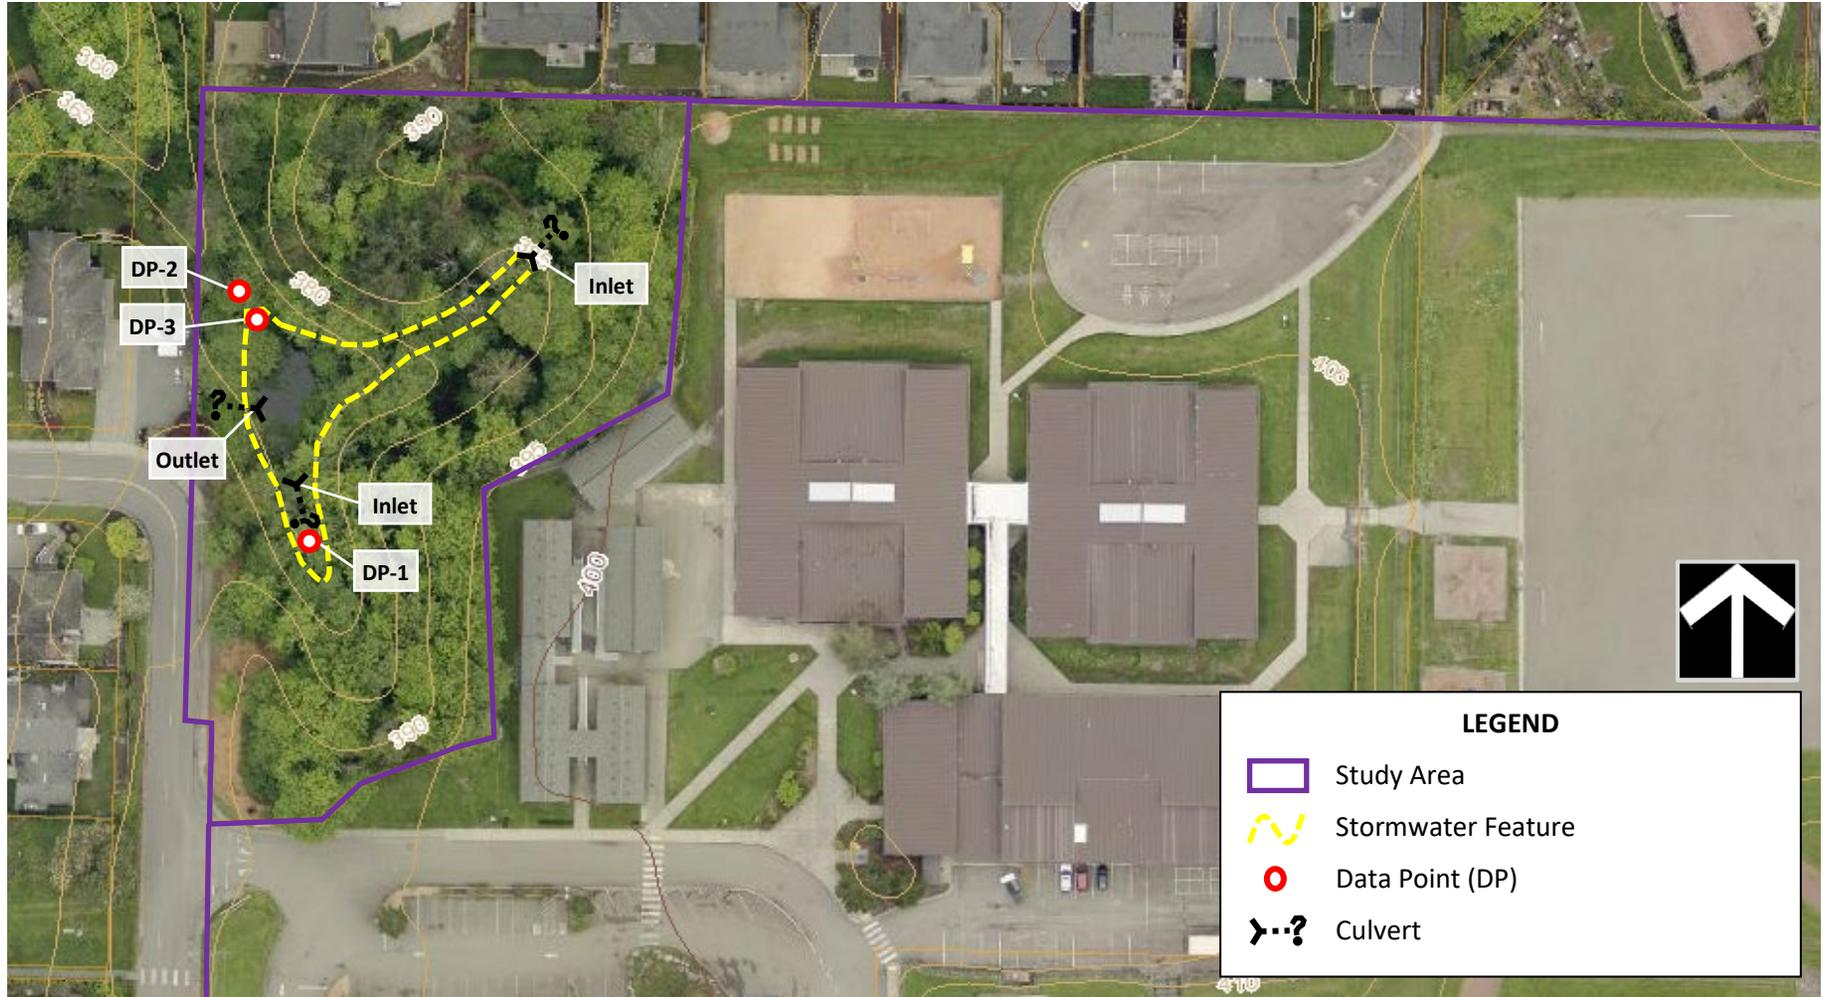
## Wetland and Stream Assessment Sketch – Mukilteo Elementary School

**Note:** Field sketch only. Features depicted are approximate and not to scale. Data points are marked with yellow- and black-striped flags. All observations were made from within the study area; adjoining private properties were not entered. Study area focused on forested patch (parcel #2804090014200) where a documented stormwater feature was present. Parcels #28040900102200, 00591100000102, and 00591100000701 were also screened in this study but no wetlands or streams were identified.

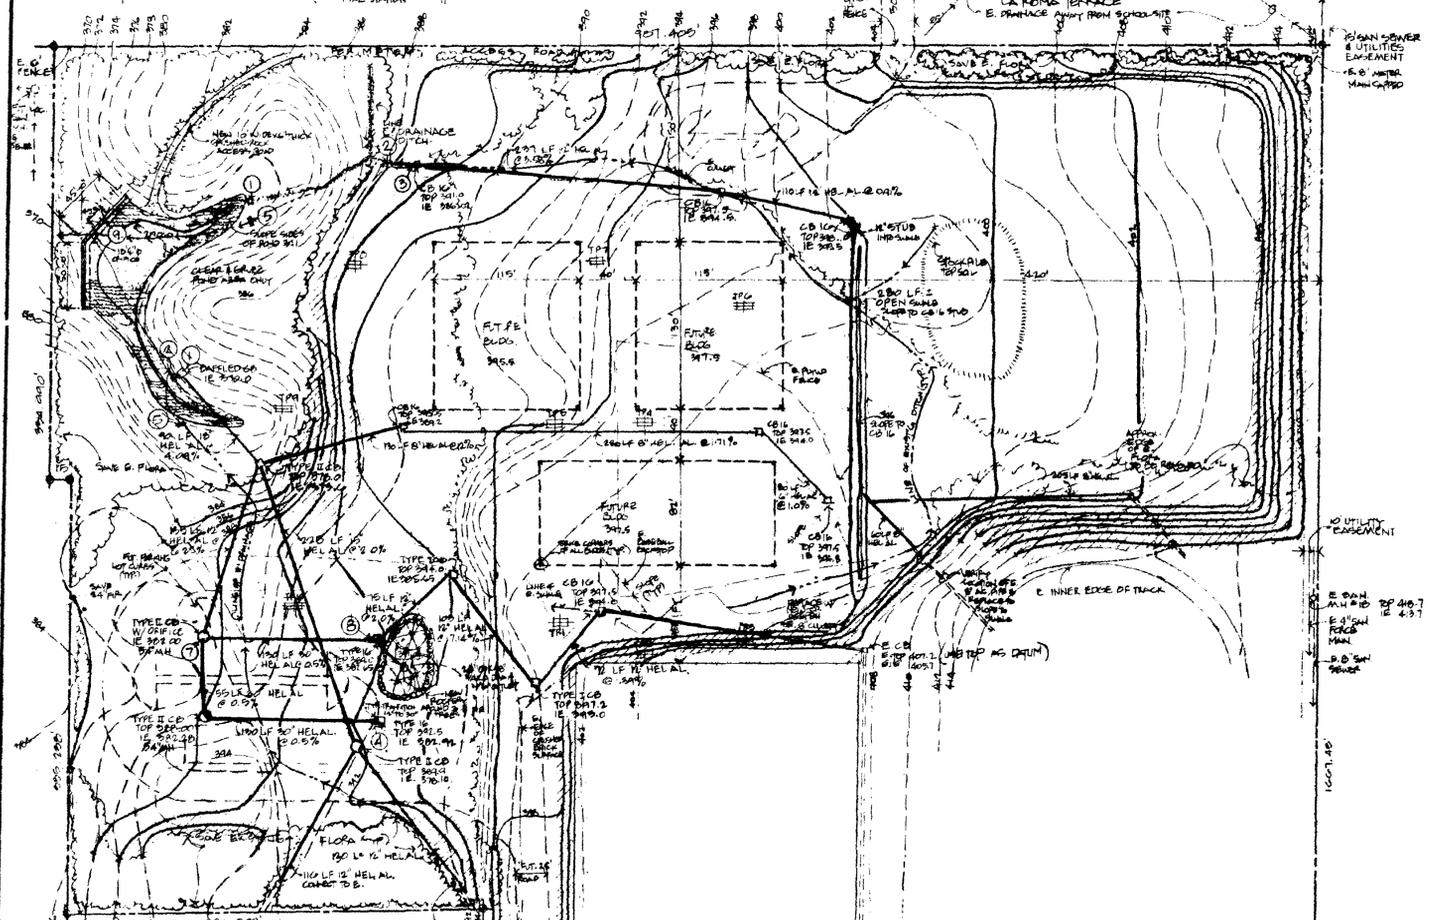
**GRADING & DRAINAGE PLAN**  
SCALE: 1" = 30'-0"

Site observations and the enclosed drainage plan indicate the stormwater feature is an artificial wetland intentionally created from non-wetland conditions to detain stormwater from the adjacent developed schools.

MUKILTEO ELEMENTARY SCHOOL STORM DRAINAGE PLAN  
ADVANCE CIVIL & GRADING WORK
