**61<sup>st</sup> PI W Culvert Improvement Project  
Critical Areas Report**

**The City of Mukilteo  
11930 Cyrus Way  
Mukilteo, WA 98275**

**Northwest Environmental Consulting, LLC  
3639 Palatine Avenue North  
Seattle, WA 98103  
206-234-2520**

**February 2019**

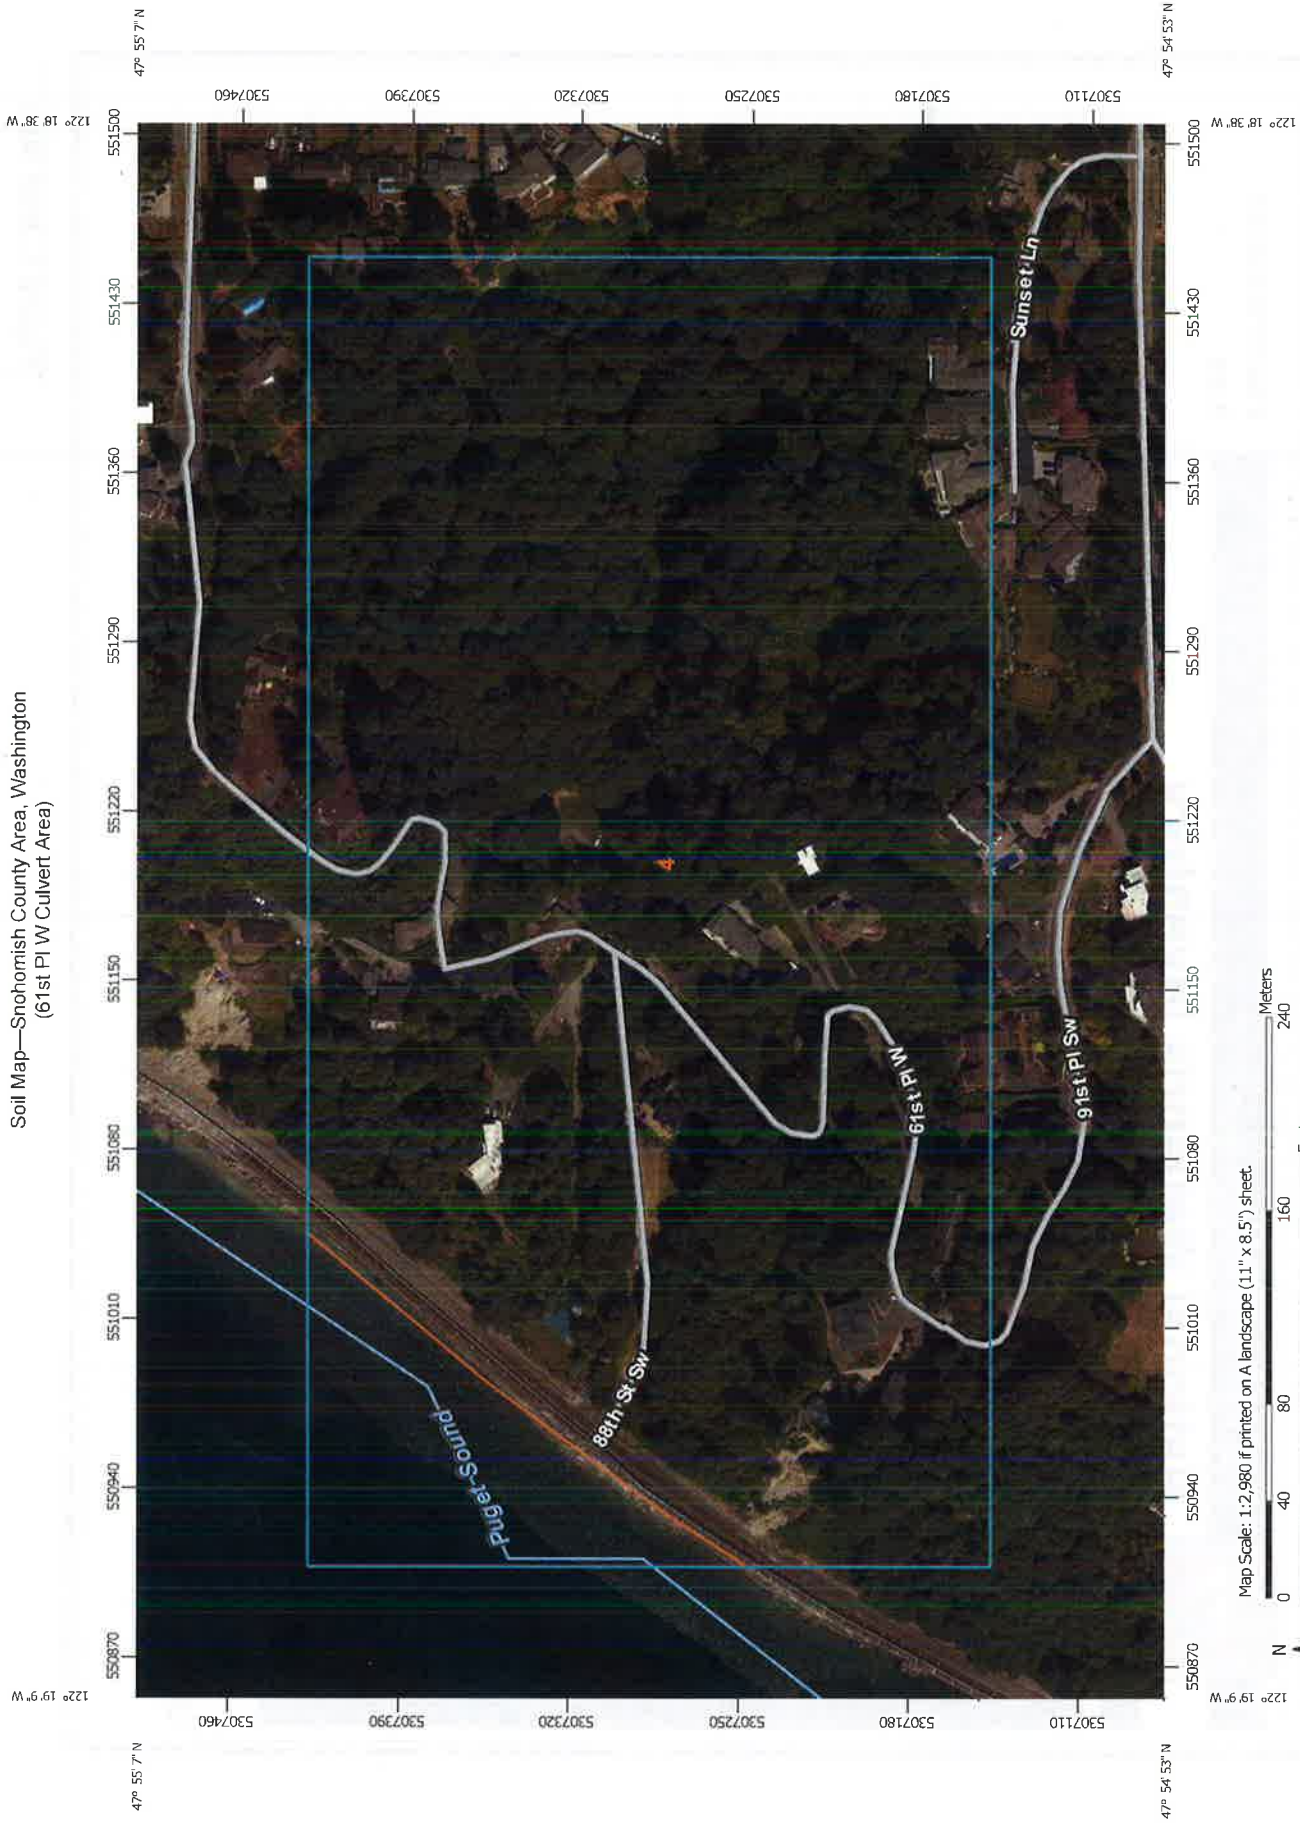
**Figure 2a -Soils Map**

The USDA Soil Survey for Snohomish County maps all soils around the culvert site and the stream as Alderwood-Everett gravelly sandy loams, 25 to 70 percent slopes. The Alderwood series is made up of moderately well drained soils, which are considered upland soils. Figure 16 shows a map of soils found in the project vicinity.

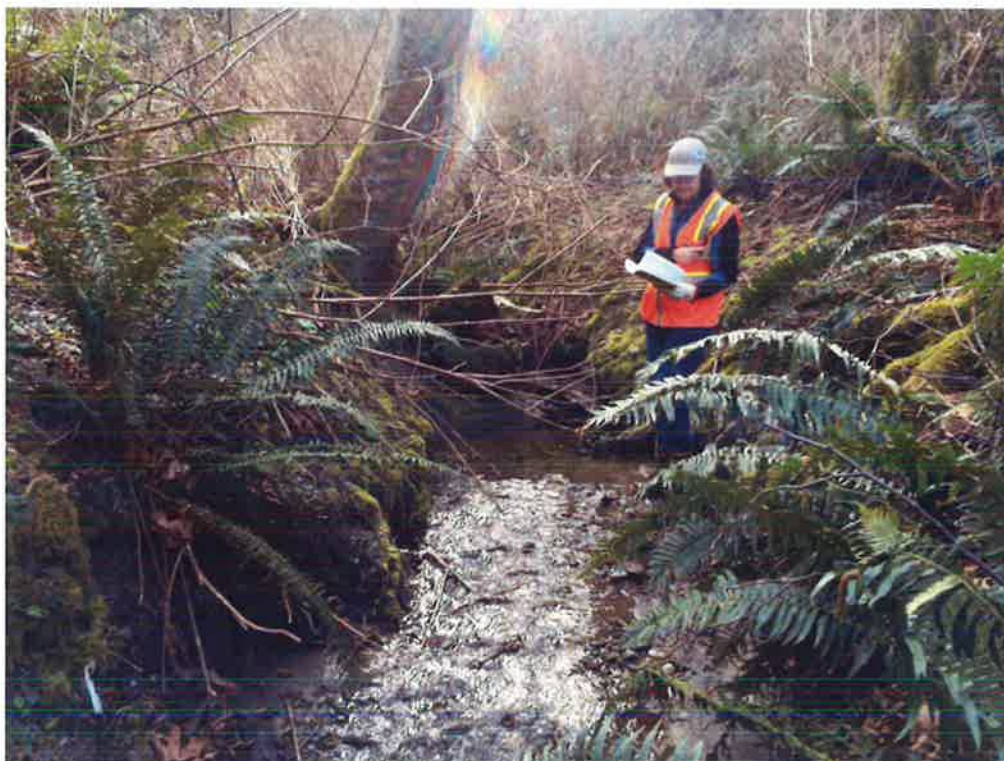
Photo 1. Stream channel about 100 feet upstream of 61<sup>st</sup> Pl W culvert

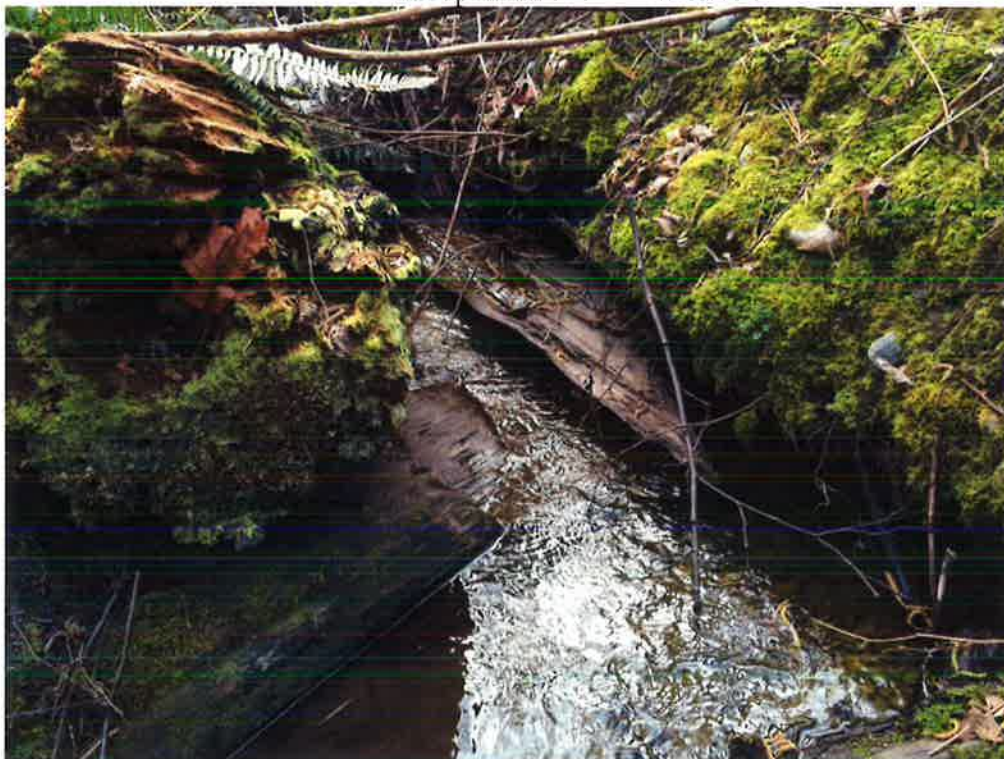
Photo 2. Stream channel about 100 feet upstream of 61<sup>st</sup> Pl W culvert, showing woody debris in stream

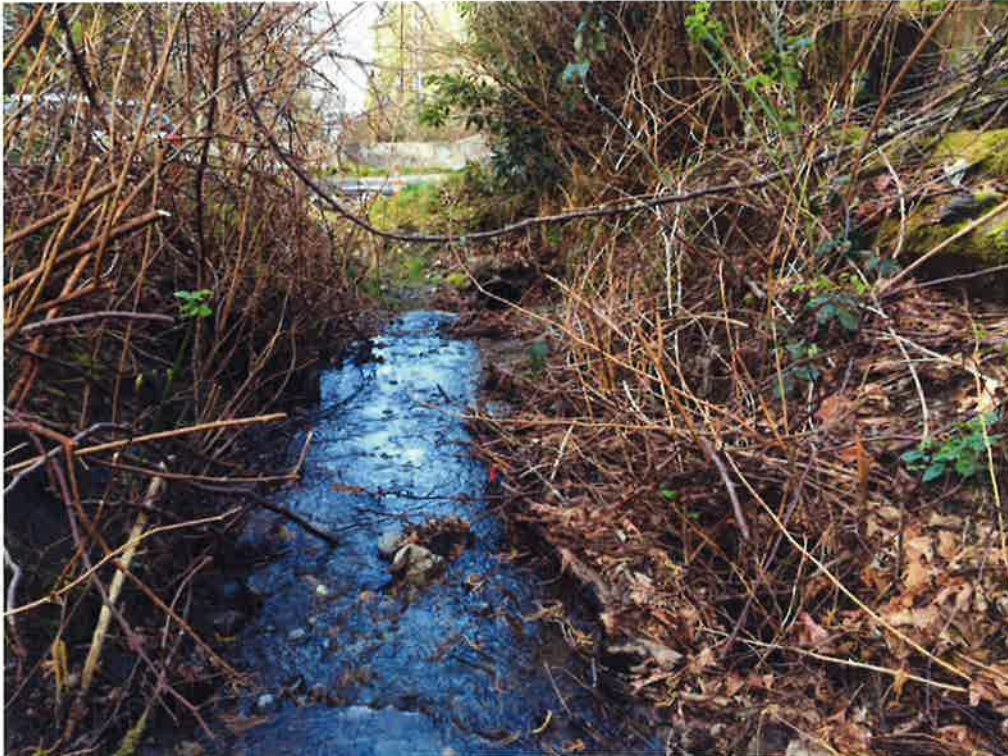
Photo 3. Stream channel at 61<sup>st</sup> Pl W Culvert, looking downstream at culvert

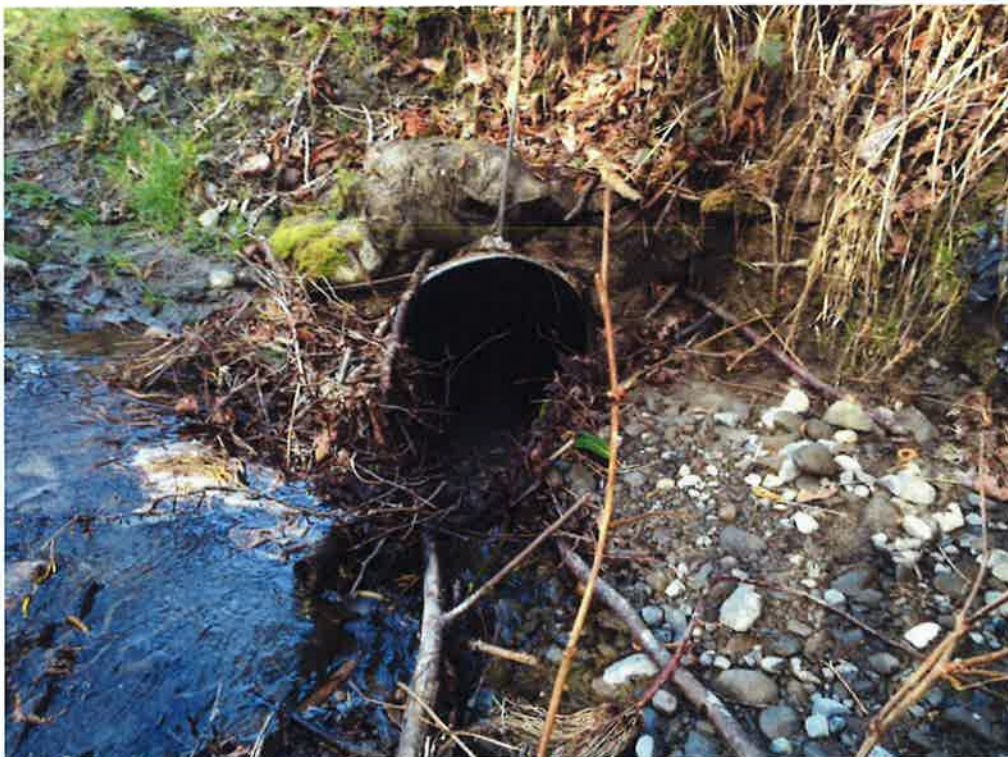
Photo 4. Upstream end of culvert under 61<sup>st</sup> Pl W

end had some debris partially blocking the entrance during the March 10, 2015 site visit (Photo 4). The lower end is perched about 10 feet above a pool. Stream banks are heavily eroded.

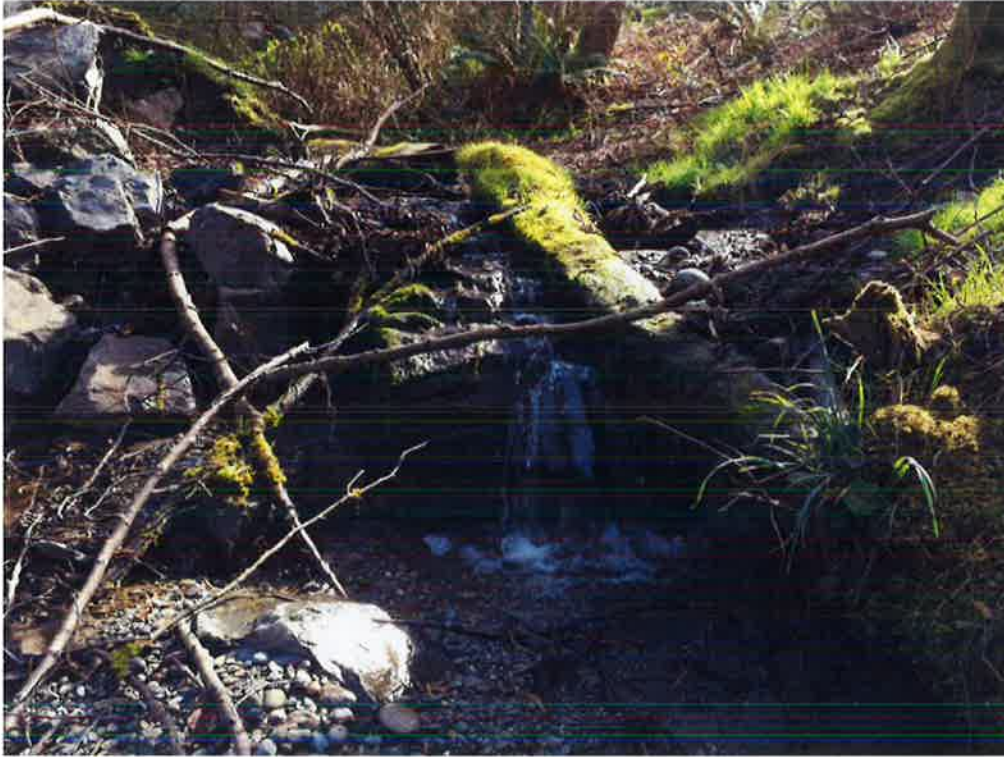
Photo 5. Barrier along stream, downstream of 61<sup>st</sup> Pl W culvert

Below the 61<sup>st</sup> Place West culvert, the stream is a riffle run with cascades and an incised channel (Photo 5). The stream runs past a couple of residential homes and runs parallel to 88<sup>th</sup> Street SW, where a riprap bank along the road extends below the ordinary high water mark (OHWM) of the stream (Photo 6). The stream crosses under 88<sup>th</sup> Street SW through another culvert (Photos 8 and 9) that is a partial fish-passage barrier due to a perched outlet observed during the March 10, 2015 site visit. Finally, the stream crosses under the railroad tracks via a 36-inch-diameter concrete culvert that does appear fish-passable before entering Puget Sound (Photo 10).

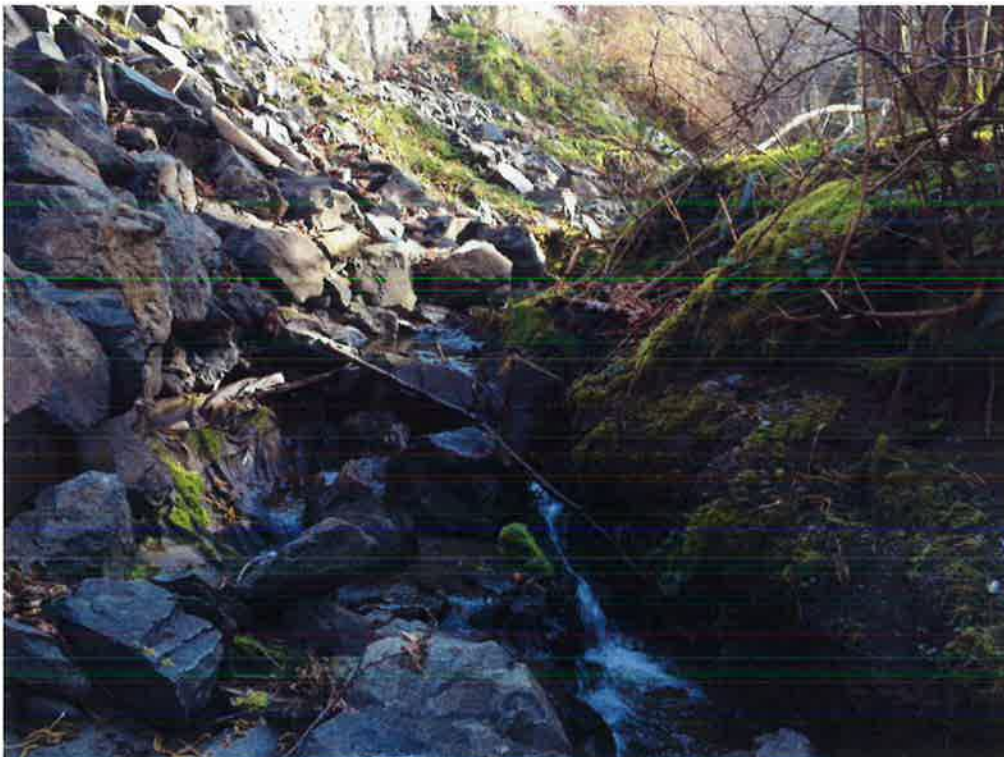
Photo 6. Riprap bank descending into stream, downstream of 61<sup>st</sup> Pl W culvert

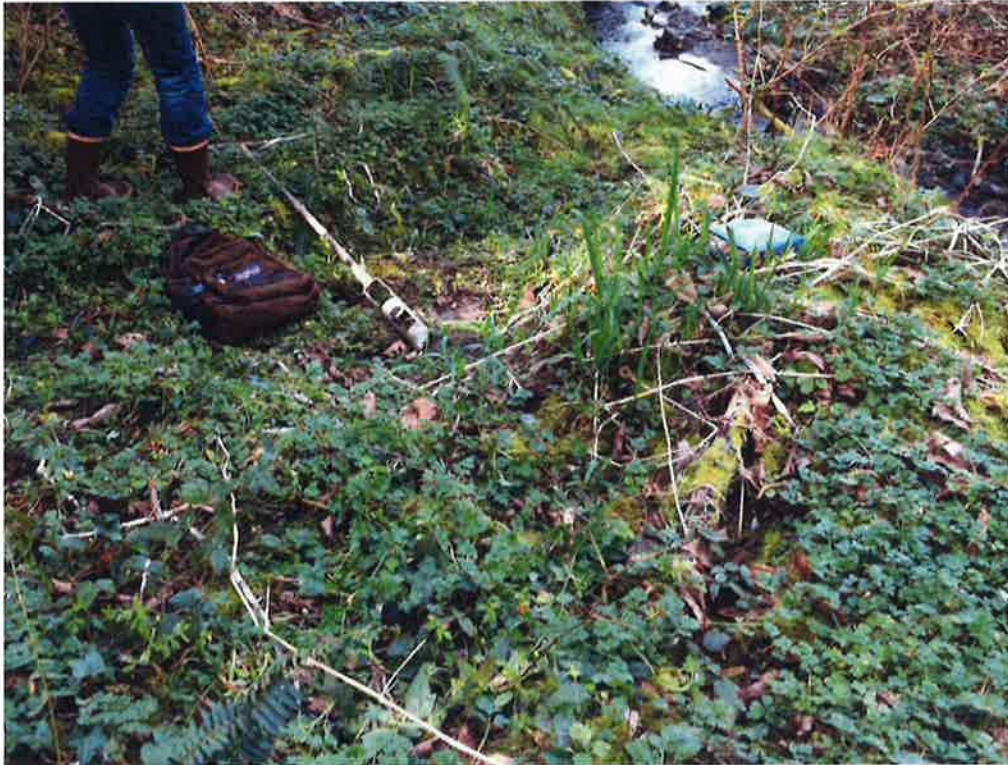
Photo 7. Streambank at site of Test Plot 1

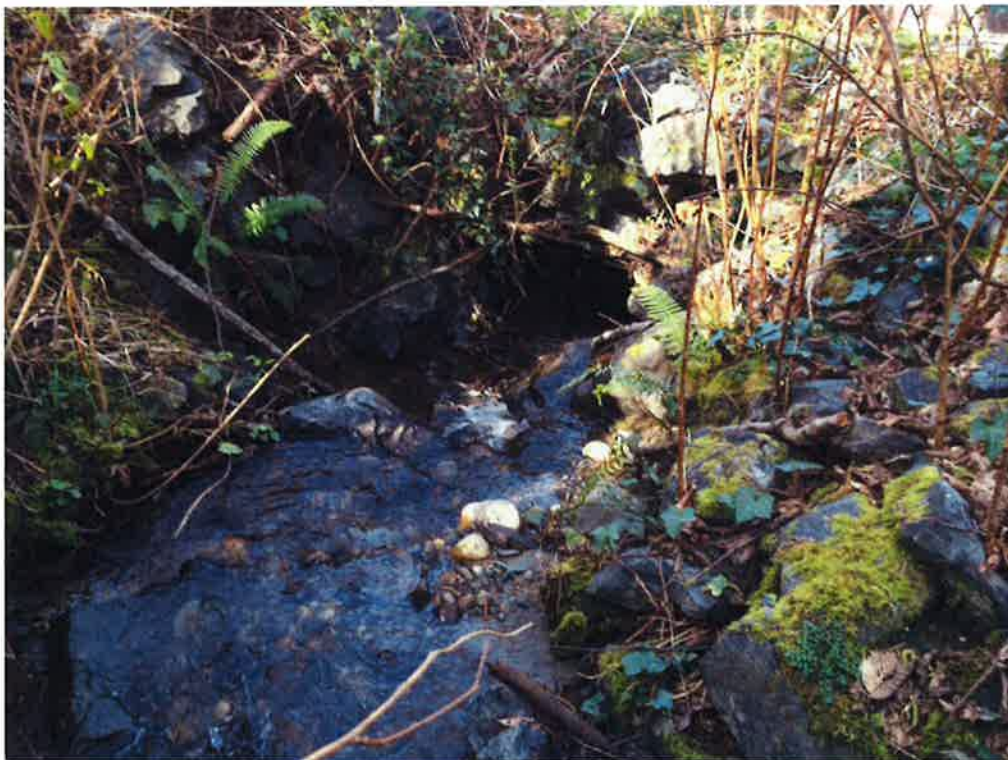
Photo 8. Upstream end of second culvert under 88<sup>th</sup> Street SW, downstream of 61<sup>st</sup> Pl W culvert

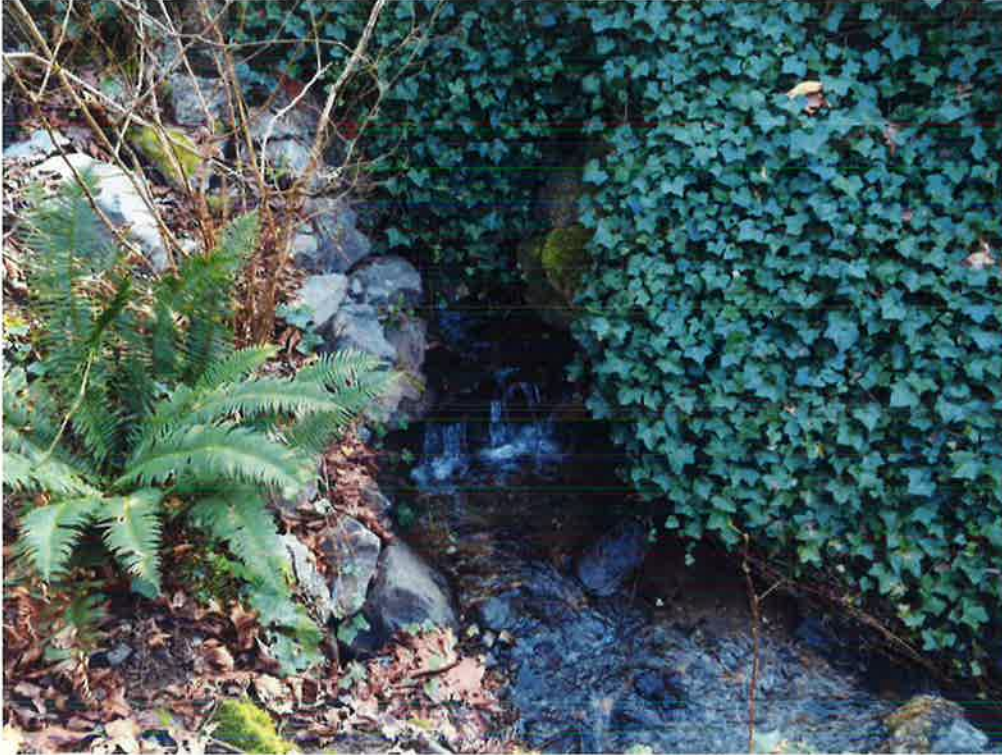
Photo 9. Outlet of second culvert under 88<sup>th</sup> Street SW, downstream of 61<sup>st</sup> Pl W culvert

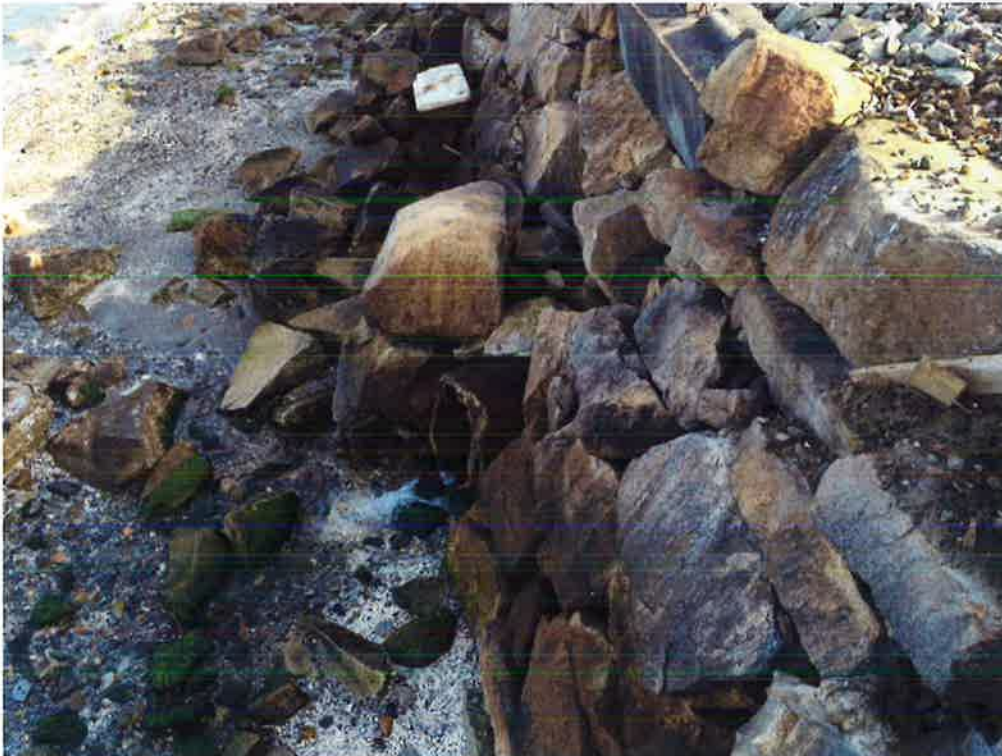
Photo 10. Stream outlet into Puget Sound; concrete culvert under railroad tracks

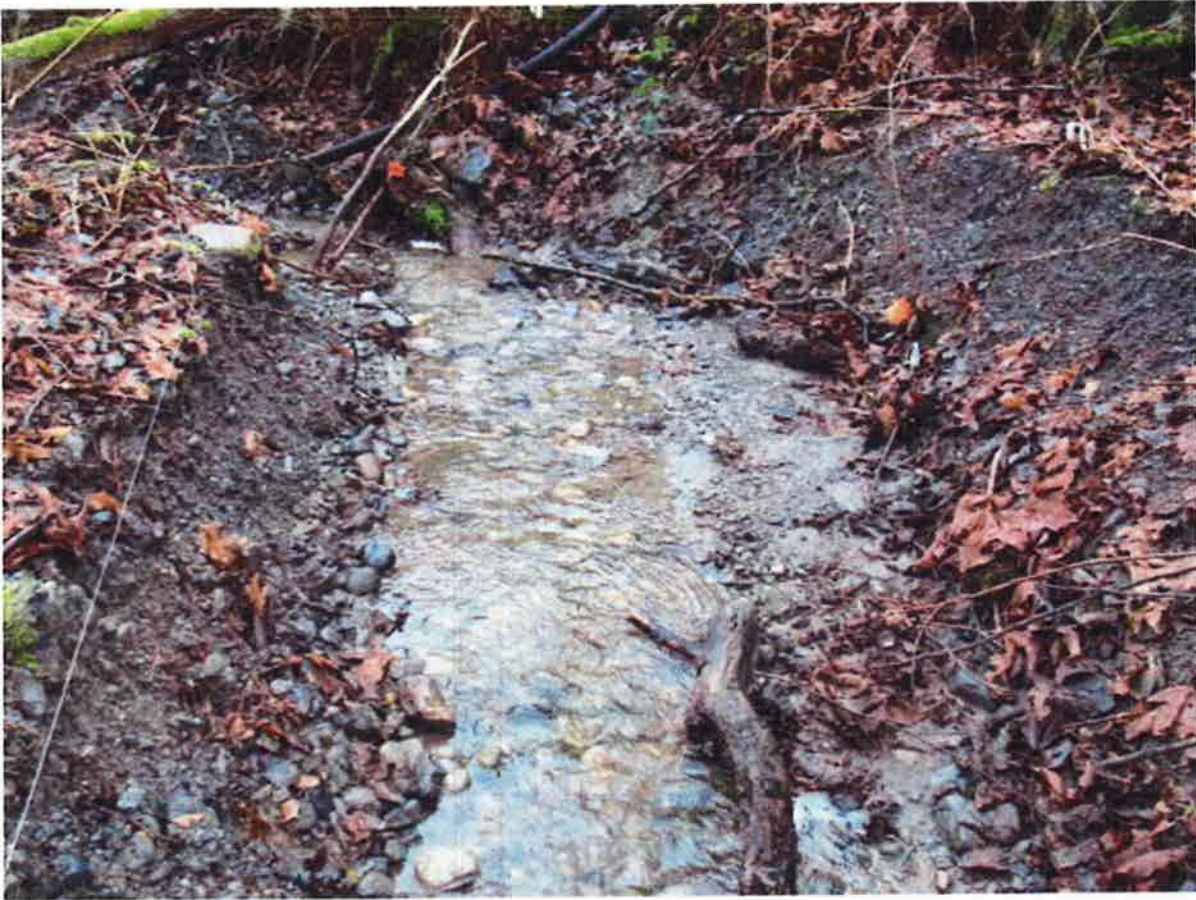
**Photo 1: Typical section in lower portion of surveyed reach. Note sediment deposition on either side of channel**

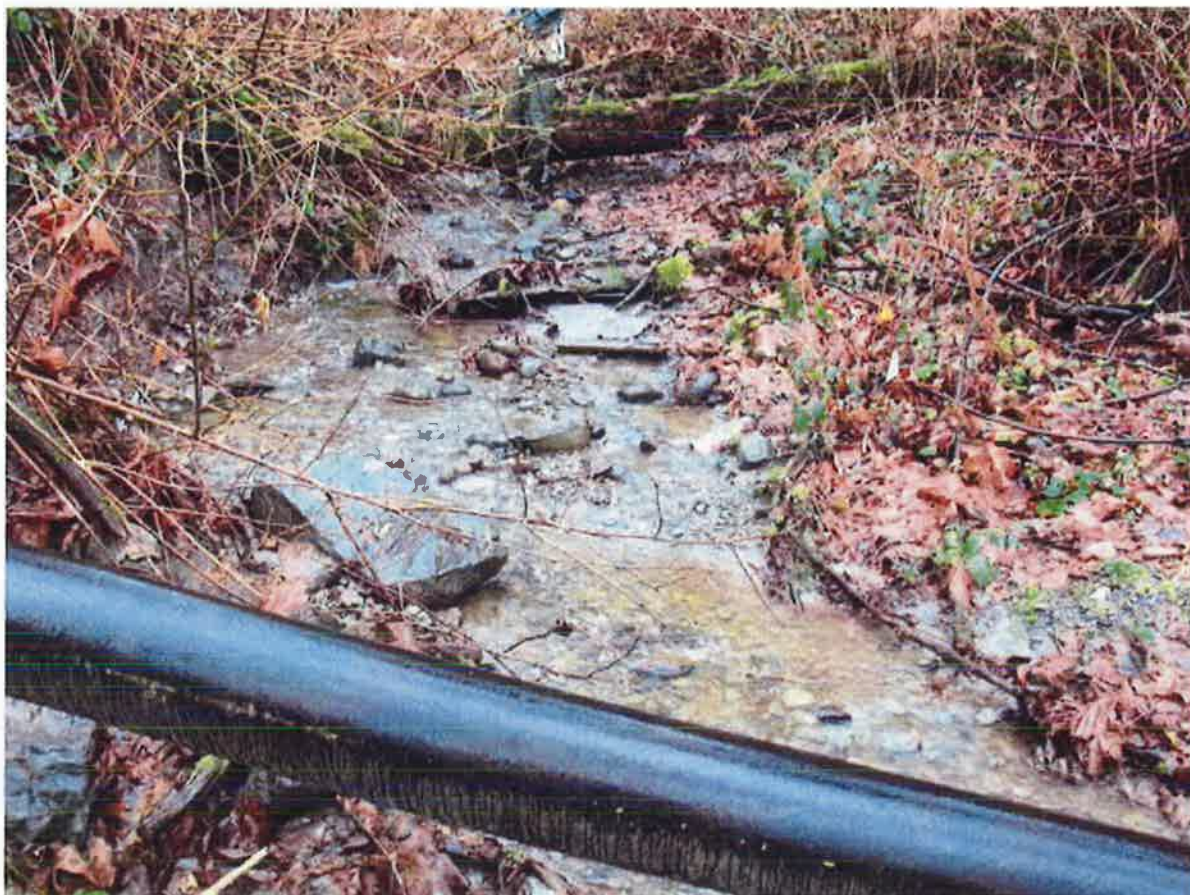
**Photo 2: Stream channel with exposed sewer pipe crossing stream in foreground, indicative of historic downcutting and channel incision**

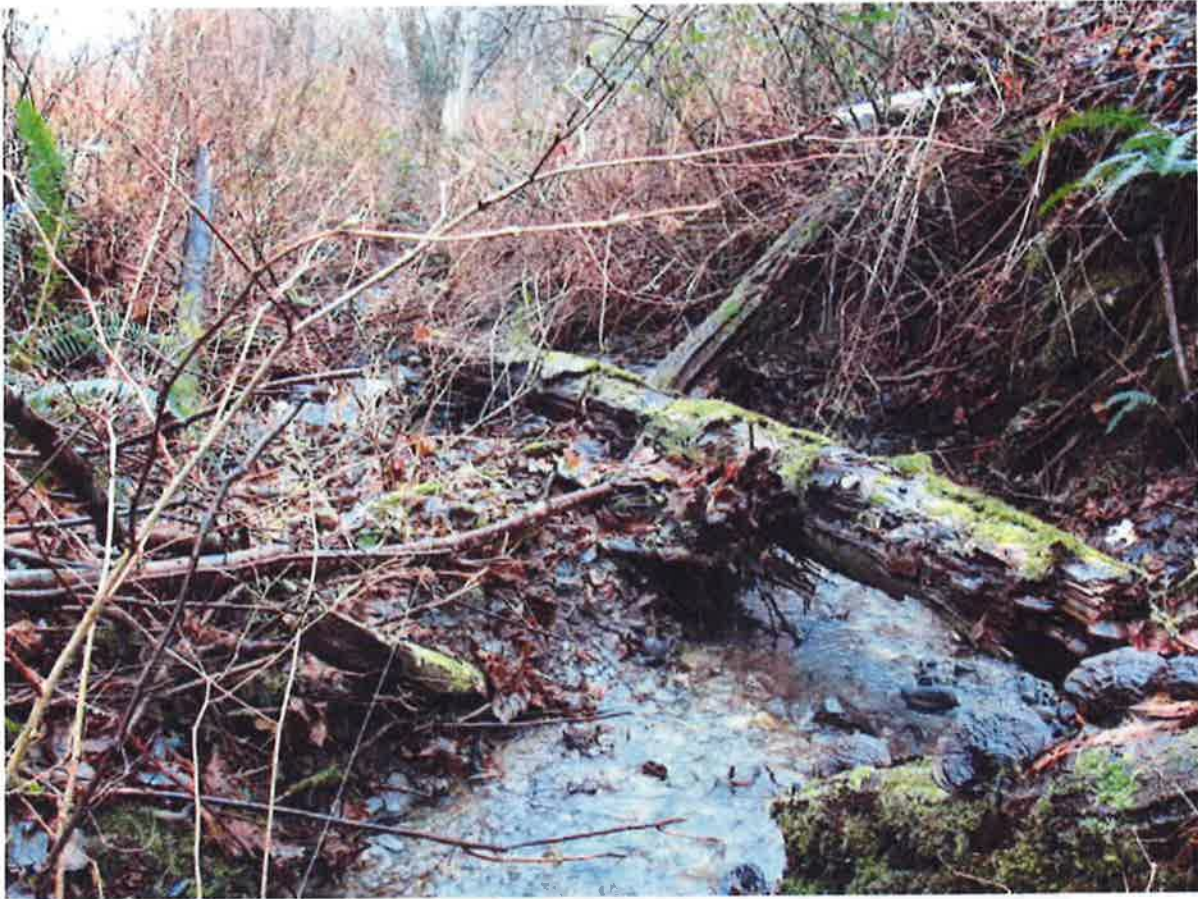
**Photo 3: Typical LWD element spanning channel**

Large woody debris (LWD) elements in the reach occurred at a density of 24 LWD elements over the course of the 385-foot reach. Many of these LWD units occurred in association with one another as debris jams, with the two largest debris jams occurring at the upper end of the reach. Mean length of the LWD elements was 21.3 feet, with a mean diameter of 15.0 inches. Bank instability was noted in the form of bank undercutting and erosion, particularly in the lower part of the reach along the right bank. Much of the lower portion of the reach appeared subject to substantial channel incision, with downcutting observed and a number of bed control structures obviously placed in the channel in an attempt to control the incision. The channel appeared fairly stable higher up in the reach largely due to erosion-resistant till providing some armoring, but the steeper slopes higher in the reach appeared to contribute substantial amounts of sediment to the system in the form of ravine wall sloughing and mass wasting.

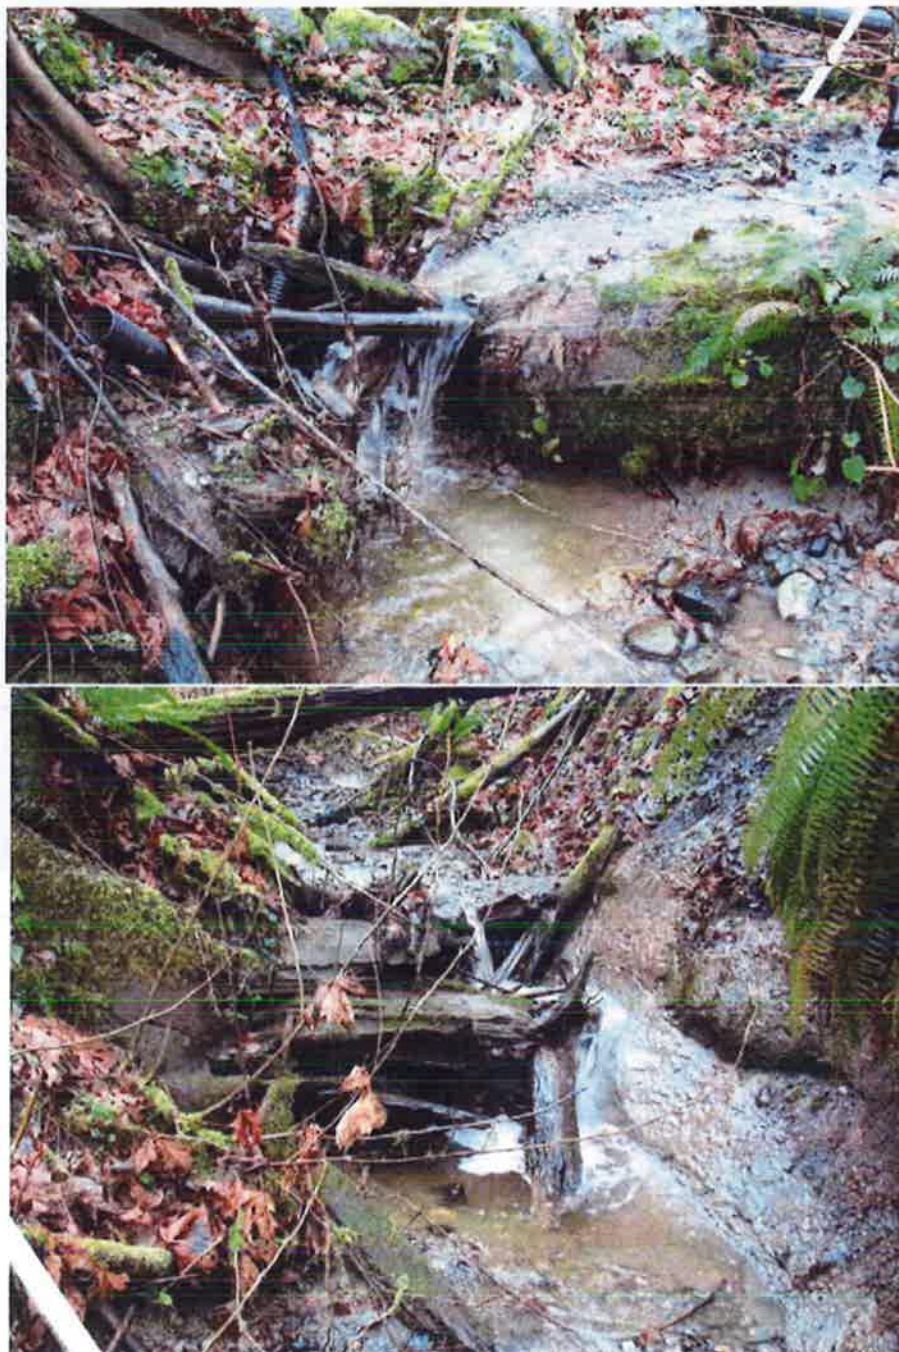
**Photo 4: Gradient jumps/drops in system, ranging from 2 to 3 feet in height**

Fish passage appeared to be relatively unimpeded upstream of the 61<sup>st</sup> Place West culvert and below the steep cascades in the system, although two gradient jumps occur due to knick points or debris jams—one with a 2-foot perch and the other with a 3-foot perch. As noted above, cascades appear at 385 feet above the culvert and the gradient steepens to 24%, imposing a fish passage barrier to any potential movement further upstream. The culvert itself appears to pose a gradient and velocity barrier to upstream passage as well. During the course of the survey, no fish or evidence of fish activity were noted in the stream reaches.

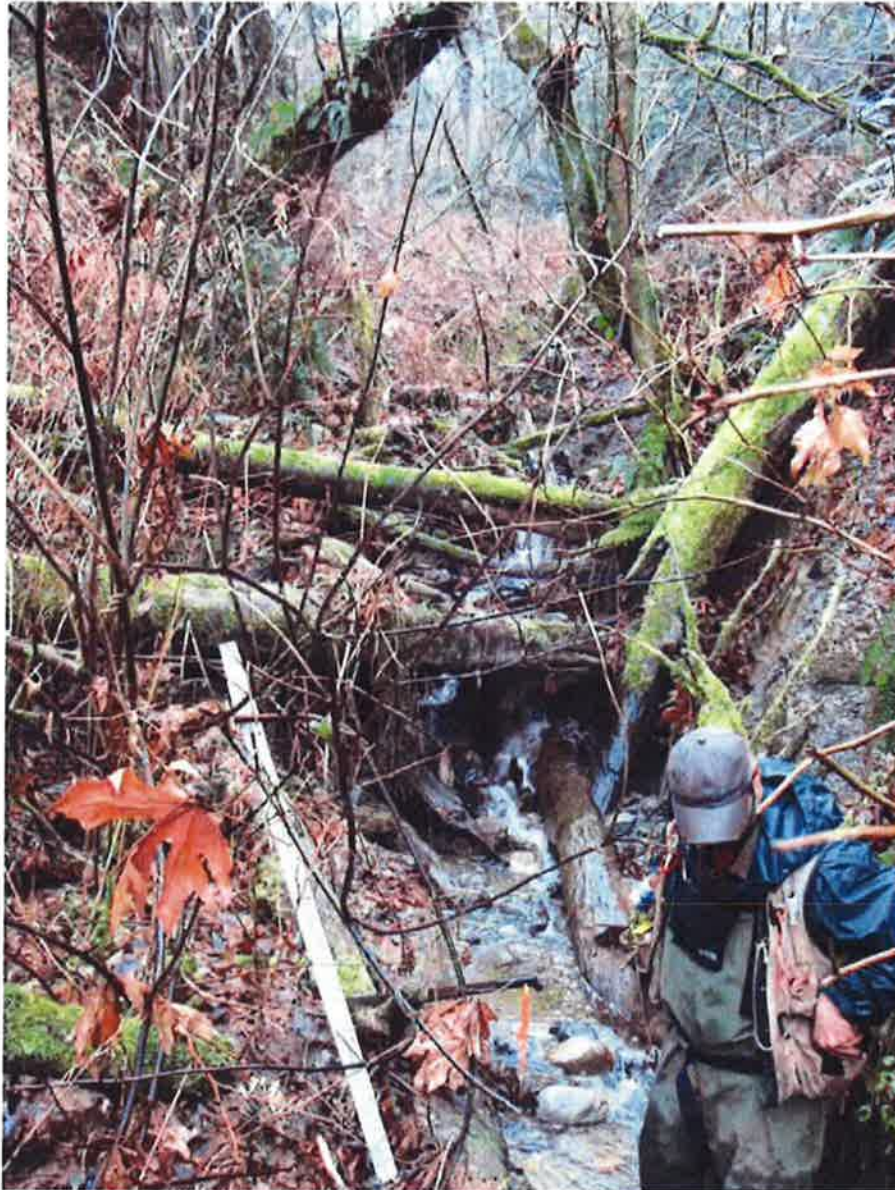
**Photo 5: Debris jam and beginning of cascade sequence. Gradient increases to approximately 24% above the jam**
