**Geotechnical Engineering Report**  
Mukilteo Elementary School  
2600 Mukilteo Speedway  
Mukilteo, WA 98275

June 23, 2023  
Project No. 23-0066

**Regarding: Geotechnical Engineering Report**  
Mukilteo Elementary School  
2600 Mukilteo Speedway  
Mukilteo, WA 98275  
(Parcel Nos. 28040900104200, 28040900102200, 00591100000102)

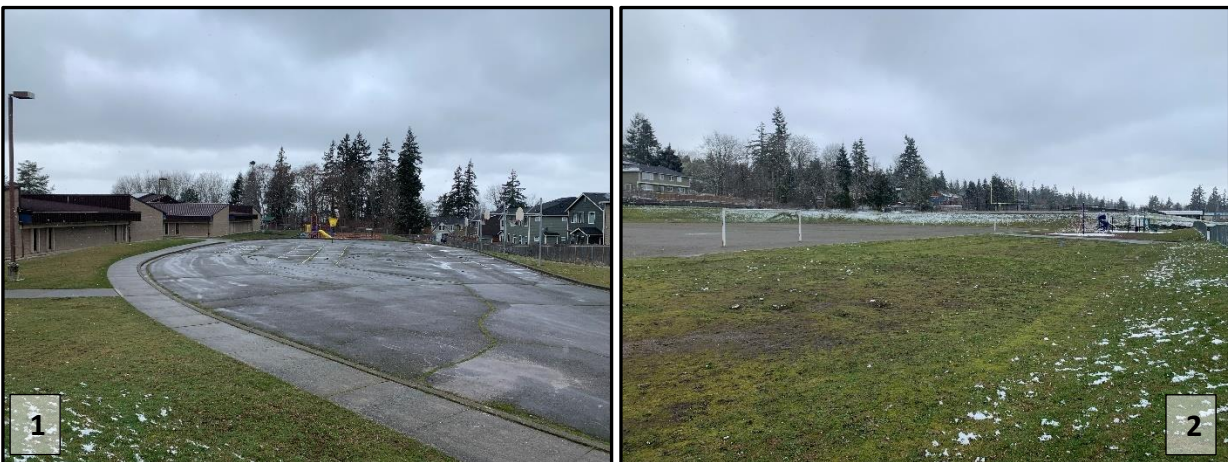
**Images 1 and 2:** Playground and basketball hardscape in the northern portion of property, facing west (Image 1). Dirt soccer field east of the main school buildings, facing southeast (Image 2). Images 1 through 6 taken on February 22, 2023.

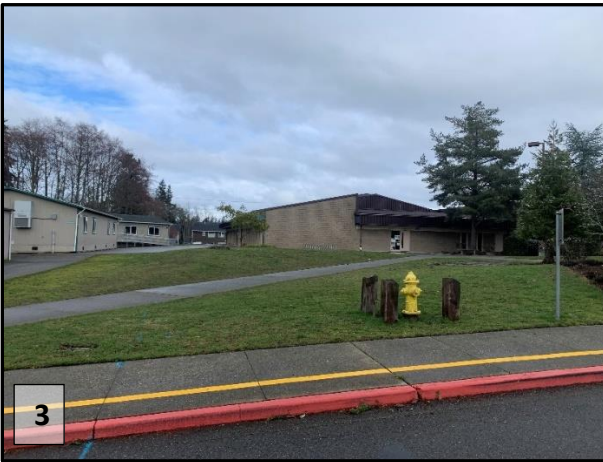
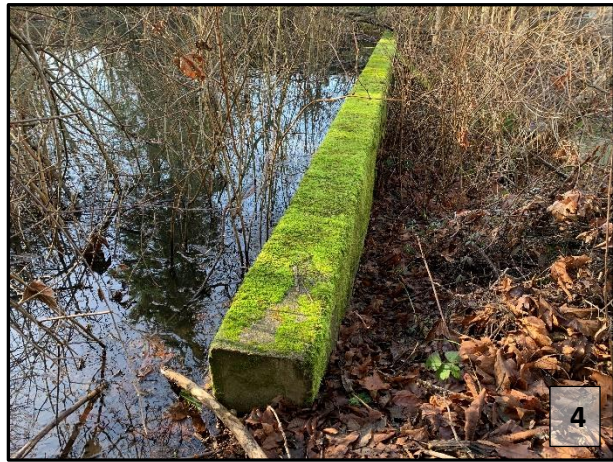
**Image 3 and 4:** Administration/gymnasium building and some portable buildings north of the parking lot in the southern portion of the project area, facing north (Image 3). A concrete dam in the natural learning area (Image 4).

The soccer and baseball/softball fields to the east are higher in elevation than the majority of the rest of the project area. A retaining wall approximately 6 feet tall separates the elevated play

fields and the eastern classrooms. The parking lot and bus loop area slopes gently to the southwest. The northwest corner of the property consists of a drainage gulch which is also referred to as the “natural learning area” by school staff. This area is mostly vegetated with deciduous trees, foliage, and a few old growth trees. Slopes adjacent to the school property in proximity to the gulch are west and northwest facing, and are approximately 20 feet tall. Within the lowest portion of the gulch, GeoTest observed a 12-inch-thick cast in place dam that is upwards of 5 feet tall. This dam is currently retaining water on its south side and is approximately 50 feet across the basin in the southwest direction before elbowing to the south for another 12 or so feet.

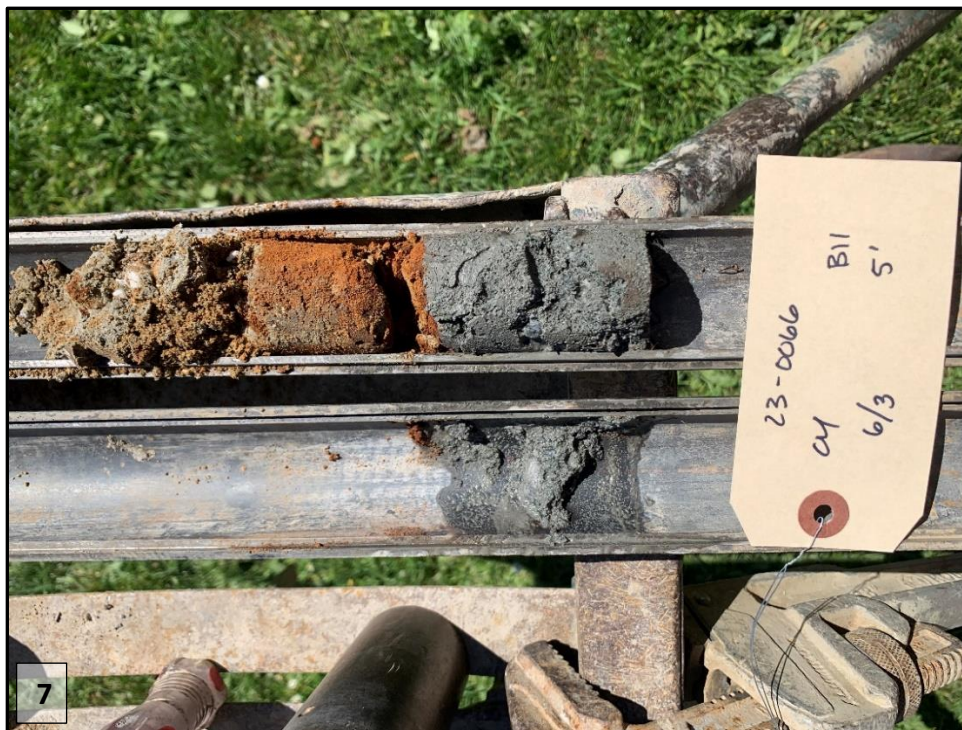
**Image 7:** Soil sample at a depth of 5 feet BGS at boring location B-11 showing perched water in a more permeable sand lens overlying the less permeable weathered Till.

Perched groundwater conditions can occur and should be anticipated in these soil types. Perched groundwater occurs above the regional groundwater table in the unsaturated zone and typically occurs when loose, more permeable soil is underlain by harder, less permeable soil. The vertical movement of water through looser soils is restricted once a hard or less permeable soil is encountered. Perched groundwater conditions typically develop in the wet season or after extended periods of rainfall.
