CRITICAL AREA REPORT

MONTGOMERIE MUKILTEO, WASHINGTON

July 1, 2025

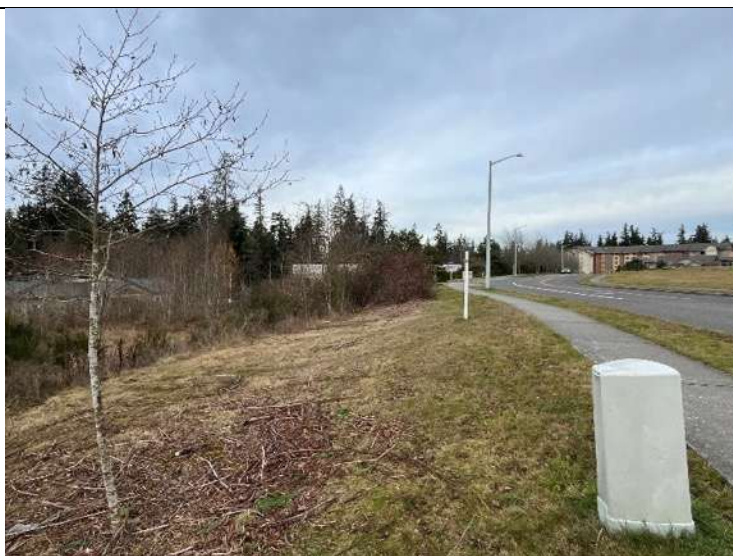
Photo 1. East edge of the Site, looking north along Harbour Place. Photo taken on 12/11/2024.

The Site is located on a bluff overlooking the South Fork of Big Gulch, within the City of Mukilteo in Snohomish County, Washington. The Site occupies a transitional position between the developed urban uplands of Mukilteo and the steeply incised ravine of Big Gulch, a forested natural corridor that drains westward toward Possession Sound. The parcel features moderate to steep slopes along the west edge that descend toward the gulch, with localized areas of fill or surface disturbance likely resulting from past grading or land-clearing activities (described further in this report). Adjacent land uses include residential and commercial developments, with Harbour Place bordering the eastern edge (**Photo 1**).

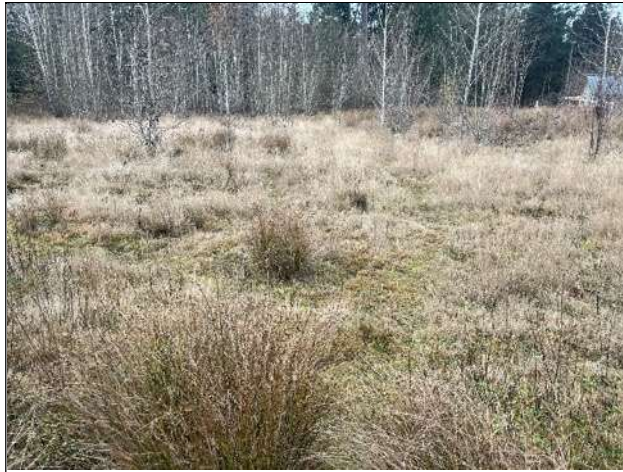
Photo 3. Looking west from northeastern portion of parcel within Feature 1. Photo taken on 12/11/2024.

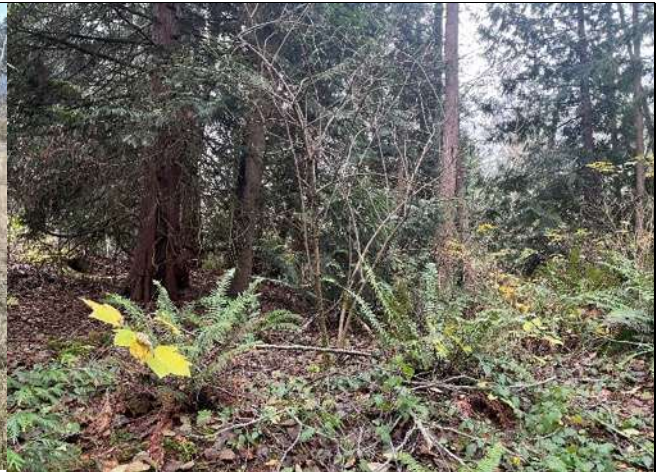
Photo 4. On-site undisturbed forested area connected to Big Gulch ravine. Photo taken on 12/11/2024.

The disturbed depression in the central-east portion of the parcel contains vegetation which consists of tufted hairgrass (*Deschampsia caepitosa*) and soft rush (*Juncus effusus*) with scattered young black cottonwoods (*Populus balsamifera*) and a few red alders (*Alnus rubra*). The composition of black cottonwood abruptly changes where it meets the undisturbed forest associated with Big Gulch to the west and south edges of the previously disturbed area. The east and north perimeter of the disturbed area is dominated by Scotch broom (*Cytisus scoparius*) and Himalayan Blackberry (*Rubus armeniacus*) (**Photo 3**). The forested portion of the site is dominated by red alder, salmonberry (*Rubus spectabilis*), western red cedar (*Thuja plicata*), sword fern (*Polystichum munitum*), Oregon grape (*Mahonia aquifolium*), fringe cups (*Tellima grandiflora*), herb-Robert (*Geranium robertianum*), and Himalayan blackberry (**Photo 4**).

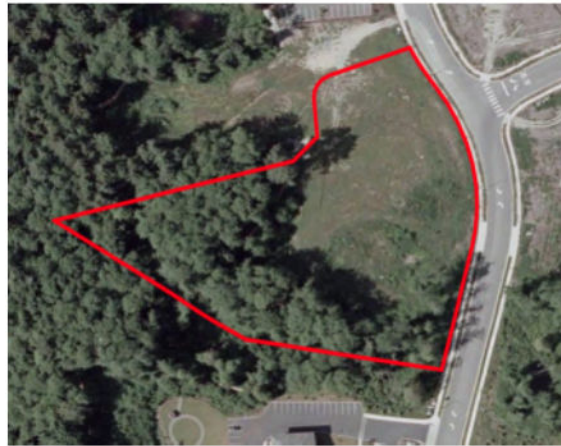
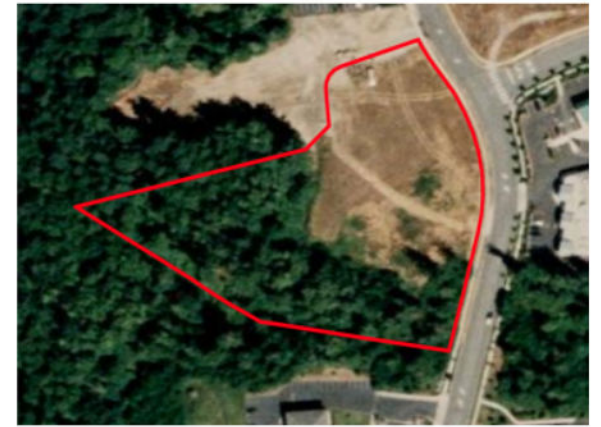
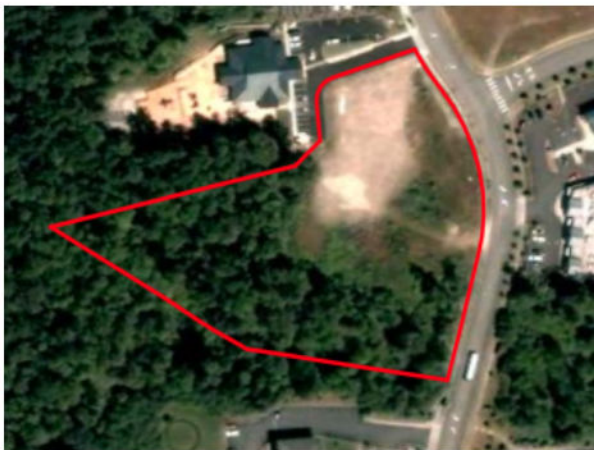
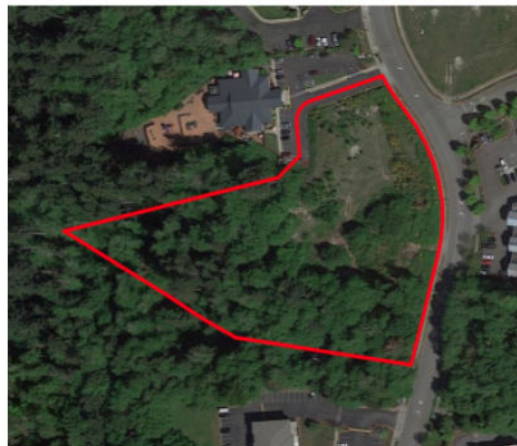
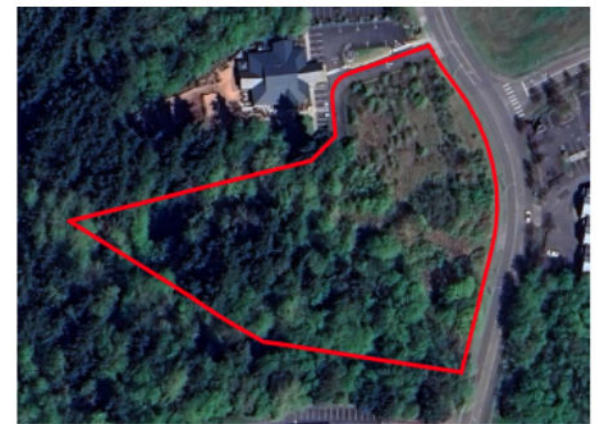
07/1990

06/2002

07/2006

07/2007

05/2019

04/2025

Historical aerial imagery indicates that prior to 1990, the site was entirely forested (**Appendix A/Figure 2**). Between 1990 and 2002, the northeastern and eastern portions of the site were cleared, except for the steep slope along the west edge of the Site. By 2006, an unimproved access road from Harbour Place had been established along the eastern edge, and construction staging is observed—likely in support of adjacent development to the north. Additional soil disturbance and vegetation clearing

occurred in 2007, likely contributing to the formation of a depression on this bluff terrace. Subsequent aerial imagery from 2019 and 2025 shows gradual natural succession, with woody vegetation becoming reestablished in the previously disturbed area. The soil surface today contains tracks and cut marks from those past clearing and excavation activities (**Photo 2**).
