# Montgomerie Mukilteo, WA

## Preliminary Stormwater Site Plan

**Date:** October 29, 2025

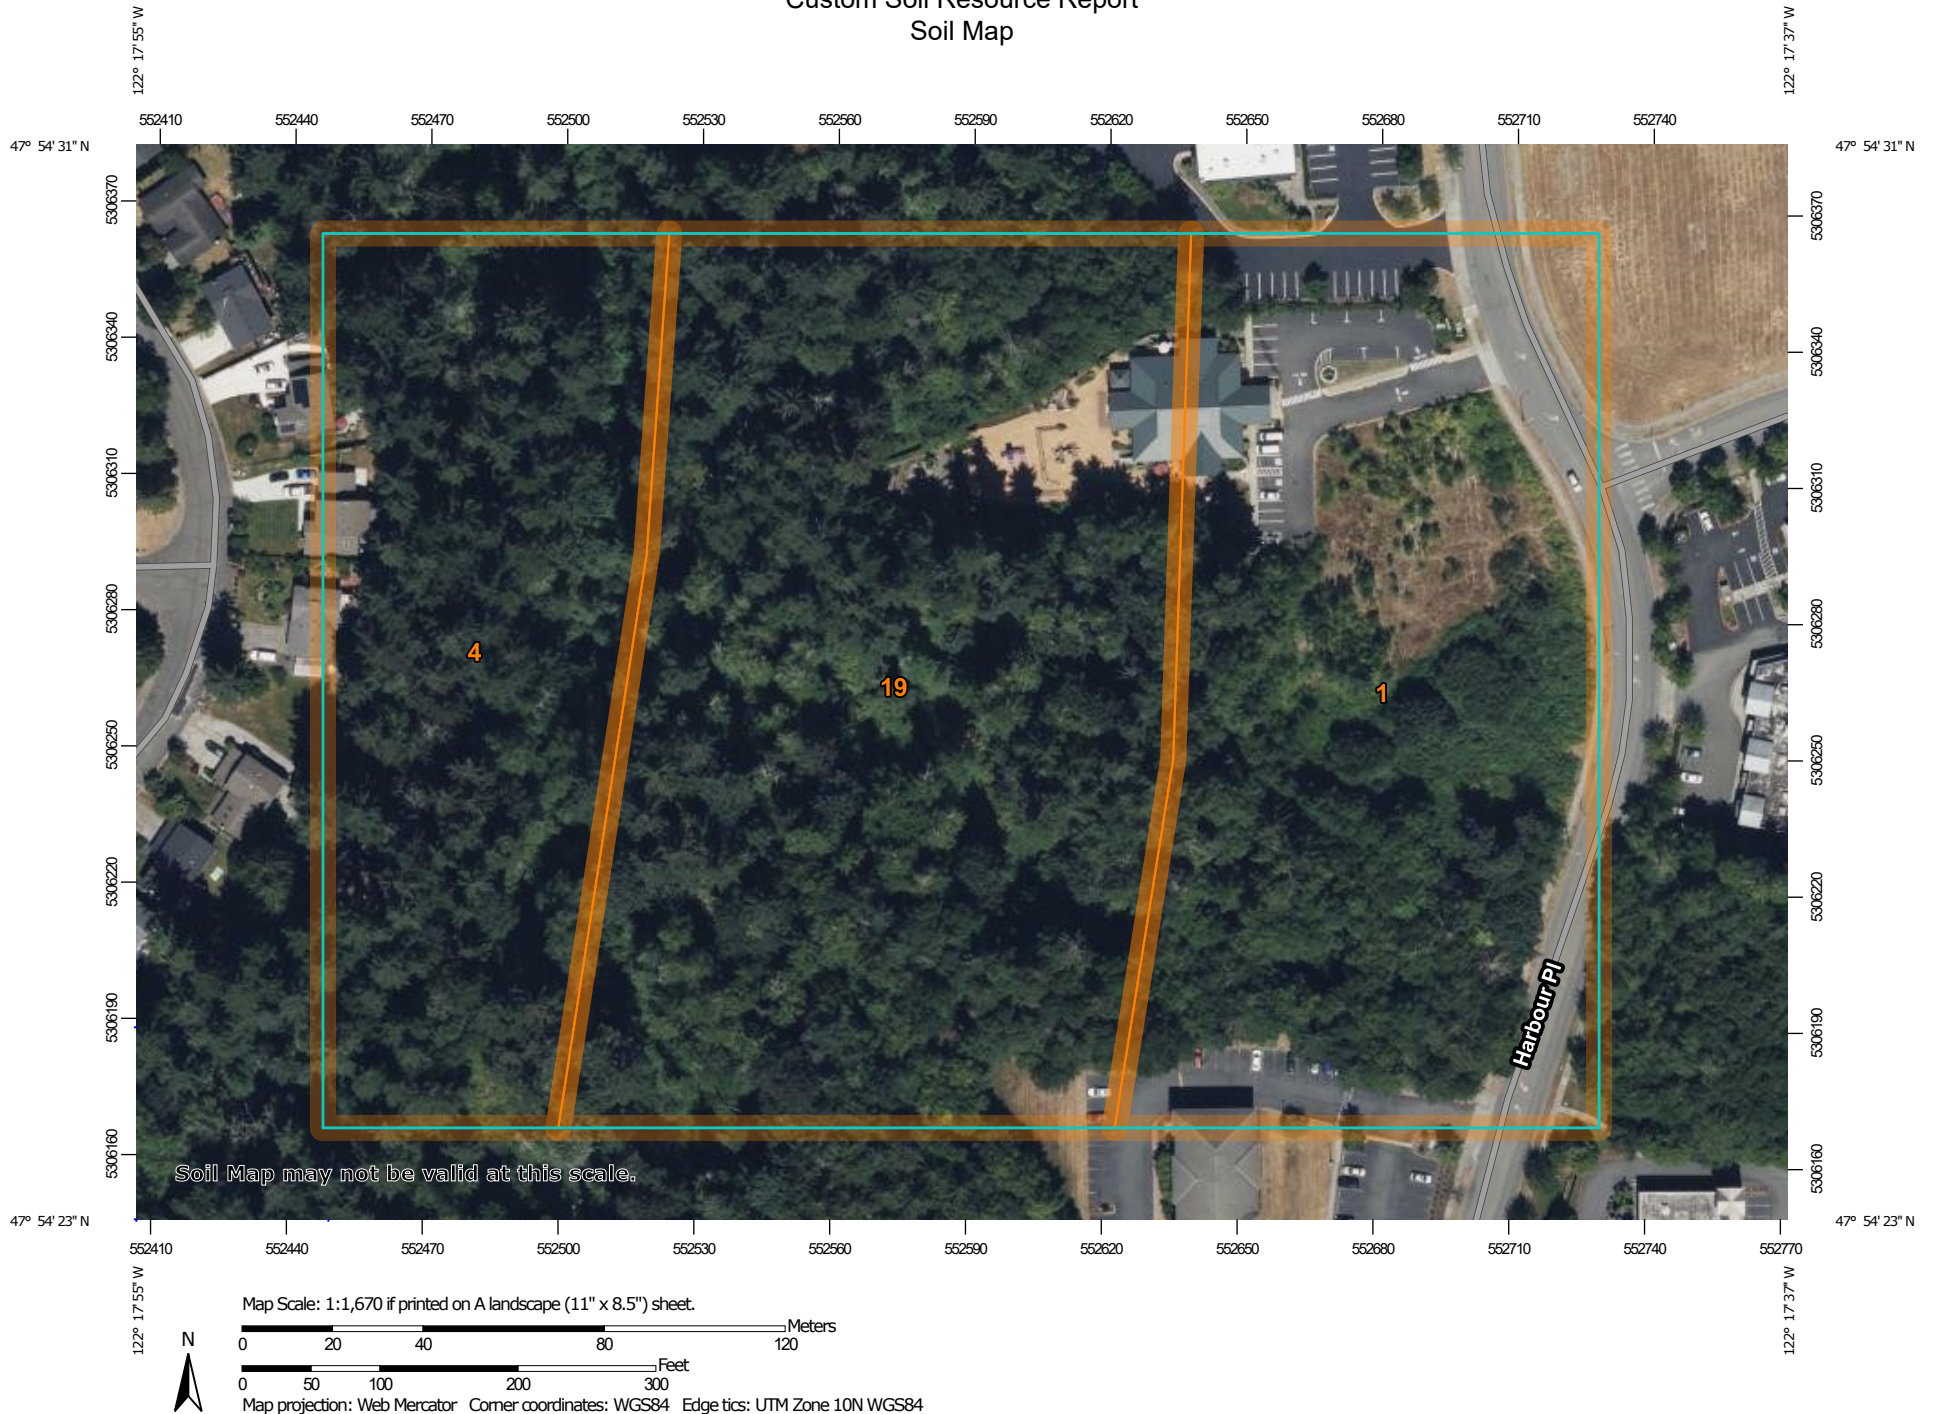
# Custom Soil Resource Report Soil Map

The soil map section includes the soil map for the defined area of interest, a list of soil map units on the map and extent of each map unit, and cartographic symbols displayed on the map. Also presented are various metadata about data used to produce the map, and a description of each soil map unit.

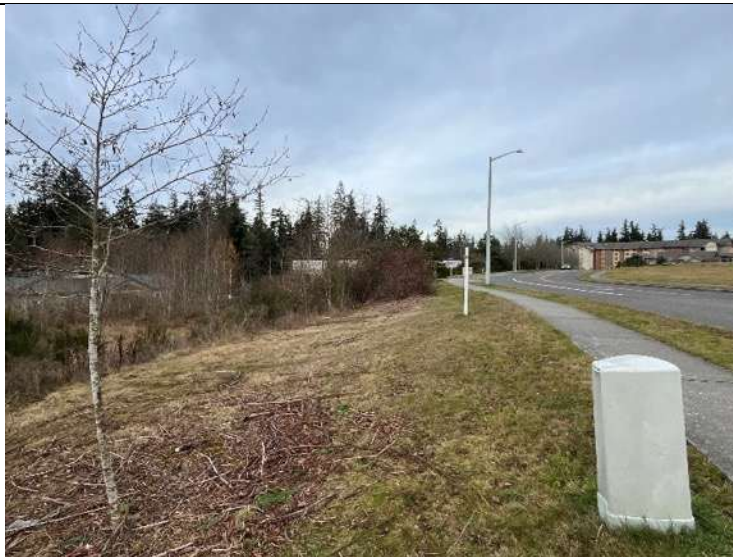
**Photo 1.** East edge of the Site, looking north along Harbour Place. Photo taken on 12/11/2024.

The Site is located on a bluff overlooking the South Fork of Big Gulch, within the City of Mukilteo in Snohomish County, Washington. The Site occupies a transitional position between the developed urban uplands of Mukilteo and the steeply incised ravine of Big Gulch, a forested natural corridor that drains westward toward Possession Sound. The parcel features moderate to steep slopes along the west edge that descend toward the gulch, with localized areas of fill or surface disturbance likely resulting from past grading or land-clearing activities (described further in this report). Adjacent land uses include residential and commercial developments, with Harbour Place bordering the eastern edge (**Photo 1**).

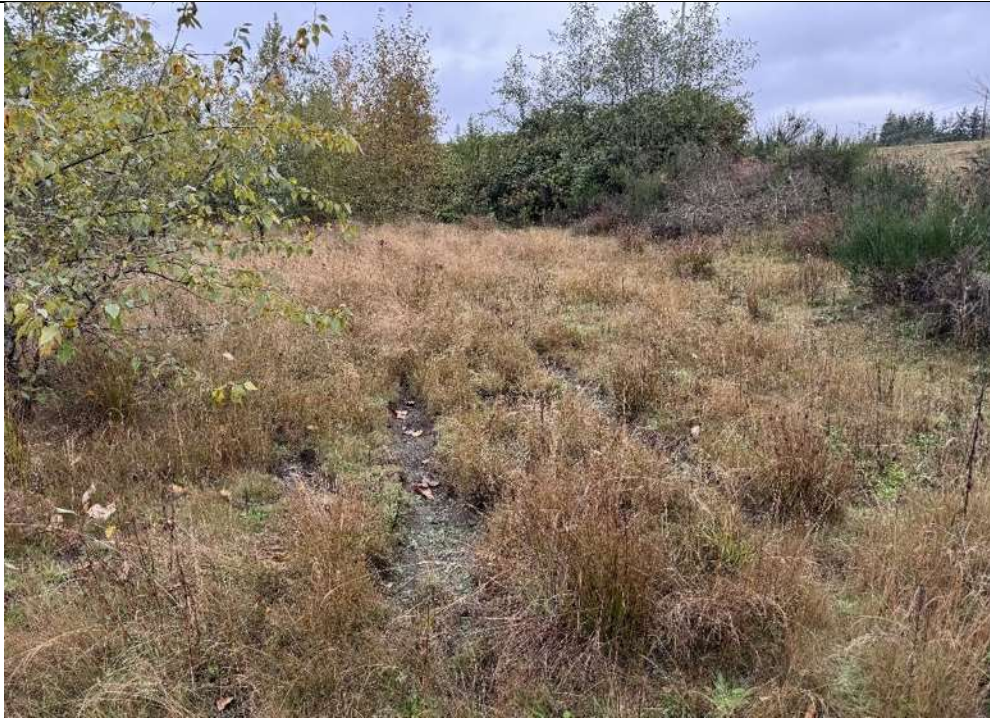
**Photo 2.** Emergent plants and former scarring of the soil surface from past excavation activities. Photo taken on 10/4/2024.

occurred in 2007, likely contributing to the formation of a depression on this bluff terrace. Subsequent aerial imagery from 2019 and 2025 shows gradual natural succession, with woody vegetation becoming reestablished in the previously disturbed area. The soil surface today contains tracks and cut marks from those past clearing and excavation activities (**Photo 2**).

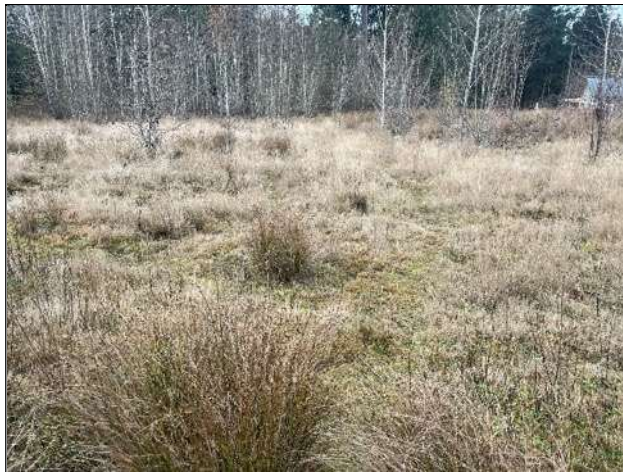
**Photo 3.** Looking west from northeastern portion of parcel within Feature 1. Photo taken on 12/11/2024.

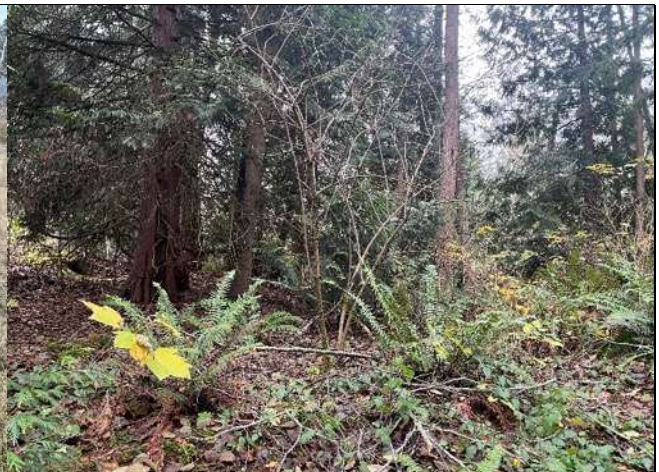
**Photo 4.** On-site undisturbed forested area connected to Big Gulch ravine. Photo taken on 12/11/2024.

The disturbed depression in the central-east portion of the parcel contains vegetation which consists of tufted hairgrass (*Deschampsia caepitosa*) and soft rush (*Juncus effusus*) with scattered young black cottonwoods (*Populus balsamifera*) and a few red alders (*Alnus rubra*). The composition of black cottonwood abruptly changes where it meets the undisturbed forest associated with Big Gulch to the west and south edges of the previously disturbed area. The east and north perimeter of the disturbed area is dominated by Scotch broom (*Cytisus scoparius*) and Himalayan Blackberry (*Rubus armeniacus*) (**Photo 3**). The forested portion of the site is dominated by red alder, salmonberry (*Rubus spectabilis*), western red cedar (*Thuja plicata*), sword fern (*Polystichum munitum*), Oregon grape (*Mahonia aquifolium*), fringe cups (*Tellima grandiflora*), herb-Robert (*Geranium robertianum*), and Himalayan blackberry (**Photo 4**).

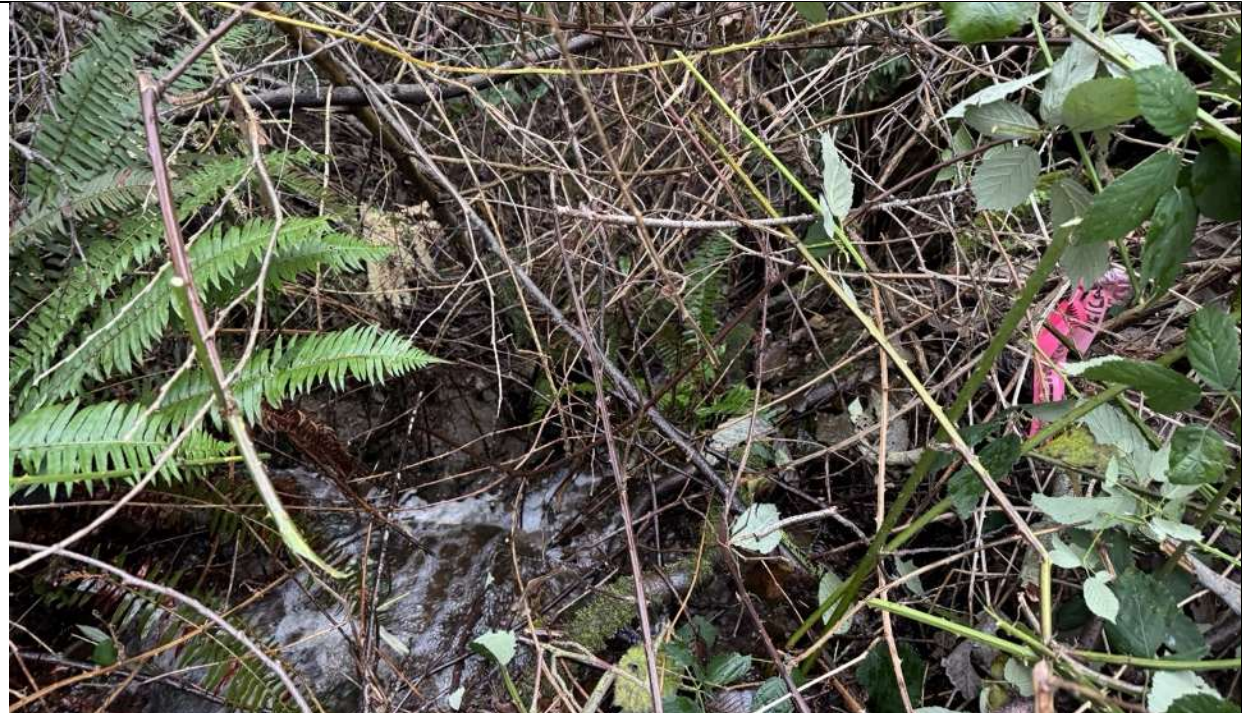
**Photo 5.** Drainage 1 is a narrow, confined channel overgrown with Himalayan blackberry. Photo taken on 12/20/2024.

Drainage 1 is a seasonal, non-fish bearing stream, located offsite along the southern boundary of the parcel and flows through Wetland K. Flow was present during the December 2024 field visit but was absent during the June 2025 follow up visit. It is a feeder stream that flows into the South Fork of Big Gulch (**Appendix A/Figure 7**). The ordinary high-water mark (OHWM) was not flagged as the channel width was very narrow (**Photo 5**). A 50-foot standard buffer width is required for Type 5 streams (MMC 17.52C.090).

This drainage feature, originating from the 18-inch culvert upstream of Wetland K, has a defined bed and bank with visible signs of bedload transport. The bed width generally remains under 2 feet. Due to steep slopes on both sides of this drainage west of Wetland K, access to the channel was restricted. LIDAR (**Appendix A/Figure 4**) was used to map the channel center line.

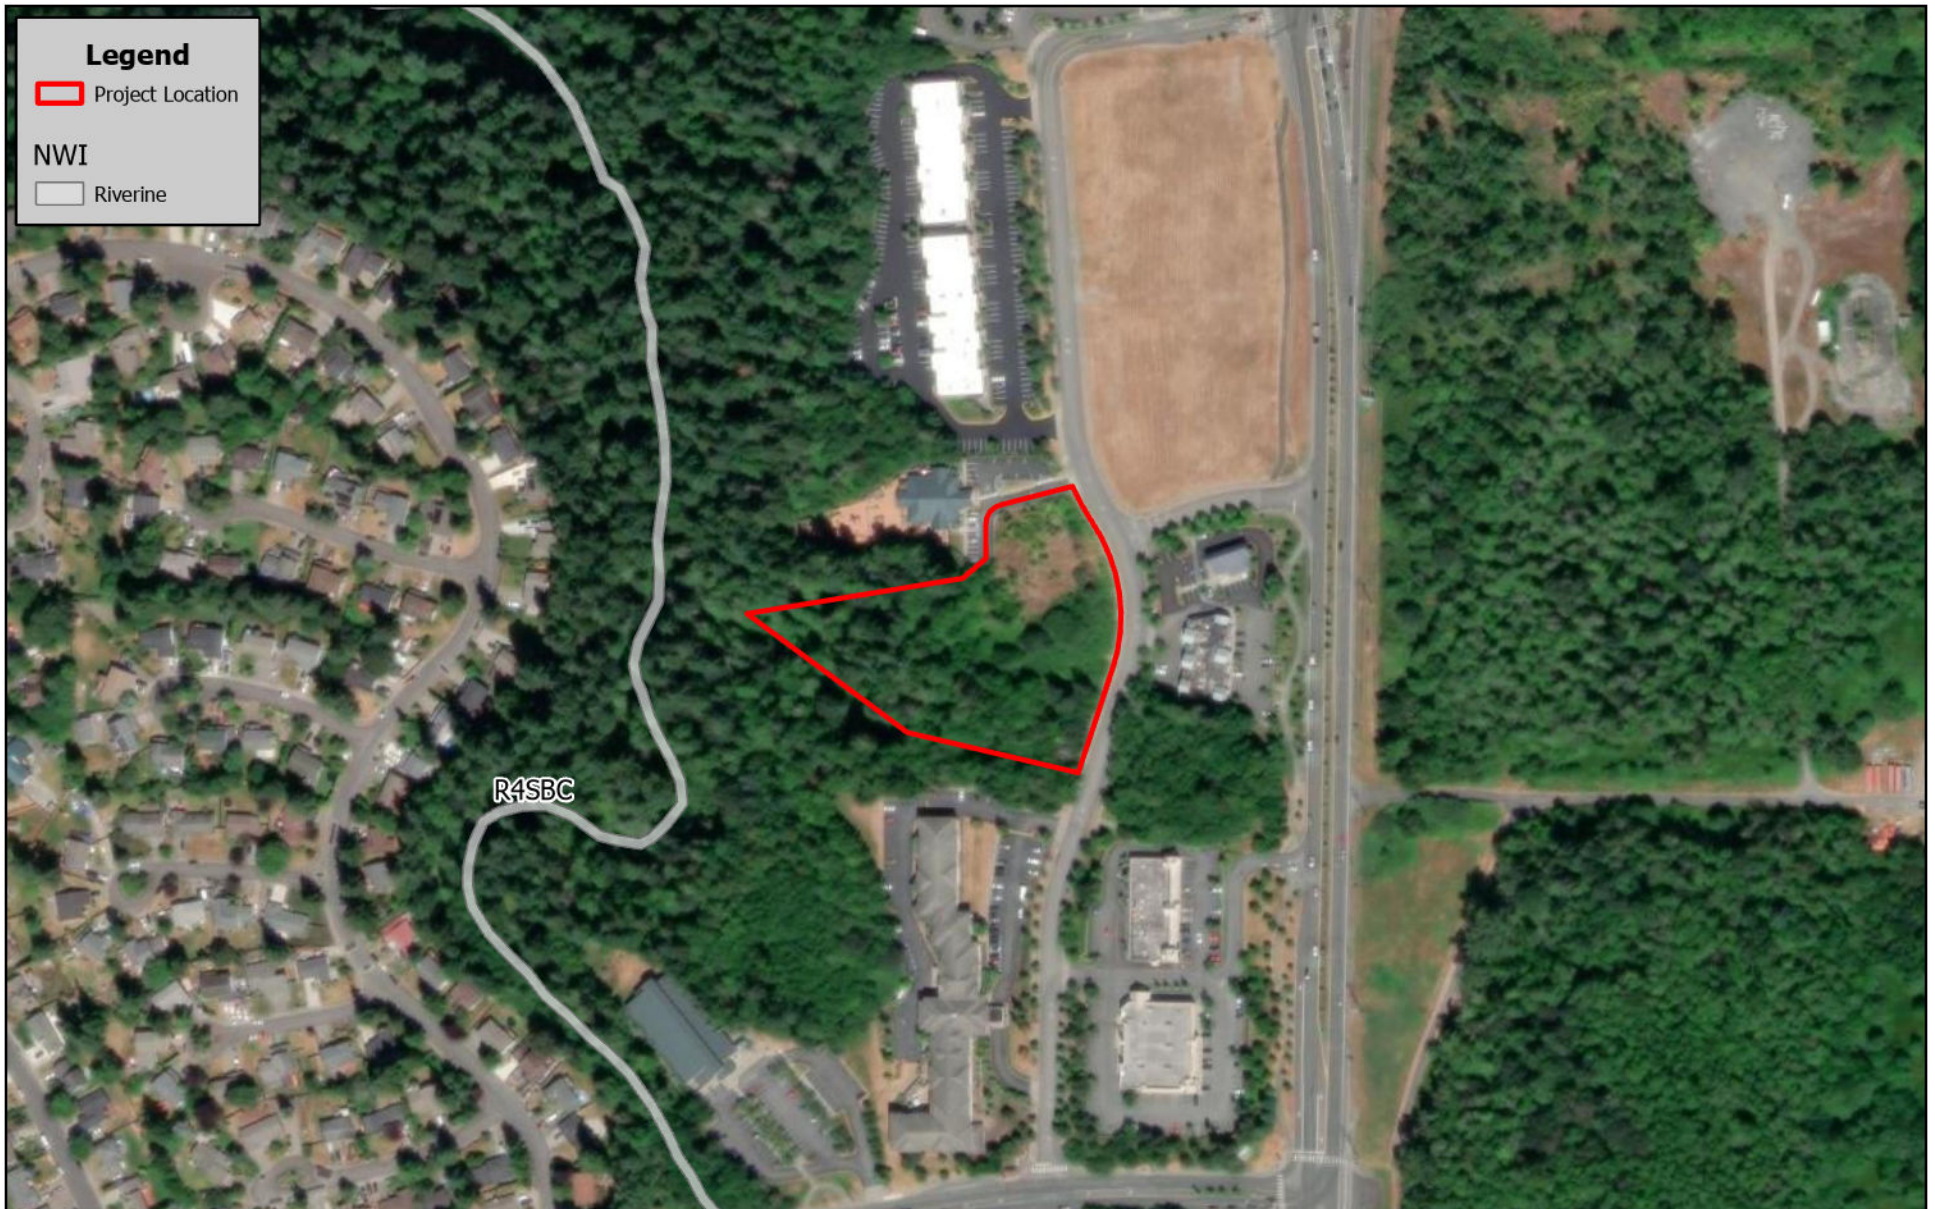
### Figure 5a - NWI Wetland Inventory Map

The National Wetland Inventory (NWI) is compiled by the U.S. Department of Interior Fish and Wildlife Service (USFWS 2025). NWI relies upon visual aerial photo interpretation of wetland indicators including hydrologic, vegetation and topographic signatures. Wetland areas identified under NWI are also classified in accordance with the Cowardin classification system (Cowardin et al. 1979). The National Wetlands Inventory does not identify any mapped features on site but identified a riverine polygon which is associated with Big Gulch to the west. (**Appendix A/Figure 5a**).

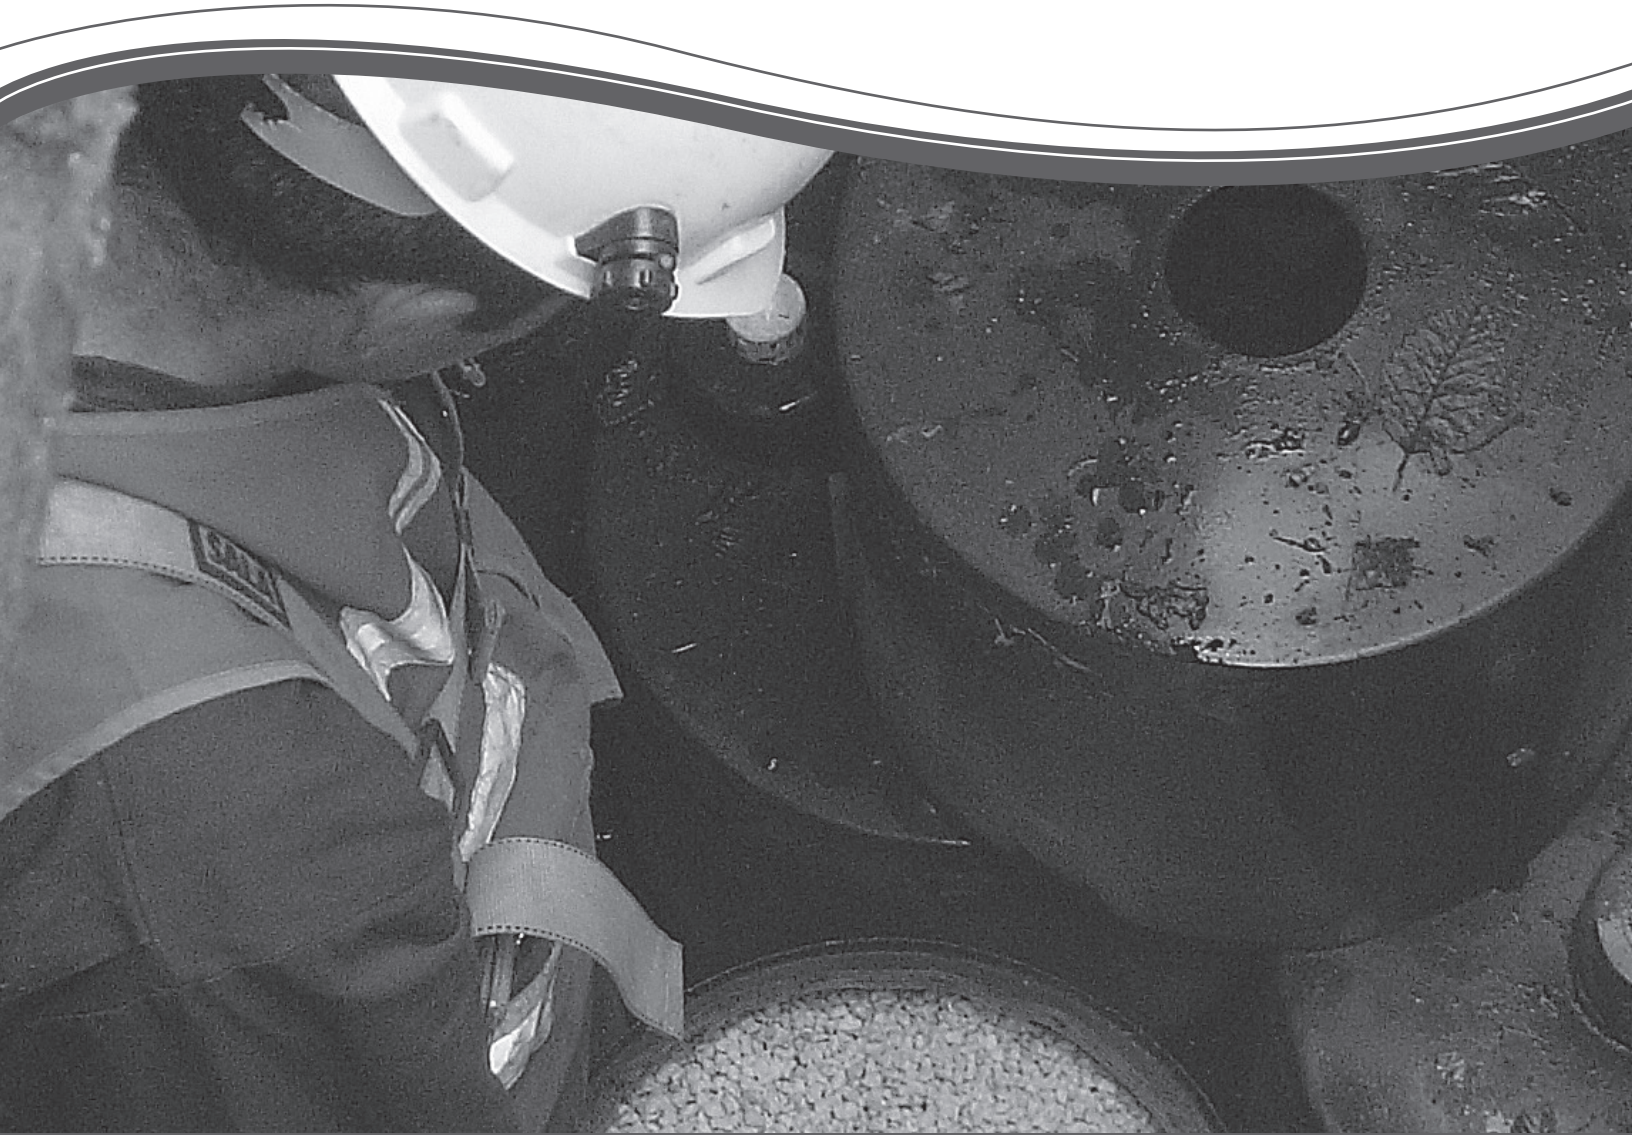
## StormFilter Inspection and Maintenance Procedures

The primary purpose of the Stormwater Management StormFilter® is to filter and prevent pollutants from entering our waterways. Like any effective filtration system, periodically these pollutants must be removed to restore the StormFilter to its full efficiency and effectiveness.
