Comprehensive Surface Water Management Plan Update

City of Mukilteo

August 2015

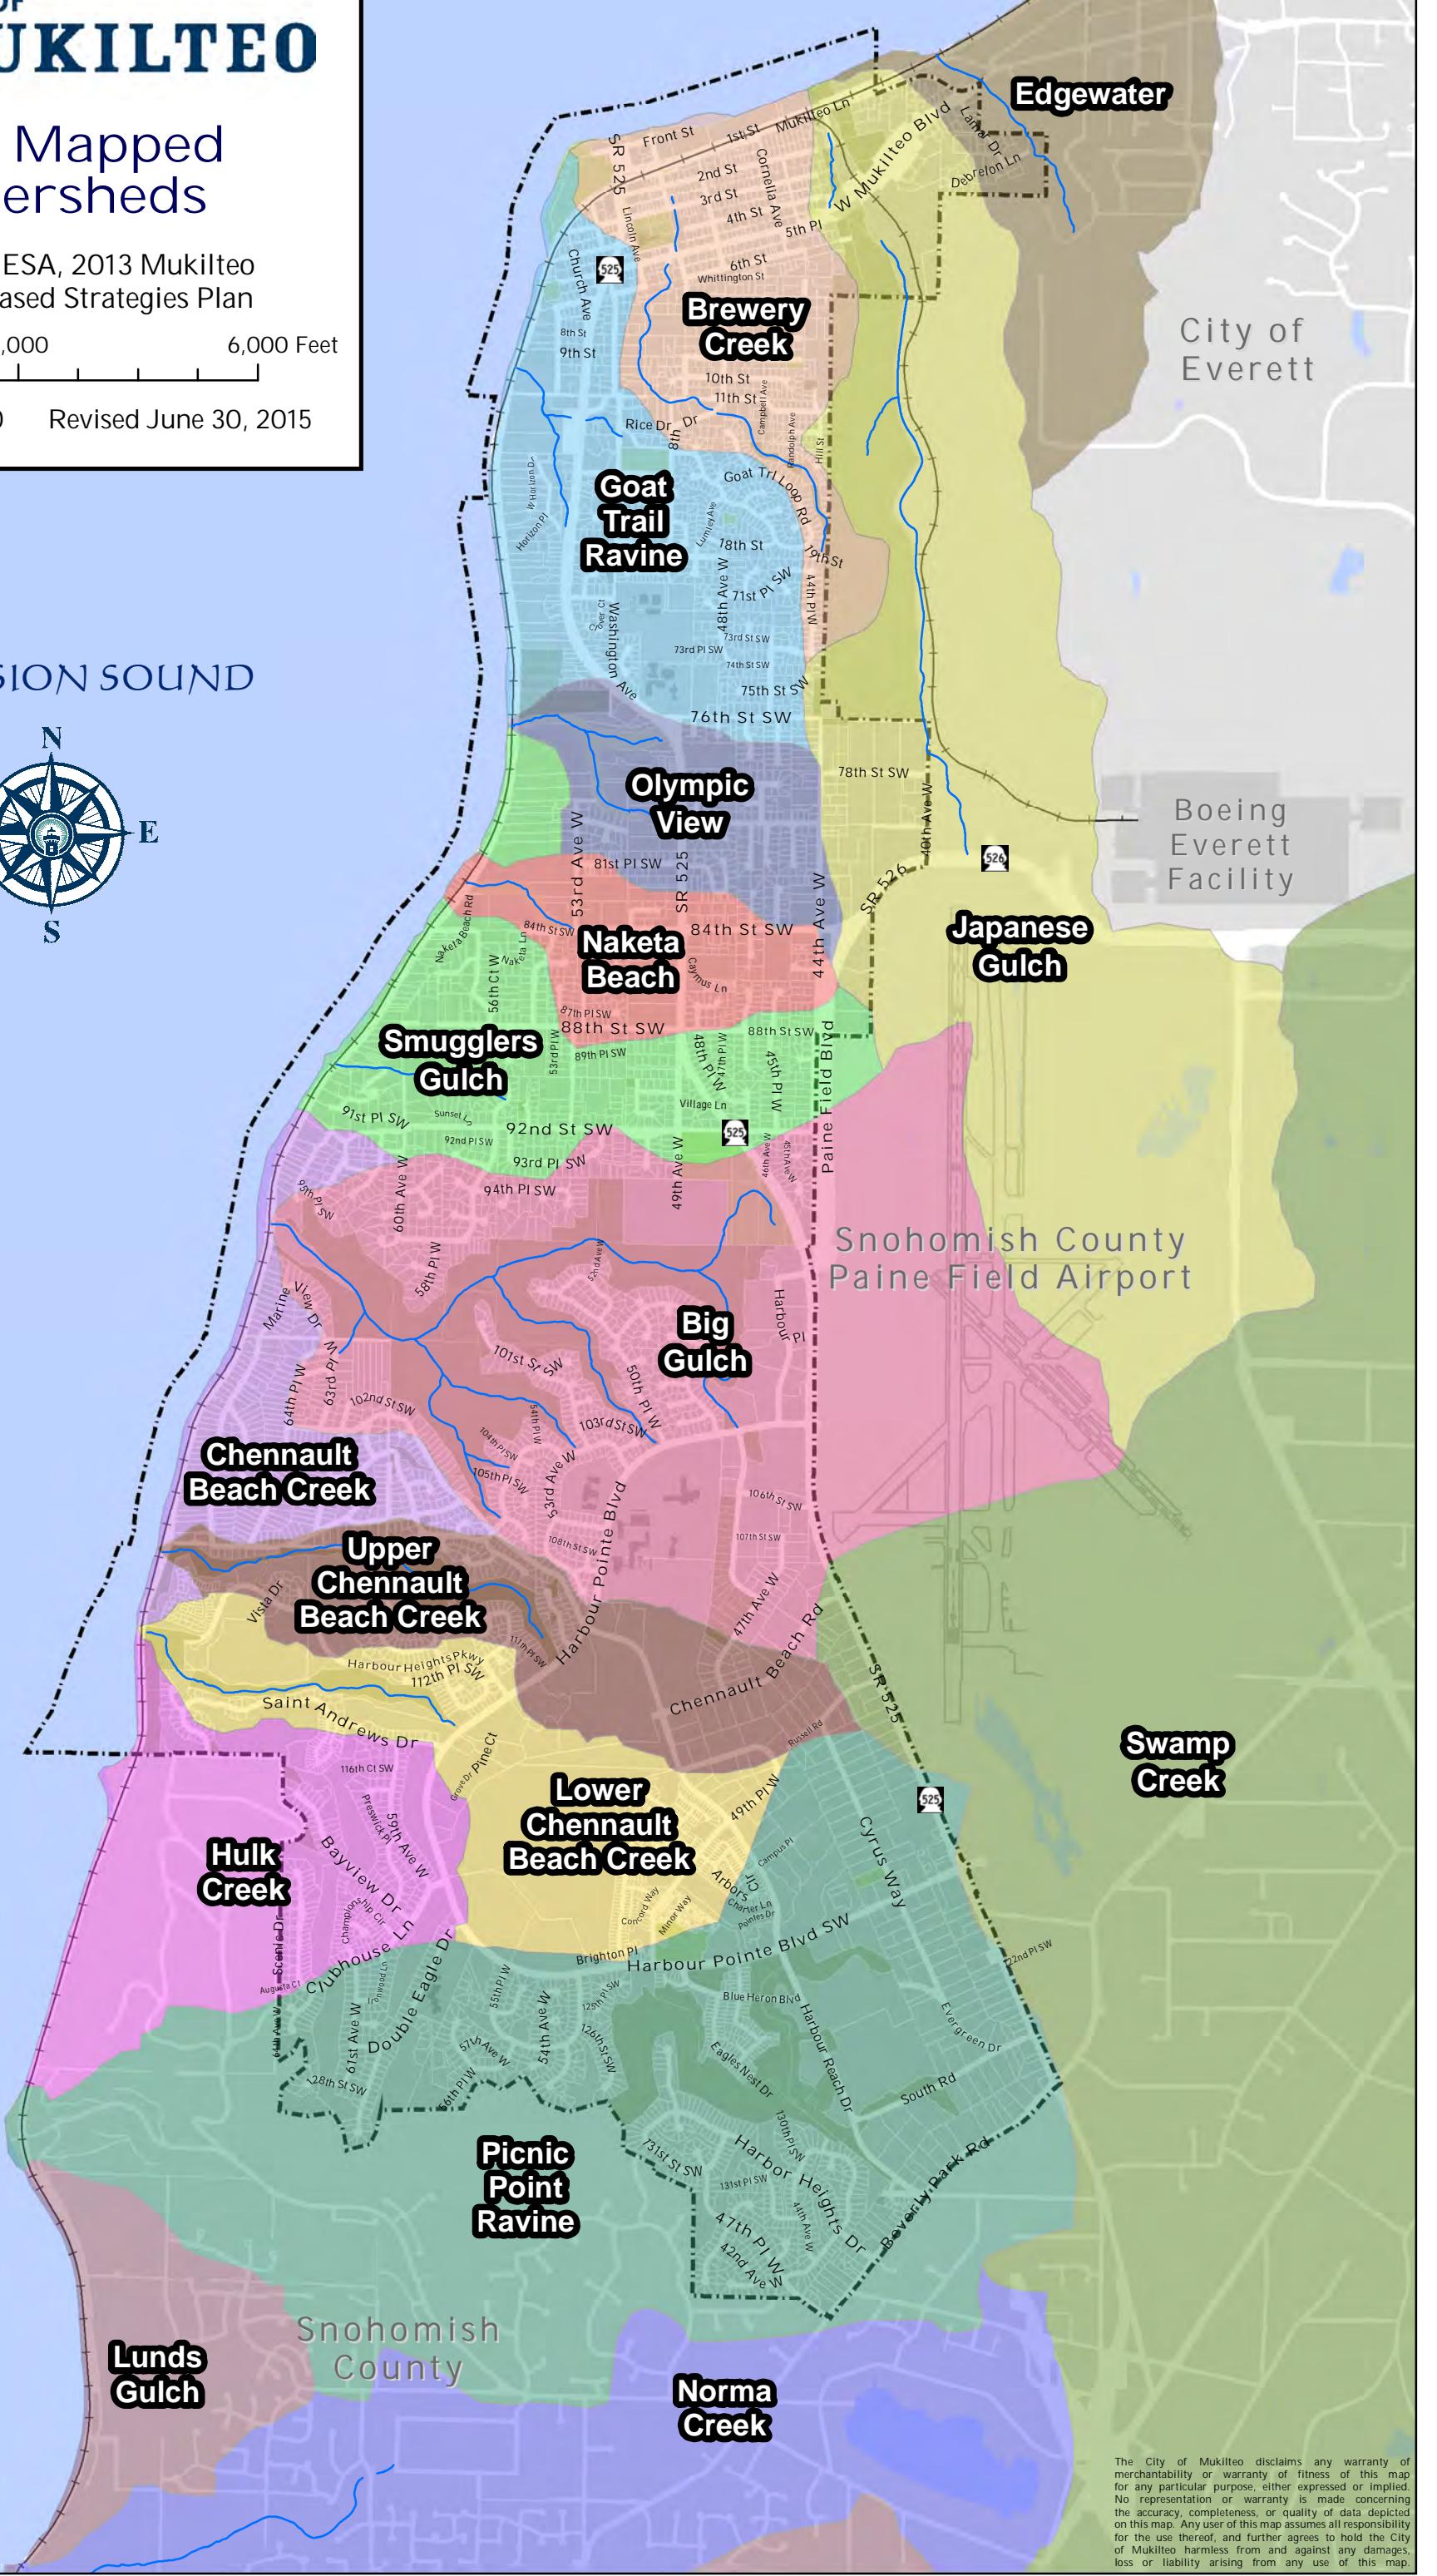
A map of the current watershed delineations is found in Figure 2-2.

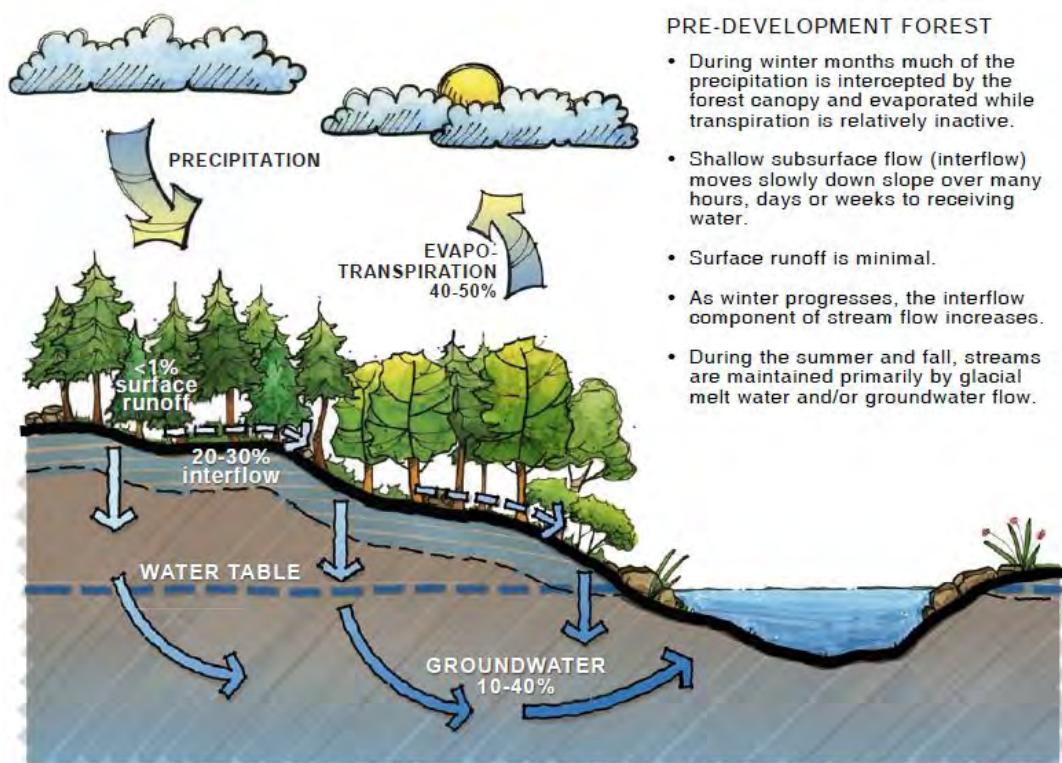
FIGURE 2-3: HYDROLOGY OF PRE-DEVELOPED CONDITIONS

In-stream hydrology is driven by rain events and the condition of the surrounding watershed (for example: geology, effective impervious surface, and tree canopy cover). When rain falls in forested conditions, the vegetation and soils provide water storage. When the land is converted to impervious areas, groundwater recharge is diminished and surface flows are increased. During the dry summer months, the lack of recharge results in decreased stream base flows, which translates to dry streambeds. In winter months, during heavy rain events, surface flows reach streams more quickly and with higher peaks, which translate to scoured stream beds, and undercut ravines.

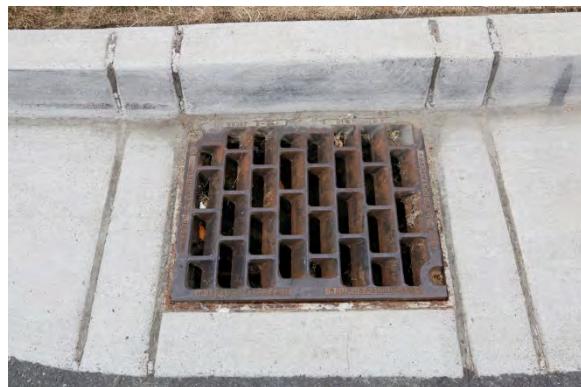
FIGURE 2-5: CATCH BASIN IN RIGHT OF WAY

- *Ditches.* The City has mapped 270 ditches, totaling 7.2 miles. Like pipes, ditches provide stormwater conveyance, moving water downstream. An advantage to ditches is they can provide some water quality treatment as flows pass through vegetation and / or discharge to groundwater, providing recharge.
- *Swales.* The City has mapped 29 swales. Swales are designed to infiltrate water as the primary purpose, with some water also discharging downstream.
- *Catch Basins / Inlets.* The City has over 4,700 catch basins and inlets mapped within the City's boundaries. These are the drains, visible on the surface, often in the right of way (Figure 2-5). Inlets capture stormwater and move it into the stormwater system. Catch basins can also have a sump to capture pollutant-laden sediment.

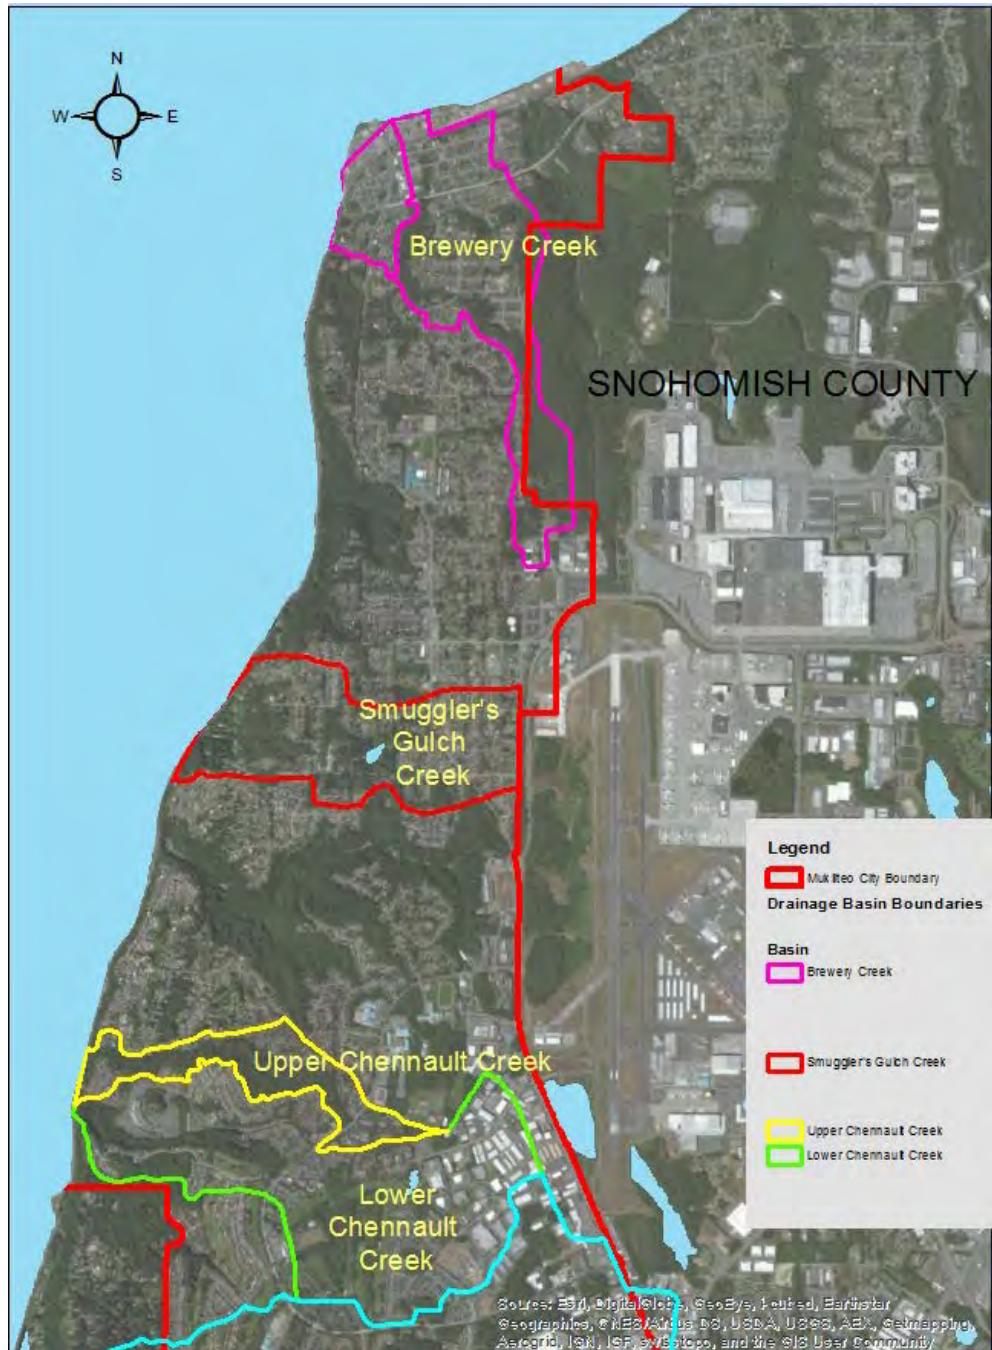
Figure 1 Locations of drainage basins and stream channels walked during reconnaissance

Figure 1 shows the locations of the stream channels walked during this evaluation.

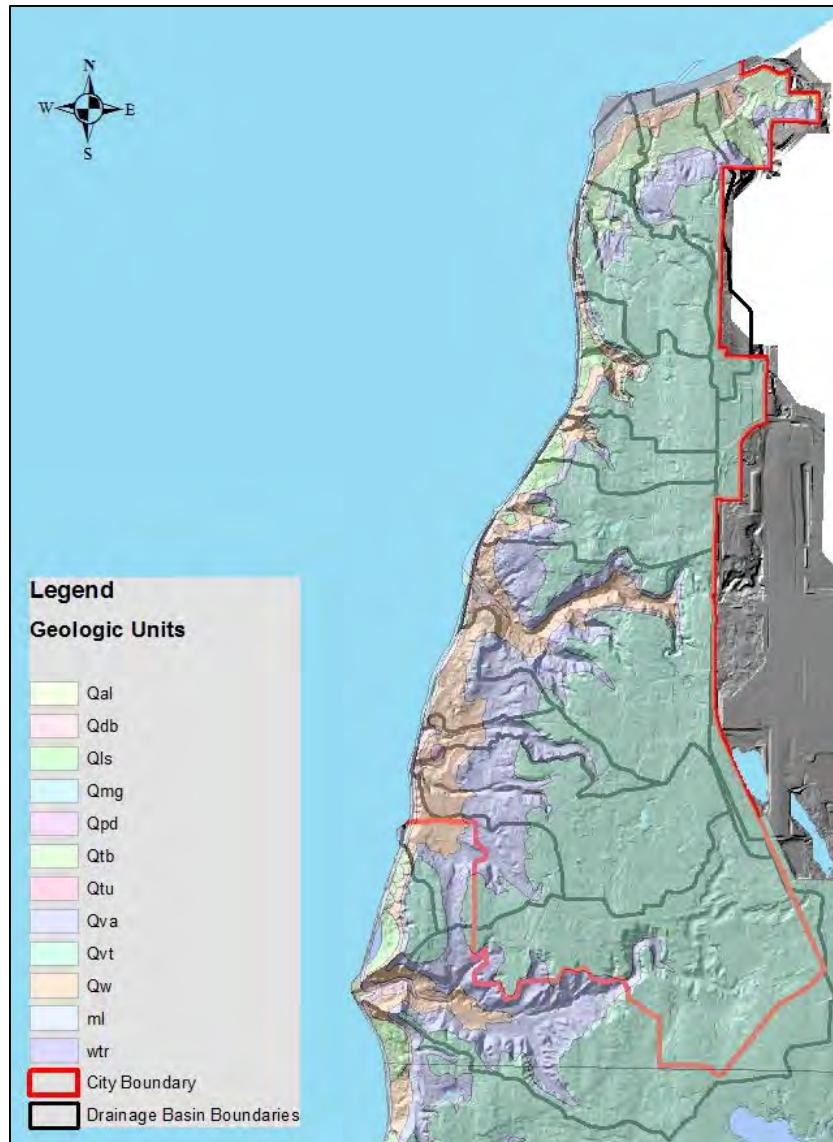
Figure 2 Geologic map

Geology of the Smith and Minard maps forms the basis for the geology presented on the Washington State Department of Natural Resources (DNR) online geologic map (Washington DNR, 2014), generally with only minimal re-interpretation or re-naming of the original map's geologic units. Figure 2 shows the DNR-compiled geology of the study area.

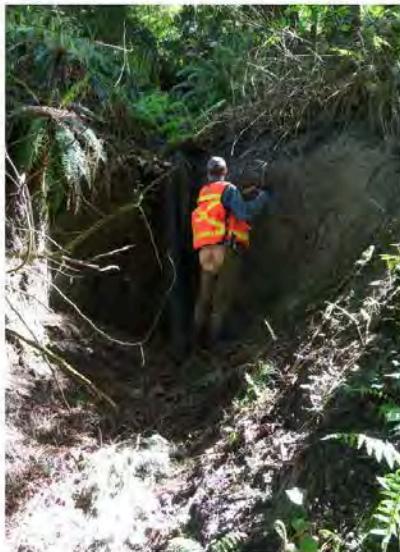
Gully on right bank from stormwater outfall erosion.

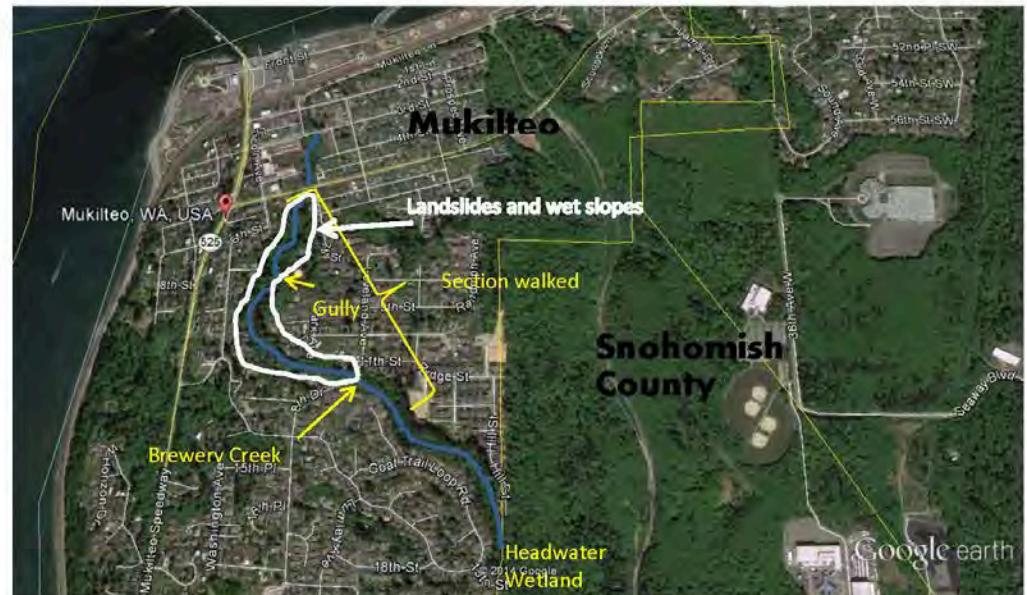
Unstable wet hillslopes, failed stormwater tightlines.

Figure 3 Map of Brewery Creek and summary of conditions

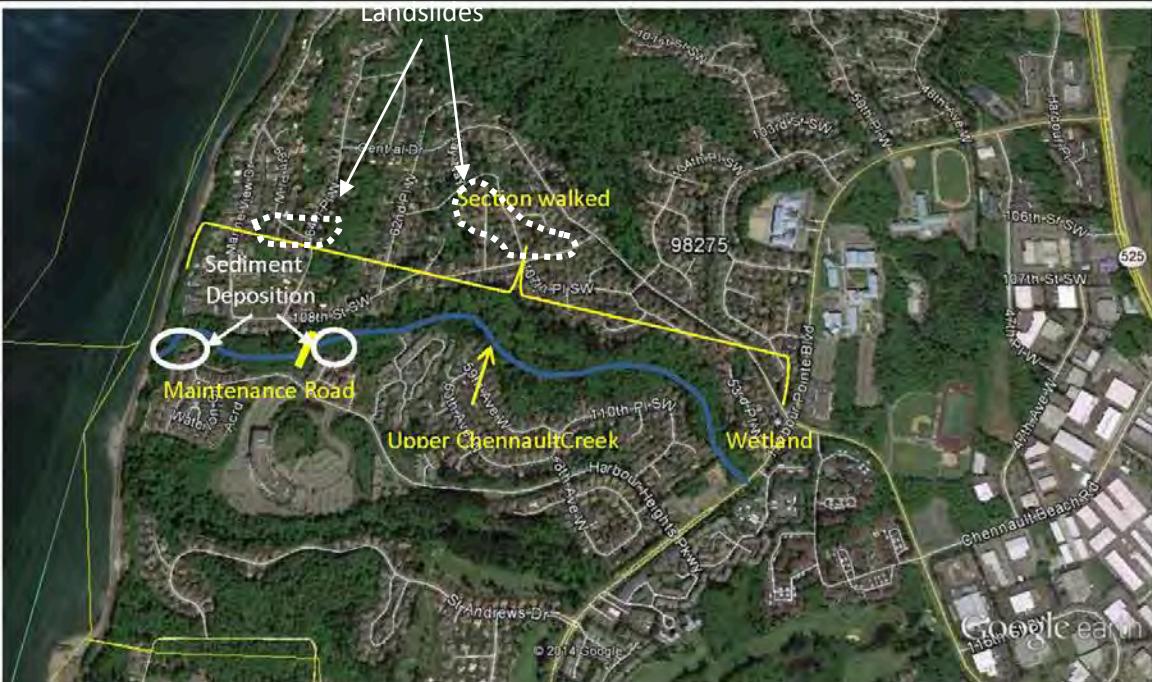
Unstable wet hillslopes, failed stormwater tightlines, sedimentation.

Figure 4 Map of Upper Chennault Creek and summary of conditions

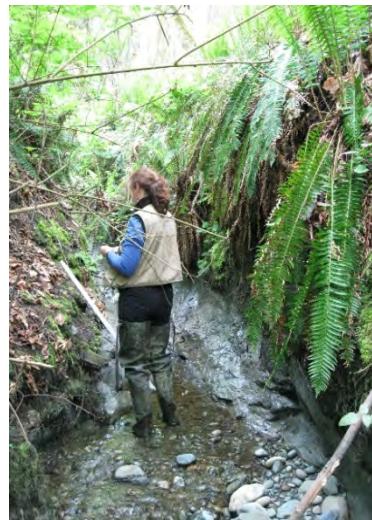
Photo 1. Example of channel incision

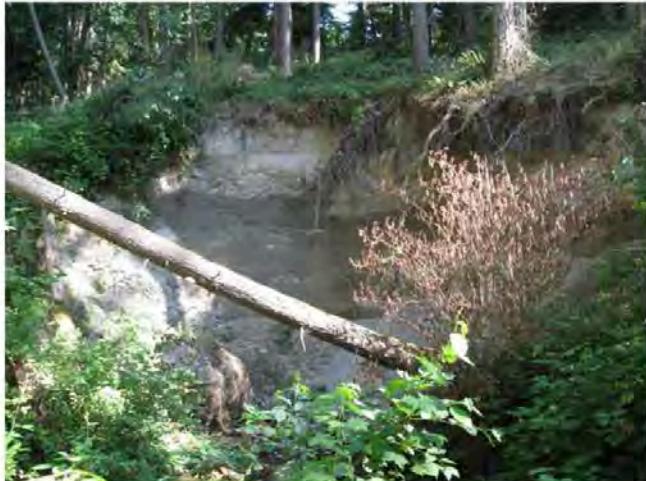
Large landslide initiated in advance outwash glacial deposits.
Note: This landslide is likely a spalling failure and caused by erosion of the toe of the slope by the creek, not seepage induced.

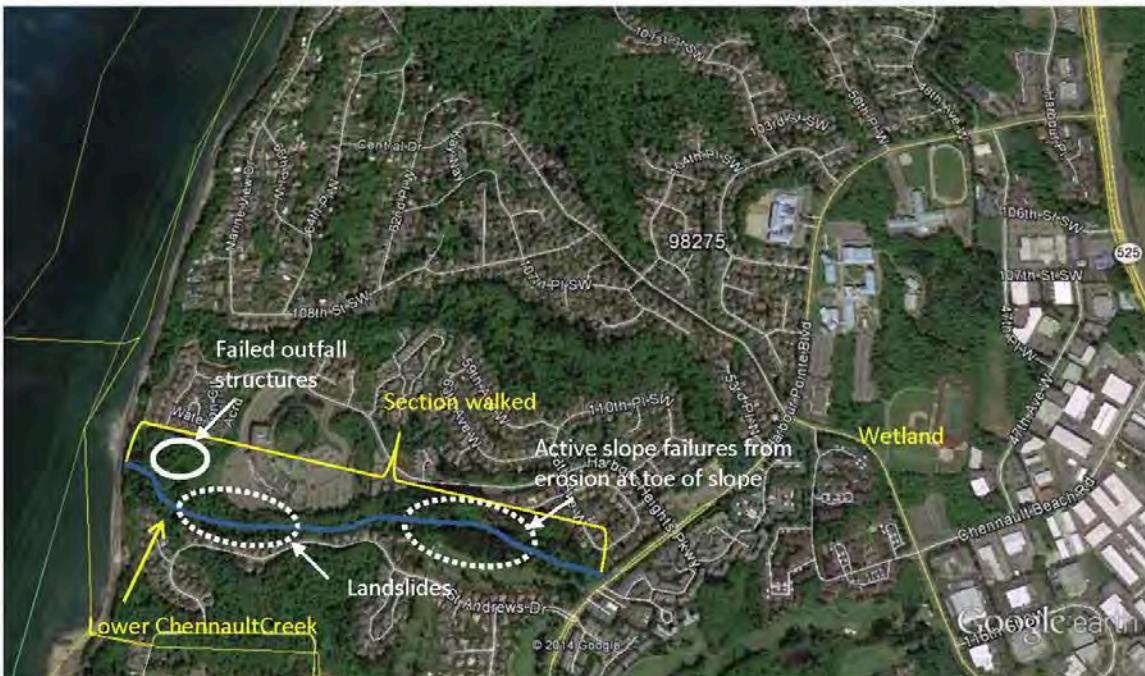
Active erosion and landslides, failed stormwater tightlines and stormwater outfall structures.

Figure 5 Map of Lower Chennault Creek and summary of conditions

General stream channel conditions are summarized in Figure 5. Extensive sedimentation at the mouth and in other locations was not observed in Lower Chennault Creek, especially in comparison to Upper Chennault Creek. Additionally, channel incision, while present in some locations, was not as significant in Lower Chennault Creek as compared to Upper Chennault Creek.

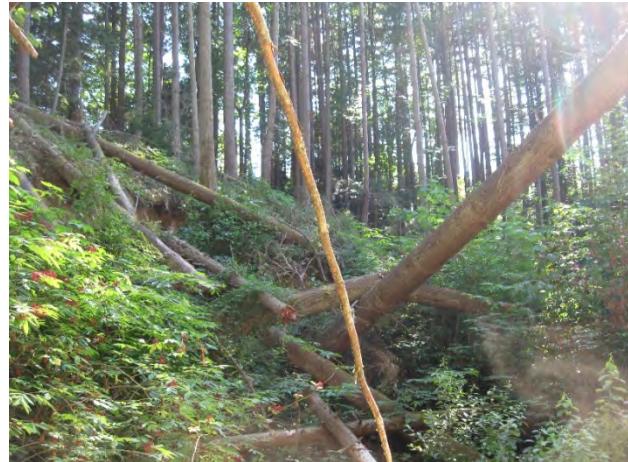
Photo 4. Large trees above channel that have toppled as a result of hillslope spalling failures

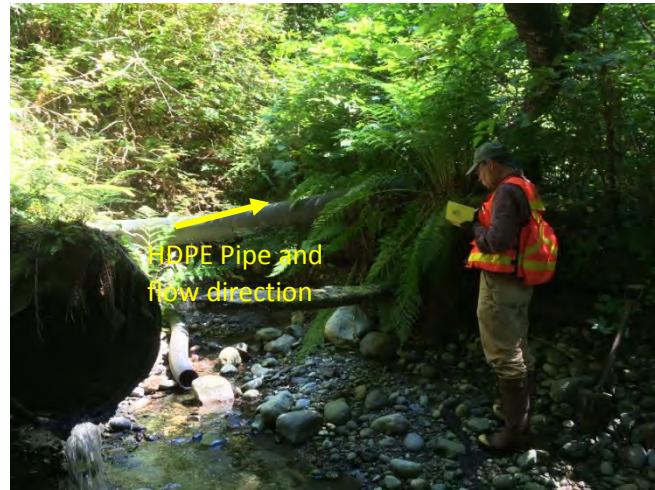
In one location, it appears that an original 24-inch corrugated metal pipe and control structure were installed to convey stormwater flows from development on the north side of the stream channel. This system is broken and other pipes have been installed to convey the flow, including a solid wall HDPE pipe. Erosion has occurred around the structures from uncontained flows and the solid wall HDPE pipe is bent upward (photo 5).

Photo 5. Solid HDPE pipe

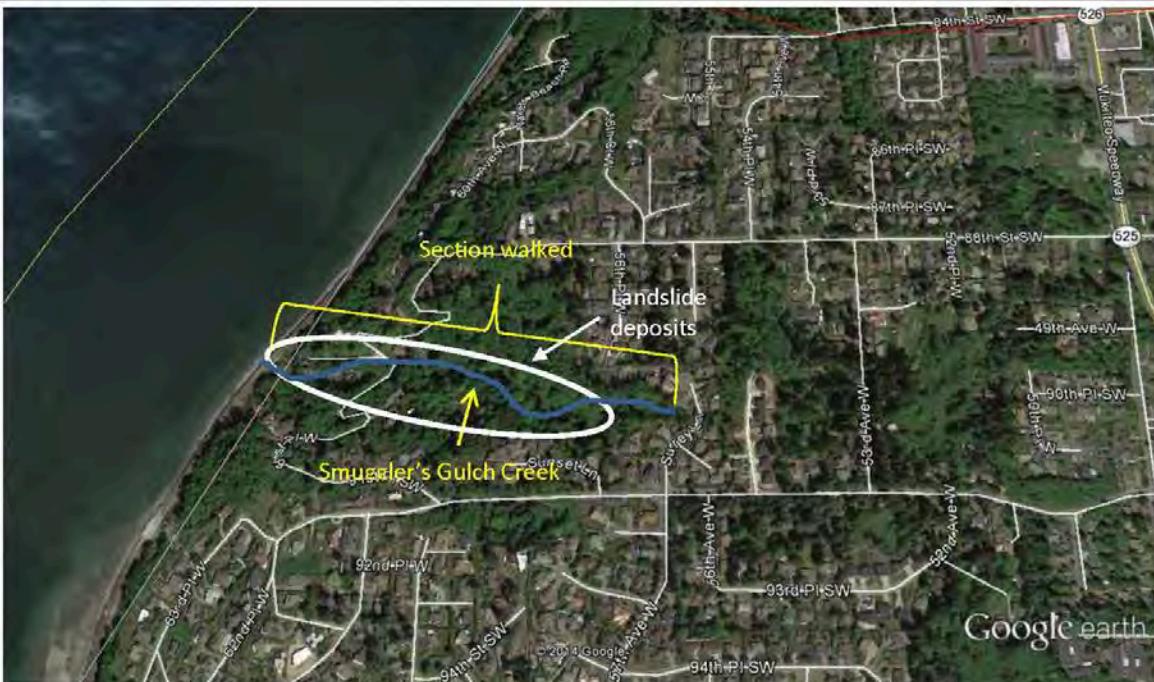
Figure 6 Map of Smuggler's Gulch Creek and summary of conditions

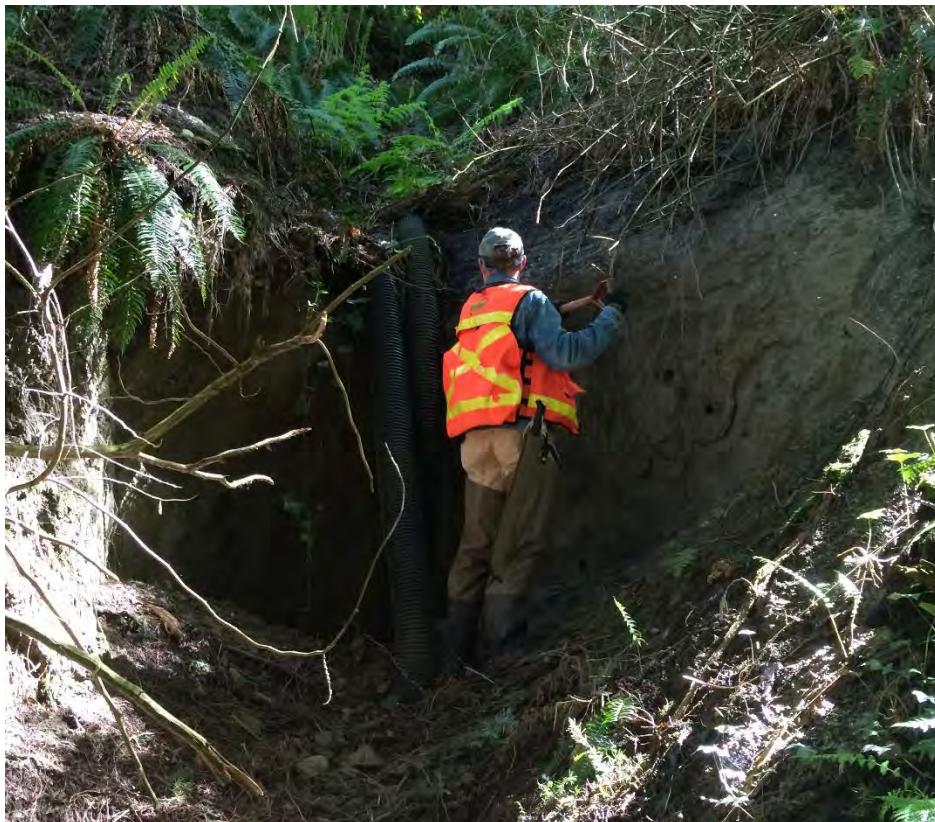
Photo #7. Broken tightline and eroded gully on right bank approximately 50 feet east of channel.

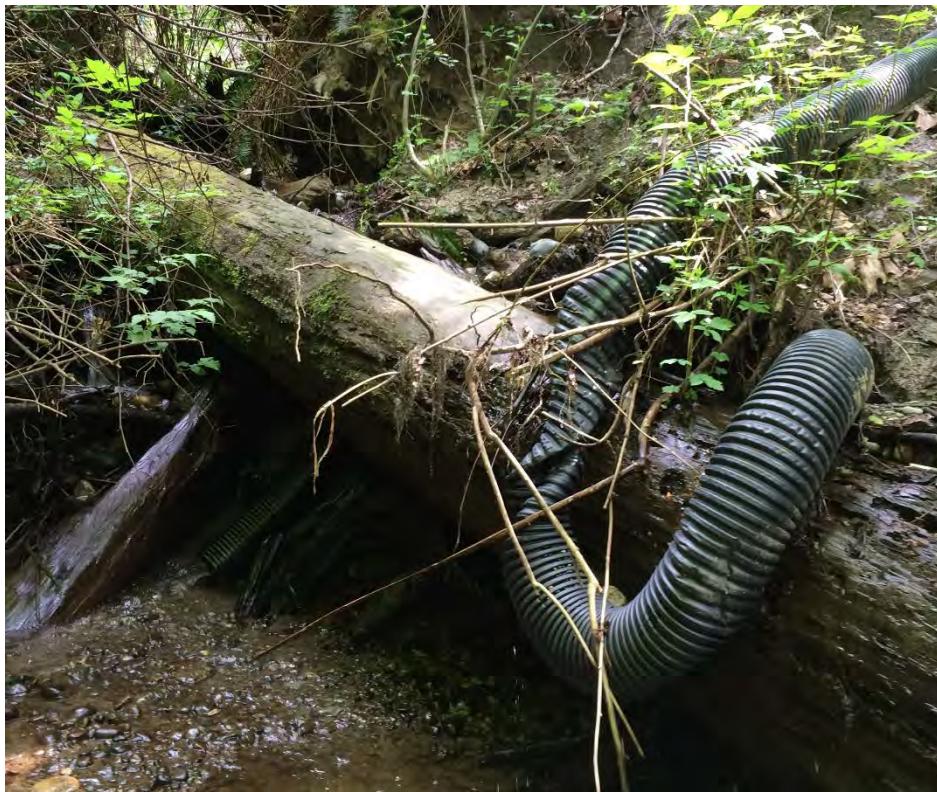
Photo #6. Example of damaged drain pipe in channel (many broken pipes were observed).

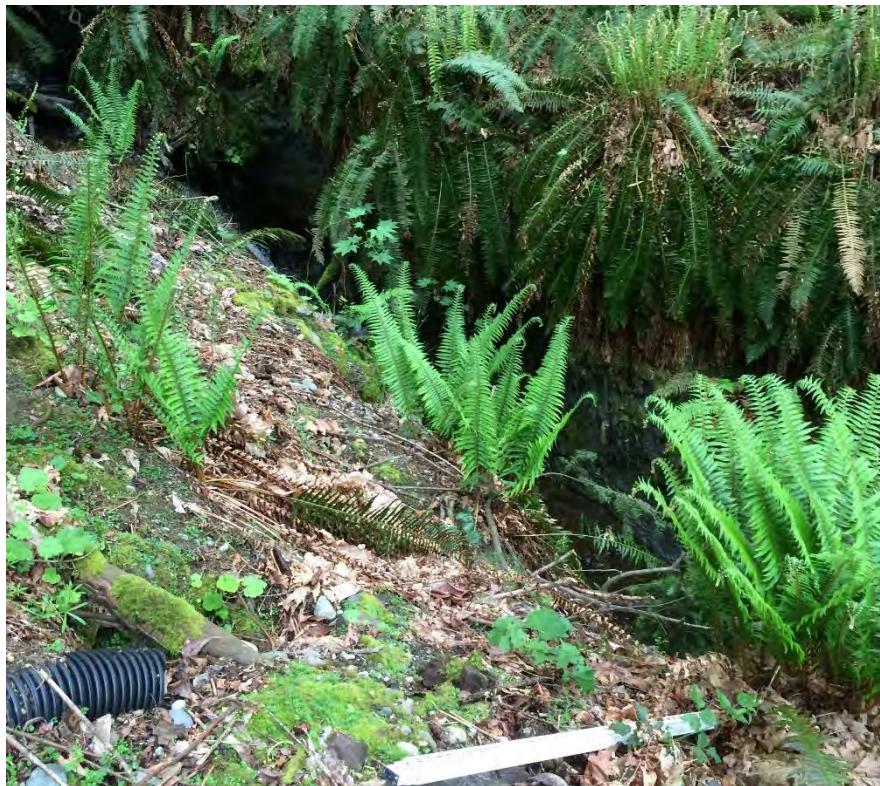
Photo #11. Right bank broken drain pipe and T-section. Channel is incised about 8 feet in this location.

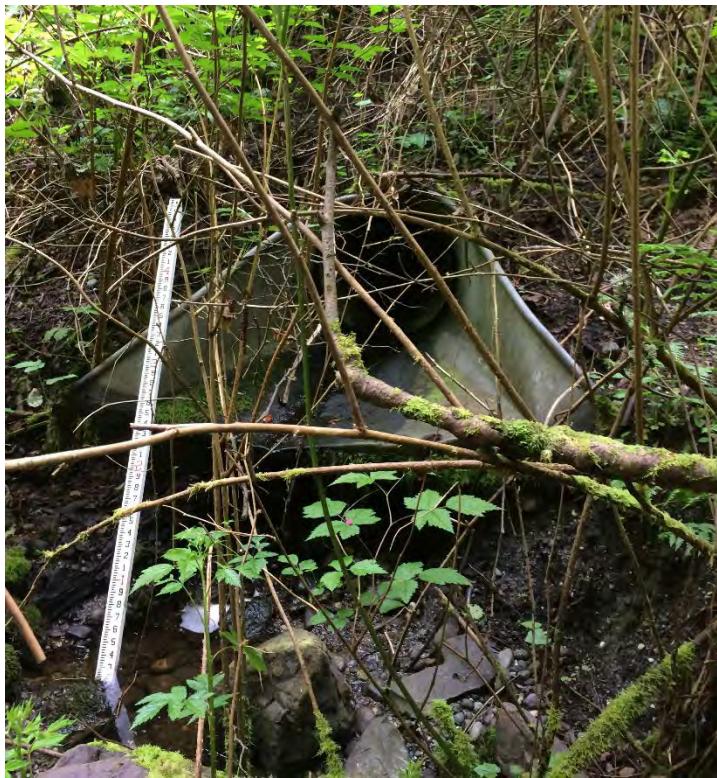
Photo #23. 18-inch corrugated metal culvert on right bank (broken).

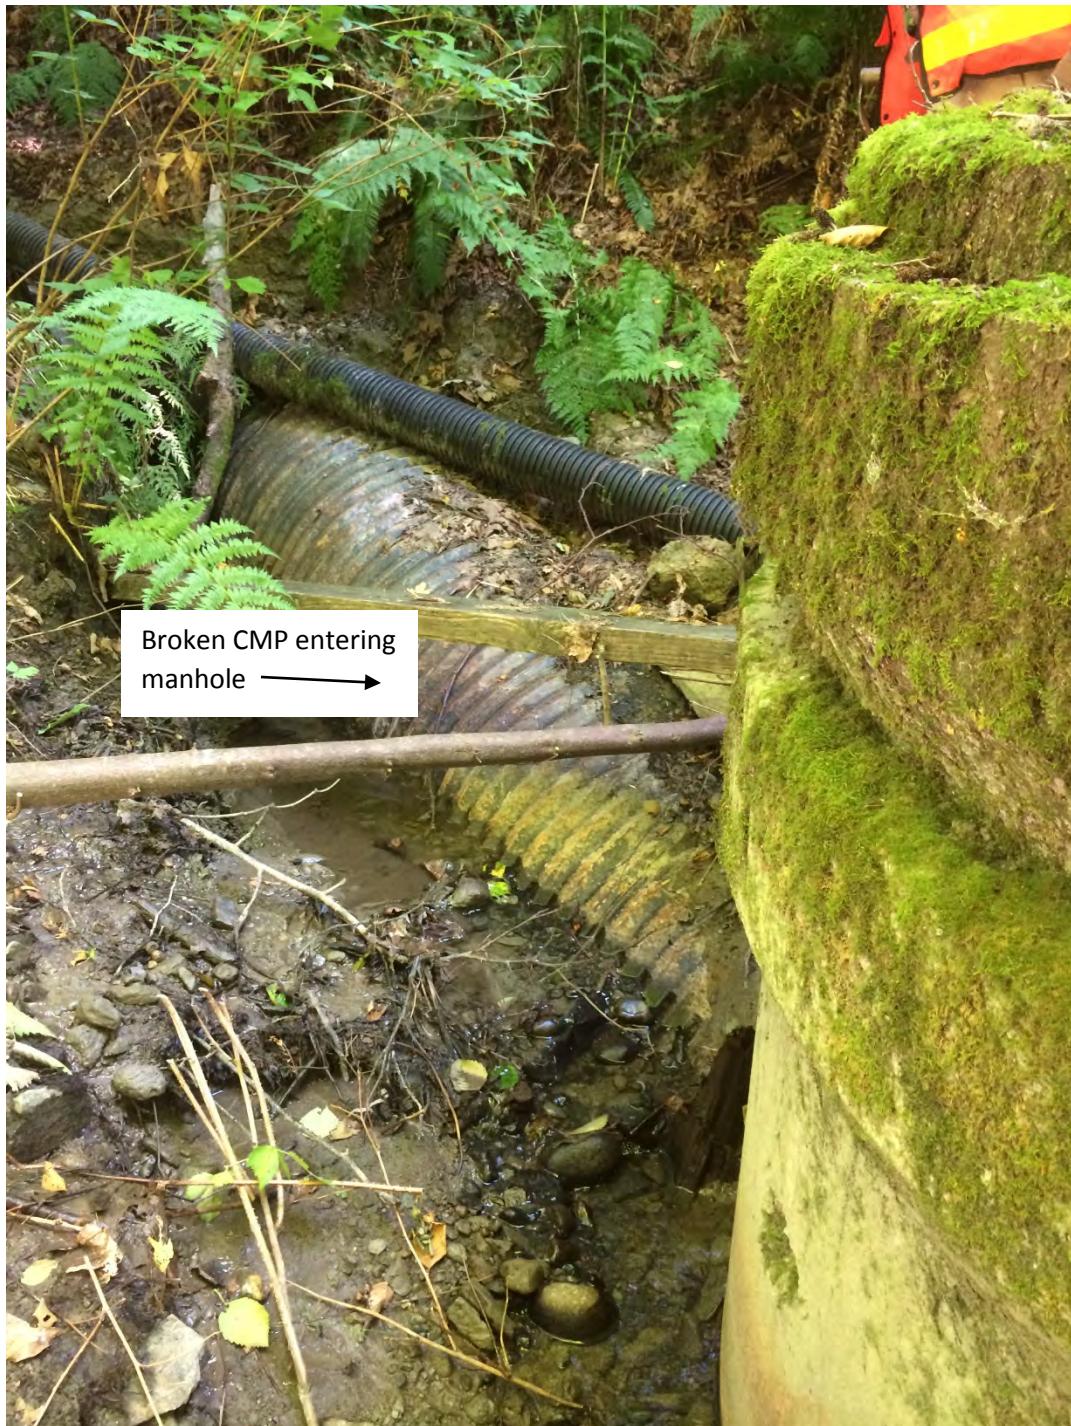
Photo #5. Upslope on right bank from CMP outfall. Pipe entering manhole is broken and flow is going around manhole and eroding slope. Small diameter black drainpipe is also being used to route flow from upslope.

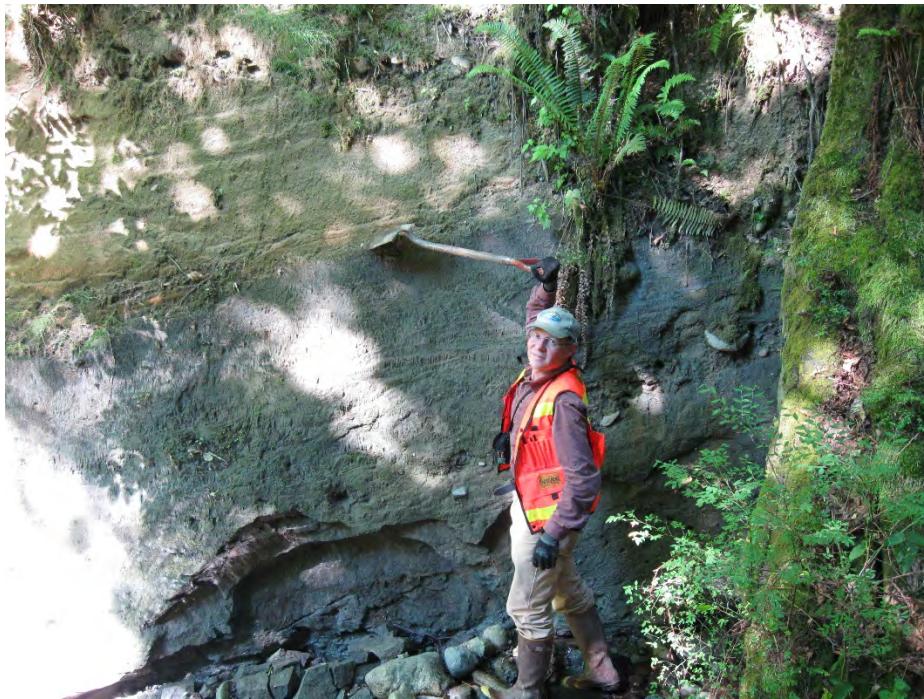
Photo #17. Contact between Vashon advance outwash (Qva) (top, light brown) and Transitional beds (Qtb) lacustrine deposits (bottom, gray).

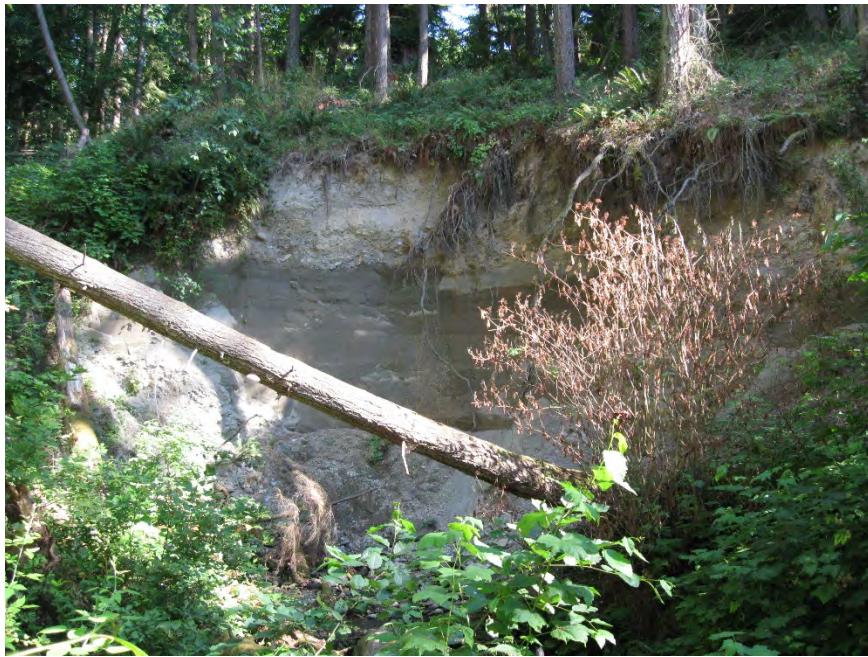
Photo #20. Spalling failure Landslide adjacent to channel on left bank.

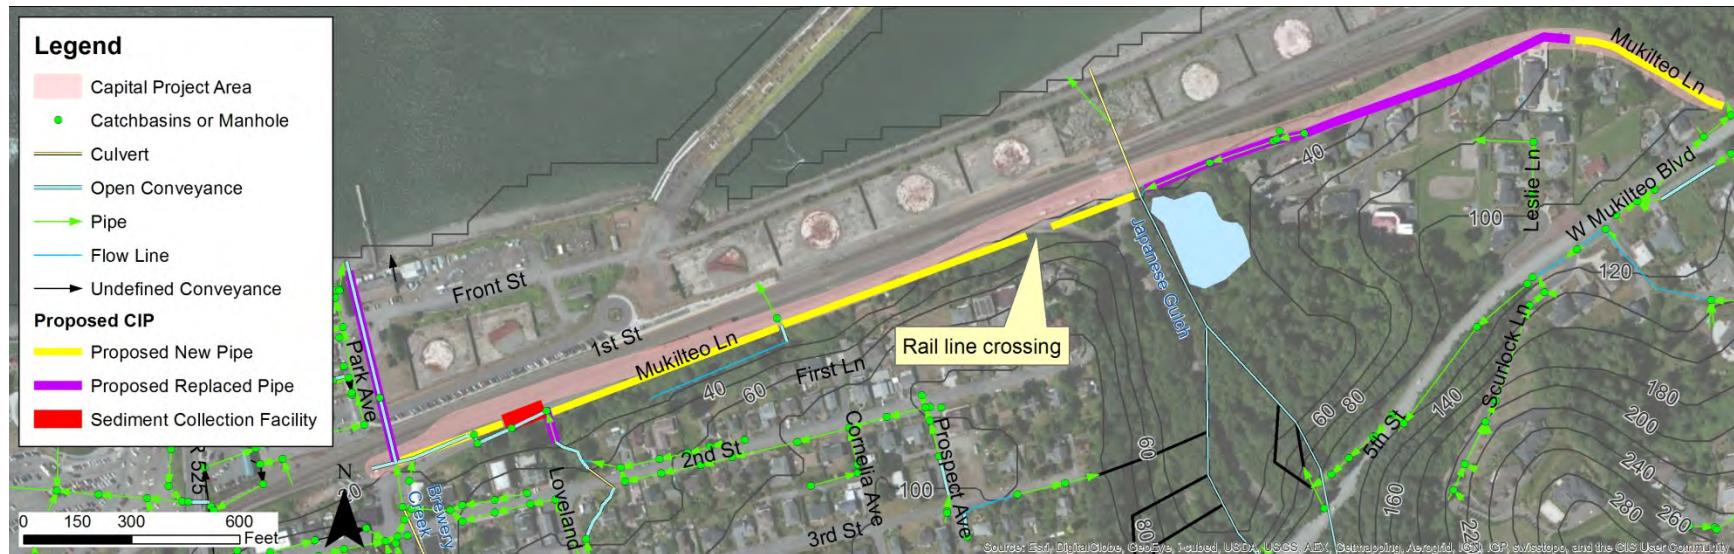
Construction management and inspections (15% of construction costs).....	\$659,000
	Administration, engineering design, public outreach, cultural resources, and permitting, including railroad crossing permitting (35% of construction costs).....	\$1,538,000
	CIP 2 project cost	\$6,591,000
	Annual O&M costs	\$700

Figure 2. CIP Rank 2, Mukilteo Lane Drainage Improvements

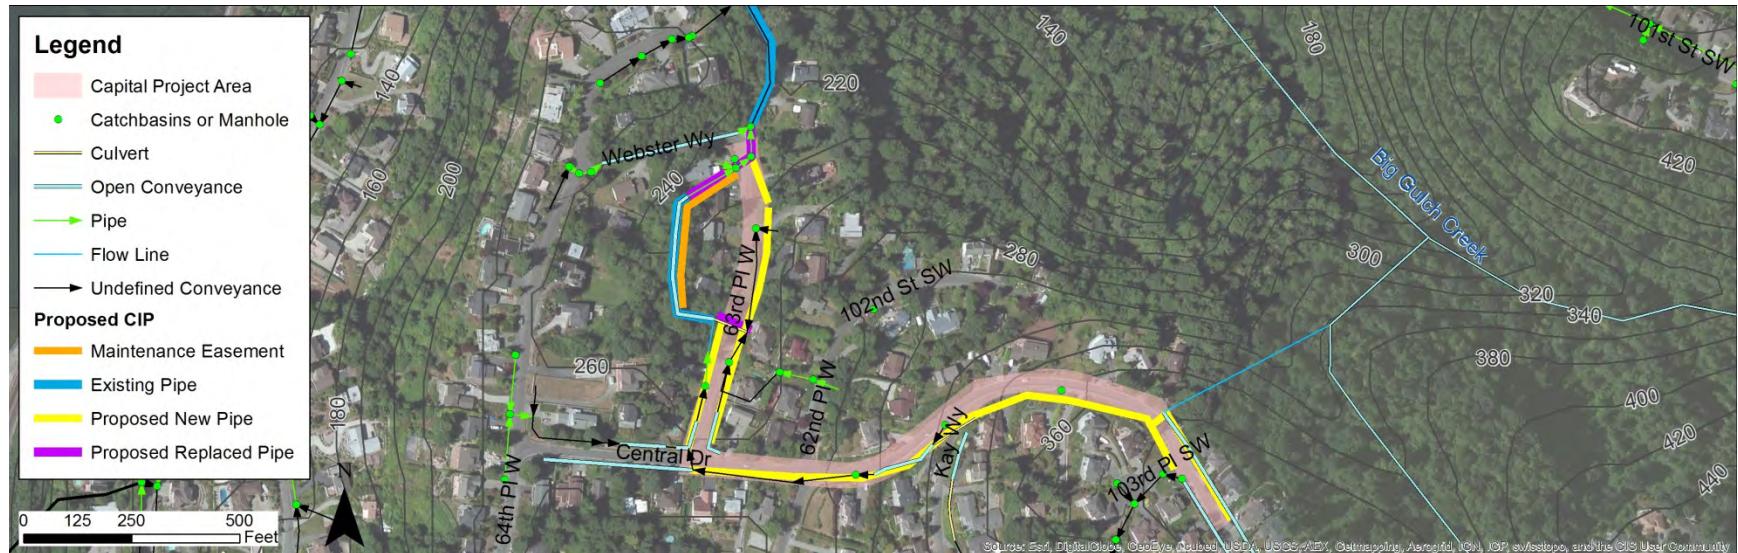
Cost estimate	Gravity storm drain: replace 320 feet of pipe with 18-inch-diameter pipe in ROW	\$269,000
	Gravity storm drain: install 2,650 feet of 12-inch-diameter pipe in ROW	\$1,824,000
	Maintenance easement	\$171,000
	<i>Subtotal line-item costs</i>	\$2,264,000
	Contractor overhead, profit, and mobilization (18% of subtotal of line-item costs).....	\$408,000
	Construction contingency (20% of all above construction costs).....	\$534,000
	Washington State and Snohomish County sales tax (9.5% of all above construction costs).....	\$305,000
	<i>Subtotal construction costs</i>	\$3,511,000
	Construction management and inspections (15% of construction costs).....	\$527,000
	Administration, engineering design, public outreach, and permitting (35% of construction costs)	\$1,229,000
	CIP 6 project cost	\$5,267,000
	Annual O&M costs	\$1,050

Figure 5. CIP Rank 6, Central Drive Storm Drainage Improvements for Big Gulch

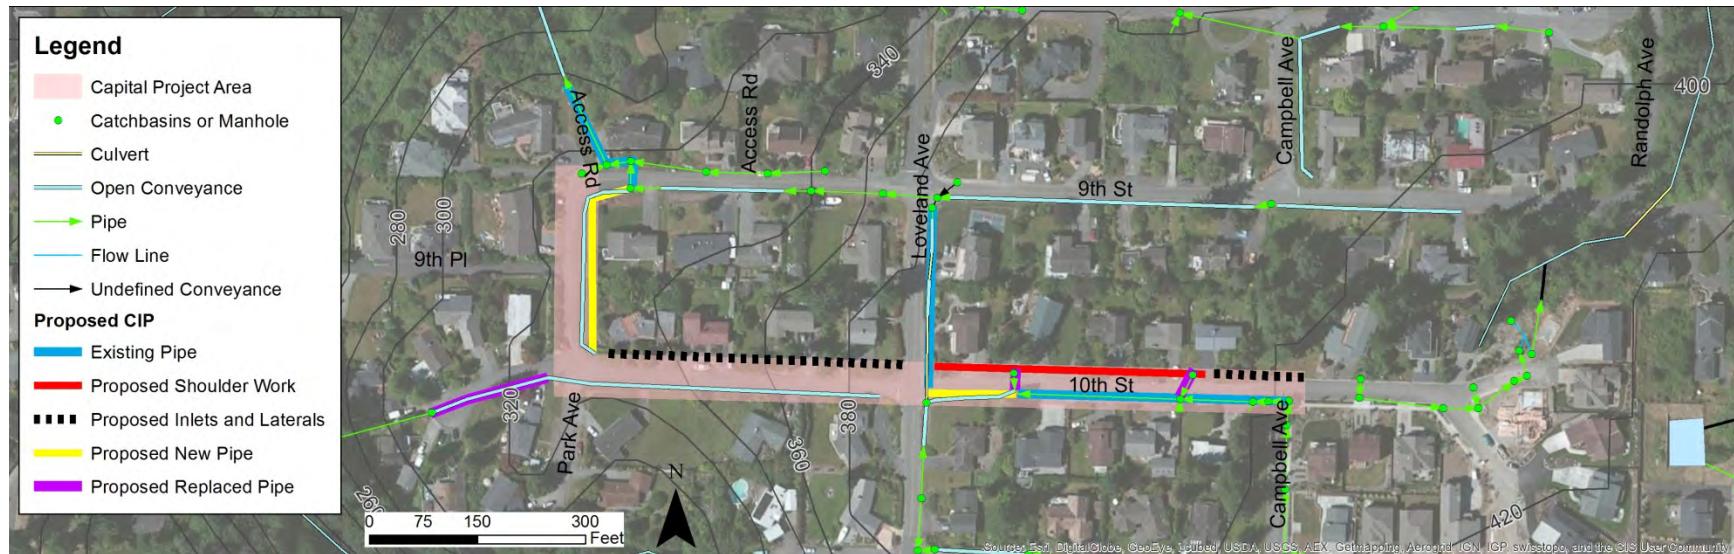
Gravity storm drain: install 400 feet of 12-inch-diameter pipe in ROW	\$159,000	Gravity storm drain: replace 180 feet of pipe with 12-inch-diameter pipe in ROW	\$78,000	Install 6 inlets and associated laterals that tie into existing system.....	\$86,000	Improve feet of ROW shoulder	\$30,000	<i>Subtotal line-item costs</i>	\$353,000	Contractor overhead, profit, and mobilization (18% of subtotal of line-item costs).....	\$64,000	Construction contingency (20% of all above construction costs).....	\$83,000	Washington State and Snohomish County sales tax (9.5% of all above construction costs).....	\$48,000	<i>Subtotal construction costs</i>	\$548,000	Construction management and inspection (15% of construction costs).....	\$82,000	Administration, engineering design, public outreach, and permitting (30% of construction costs)	\$164,000	CIP 8 project cost	\$794,000	Annual O&M costs	\$200
Gravity storm drain: install 400 feet of 12-inch-diameter pipe in ROW	\$159,000																											
Gravity storm drain: replace 180 feet of pipe with 12-inch-diameter pipe in ROW	\$78,000																											
Install 6 inlets and associated laterals that tie into existing system.....	\$86,000																											
Improve feet of ROW shoulder	\$30,000																											
<i>Subtotal line-item costs</i>	\$353,000																											
Contractor overhead, profit, and mobilization (18% of subtotal of line-item costs).....	\$64,000																											
Construction contingency (20% of all above construction costs).....	\$83,000																											
Washington State and Snohomish County sales tax (9.5% of all above construction costs).....	\$48,000																											
<i>Subtotal construction costs</i>	\$548,000																											
Construction management and inspection (15% of construction costs).....	\$82,000																											
Administration, engineering design, public outreach, and permitting (30% of construction costs)	\$164,000																											
CIP 8 project cost	\$794,000																											
Annual O&M costs	\$200

Figure 7. CIP Rank 8, 10th Street and Loveland Storm Drainage Improvement
