Comprehensive Surface Water Management Plan Update

City of Mukilteo

August 2015

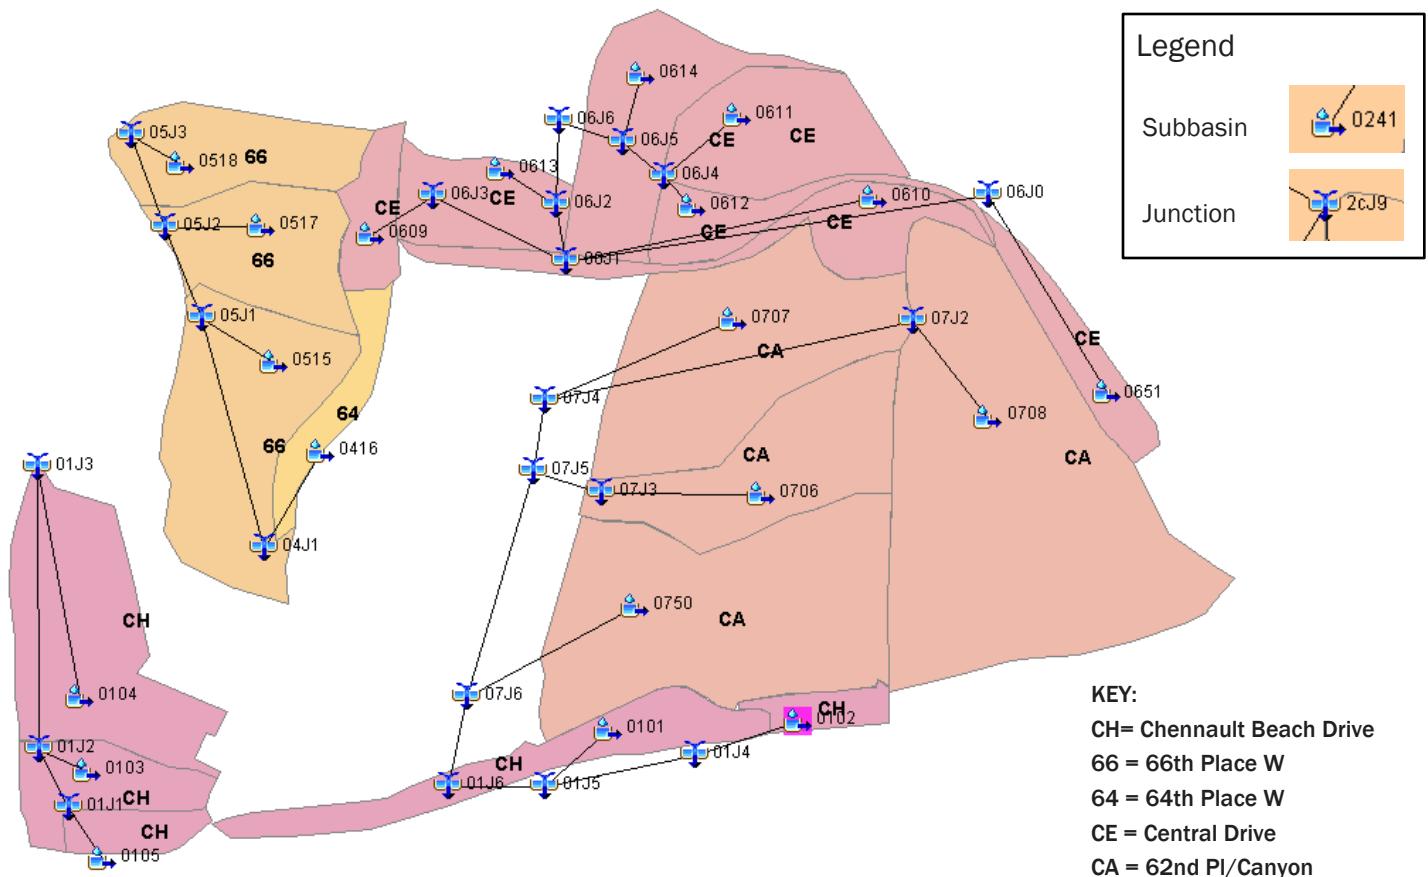
Figure B-1. HEC-HMS Subbasins and Junctions for CIP Rank 1 (Chennault Beach Drive), Rank 4 (64th Place W), Rank 5 (66th Place W), Rank 6 (Central Drive), and Rank 7 (62nd Pl/Canyon).

HEC-HMS model subbasins and junctions are shown the Figures B-1 through B-3. Subbasin input values are summarized on Table B-1. Design flows and locations of design flows (subbasin or junction) are summarized in Table B-2.

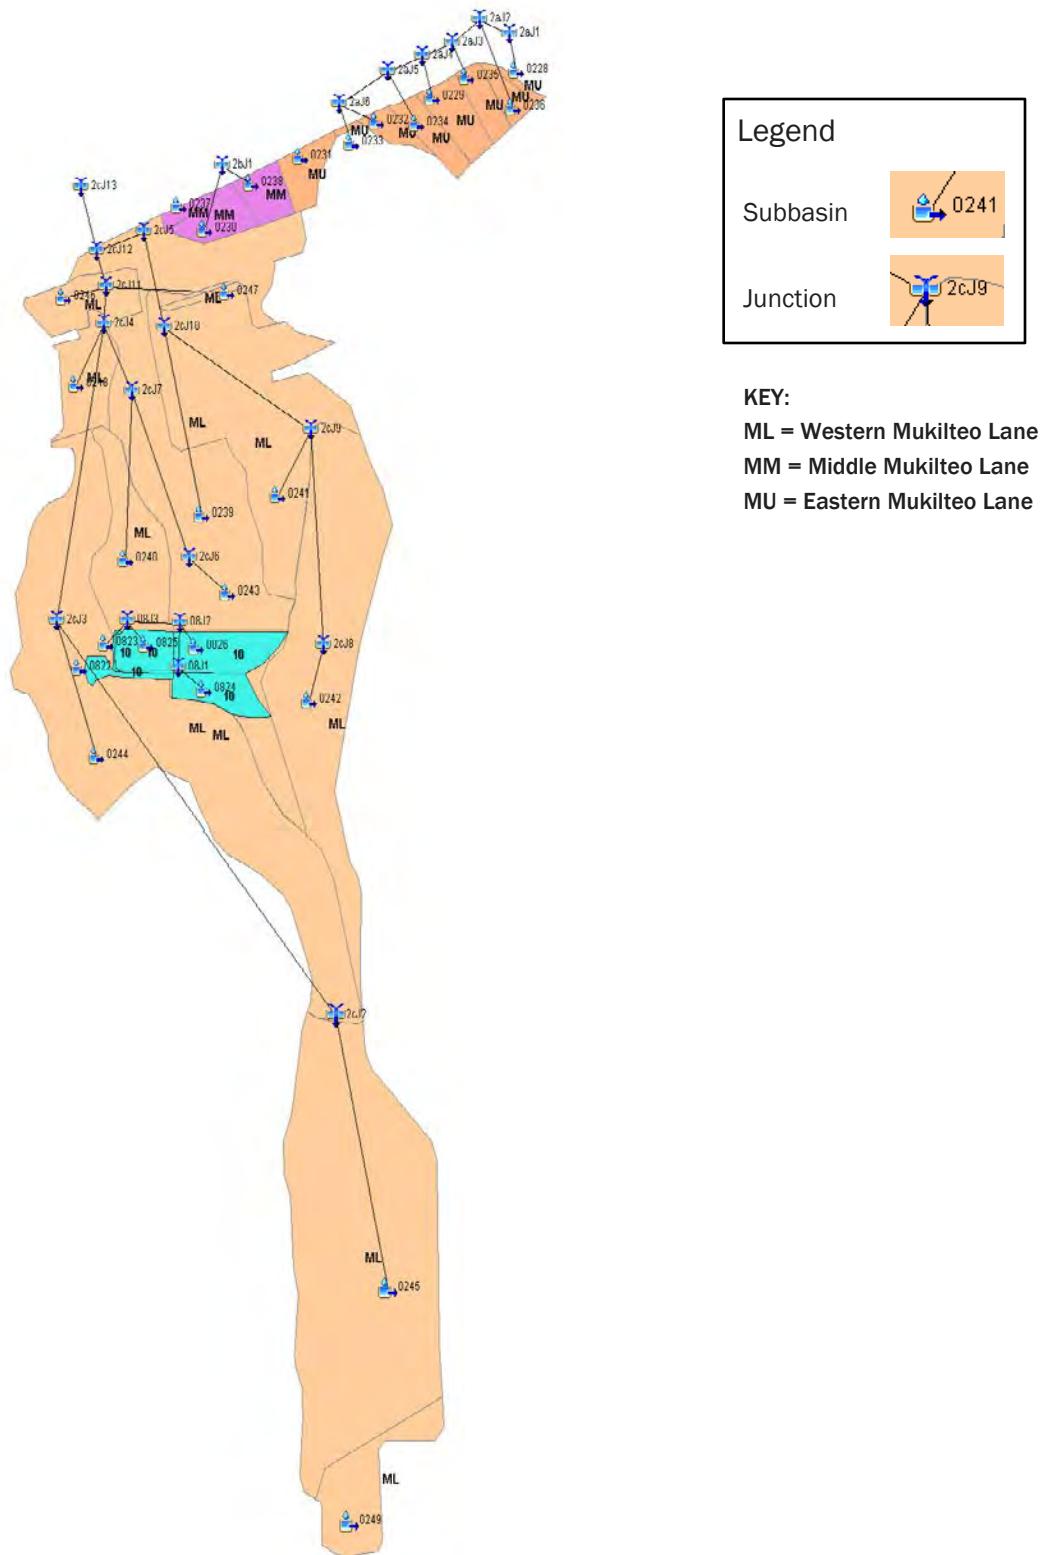
Figure B-2. HEC-HMS Subbasins and Junctions for CIP Rank 2 (Mukilteo Lane)
