**CRITICAL AREAS STUDY  
AND  
BUFFER ENHANCEMENT PLAN

**1603 DEBRELOH LANE  
MUKILTEO, WA**

*Wetland Resources, Inc. Project #17079*

October 17, 2018

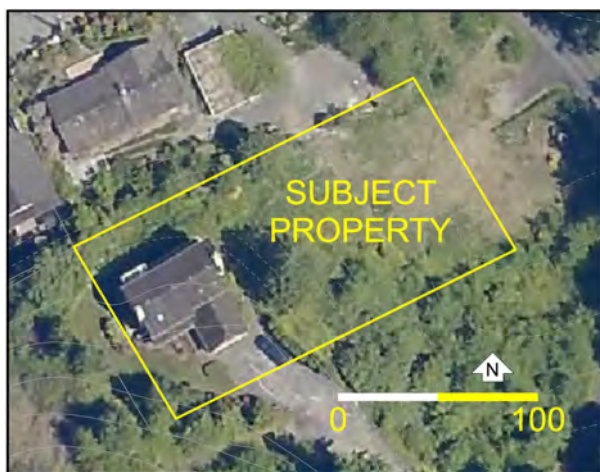
**Figure 1:** Aerial view of the subject property

The 0.41-acre subject property is within a suburban single-family neighborhood, itself being developed as a single-family residence in the western-most portion of the site. A steeply-sloped area in the middle of the parcel separates the eastern half of the property from the single-family residence above. The eastern portion of the site is topographically lower than the existing residence and is currently maintained as lawn space. East of the site, past the access road (Debreton Lane), is a forested area that eventually slopes down into a ravine containing a tributary (Type 5: seasonal, non-fish) to Edgewater Creek. An off-site Category IV wetland is present within this forested area as well. The buffer widths associated with these off-site features do not extend onto the subject site. An on-site portion of a second Category IV wetland (Wetland A) is located in the southeastern corner of the property, emanating from the base of a forested slope south of the site. In the City of Mukilteo, Category IV wetlands typically receive 40-foot buffers, pursuant to Mukilteo Municipal Code (MMC) 17.52B.100.

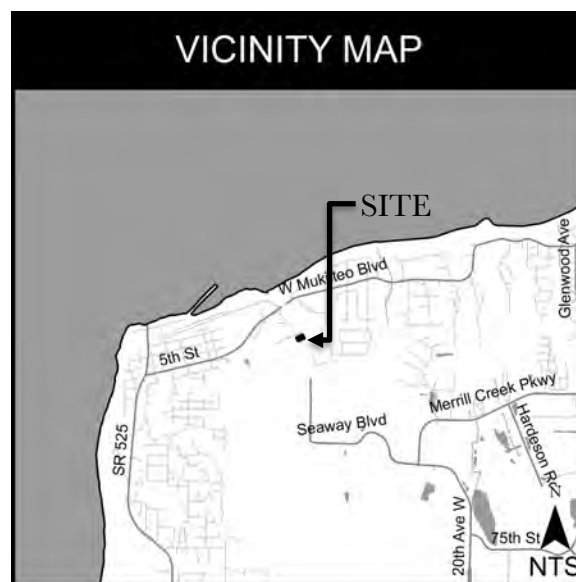
**Figure 2:** Vicinity of the subject site

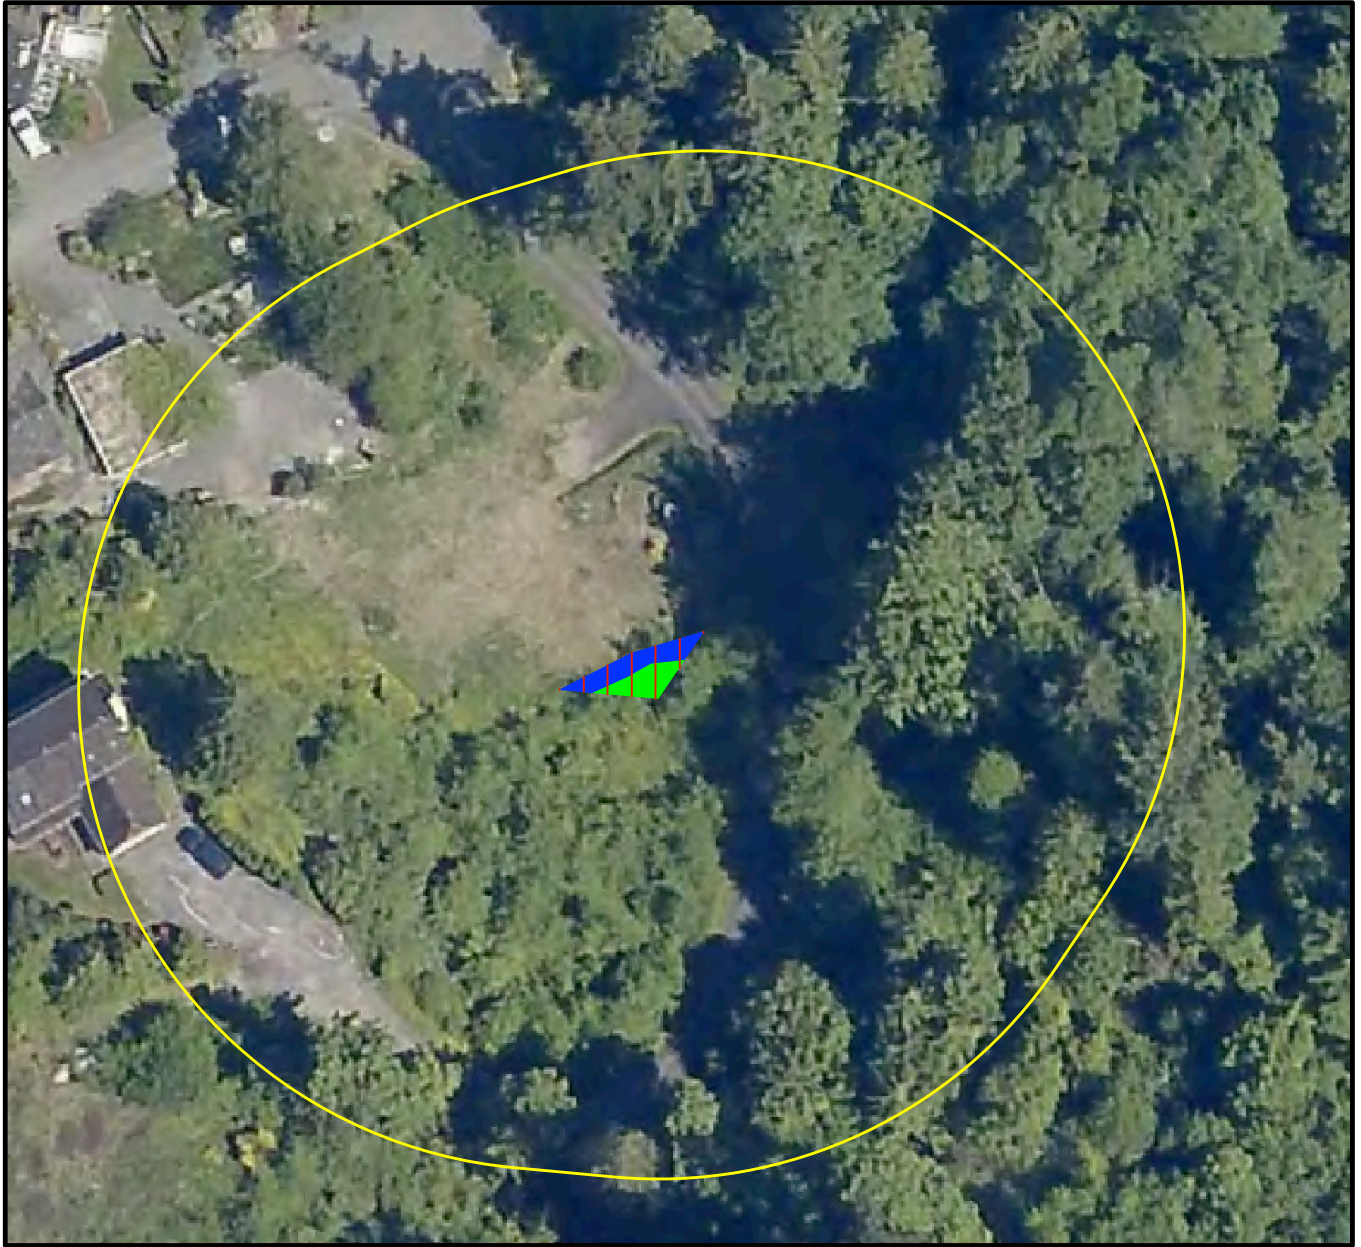
17079 LOT DESIGN - DEBRELOAN LANE  
WETLAND RATING FIGURE A1 - WETLAND A

WETLAND RATING Wetland A	
LOT Design Group Attn: Larry Thronsdon 22630 88th Avenue W Edmonds, WA 98026	Figure A1 WRI Job # 17079 Drawn by: SW
