**GEOTECHNICAL REPORT
MUKILTEO 5TH STREET
BICYCLE AND PEDESTRIAN IMPROVEMENTS
MUKILTEO, WASHINGTON**

HWA Project No. 2020-144-21

**Prepared for
KPFF, Inc & City of MUKILTEO**

November 4, 2022

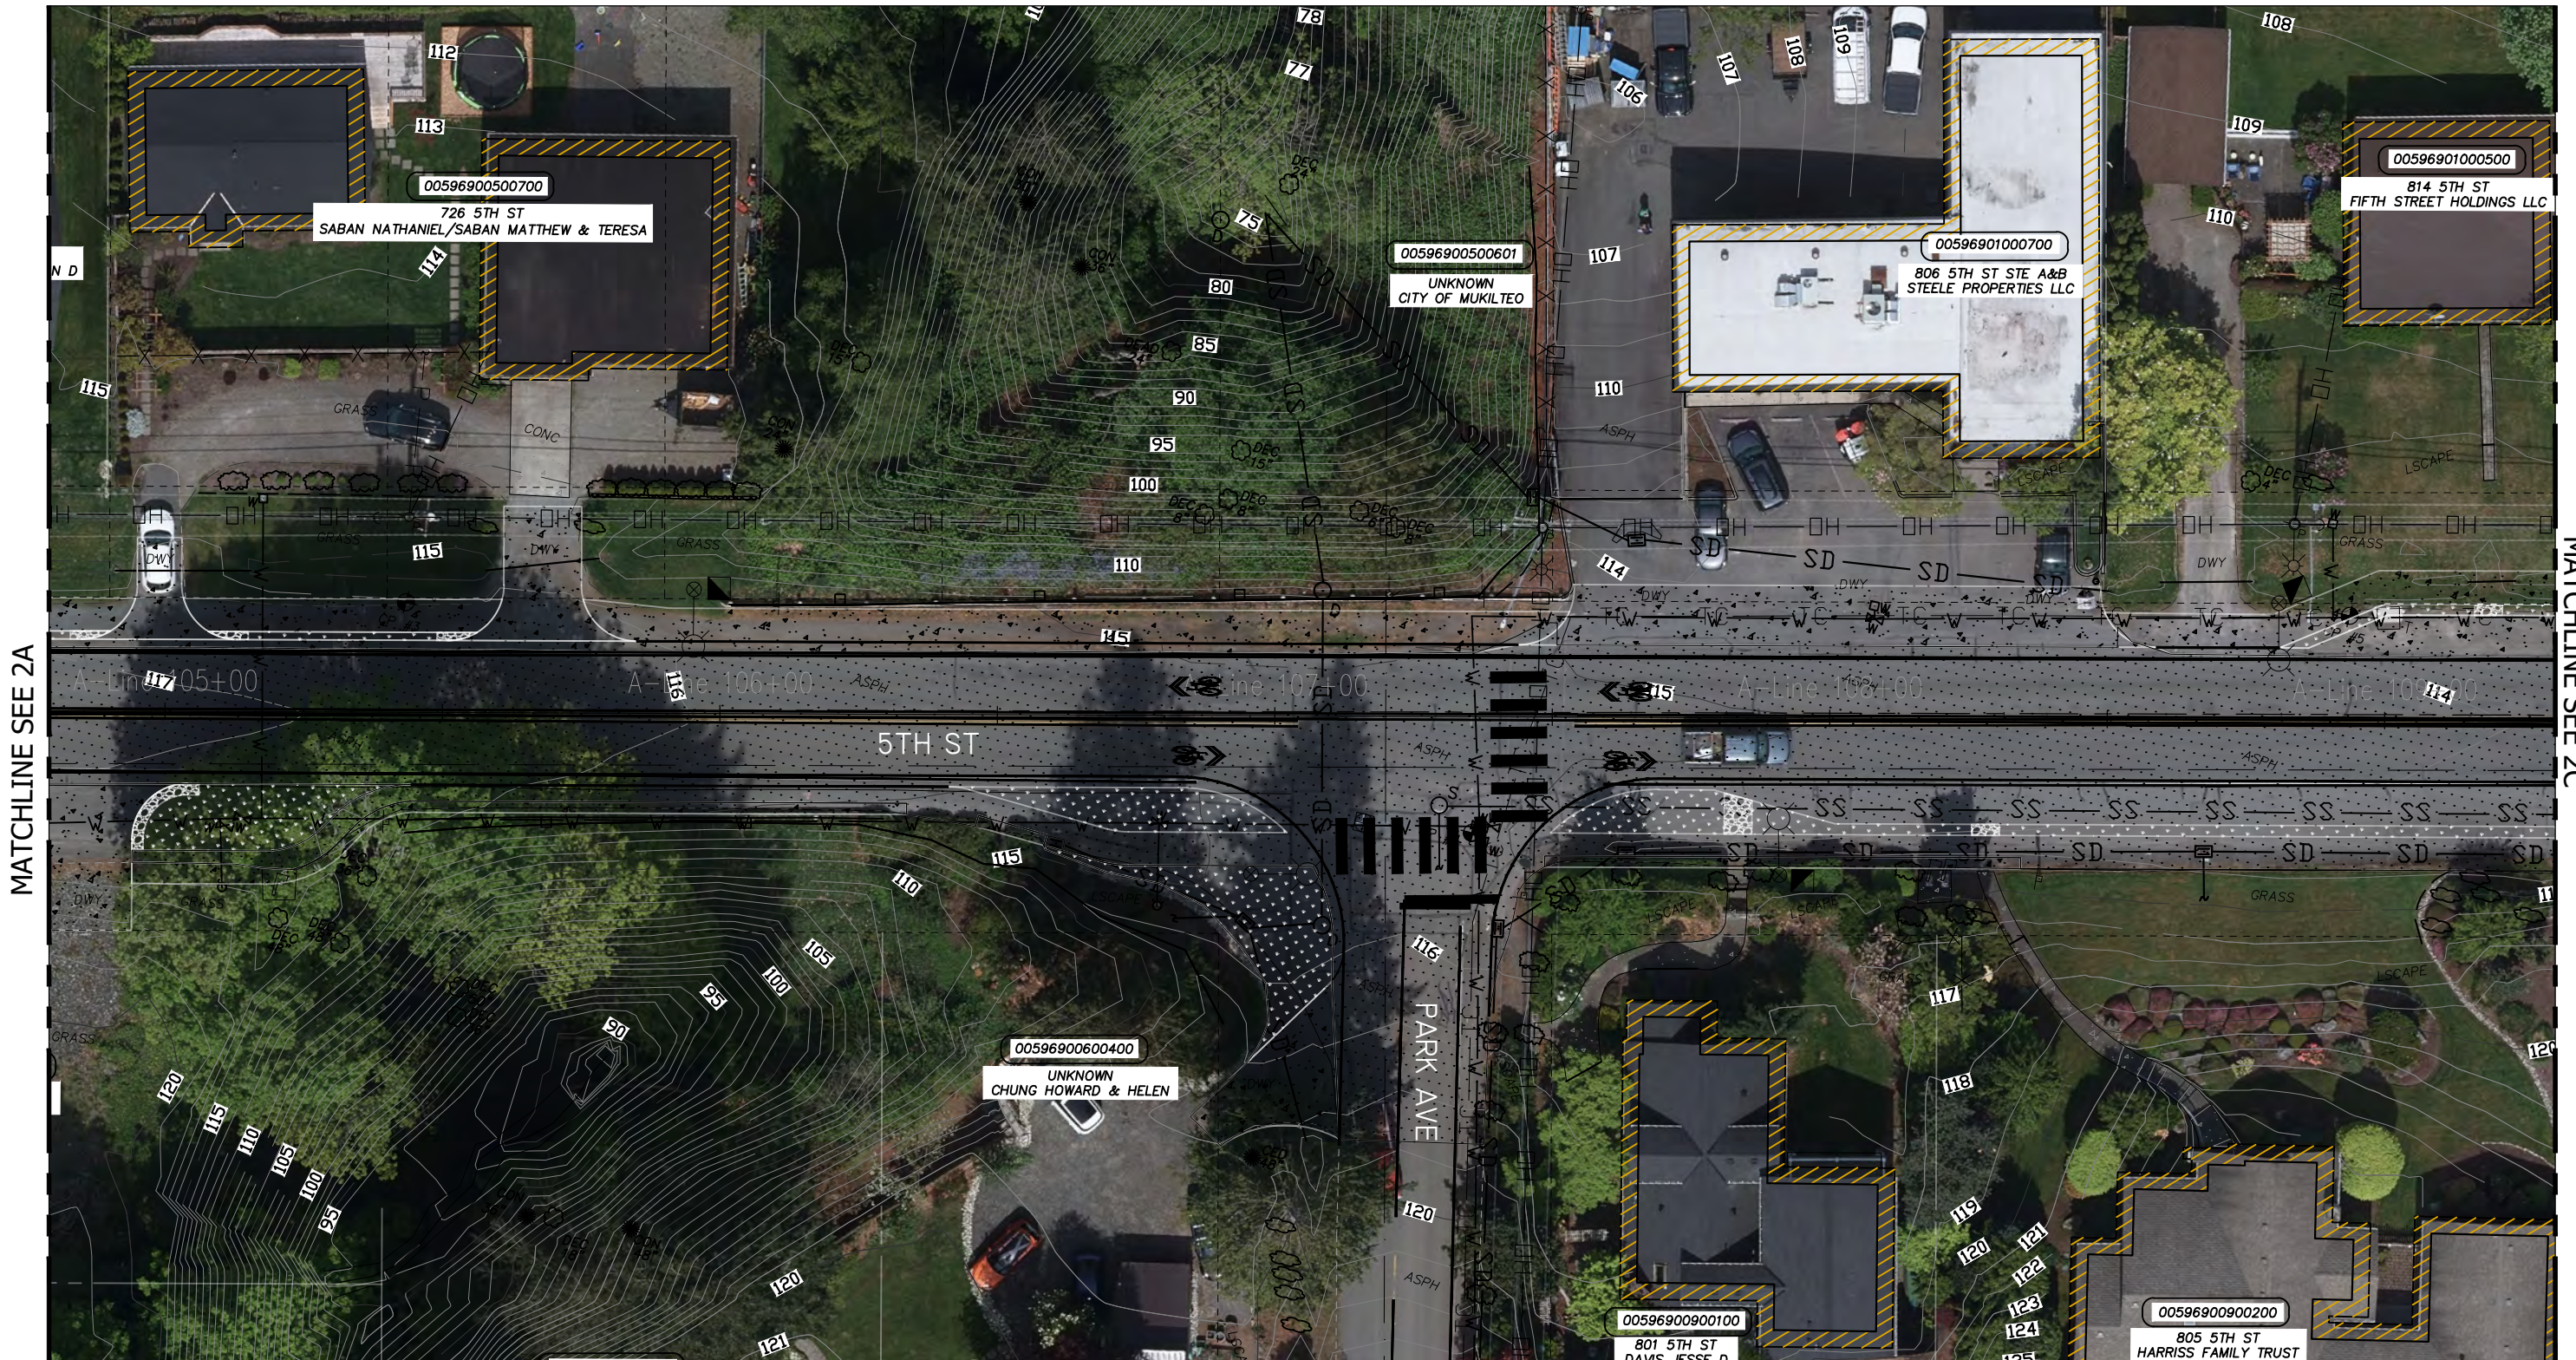
FIGURE NO.:
2B
PROJECT NO.:
2020-144-21

SITE &
EXPLORATION PLAN

A geotechnical engineer from HWA logged the drilling of 6 machine-drilled geotechnical borings, designated BH-1 through BH-6, to assess subsurface conditions along the alignment. The locations of the explorations are shown on the Site and Exploration Plans, Figures 2A through 2K. The borings were drilled by Geologic Dill Partners of Bellevue, Washington on February 1, 2022, under subcontract to HWA, using a limited access Bobcat track-mounted drill rig equipped with hollow-stem augers. The boring depths varied from approximately 16 to 21.5 feet below ground surface (bgs).

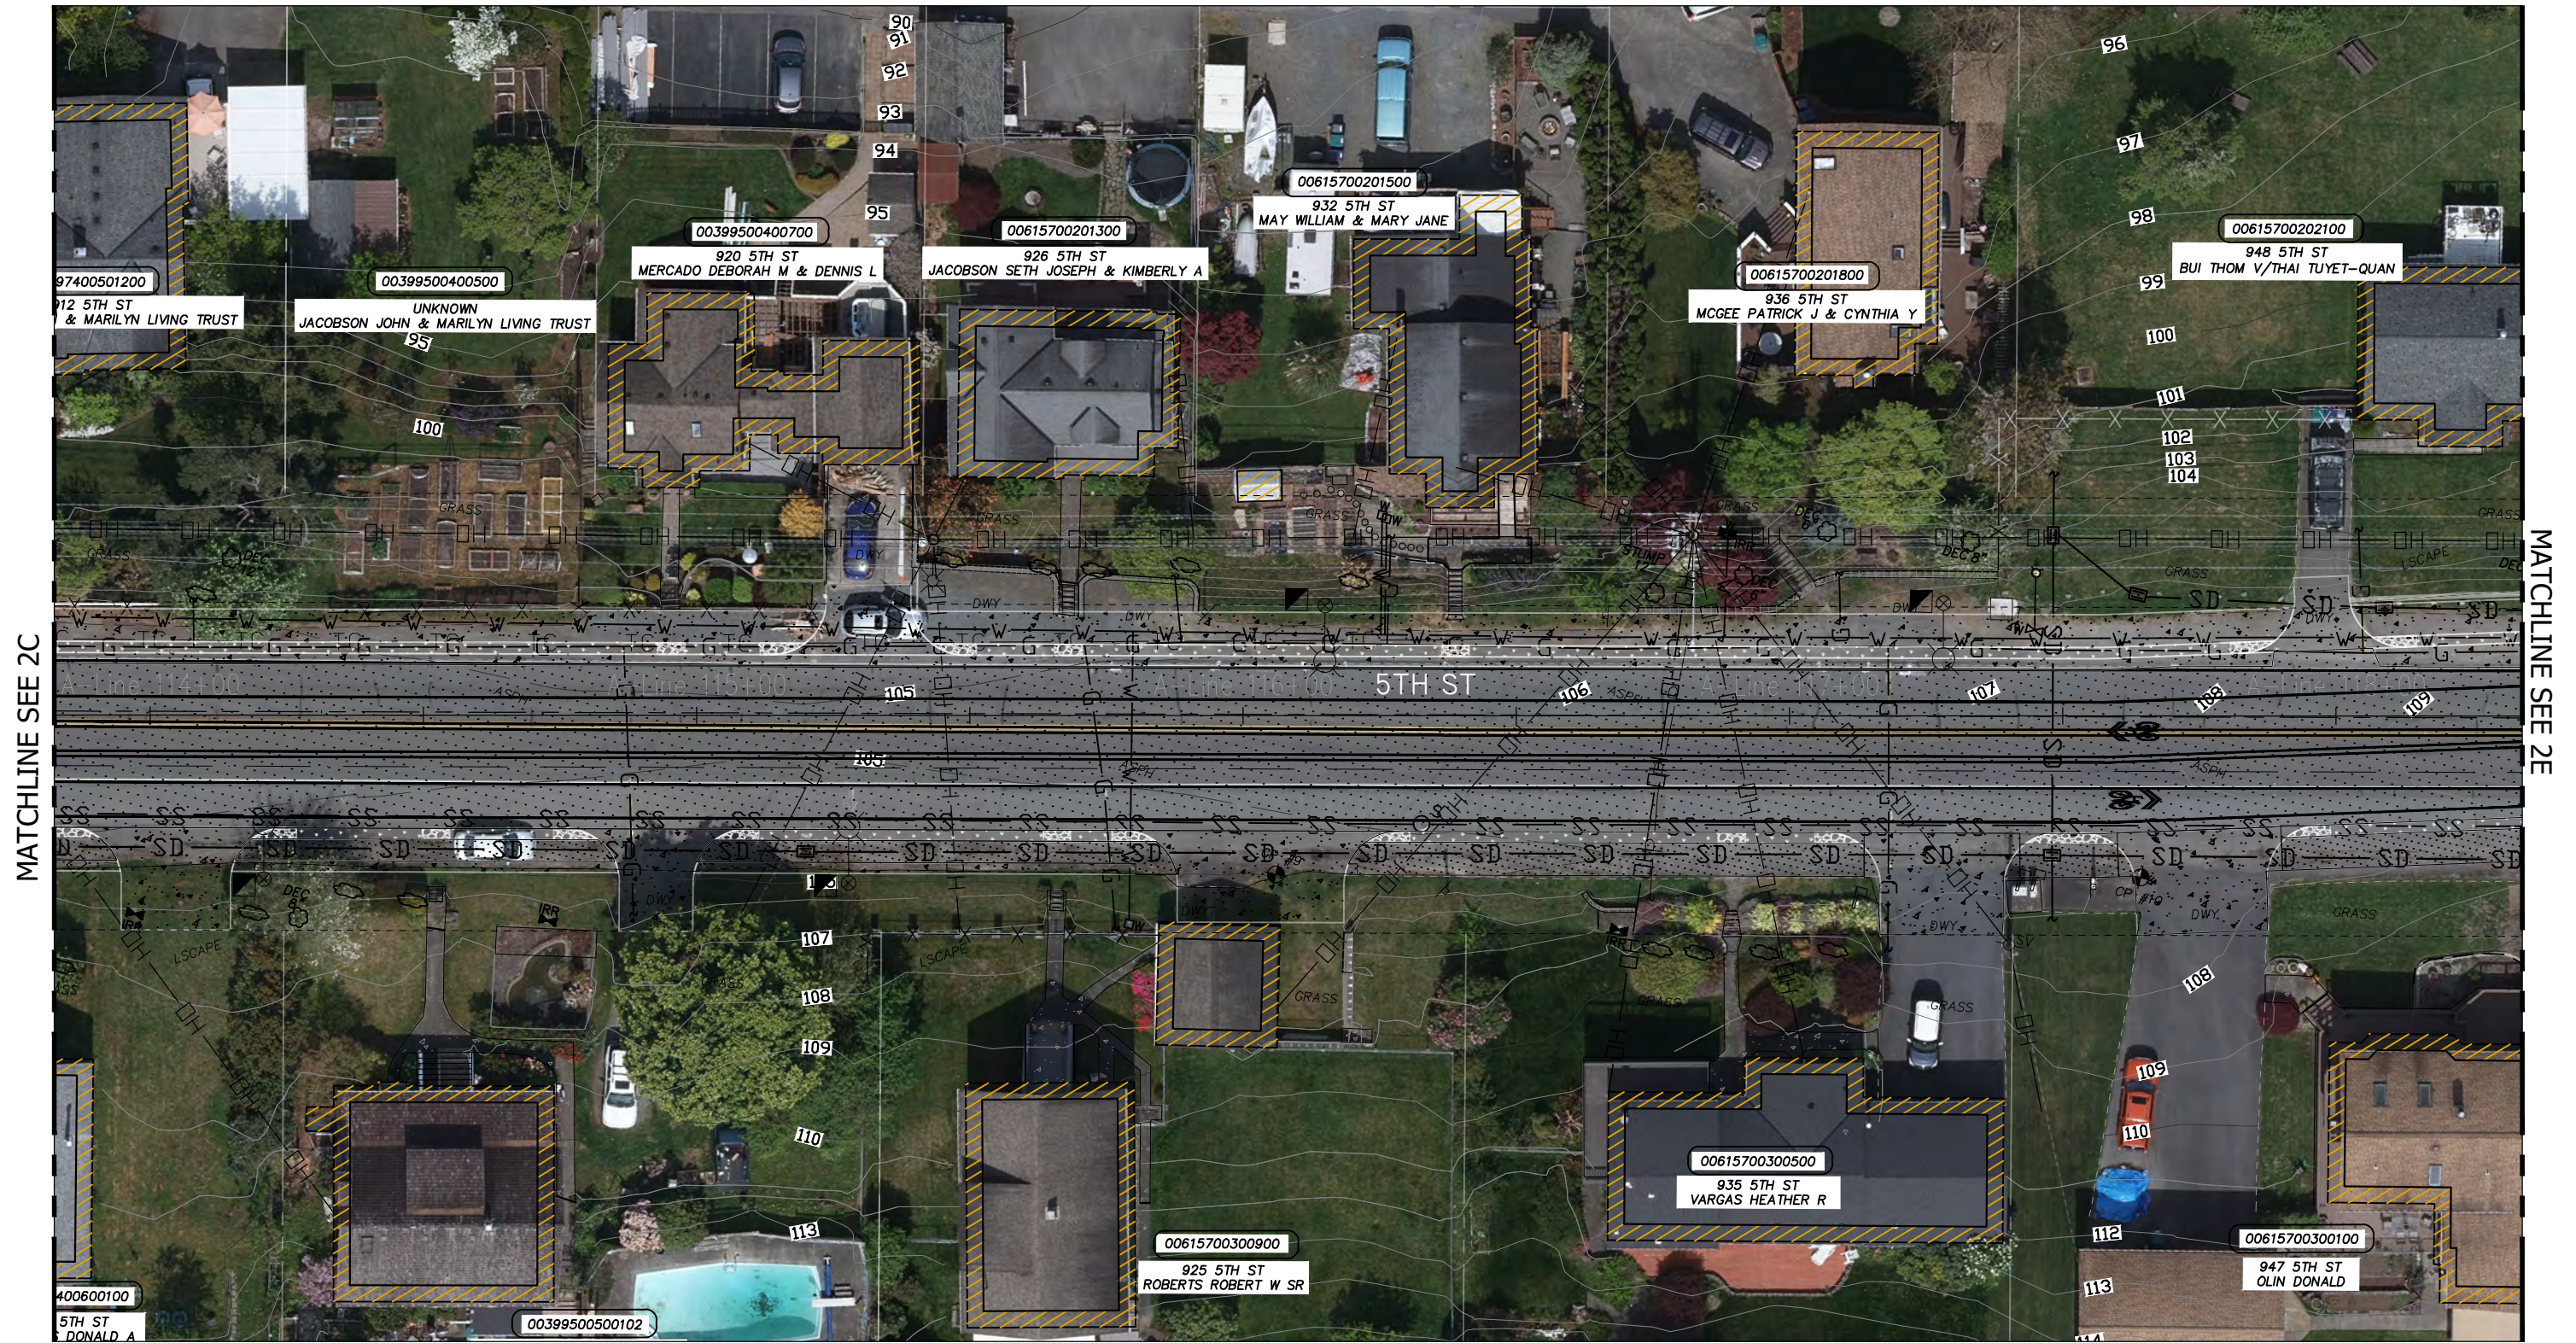
DRAWN BY:	FIGURE NO.:
CF	2D
CHECK BY:	PROJECT NO.:
AS/BKH	2020-144-21

SITE &
EXPLORATION PLAN

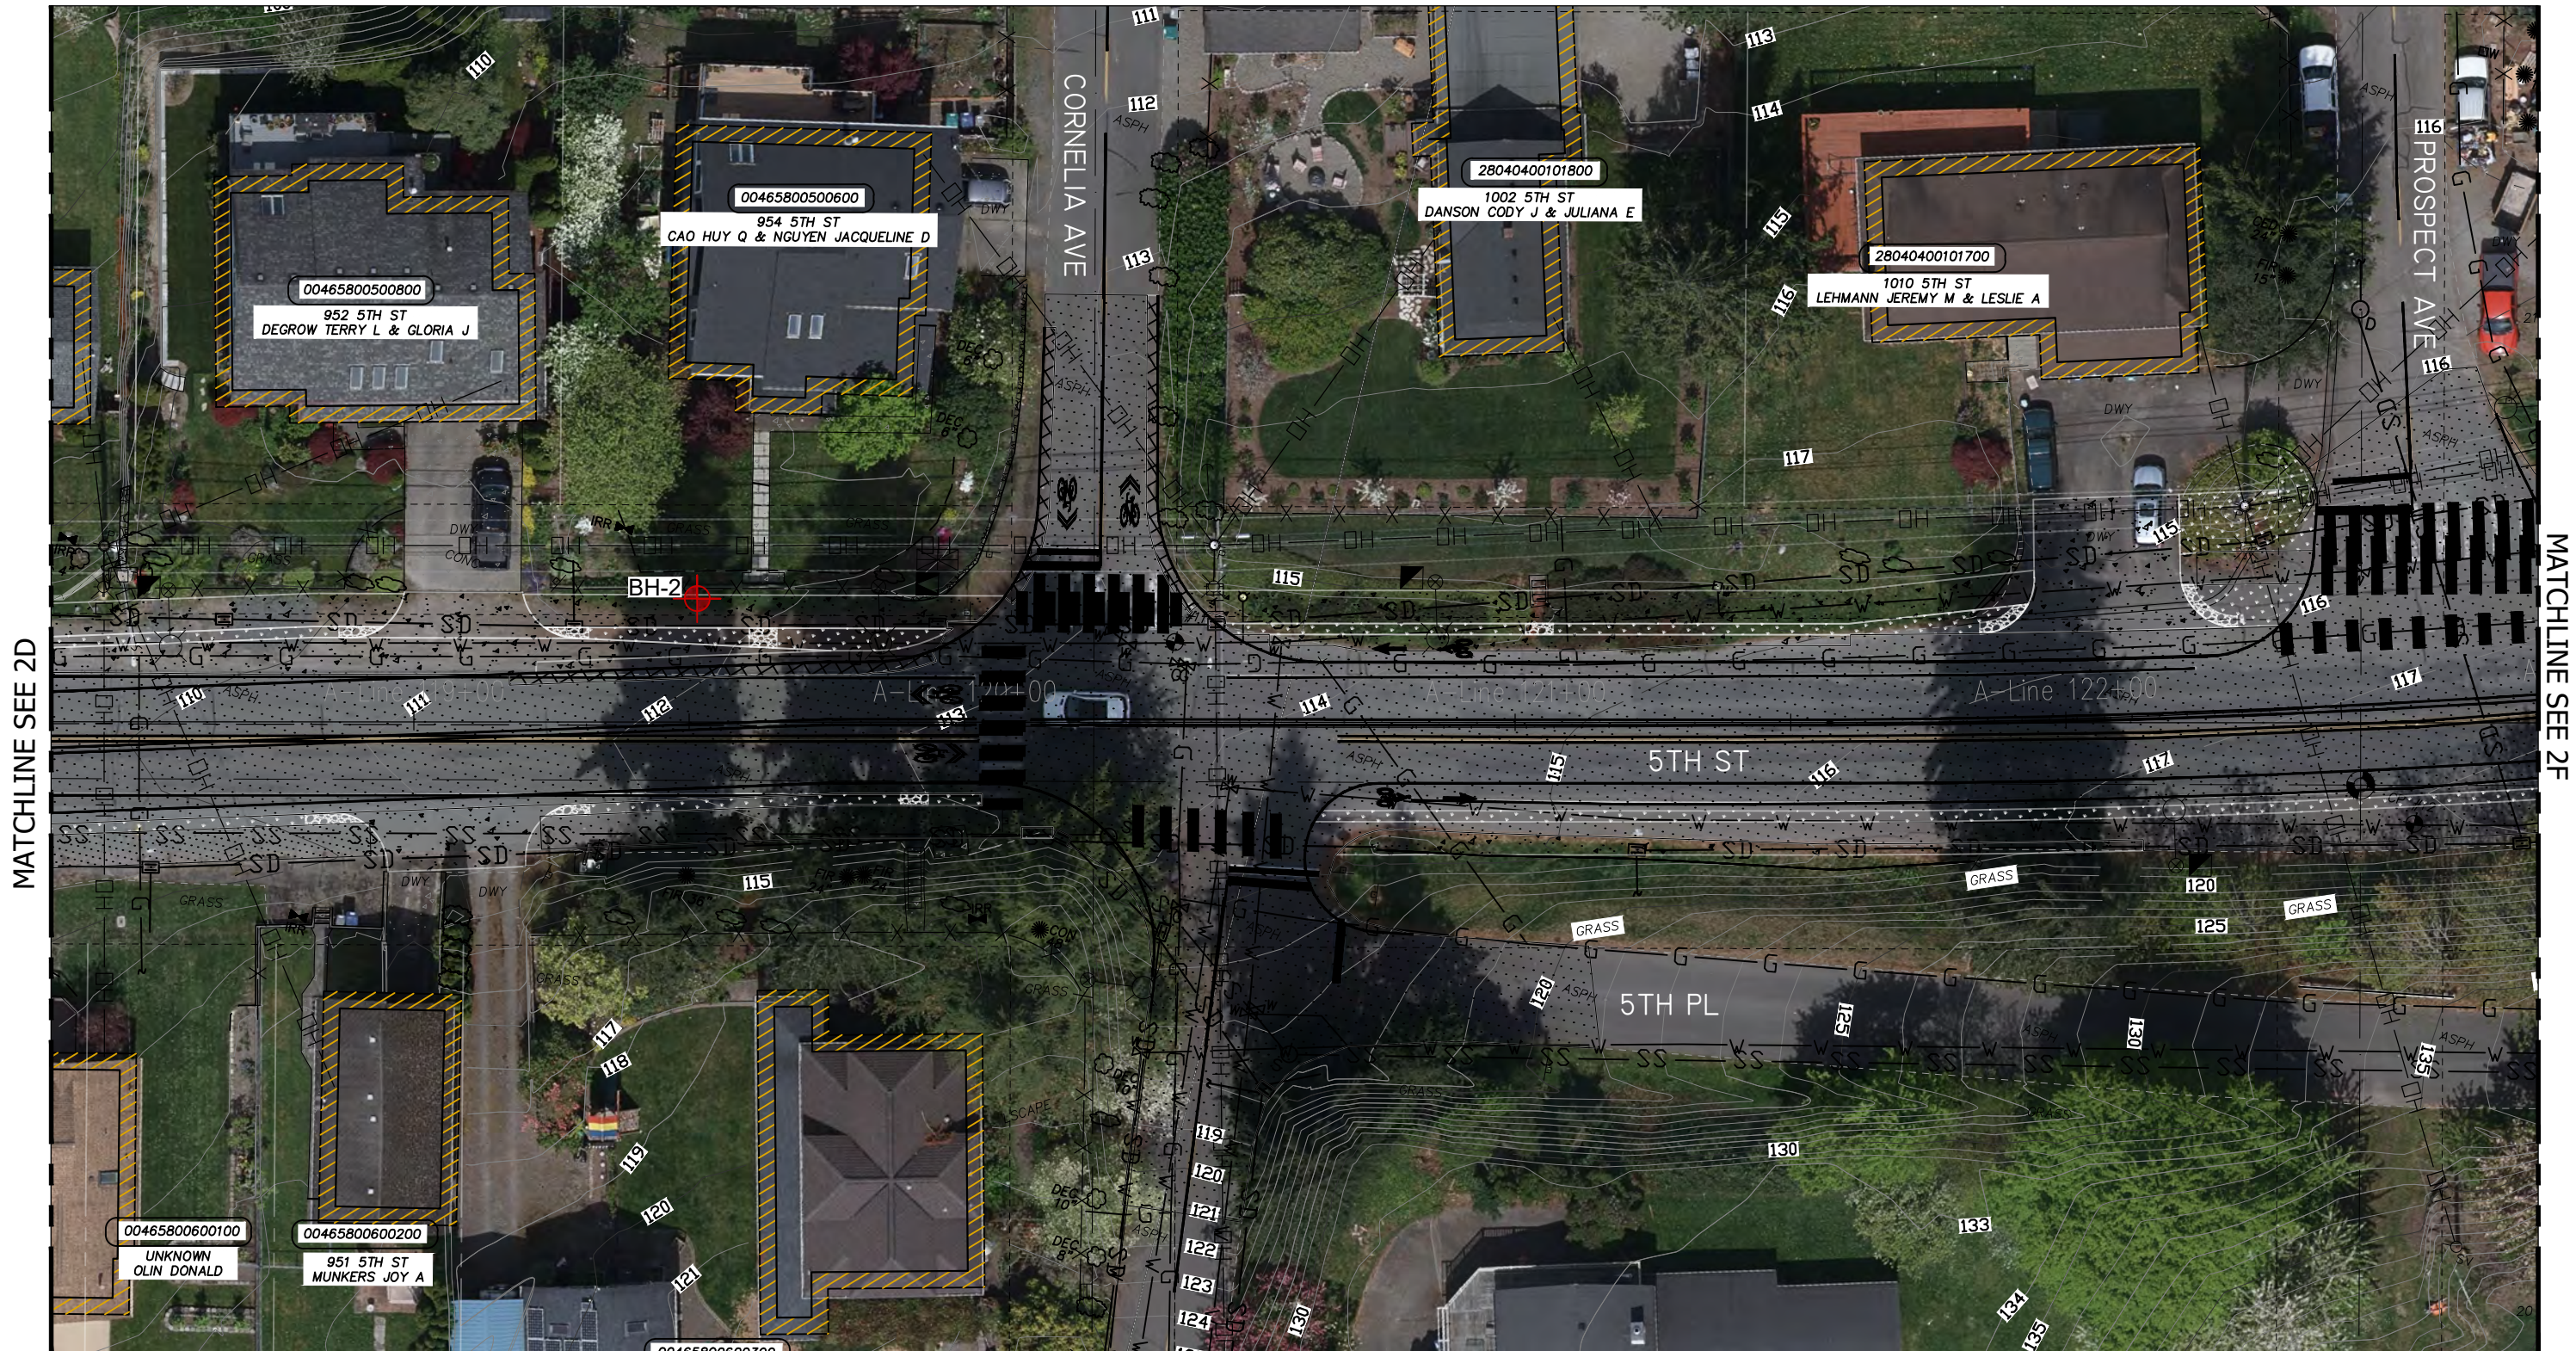
DRAWN BY:	FIGURE NO.:
CF	2E
CHECK BY:	PROJECT NO.:
AS/BKH	2020-144-21

BOREHOLE DESIGNATION AND APPROXIMATE LOCATION

SITE &
EXPLORATION PLAN

DRILLING COMPANY: Geologic Drill Partners
 DRILLING METHOD: HSA with mini-track
 SAMPLING METHOD: SPT w/ Cathead
 LOCATION: See Figure 2E

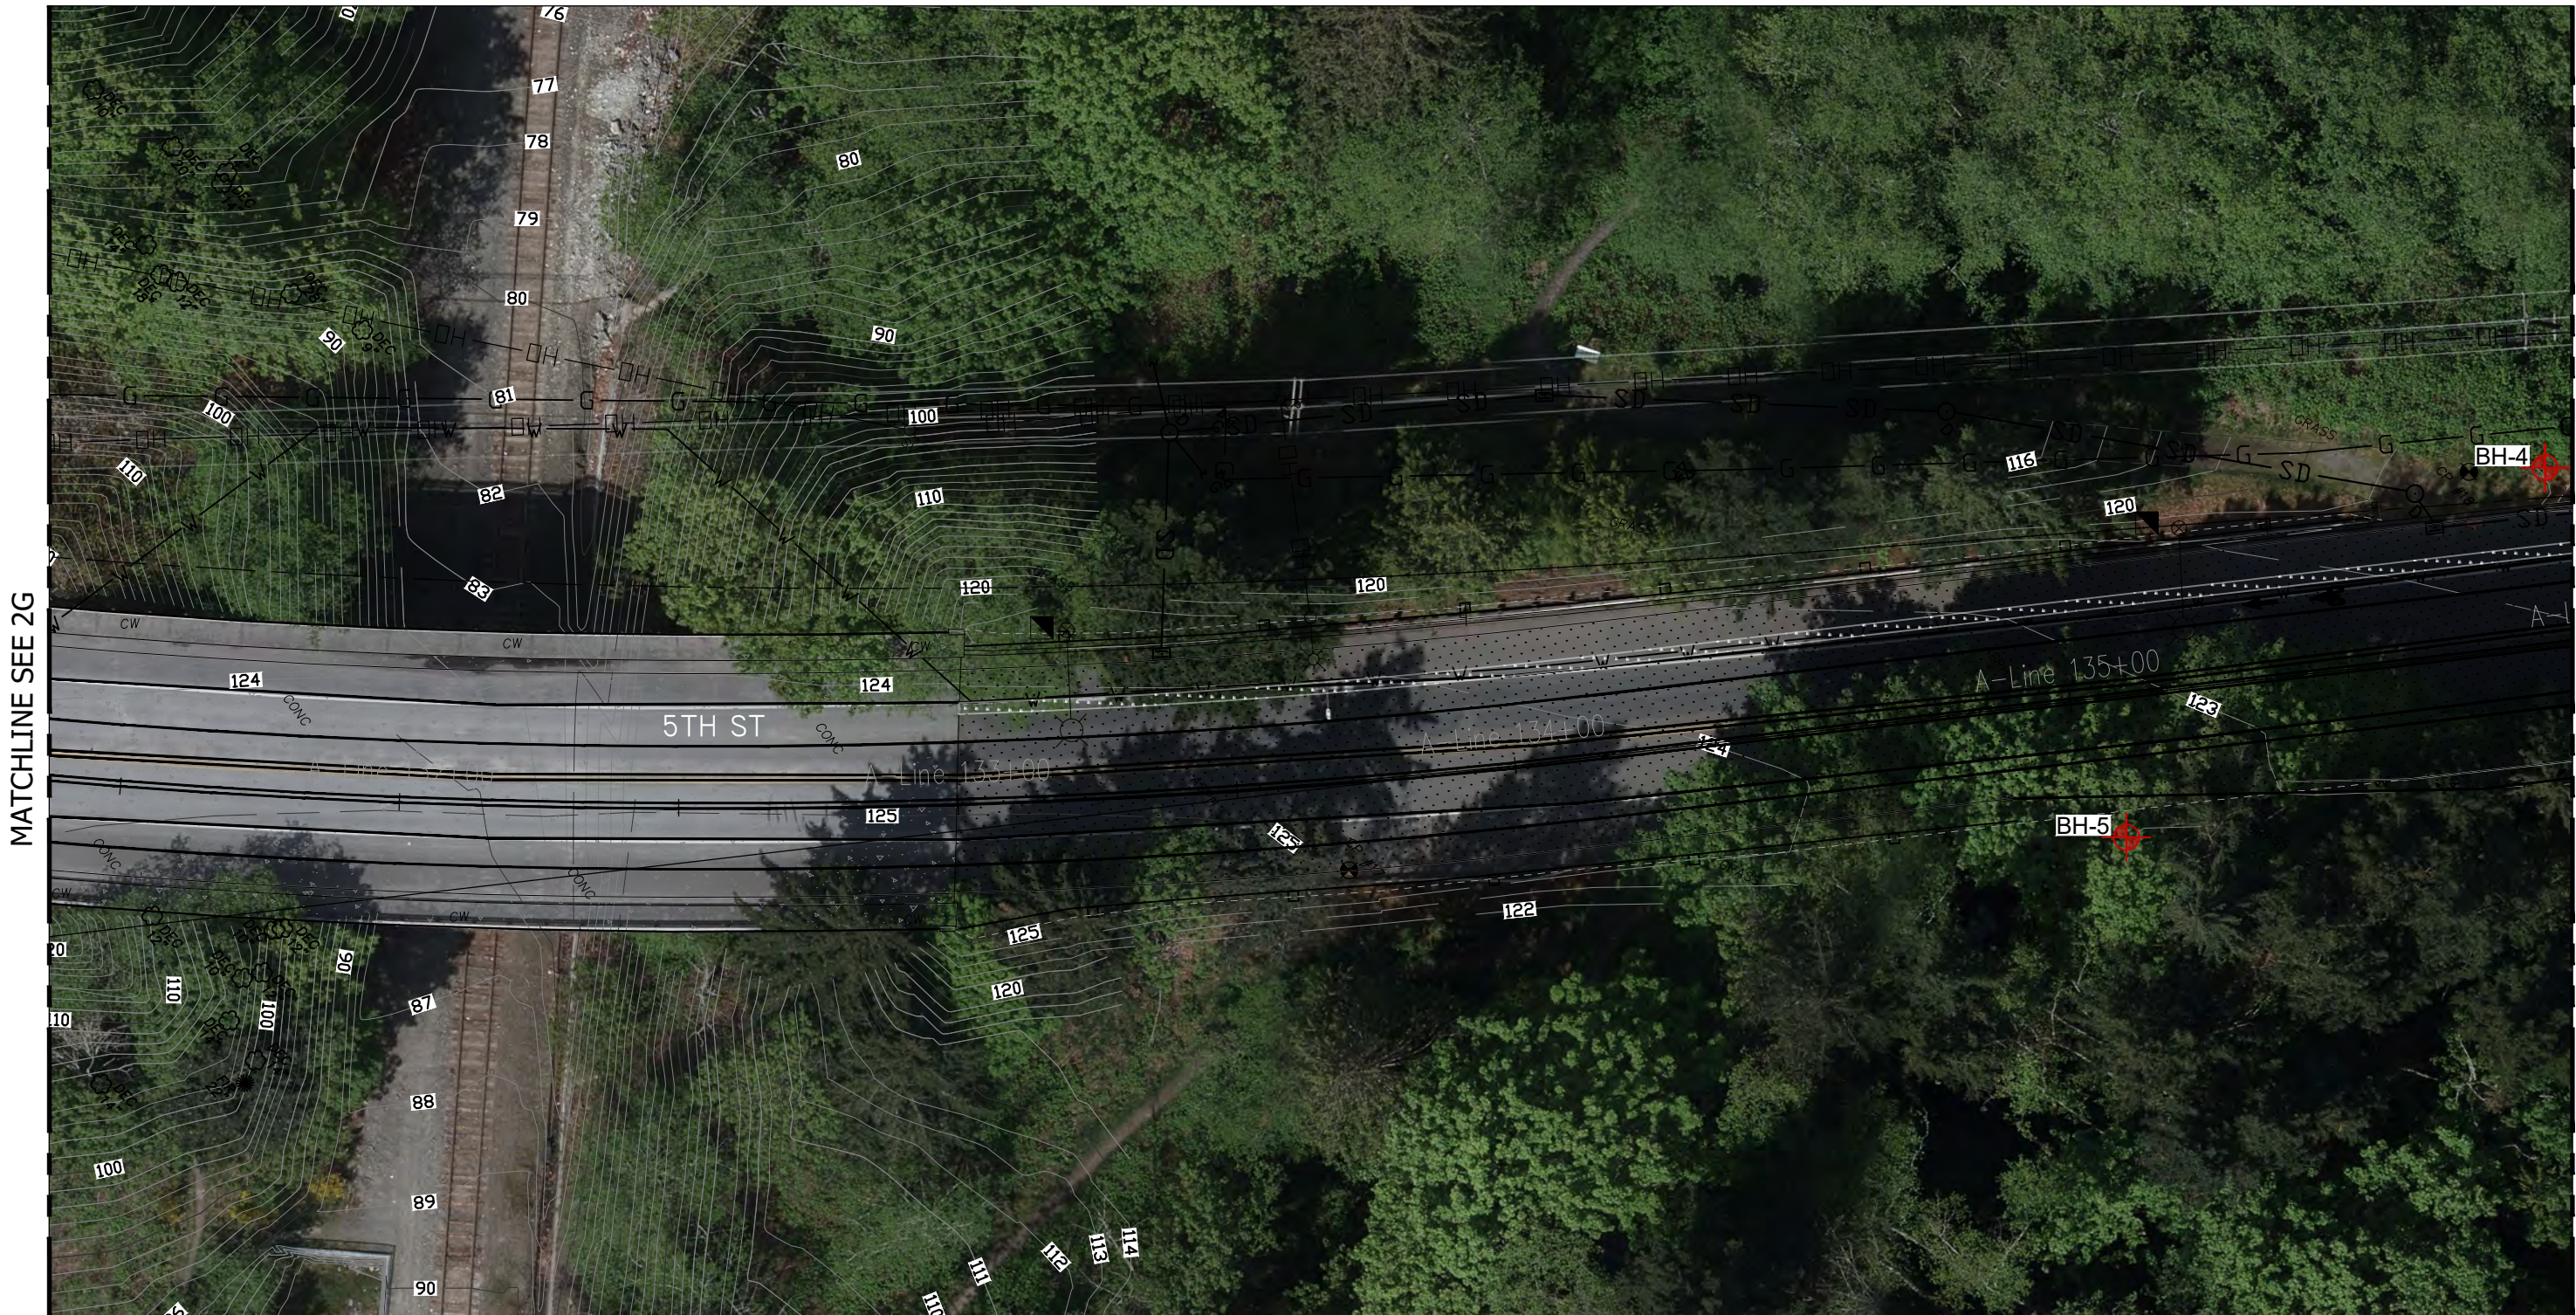
DRAWN BY:	FIGURE NO.:
CF	2H
CHECK BY:	PROJECT NO.:
AS/BKH	2020-144-21

BOREHOLE DESIGNATION AND APPROXIMATE LOCATION

SITE &
EXPLORATION PLAN

DRILLING COMPANY: Geologic Drill Partners
 DRILLING METHOD: HSA with mini-track
 SAMPLING METHOD: SPT w/ Cathead
 LOCATION: See Figure 2H

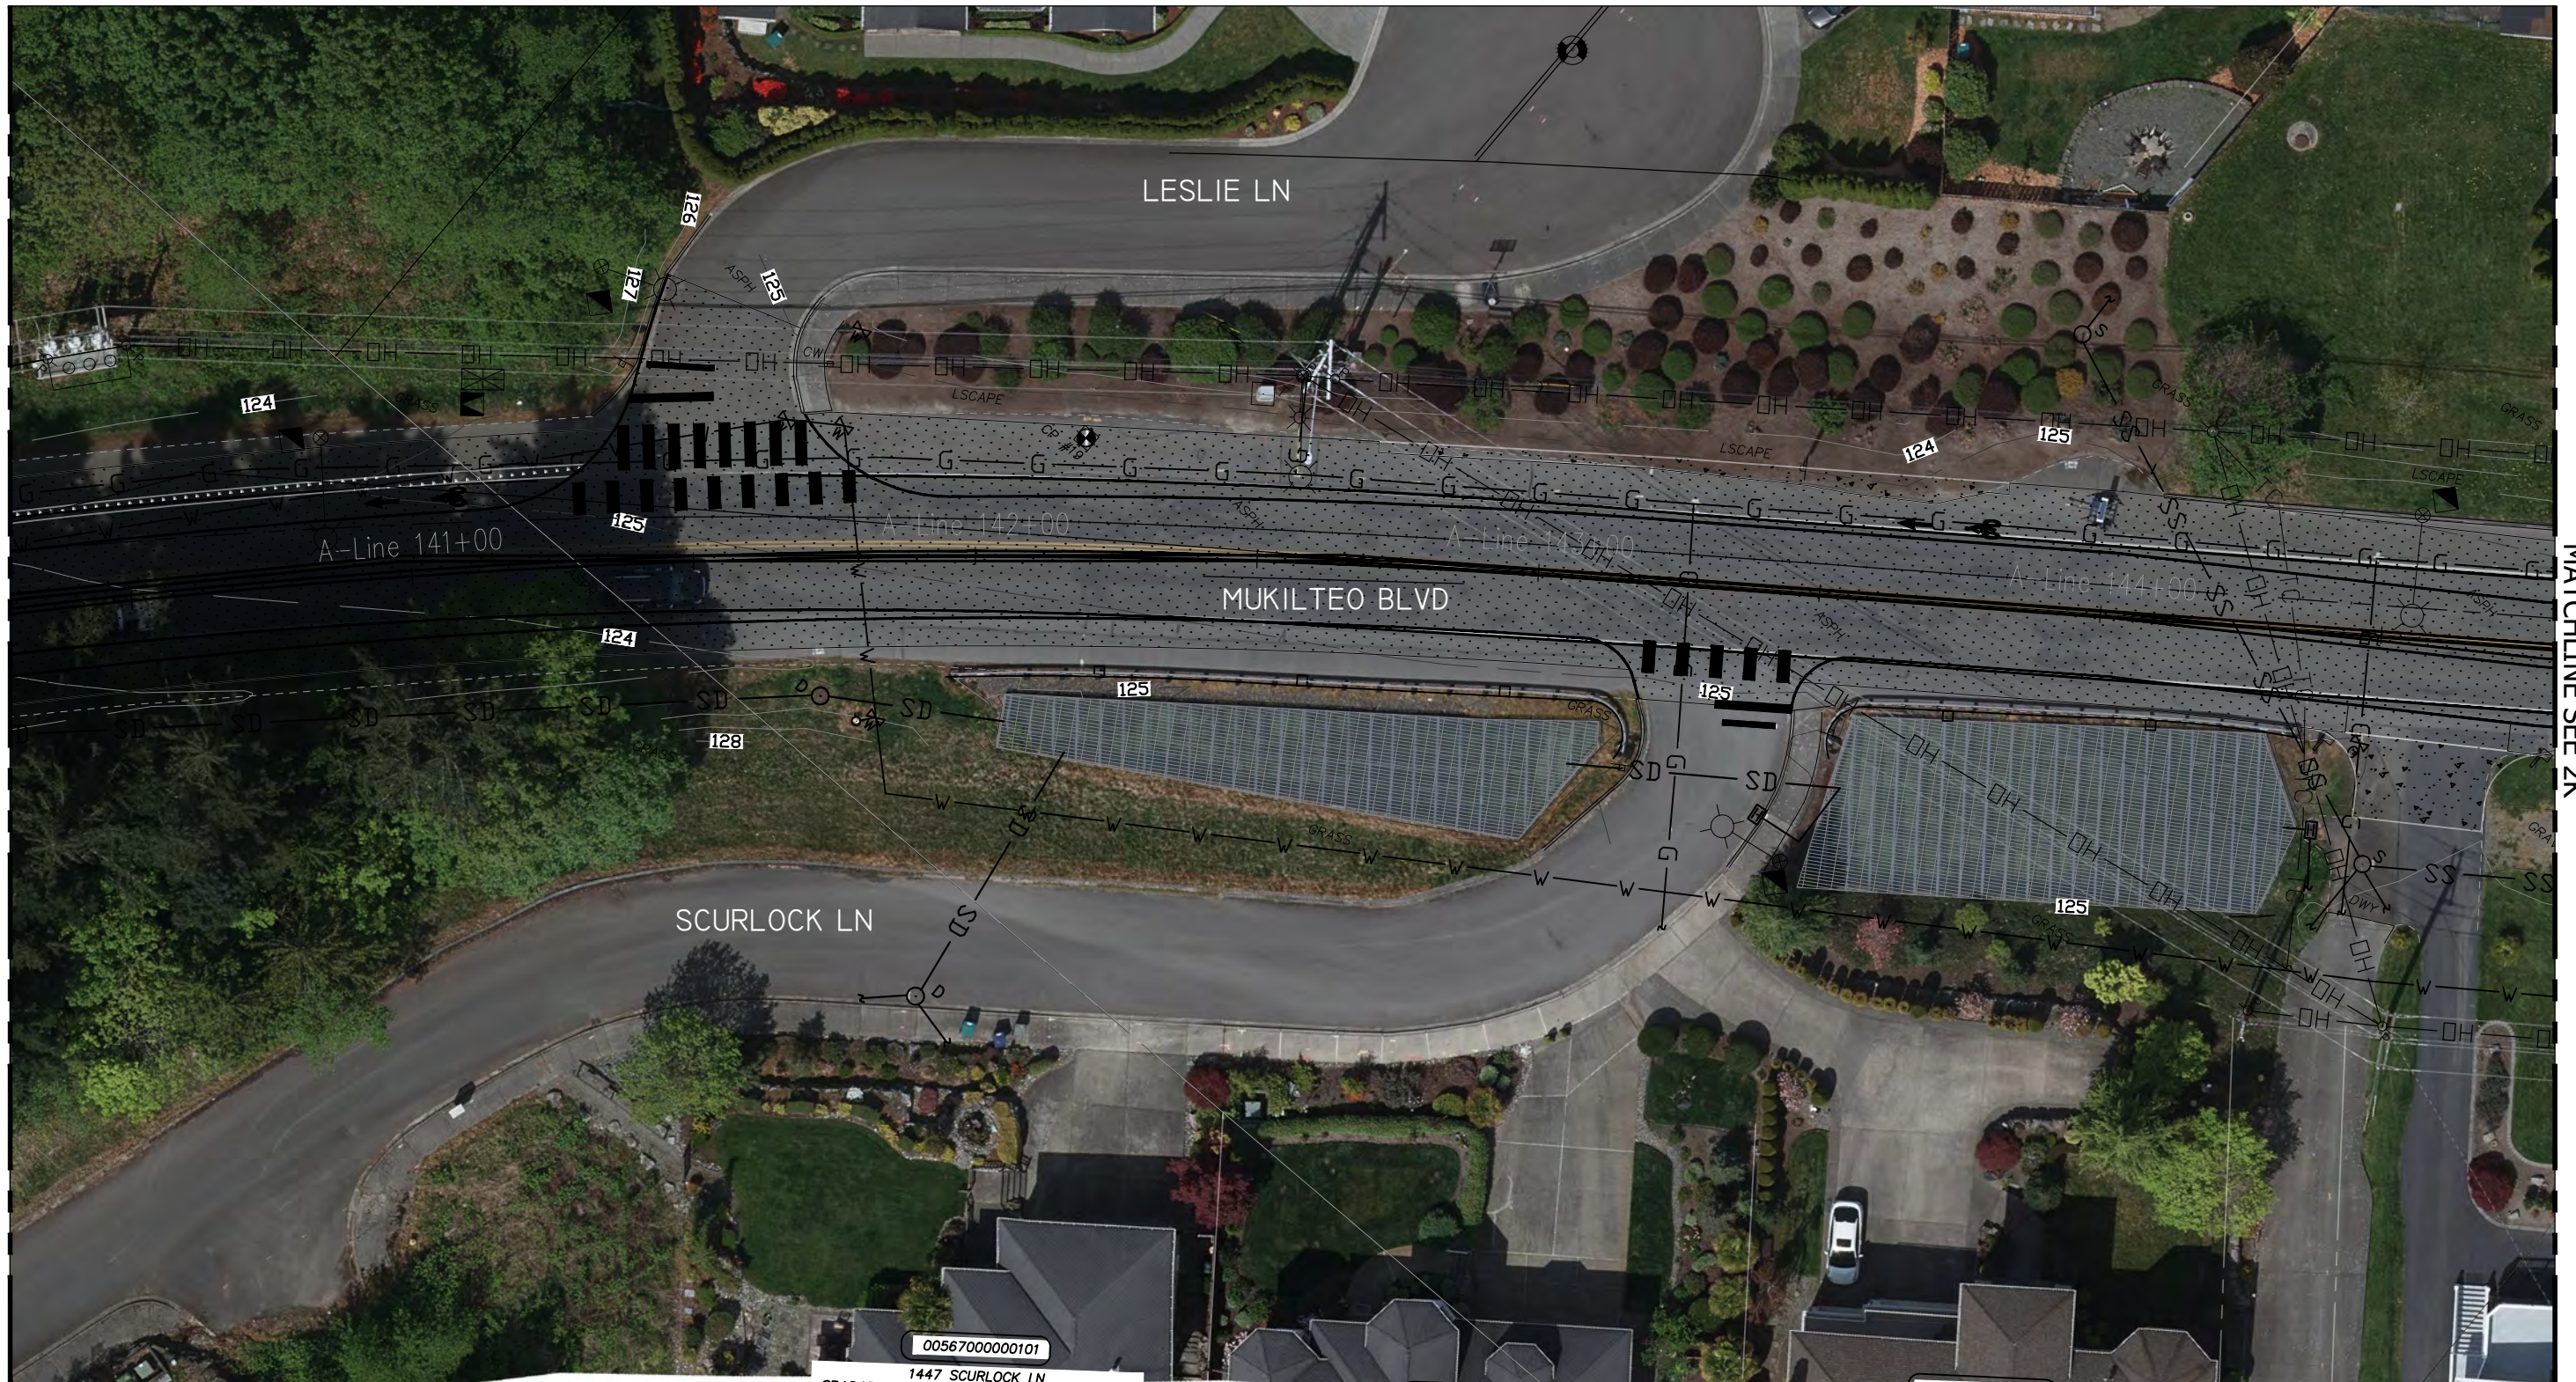
FIGURE NO.:
2J
PROJECT NO.:
2020-144-21

5TH STREET/MUKILTEO BLVD
Scale: 1" = 30'-0"
