GEOTECHNICAL REPORT

Spring of Life Church Addition

4711 116th Street Southwest

PROJECT NO. 21-013
August 2021

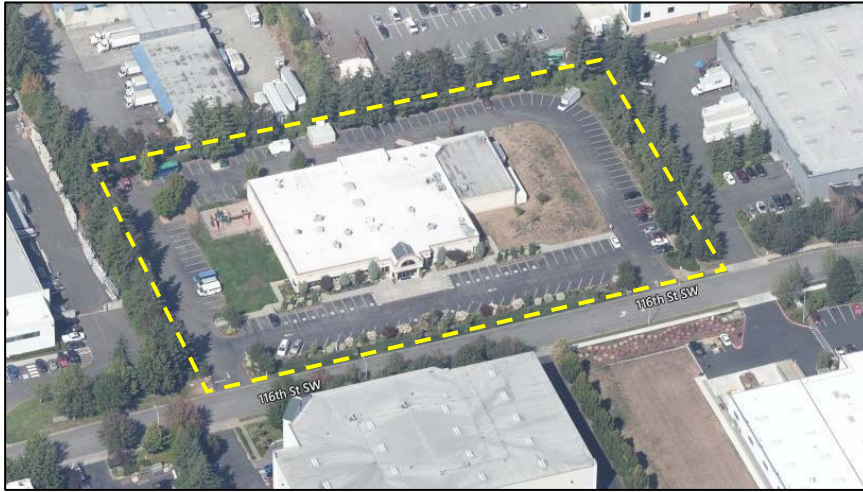
Plate 1: Oblique aerial view of the site.

Looking from south to north.

The site is outlined in yellow.

The church site is a rectangular-shaped parcel that comprises about 3.7 acres. The site is located in an office park and is bordered to the north, west and east by single story office and light manufacturing buildings and to the south by 116th Street Southwest. In the central portion of the site is an existing one-story church building that is surrounded by asphalt paved parking and drive areas. The attached Figure 2 shows the layout of the site and the locations of the existing structures. Plate 1 on the next page provides an aerial view of the site while Plate 2 provides a ground level view.

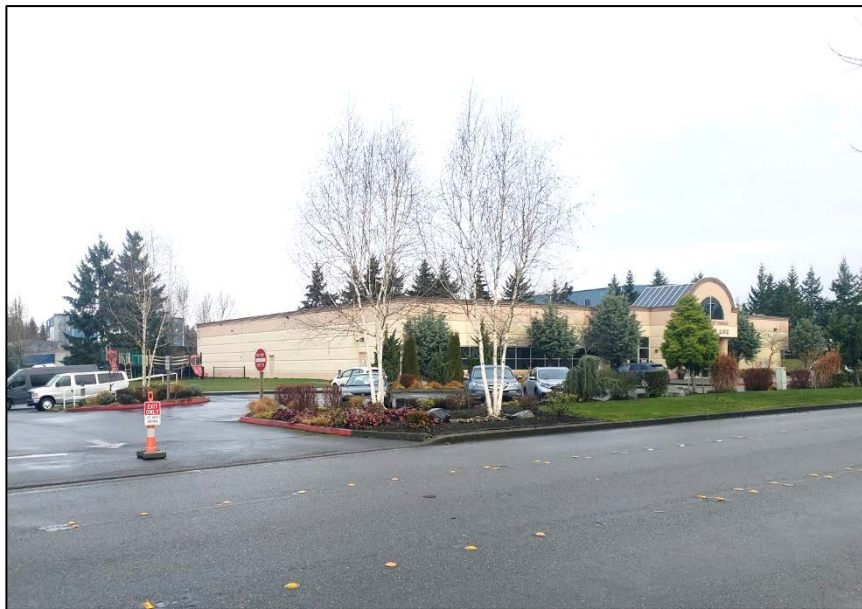
Plate 2: Ground level view of the site, looking from the southwest to the northeast.

The proposed addition will be located to the left of the church in the photo.

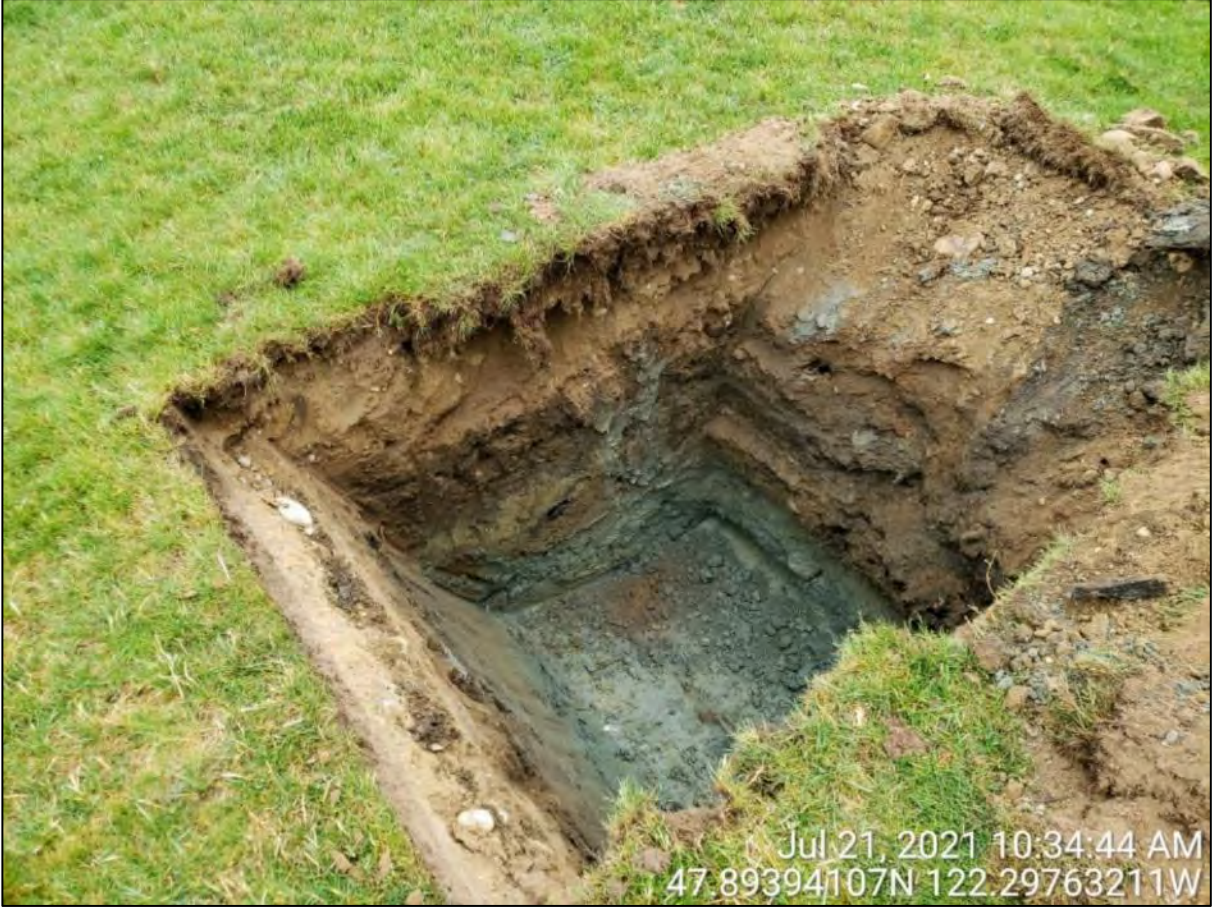
Figure A-2

Test Pit PIT-1		
Location: 329496, 1281208 (WA State Plane North)		
Approximate ground surface elevation: 514 feet (NAVD88 – Google Earth)		
<u>Depth (ft)</u>	<u>USCS</u>	<u>Material Description</u>
0 – 0.5	Topsoil	Topsoil Approximately 6 inches of topsoil and sod
0.5 – 4.0	SM	Fill Loose to medium dense, dark brown to blue-gray, silty fine SAND; trace gravel and cobble, trace angular cobbles, organic odor; non-plastic, moist <i>- Heavy organic layer, burnt wood, roots from 3- to 4-feet</i>
4.0 – 5.0	SM	Vashon Till - Qvt Dense to very dense, gray-brown to gray, silty fine to medium SAND; trace gravel and cobble; non-plastic, moist

Photo PIT-1: Image of Test Pit PIT-1; Approximately 5 feet below grade during prior to infiltration testing Test Pit PIT-1 was excavated to 5 feet for infiltration testing Groundwater was not encountered during exploration.

We attempted one infiltration test at the location of Test Pit PIT-1 on the west side of the site. The test was set up in general accordance with the small PIT test method described in the 2014 Washington Department of Ecology Stormwater Management Manual for Western Washington (WDOE Manual) WDOE, 2014) King County Surface Water Design Manual which has been adopted by the City of Mukilteo.

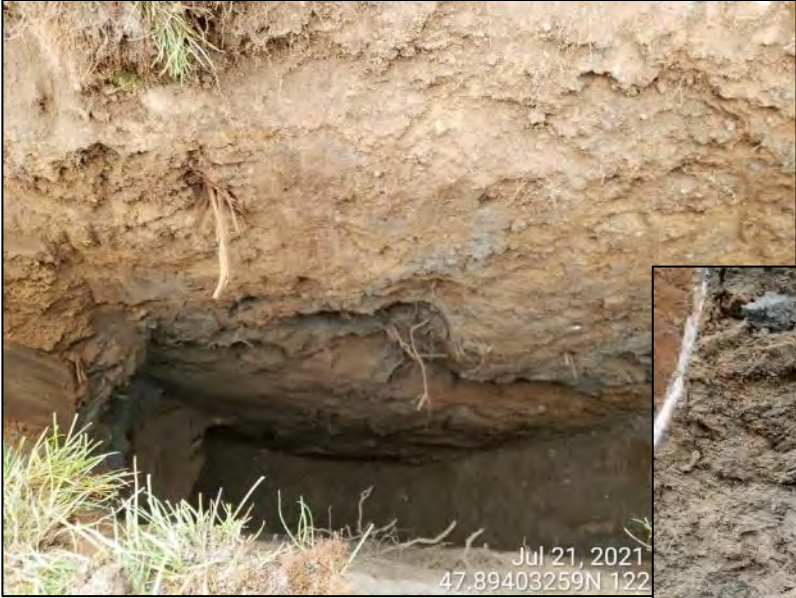
Test Pit TP-1 Location: 329550, 1281190 (WA State Plane North) Approximate ground surface elevation: 514 feet (NAVD88 – Google Earth)		
<u>Depth (ft)</u>	<u>USCS</u>	<u>Material Description</u>
0 – 0.5	Topsoil	Topsoil Approximately 6 inches of topsoil and sod above:
0.5 – 3.0	SM	Fill Loose to medium dense, light brown, silty fine to medium SAND; trace gravel and cobble, some iron-oxide staining, trace roots and rootlets; reworked texture; non-plastic, moist
3 – 10	SM	Vashon Till - Qvt Dense to very dense, gray-brown to gray, silty fine to medium SAND; trace gravel and cobble; trace iron-oxide staining; non-plastic, moist to wet <i>- Top 1-foot weathered with some iron-oxide staining</i>

(Left) Image of Test Pit TP-1;
Approximately 10 feet
in depth

Test Pit TP-1 was excavated to approximately 10 feet below ground surface.
Groundwater seepage was encountered during exploration at approximately 8 feet below grade.

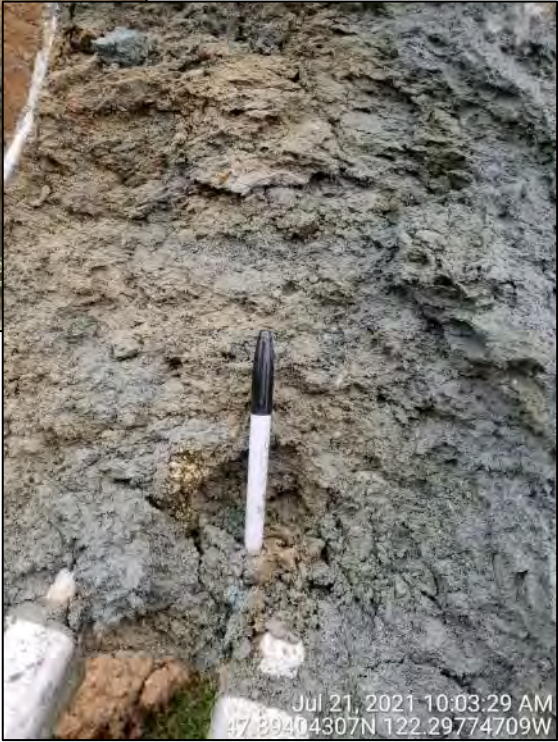
(Right) Soils from Test Pit TP-1
from approximately 10 feet
below grade

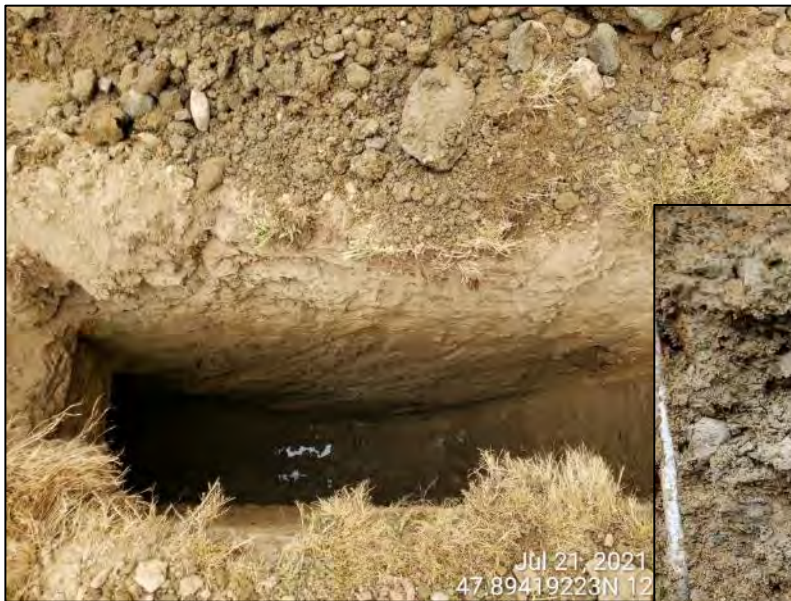
<u>Depth (ft)</u>	<u>USCS</u>	<u>Material Description</u>
0 – 0.5	Topsoil	Topsoil Approximately 6 inches of topsoil and sod
0.5 – 2.0	SM	Fill Medium dense, gray-brown to light brown, silty fine to medium SAND; trace gravel and cobble, some iron-oxide staining, till-like; non-plastic, dry
2.0 – 8.0	SM	Vashon Till - Qvt Dense to very dense, gray-brown to gray, silty fine to medium SAND; trace gravel and cobble; iron-oxide staining; non-plastic, moist to wet - <i>Top 1-foot weathered with some iron-oxide staining</i>

(Left) Image of Test Pit TP-2;
at approximately 8 feet
in depth

Test Pit TP-3 was excavated to approximately 8 feet below ground surface.

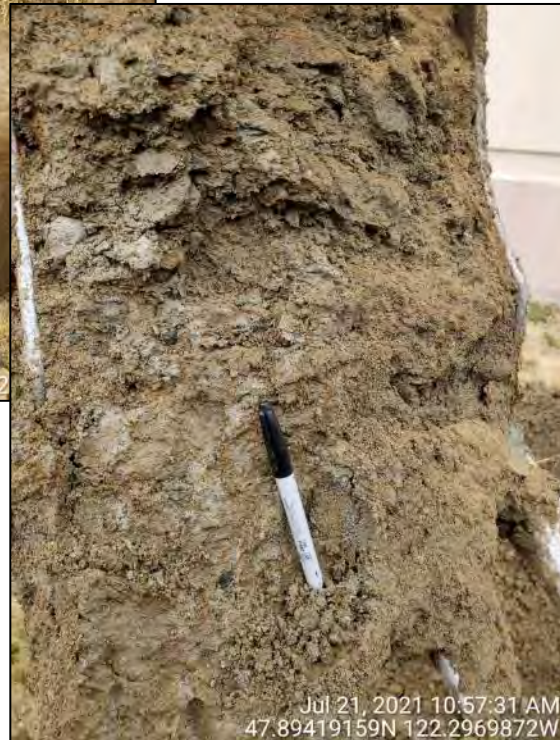
(Right) Soils from Test Pit TP-2
from approximately 8 feet
below grade
