RE: Review of Wetland Findings for Rodriguez Property

Thank you for asking the Washington Department of Ecology (Ecology) to review wetland presence/absence by arranging a site visit to the Johnny Rodriguez property in Mukilteo. This property (Parcel No. 00611600009300) covers 4.5 acres and is located at 4203 78th Street SW. The southern half of this property has been partially cleared and graded without a permit, while the northern half is forested. This Ecology review focused on the northwest corner of the parcel bordering the First Slavic Church Awakening property.

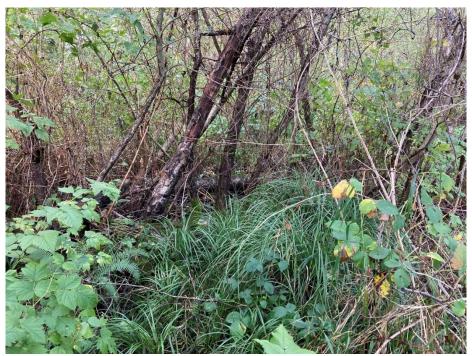
- At soil pit #1 the dominant vegetation was red alder (*Alnus rubra*), Pacific willow (*Salix lucida*), salmonberry (*Rubus spectabilis*), Himalayan blackberry (*Rubus armeniacus*), slough sedge (*Carex obnupta*), and reed canarygrass (*Phalaris arundinacea*). The soil layer from 0-5" was a dark brown (10YR 2/2) silt loam, from 5-10" it was a (10YR 2/1) silt loam with 2% redoximorphic features, and from 10-18" there was a silt loam (10YR 4/2) with 5% redoximorphic features. This soil profile met the Redox Dark Surface (F6) hydric soil indicator. Signs of hydrology consisted of saturated soil at 8" in the soil pit.

Photo 1—Vegetation at soil pit #1 on Rodriguez property.

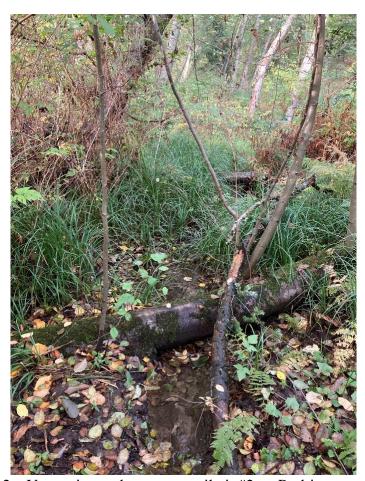
I observed a drainage feature paralleling the northwest edge of the property and noted signs of flowing water, saturated soils, and hydrophytic vegetation within this swale (see attached photos). There is a small stream that was 2' wide and 3" deep flowing north in a shallow swale. This stream originates from groundwater seeps that appear to flow from a storm water level spreader on the adjacent parcel.

- The dominant vegetation in soil pit #2 was red alder, salmonberry, Himalayan blackberry, slough sedge, reed canarygrass, and lady fern (*Athyrium filix-femina*). The soil layer from 0-6" was a very dark brown (7.5YR 2.5/1) mucky silt, and from 6-18" it was a (7.5YR 2.5/1) sandy silt with 5% redoximorphic features. This soil profile met the Redox Dark Surface (F6) hydric soil indicator. Signs of hydrology consisted of flowing water nearby in the stream and saturated soil at 6" in the soil pit.

Photo 2—Vegetation and stream at soil pit #2 on Rodriguez property.

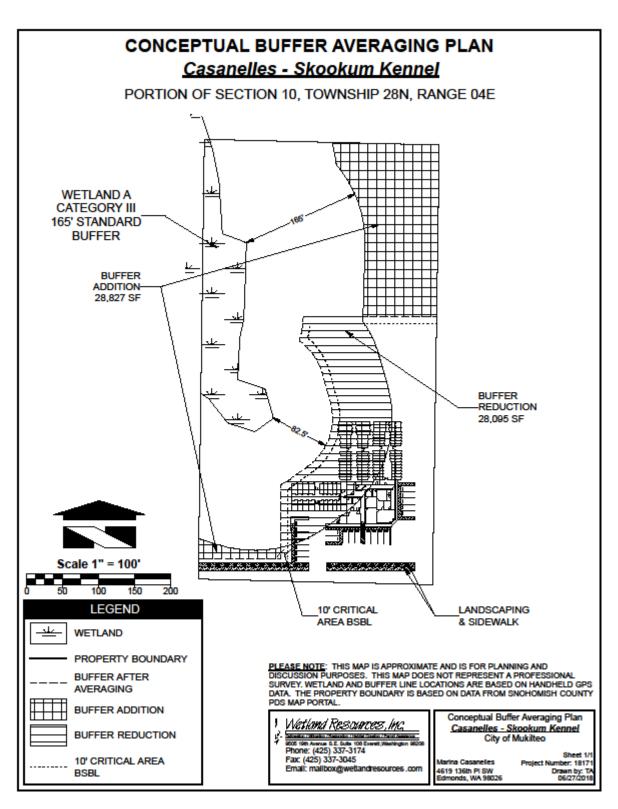
The critical areas study by Wetland Resources shows a wetland (0.81 acres) in the northwest corner of the Rodriguez property. This depressional wetland is described as being forested and seasonally flooded. They rated this as a Category III wetland with a habitat score of 6, which receives a 165' buffer according to the City of Mukilteo.

Excerpt from Conceptual Buffer Averaging Plan for Casanelles-Skookum Kennel showing wetland area on Rodriguez property

Based on the literature review and site visit, Ecology believes there is a wetland in the northwest corner of the Rodriguez property. The wetland boundary shown on the attached drawing is an approximate depiction of wetlands on the Rodriguez property. Therefore, I disagree with the B&A conclusion there are no wetlands on the property.
