CRITICAL AREAS STUDY & BUFFER MITIGATION PLAN FOR

Estfin, LLC – 124XX Cyrus Way

Tax Parcel Nos. 00441300003900 & 00441300004000

Acre Project #21063
City of Mukilteo File No.

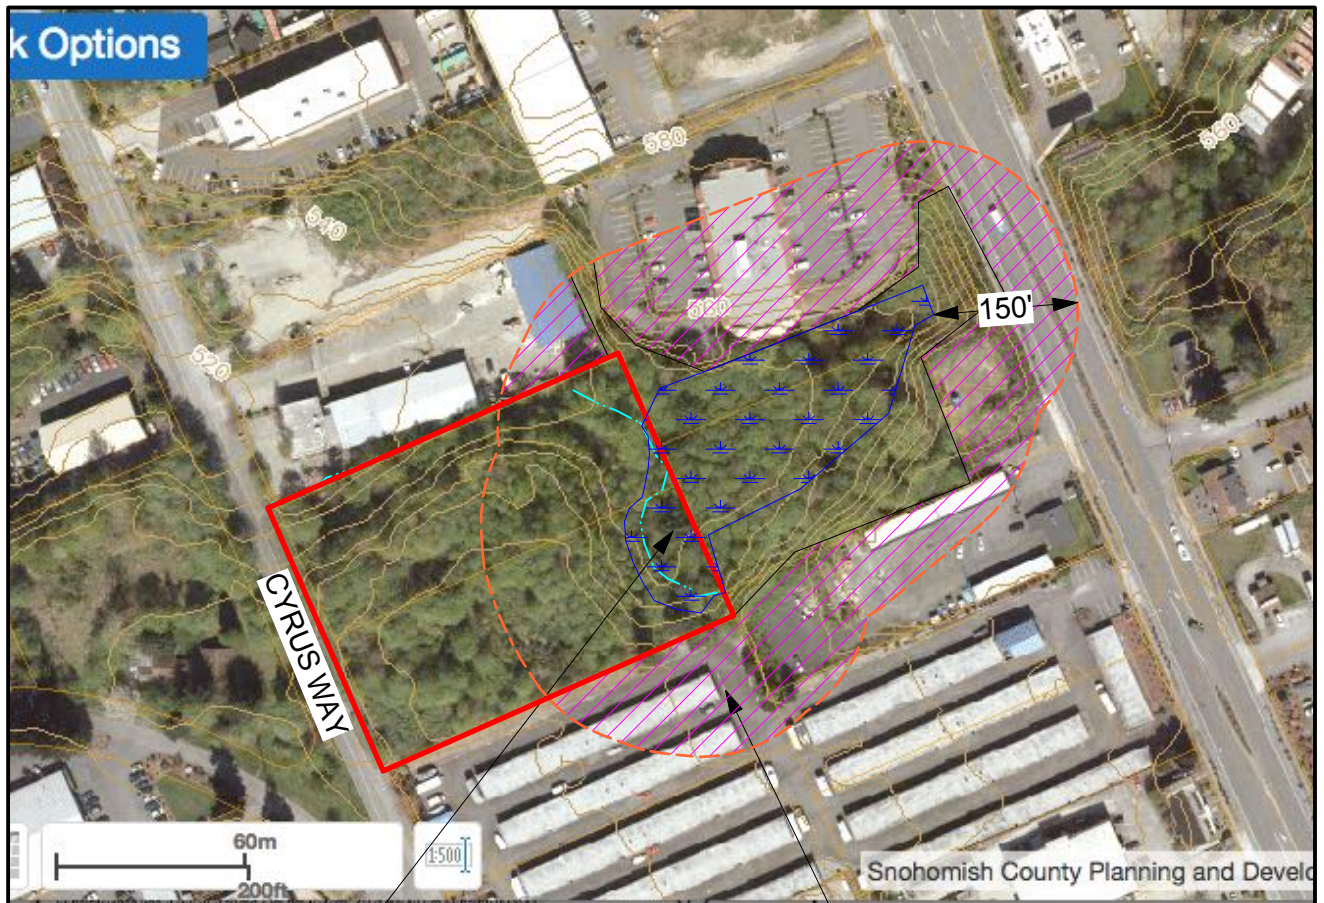
Wetland A Rating Unit

Pollution generating areas (typ.)

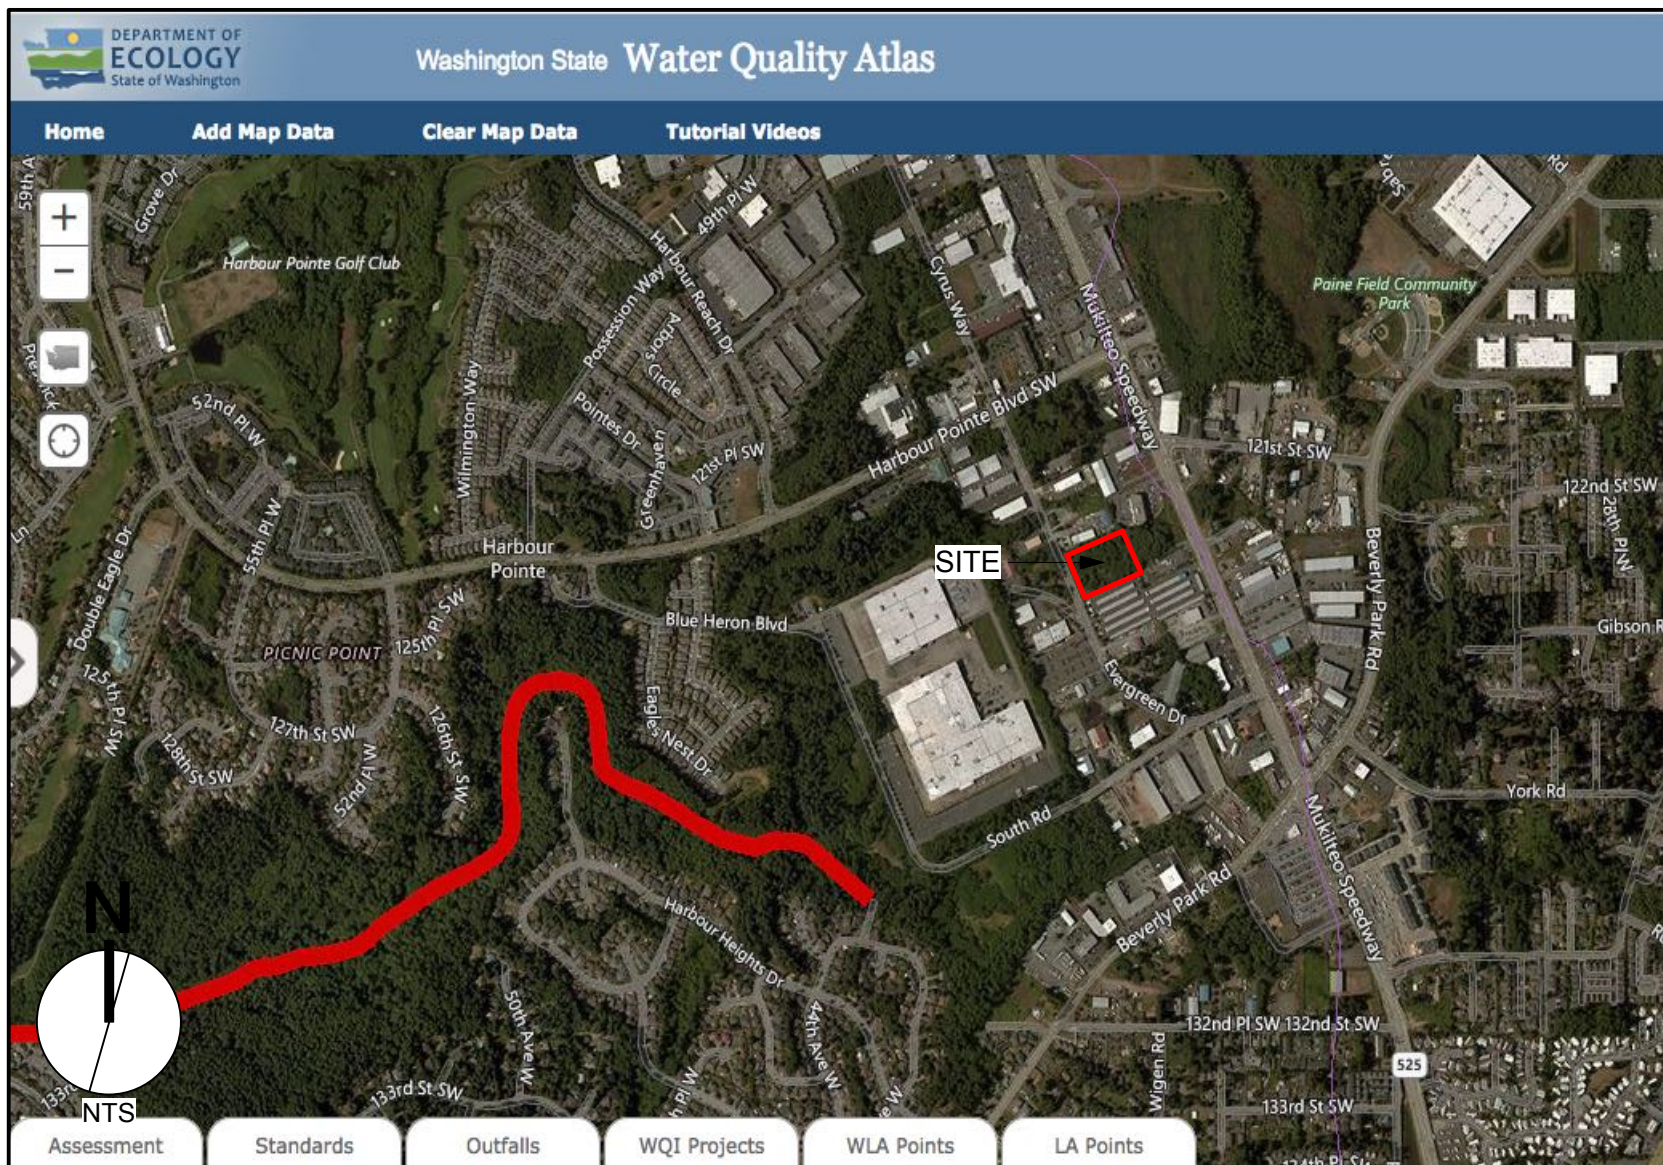
Acre Job: 19003
Drawn By:
L. Emmerhiser
Figure 3 of 4
Date: 02.23.2018
Rev #:

S3.1 The subject wetland drains directly (within 1 mile) of Picnic Point Creek listed on the 303(d) list.

S3.2 The subject wetland is located in a basin or sub-basin with an aquatic resource listed on the 303(d) list.
