CRITICAL AREAS ASSESSMENT AND CONCEPTUAL MITIGATION PLAN

CARRICK COURT
MUKILTEO, WASHINGTON

September 9, 2020
Revised December 23, 2021

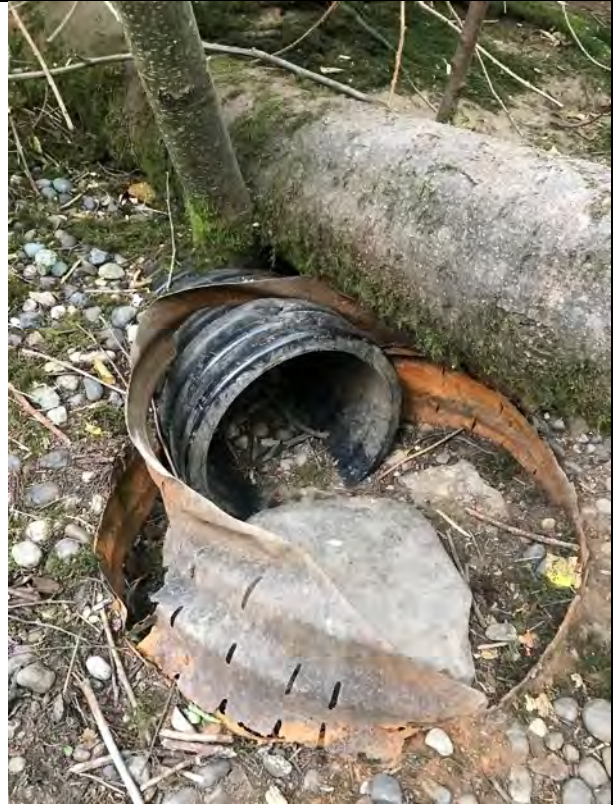
Photo 2: Existing stormwater pond outlet culvert. Photo taken October 2020.

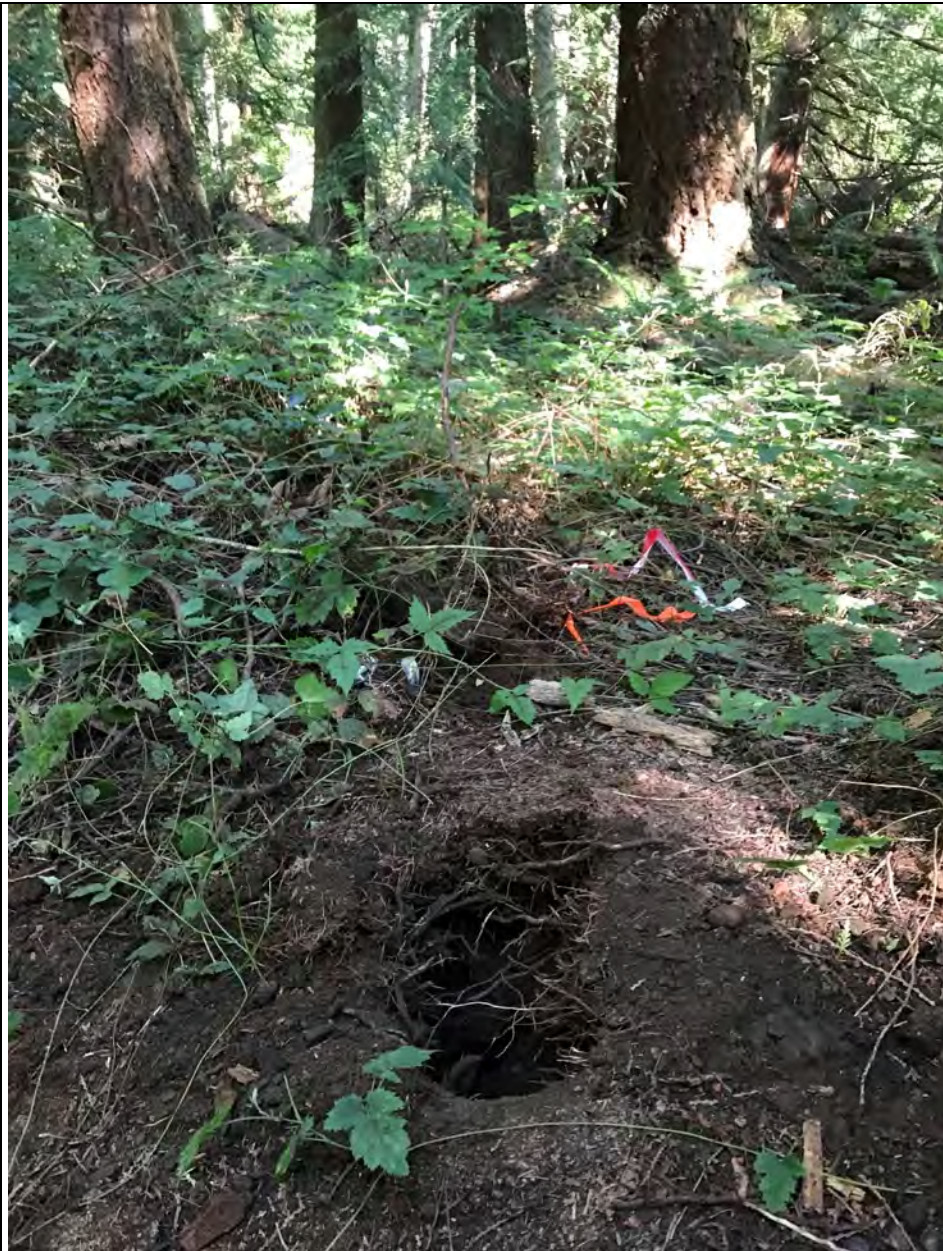
Photo 7: Upland forest conditions with Douglas fir, western red cedar, and trailing blackberry dominant at SP-4 in Parcel A. Photo taken August 4, 2020.

The project is located within the Puget Sound western hemlock (*Tsuga heterophylla*) major vegetation area (Franklin and Dyrness 1973). The south half of the project site is forested and dominated by western red cedar (*Thuja plicata*), Douglas fir (*Pseudotsuga menziesii*), red alder (*Alnus rubra*), and big-leaf maple (*Acer macrophyllum*) (**Photo 7**). Drainage 1 and a delineated wetland were also found in the south half of the site. The herbaceous plants are dominated by reed canarygrass (*Phalaris arundinacea*), creeping buttercup (*Ranunculus repens*), and western lady fern (*Athyrium cyclosorum*). Salmonberry (*Rubus spectabilis*) and Himalayan blackberry (*Rubus armeniacus*) are the dominant shrub species. Refer to **Appendix B** for data forms.

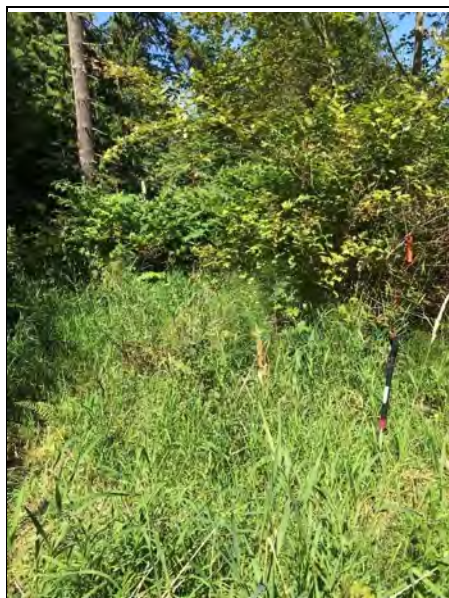
Photo 8: Wetland A emergent vegetation. August 7, 2020.

Drainage 1. This area consisted of reed canarygrass and creeping buttercup with Himalayan blackberry and salmonberry in the PSS class (**Photo 8**). As the slope of the wetland decreases westward, there was greater prevalence of PFO and PSS classes. The dominant species were Pacific willow (*Salix lucida*), western red cedar in the PFO class and hardhack (*Spiraea douglasii*), Pacific willow, and salmonberry in the PSS class. The wetland was assessed using soil pits SP-1, SP-2, SP-3, and SP-4. The wetland edge in the PEM area was delineated between the canarygrass limits and sword fern (*Polystichum munitum*) and bracken fern (*Pteridium aquilinum*). More pronounced topographic breaks and vegetation breaks along sword fern edges were used to flag the PFO and PSS classes.

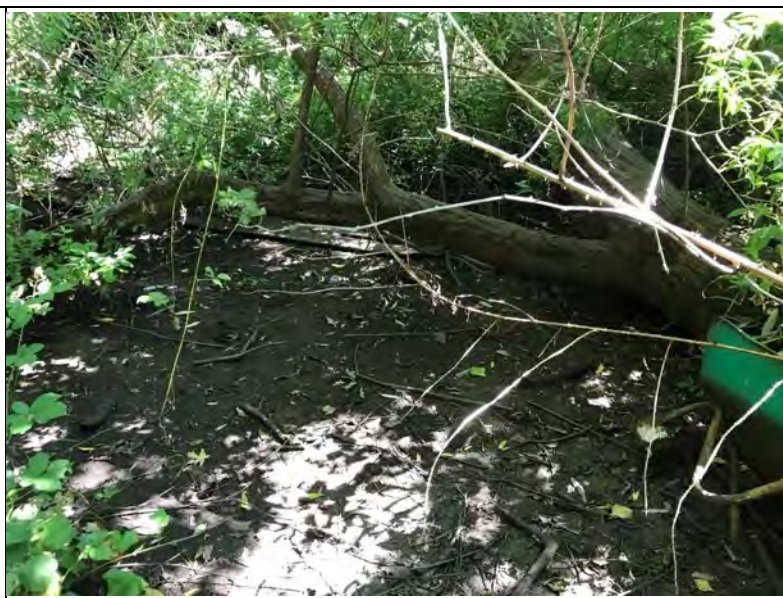
Photo 9: SP-3 location in a seasonal ponded (dry) area within Wetland A. August 7, 2020.

This wetland receives direct precipitation runoff, groundwater seepage and occasional overflow from Drainage 1. The outlet is slightly constrained by a shallow berm on the west end of the site adjacent to 88th Street SW. This berm is likely be the result of ditch clearing activities over time along 88th Street SW. There, water flows to a roadside drainage ditch and flows west. Water from the un-maintained detention pond in Parcel B also enters the western portion of the wetland. Water flow and soil saturation was present in a February 2020 site visit but absent in the subsequent August field visit (**Photo 9**).

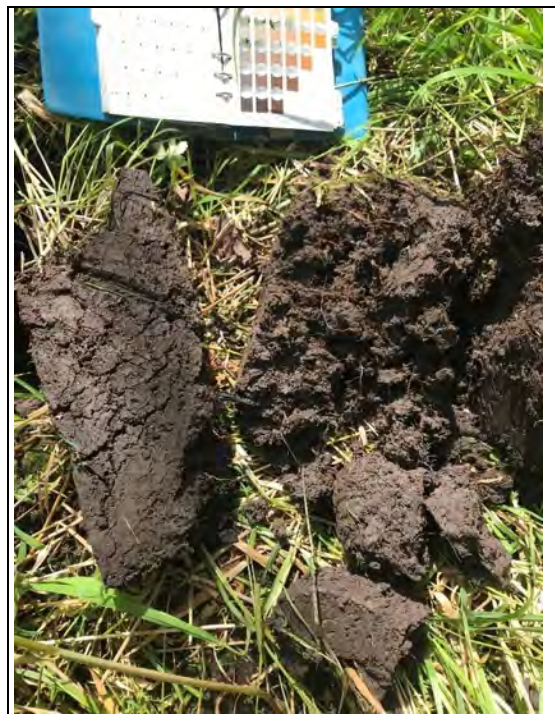
Photo 10: SP-1 soil profile in Wetland A.
Photo taken August 7, 2020.

The soil texture is sandy loam (10YR 3/1) to a depth of 5 inches and matches the description of the mapped Alderwood-Urban soil map unit (NRCS 2020b). The texture changes to sandy clay loam (10YR 3/1 with 20% redox concentrations present) to at least 16 inches. The soil exhibited wetland soil indicator redox dark surface (F6) with low chroma matrix and distinct concentrations (**Photo 10**).

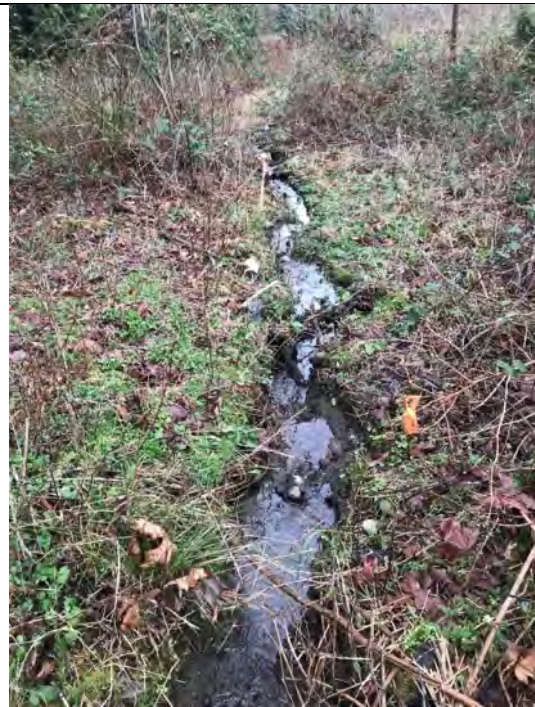
Photo 11: Drainage 1 flowing through upper reaches of Parcel A. Photo taken February, 2020.

This drainage has a defined bed and bank with visible signs of bedload transport. The bed width varies, but in general is less than 2 feet in the upper reaches. Slopes then range between 3 to 8 percent. The channel width expands as the site flattens out with slopes approaching 2 percent (Photo 12). The drainage flows into a roadside ditch along 88th Street SW and flows west eventually joining the Naketa Beach drainage ravine.

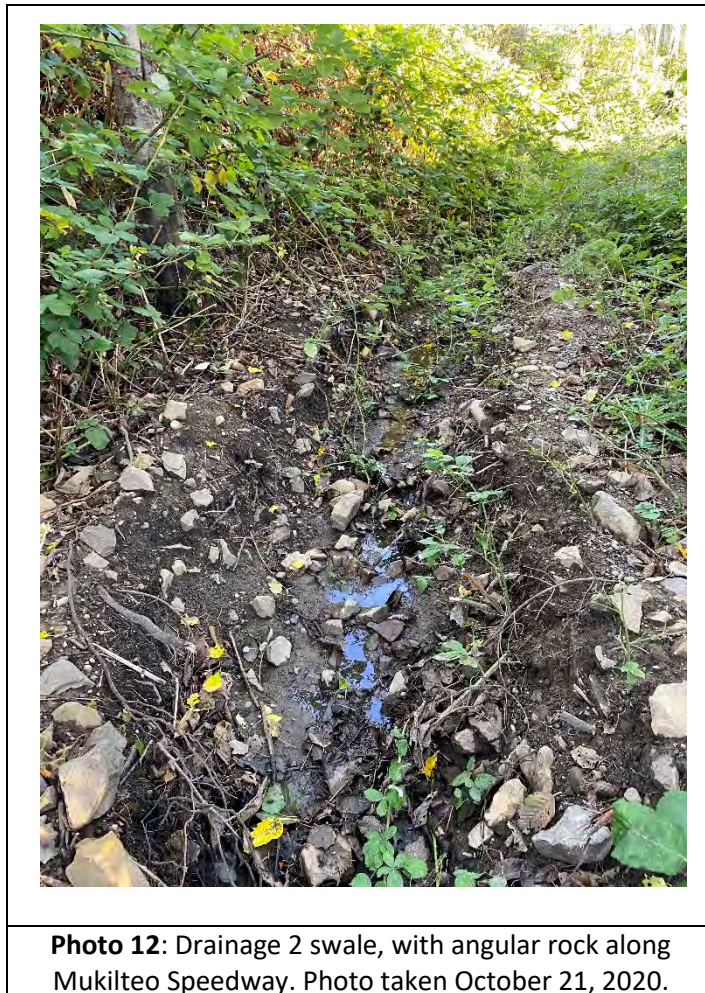
Drainage 2 transitions from a swale (**Photo 12**) along the Mukilteo Speedway right-of-way to forest floor where water sheet flows across the property (**Photo 6**). The water vector map (**Appendix A/Figure 6**) shows this flow path exiting Parcel C in the southwest corner. The adjacent development to the west, Courtyard Townhomes, has installed a 12-inch inlet at the southeast corner of their property to capture these intermittent sheet flows and convey them to the Cat. IV offsite wetland (RAM 2020).

This drainage does not meet the WAC 222-16-031 definition of a stream as there is no defined bed or bank through the site. This determination is also supported by the approved Wetland Resources, Inc Critical Area Study (WR 2016) which did not identify wetlands or streams in areas immediately adjacent (referring to Parcel C) to the subject property.

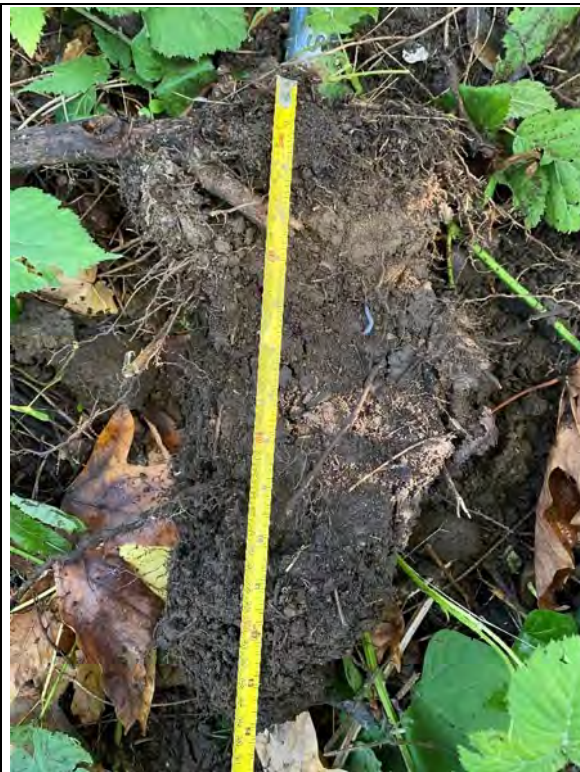
Photo 13: Soil pit existing upland soil characteristics along Drainage 2 flow path (SP-5. Photo taken October 21, 2020.

indicators (**Photo 13**). The soil was a sandy loam with gravels, which is representative of the Alderwood—Urban land complex soil series. No hydrology was present even though it has rained earlier in the day. Corresponding vegetation midway and to the west consisted of Douglas fir and bigleaf maple (both FACU species) in the tree canopy followed by patches of Japanese knotweed and Himalayan blackberry in the understory (**Photo 14**). Minimal herbaceous species were present. The lack of hydrology, presence of porous soils without hydric indicators, and dominant non-hydrophytic plant communities does not meet the criteria for wetlands along this flow path.

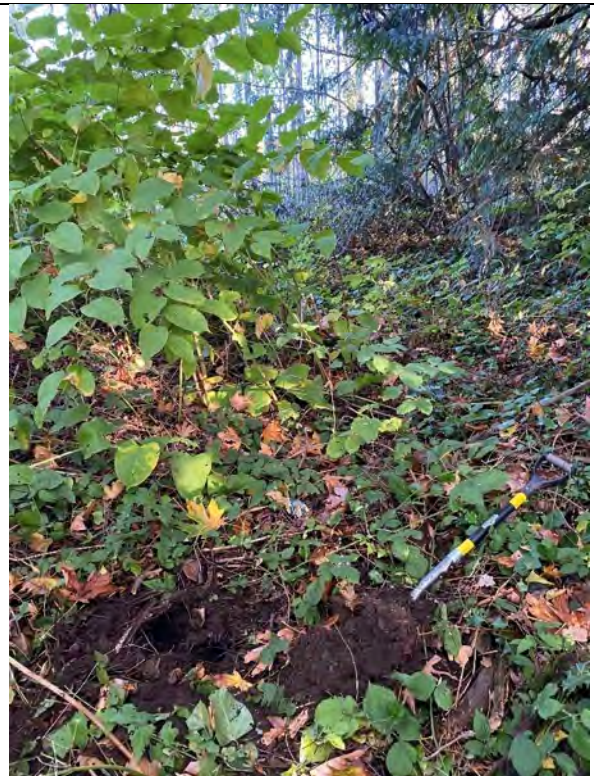
Photo 14: Parcel C, Drainage 2 flow path and forest floor looking east at SP-5. Photo taken October 21, 2020.

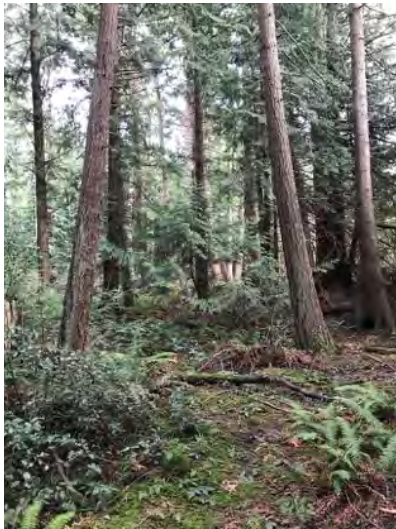
Photo 15: Forested south buffer conditions, facing west. Photo taken February 24, 2020.

There are distinct differences between the critical area buffers conditions and structure between the north and south buffer edges. The southern buffer which extends to 88th Street SW contains a 2 and 3rd growth upland forest (**Photo 15**). Dominant species include Douglas fir, western red cedar, and vine maple in the understory. Scattered sword ferns are mounded in areas which are typical of Western Washington upland forests. These buffer conditions persist

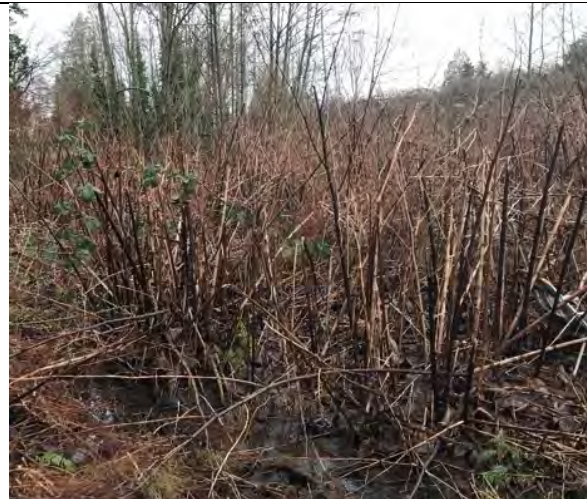
Photo 16: North buffer conditions, upper reach with Himalayan blackberry thicket and knotweed pockets. Photo taken February 24, 2020.

The north buffer contains varying degrees of disturbance from former site clearing and invasive species encroachment (**Photo 16**). The upper reach contains few conifer trees and is an early-successional red alder shrub community. Thickets of Himalayan blackberry and knotweed pockets are found along these slopes. The lower reach transitions to a forested community that contains more conifer species. In this area, English ivy, an invasive species, cover portions of the upland forest floor and some tree trunks (**Photo 17**).

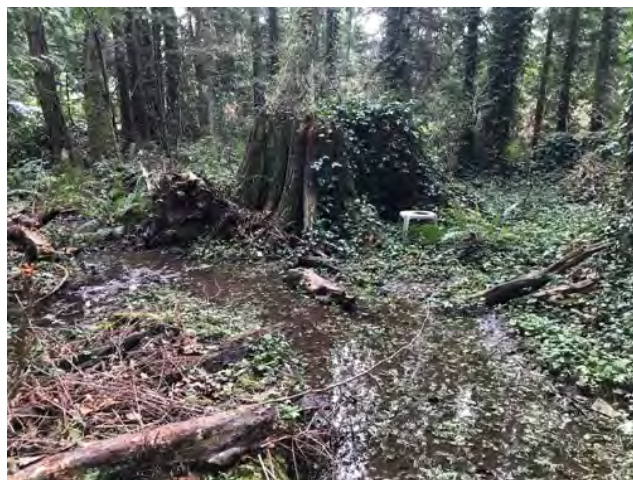
Photo 17: North forested buffer conditions with English ivy infestation on the west-side, downstream end of the site. Photo taken February 24, 2020.

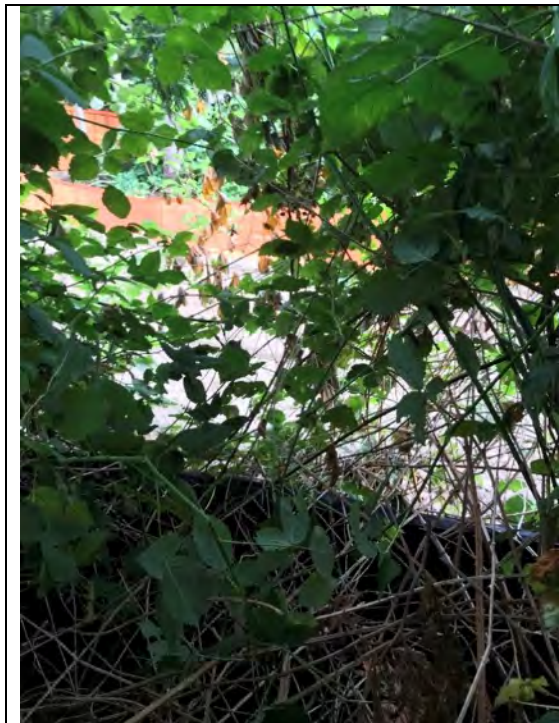
Photo 17: Off-site wetland/buffer edge with orange barrier fence looking north from Parcel B. Photo taken February 24, 2020.

There was no access to this wetland as this offsite parcel was under construction. Standing from the Strickland property boundary edge looking north (Photo 11), a silt fence was erected along the property line, the wetland and portions of the buffer edge were protected by orange barrier fencing in the background. A cleared area between the silt fence and orange barrier fence per the photo occurs along the edge of the mapped wetland buffer as shown on the engineering map (RAM 2020).

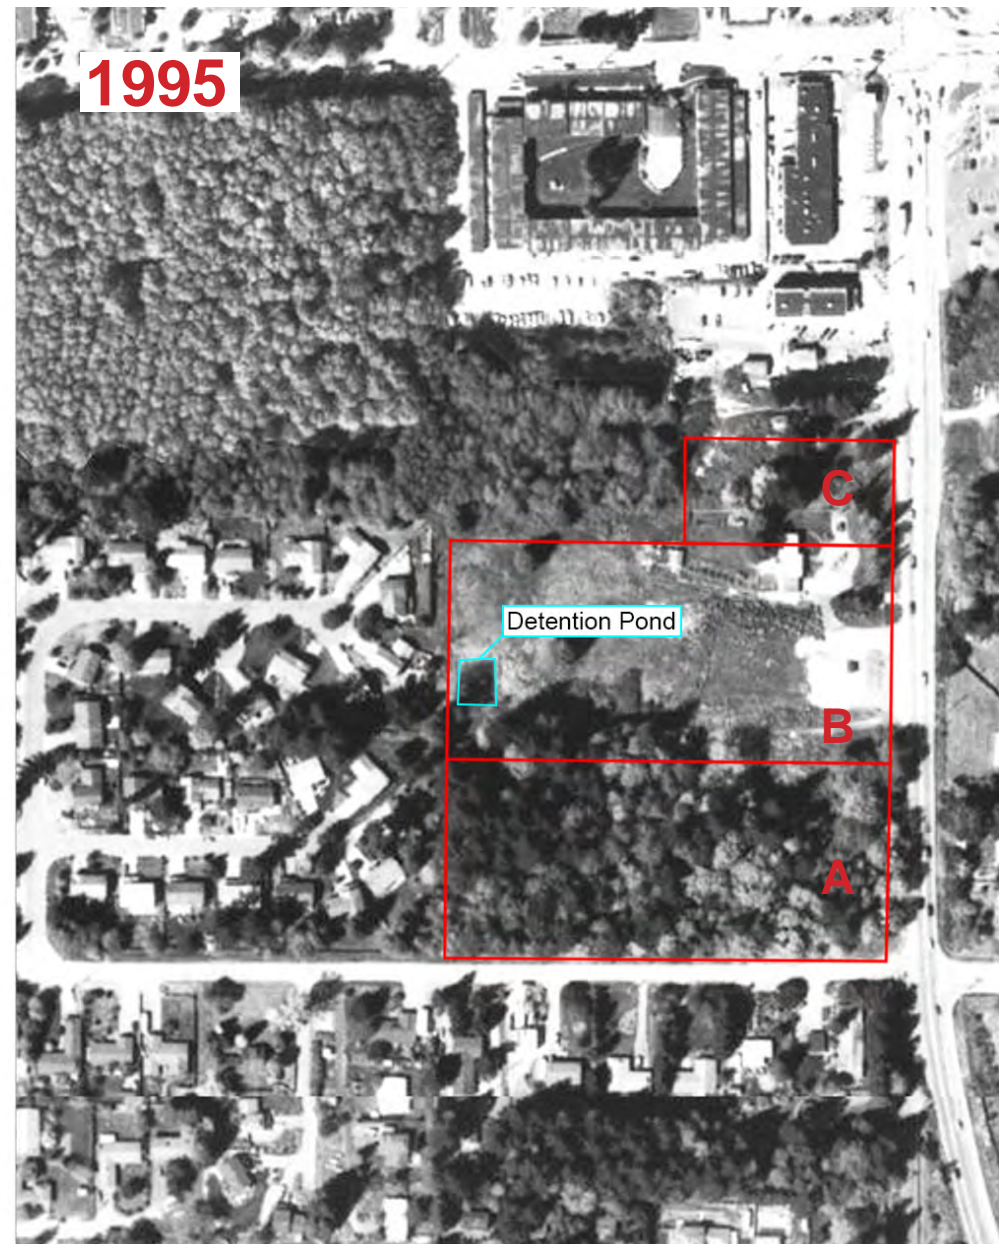
FIGURE 3: 1974 & 1995 AERIAL PHOTO
Carrick Court, Mukilteo

A review of aerial photos shows a steady pattern of land disturbance, specifically in Parcel B and portions of Parcel C. These areas have been partially cleared for agricultural/grazing uses over the past several decades (**Appendix A/Figure 3**). Parcel A however has remained relatively intact over this same period.

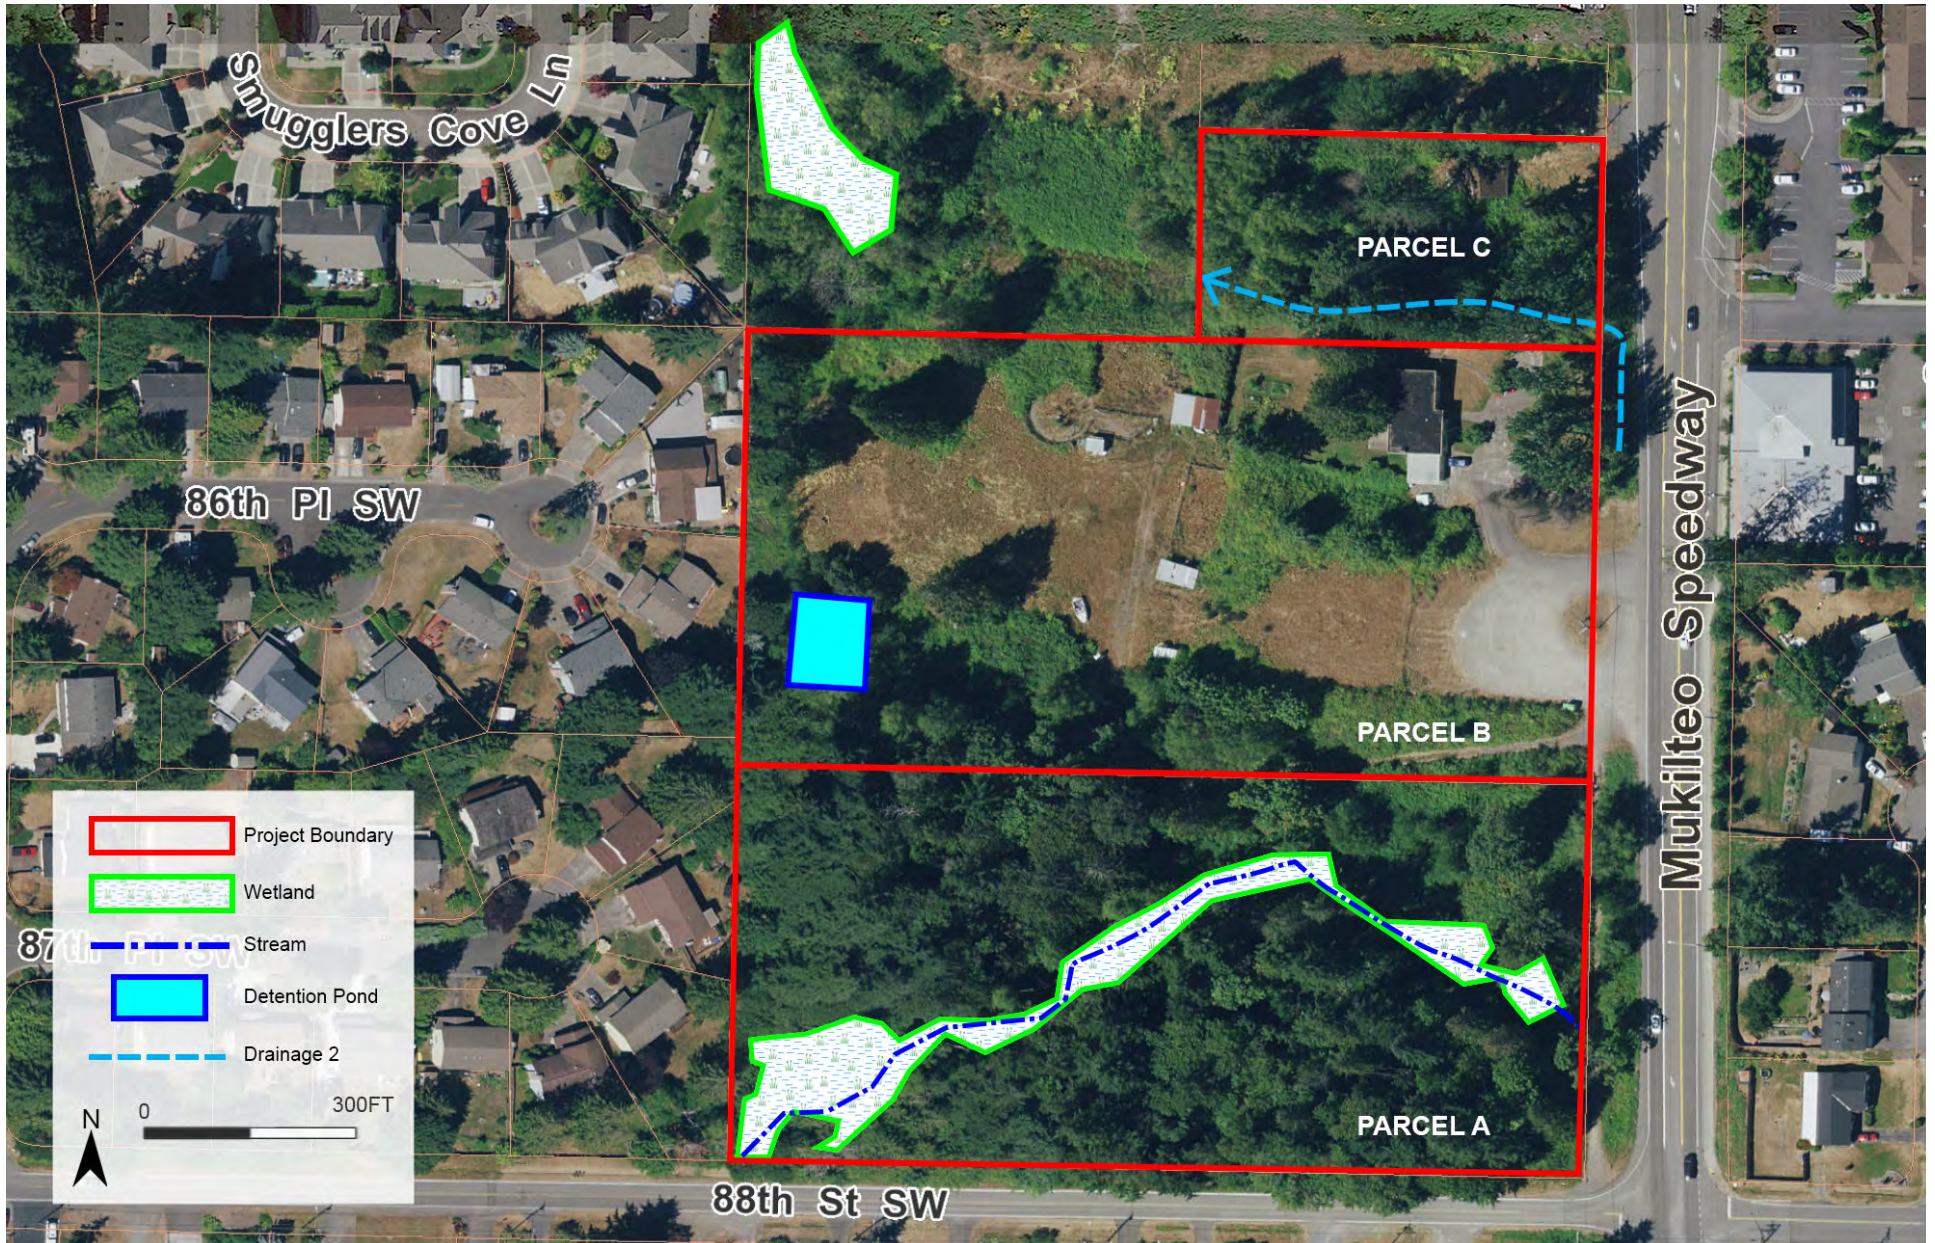
FIGURE 7: OVERALL WETLAND MAP
Carrick Court, Mukilteo

1. See Appendix E for delineation flagging details.
2. The offsite wetland was digitized from RAM Engineering As-Built Plans (RAM 2020).

A forested wetland, north of the northwest corner of Parcel B was observed (Appendix A/Figure 7; Appendix D/Sheets 1) from the Strickland property boundary. A consulting report rated this a Category IV wetland with a corresponding 40-foot buffer (WR 2016). This area has been designated as a Native Growth Protection Area (NGPA) (MMC 17.52.035). The buffer does not encroach on the Strickland Property per the drawing.

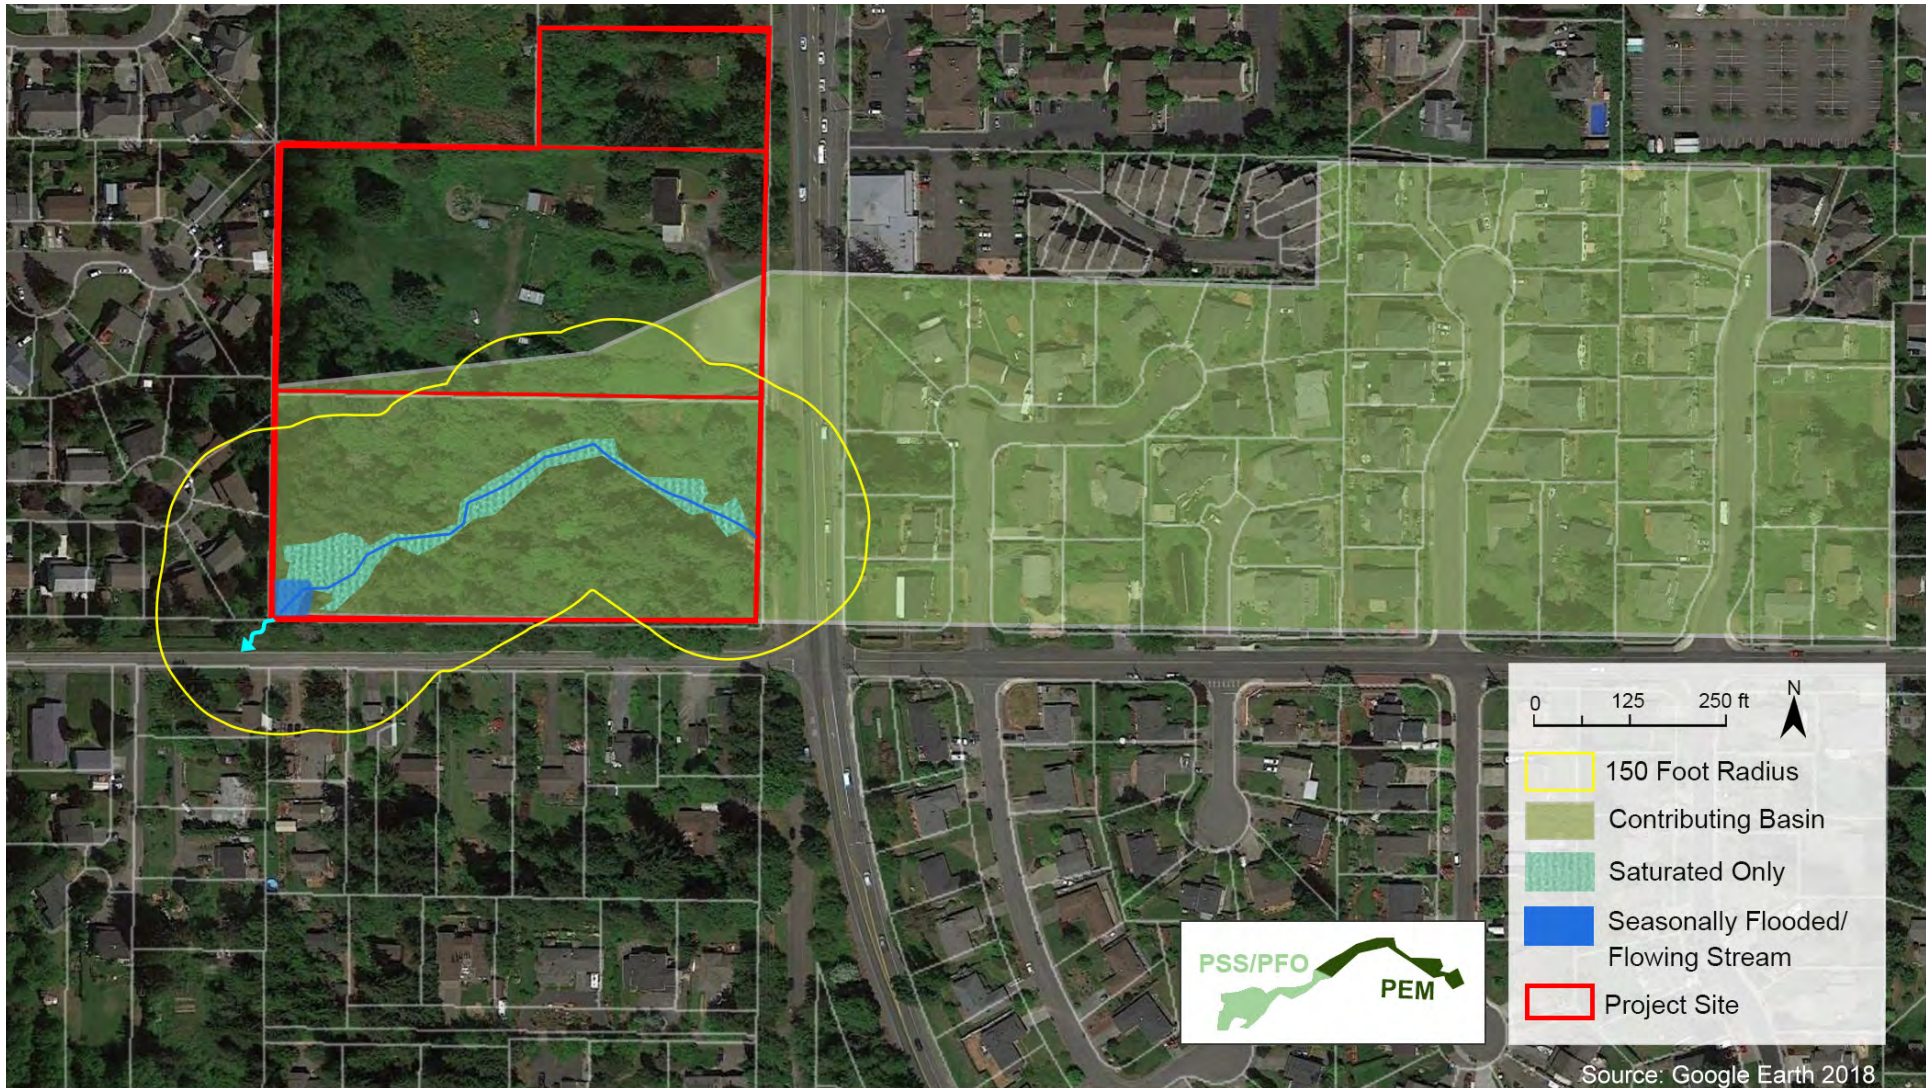
Contributing Basin (approx. 974,695 sf.)
 Wetland A (approx. 19,774 sf.)
 Carrick Court, Mukilteo

RATING FIGURE A1 (WETLAND A)
 150' RADIUS / PLANT CLASS / HYDROPERIOD

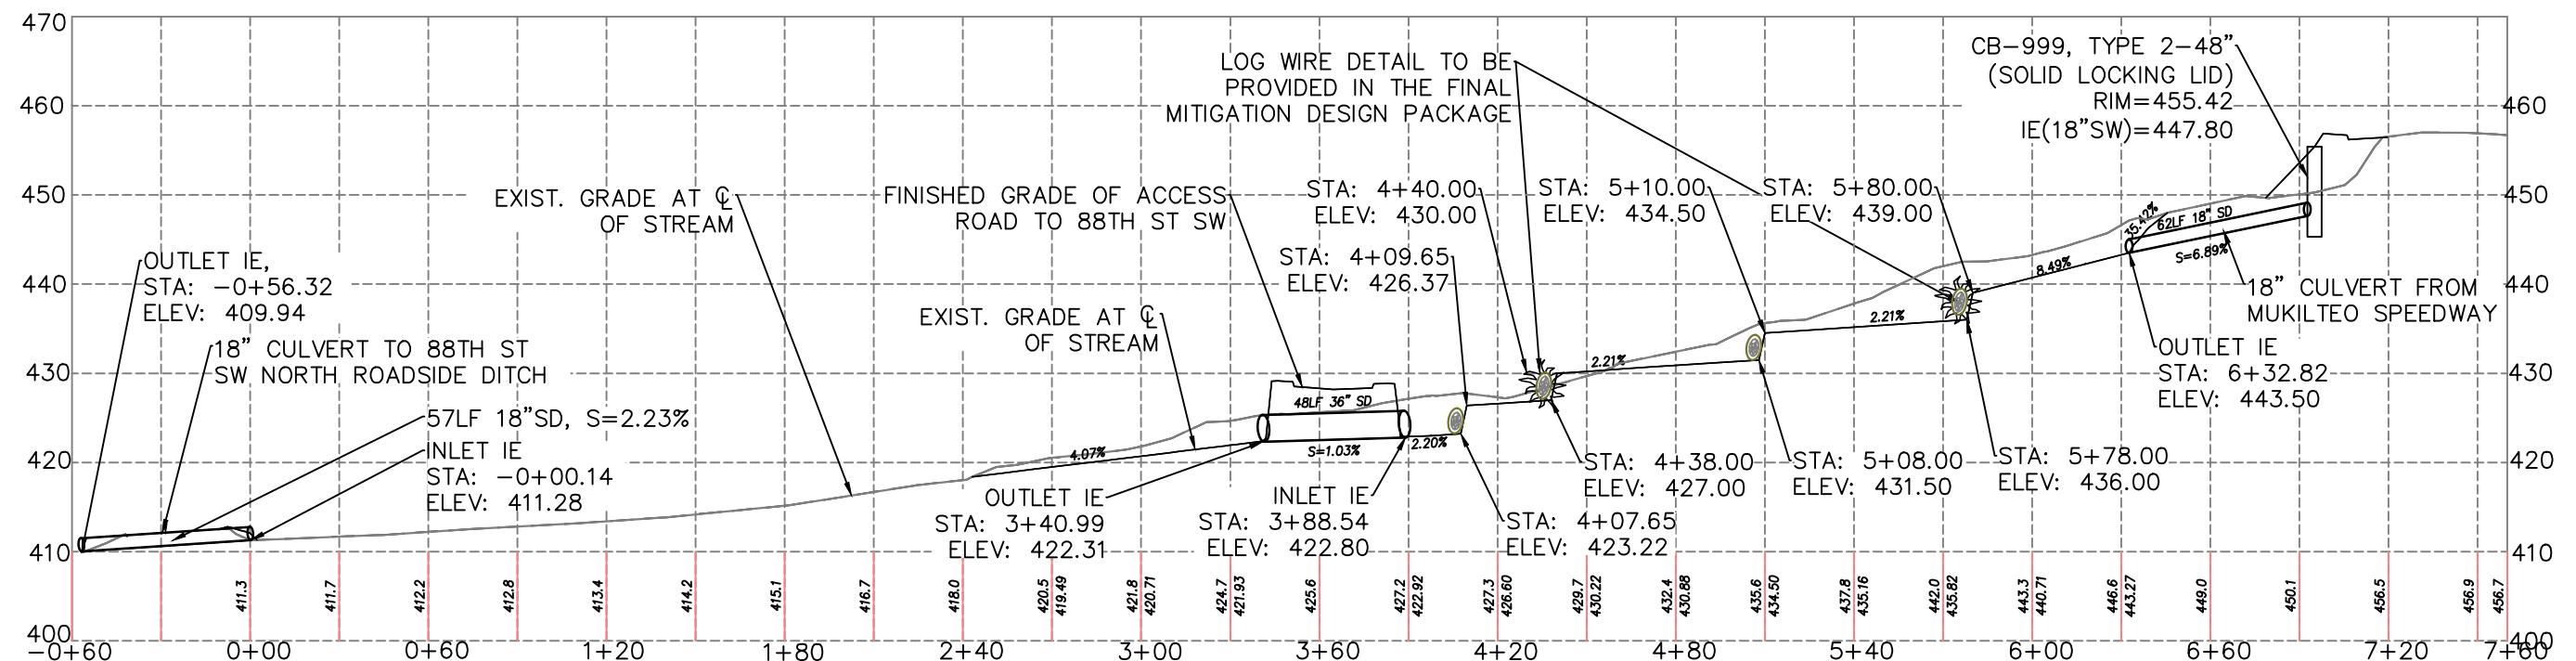
STREAM PROFILE
SCALE: HORIZ 1"=60" VERT 1"=15"

The new stream channel design is intended to handle the existing seasonal flows in Drainage 1. The new channel itself will be approximately 2-3 feet wide with 6 inches deep during average winter flows. In the eastern half of the new stream (upstream of the proposed access road) the natural gradient of the site has been broken down into a series of four terrace and log weir steps. The sloped terraces will average between 30 and 50 feet in length with log weir drops between grade breaks. A preliminary review of channel hydraulics were reviewed to ensure there are no erosive water velocities generated during 25- and 100-year events. A more refined hydraulic report will be prepared to accompany the final mitigation plan. To address potential gradient issues in the upper half of the new stream, channel spanning log weirs will extend into created wetland benches at several locations to spread water horizontally to further slow water and support wetland vegetation along the banks. Spanning wood will consist of several stepped conifer logs. Their placement is designed to raise storage capacity in the stream and wetlands by approximately six inches. The installed wood also functions as debris dams and energy dissipaters. Channel spanning log weirs have been identified in stream restoration as “critical in-stream structures” for the retention of organic matter during high flow events (Muotka and Laasonen 2002). A single, low-flow notch will be cut in each of the logs to direct a portion of water during low flows. Since this section of stream is non-fish bearing, fish passage is not an issue.

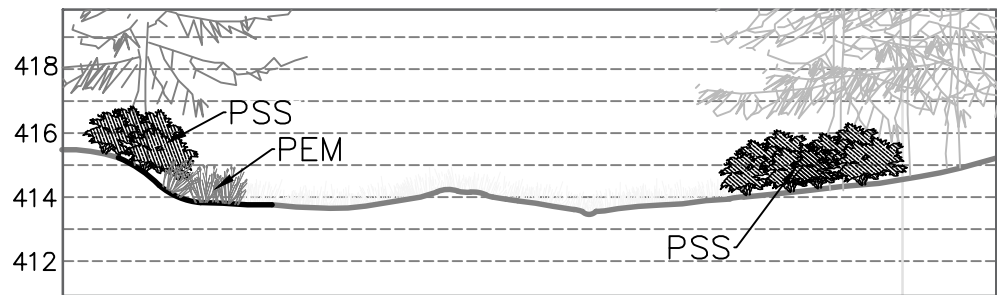
EXISTING ELEVATION
SCALE: HORIZ 1'=30" VERT 1'=6" (1-1)
C-5

PROPOSED GRADING
SCALE: HORIZ 1'=30" VERT 1'=6" (1-2)
C-5

PROPOSED FUTURE VEGETATION COMMUNITIES
SCALE: HORIZ 1'=30" VERT 1'=6" (1-3)
C-5

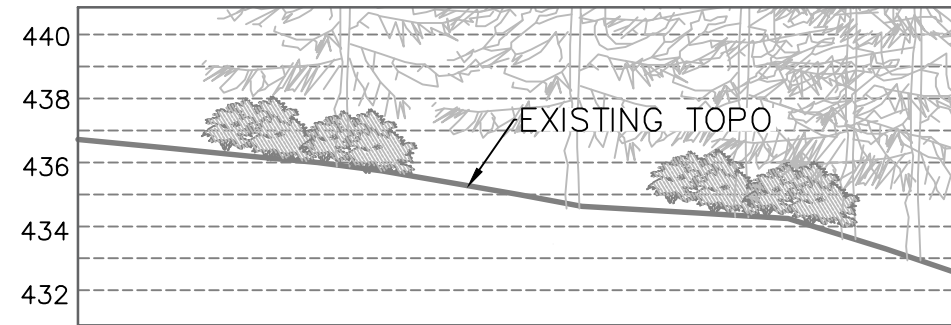
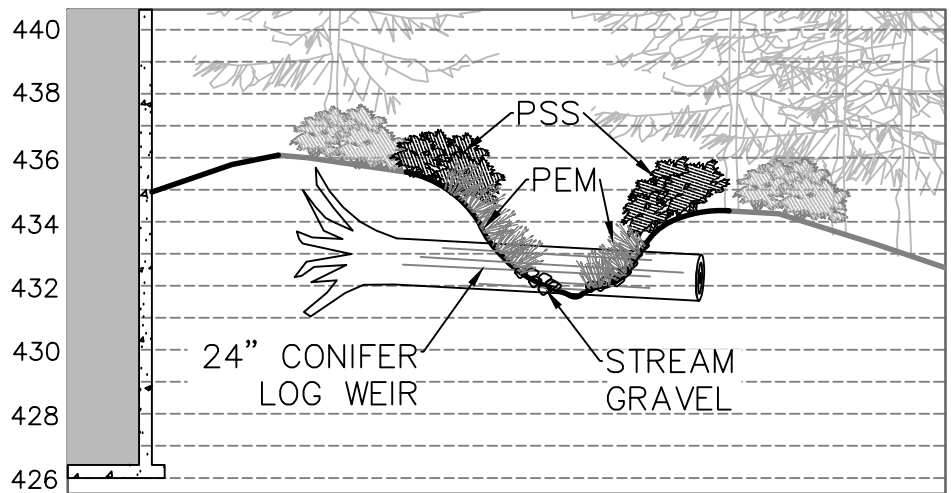
EXISTING ELEVATION
SCALE: HORIZ 1'=30" VERT 1'=6" (2-1)
C-5

PROPOSED GRADING
SCALE: HORIZ 1'=30" VERT 1'=6" (2-2)
C-5

PROPOSED FUTURE VEGETATION COMMUNITIES
SCALE: HORIZ 1'=30" VERT 1'=6" (2-3)
C-5
