PHASE I ENVIRONMENTAL SITE ASSESSMENT

Four (4) Vacant Parcels
4301 - 78th Street Southwest
Mukilteo, Washington 98275

UNDERWOOD NELSON DEVELOPMENT

Subject: **PHASE I ENVIRONMENTAL SITE ASSESSMENT**
Four (4) Vacant Parcels
Parcels #28041000300-100, -400, -500, & -600
4301 - 78th Street Southwest
Mukilteo, Washington 98275

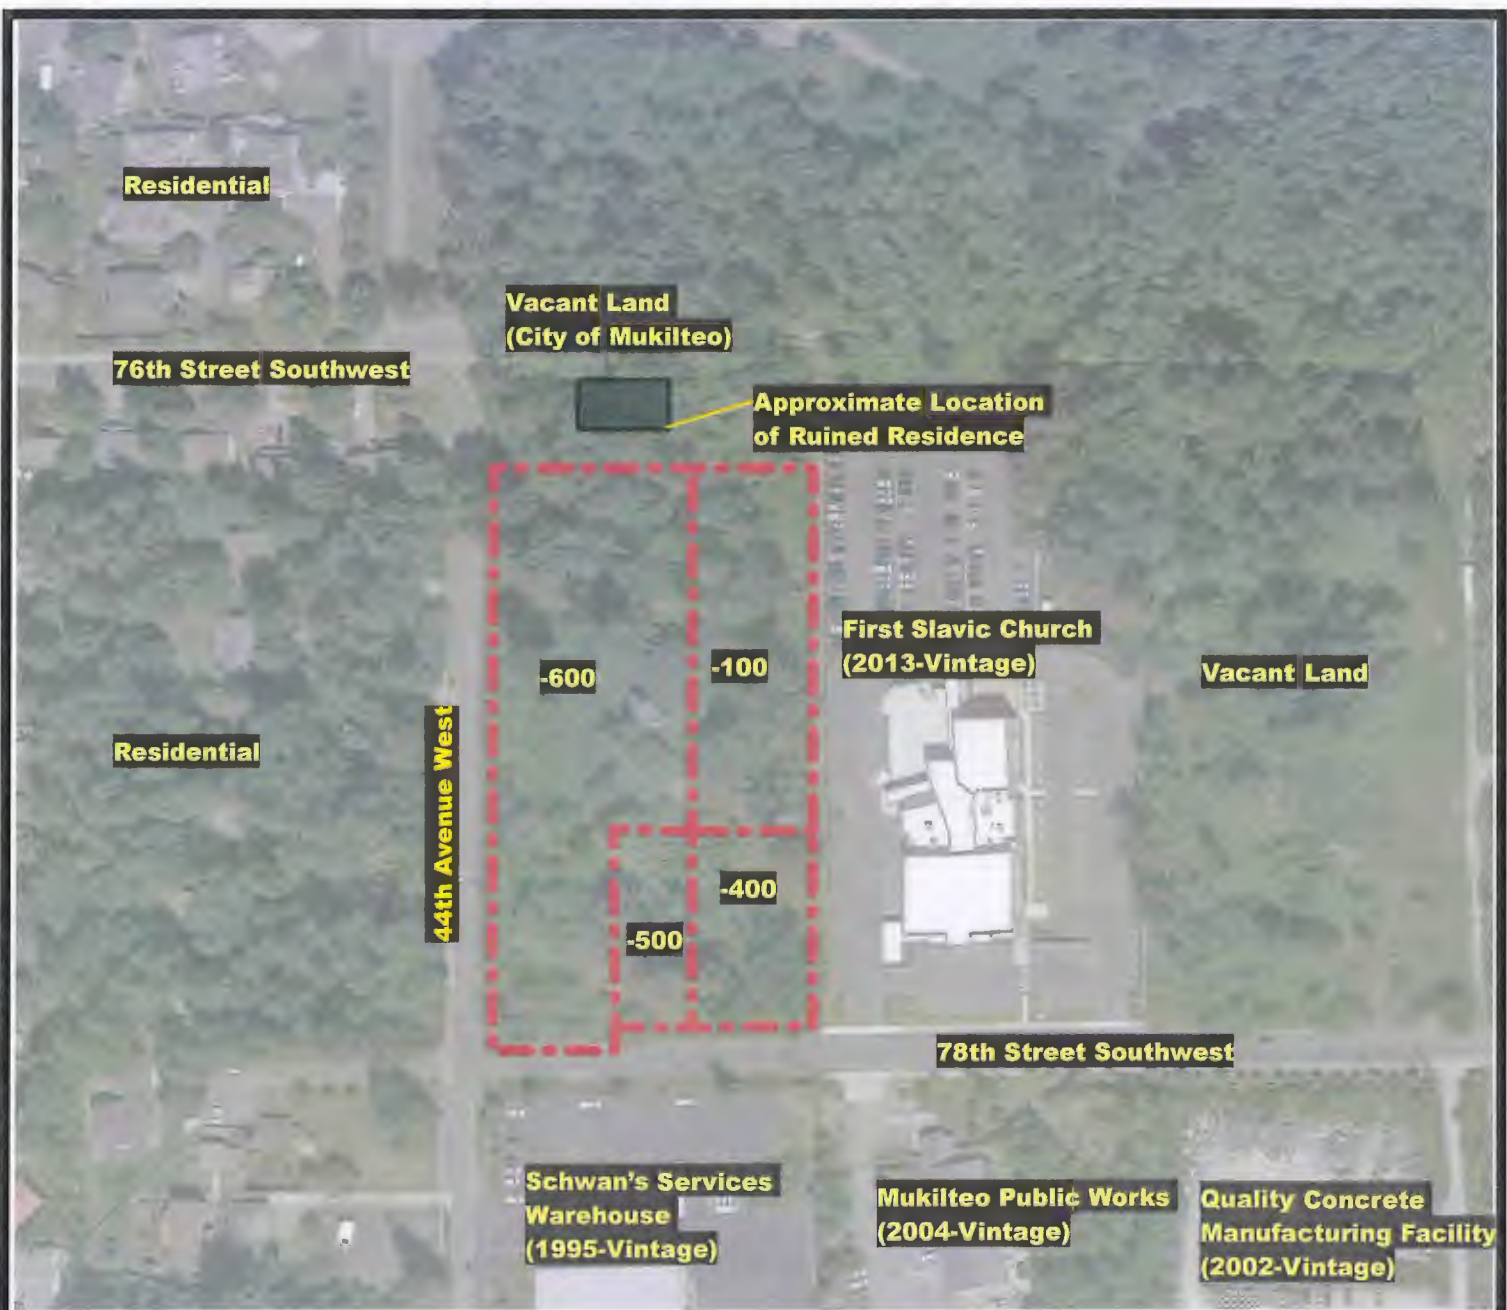
Plate:
1

Approximate Site Boundary

The subject property is comprised of four (4) contiguous parcels (tax parcels #280410000300-100, -400, -500, & -600) covering approximately 174,240 square feet (4.0 acres) of land. No functional structures currently exist on the property. The property is currently owned by Wallace H. Peterson. The approximate location of the site is shown on the Vicinity/Topographic Map, Plate 1, appended herewith.

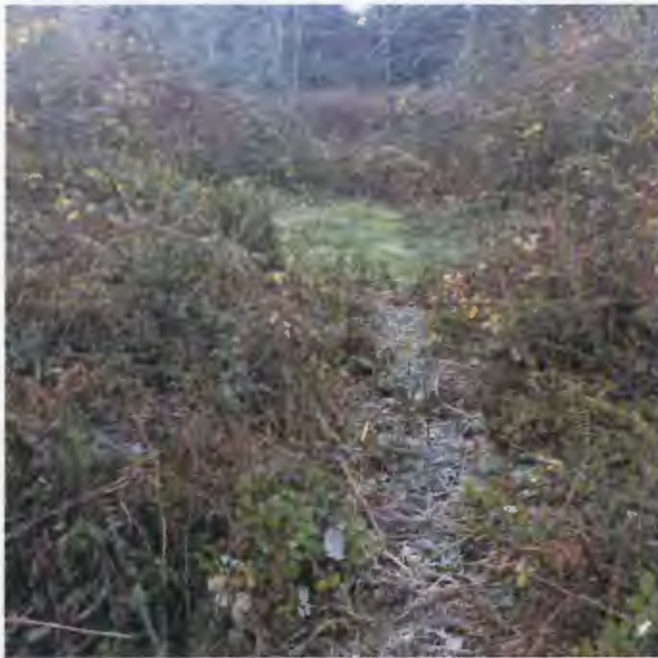
- Referring to the upper left-hand photo panel of Plate 3, a small clearing was observed near the northern section of the site along with the remnants of a very small wooden structure (possibly the remains of a small coop).
- Referring to the lower right-hand photo panel of Plate 3, a small wetland area can be seen to immediately to the north of the northwestern-most corner of the property.

View of Small Clearing

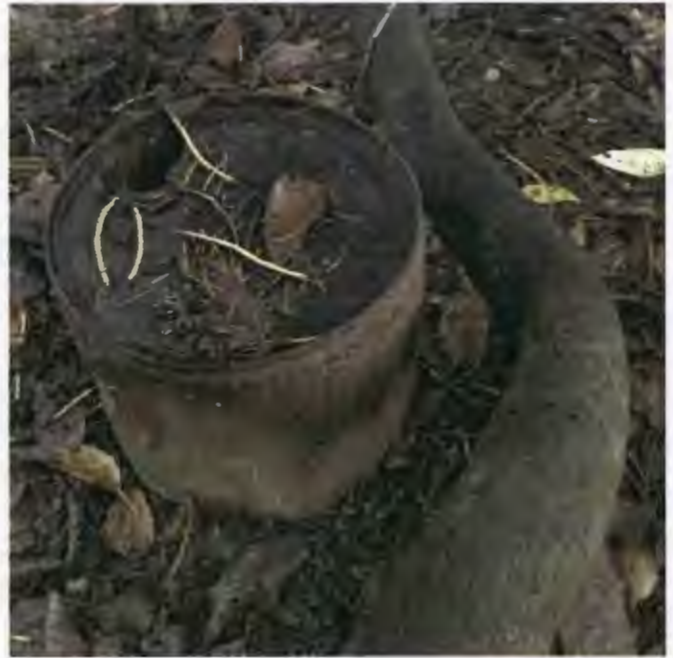
| Issue | Comment |
|---|--|
| Other Containers | Referring to the upper right-hand photo panel of Plate 3, one small (<10 gallon) metal container was noted on the southern portion of the property. That container was in poor condition and appeared to be filled with water and mud. No olfactory or visual evidence of a release of hazardous materials was observed. |

Small Container on Southern Portion of Site

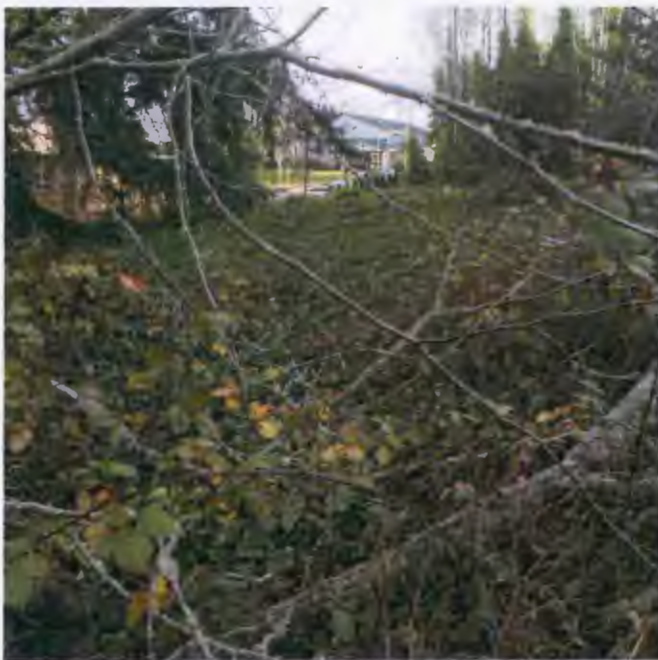
Southern View of Eastern Parcels

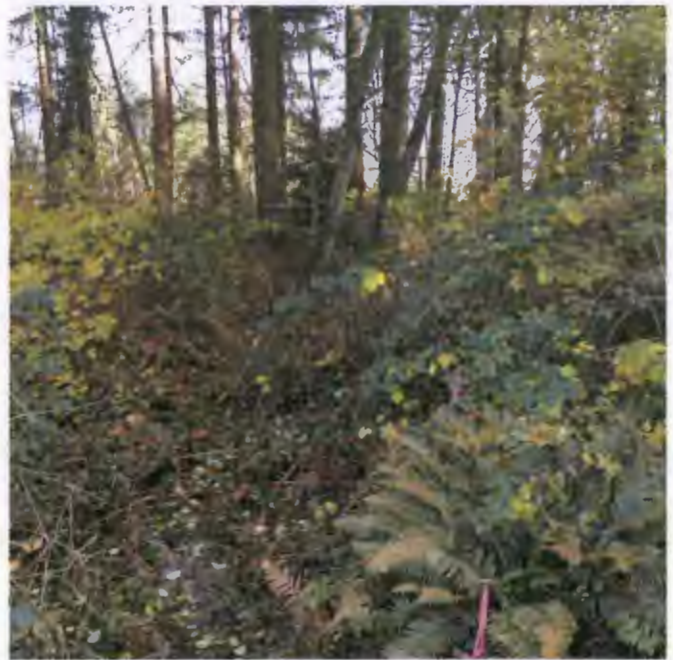
View of "Wetland" Area

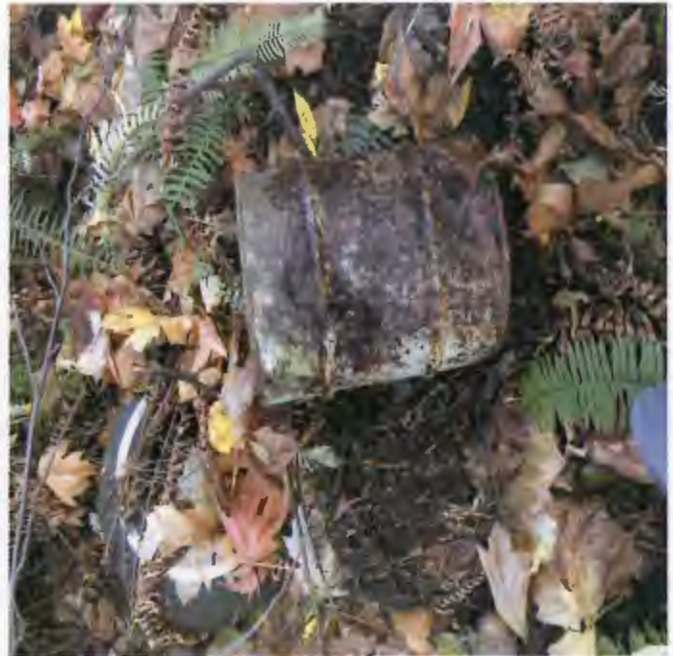
| Issue | Comment |
|---|--|
| Drums | One empty drum (~30 gallon) and a ruined 55-gallon drum were noted a short distance north of the northern boundary of the property in the general vicinity of the off-site ruined residence. No obvious signs of a release associated with those drums were observed. |

Empty Drum Near Ruined Residence (~30 Gallons)

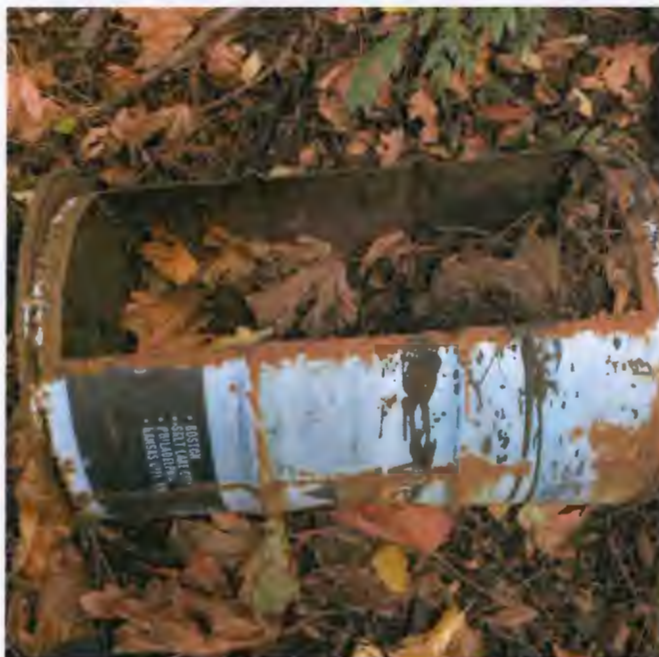
Drum Near Ruined Residence

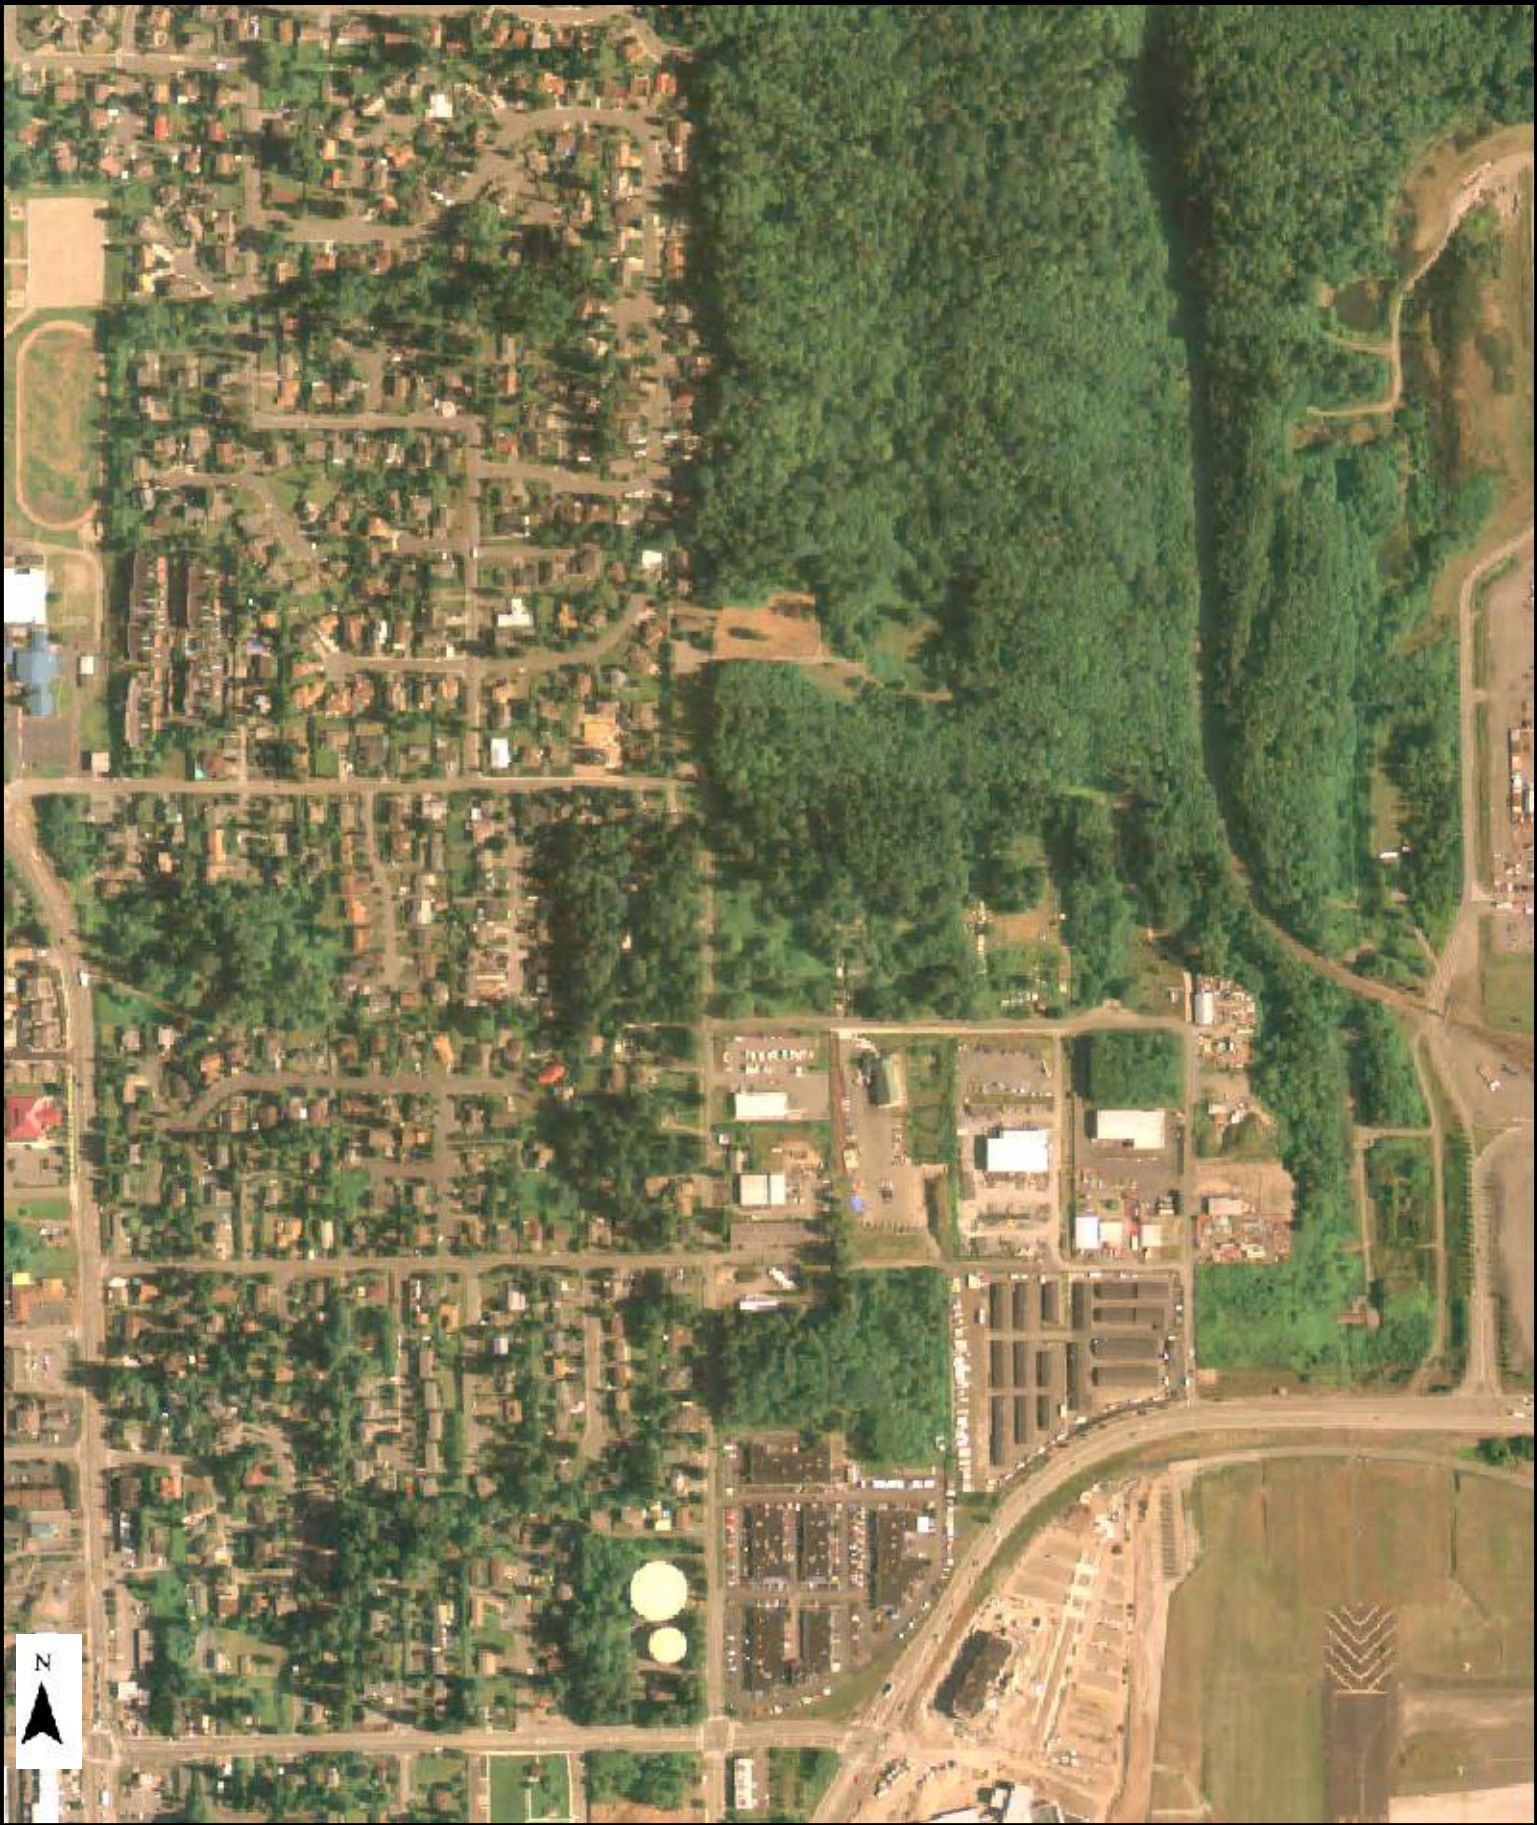
| 2004 | 1"=500' | NAIP | 11/5/2018 | 1186.1962 |

- 1990** No substantial changes to the subject or its surroundings are noted.
- 2004** The existing commercial/warehouse buildings (currently occupied by Schwan’s Services, Mukilteo Public Works, Quality Concrete) have been constructed to the south of the site. The subject remains undeveloped.

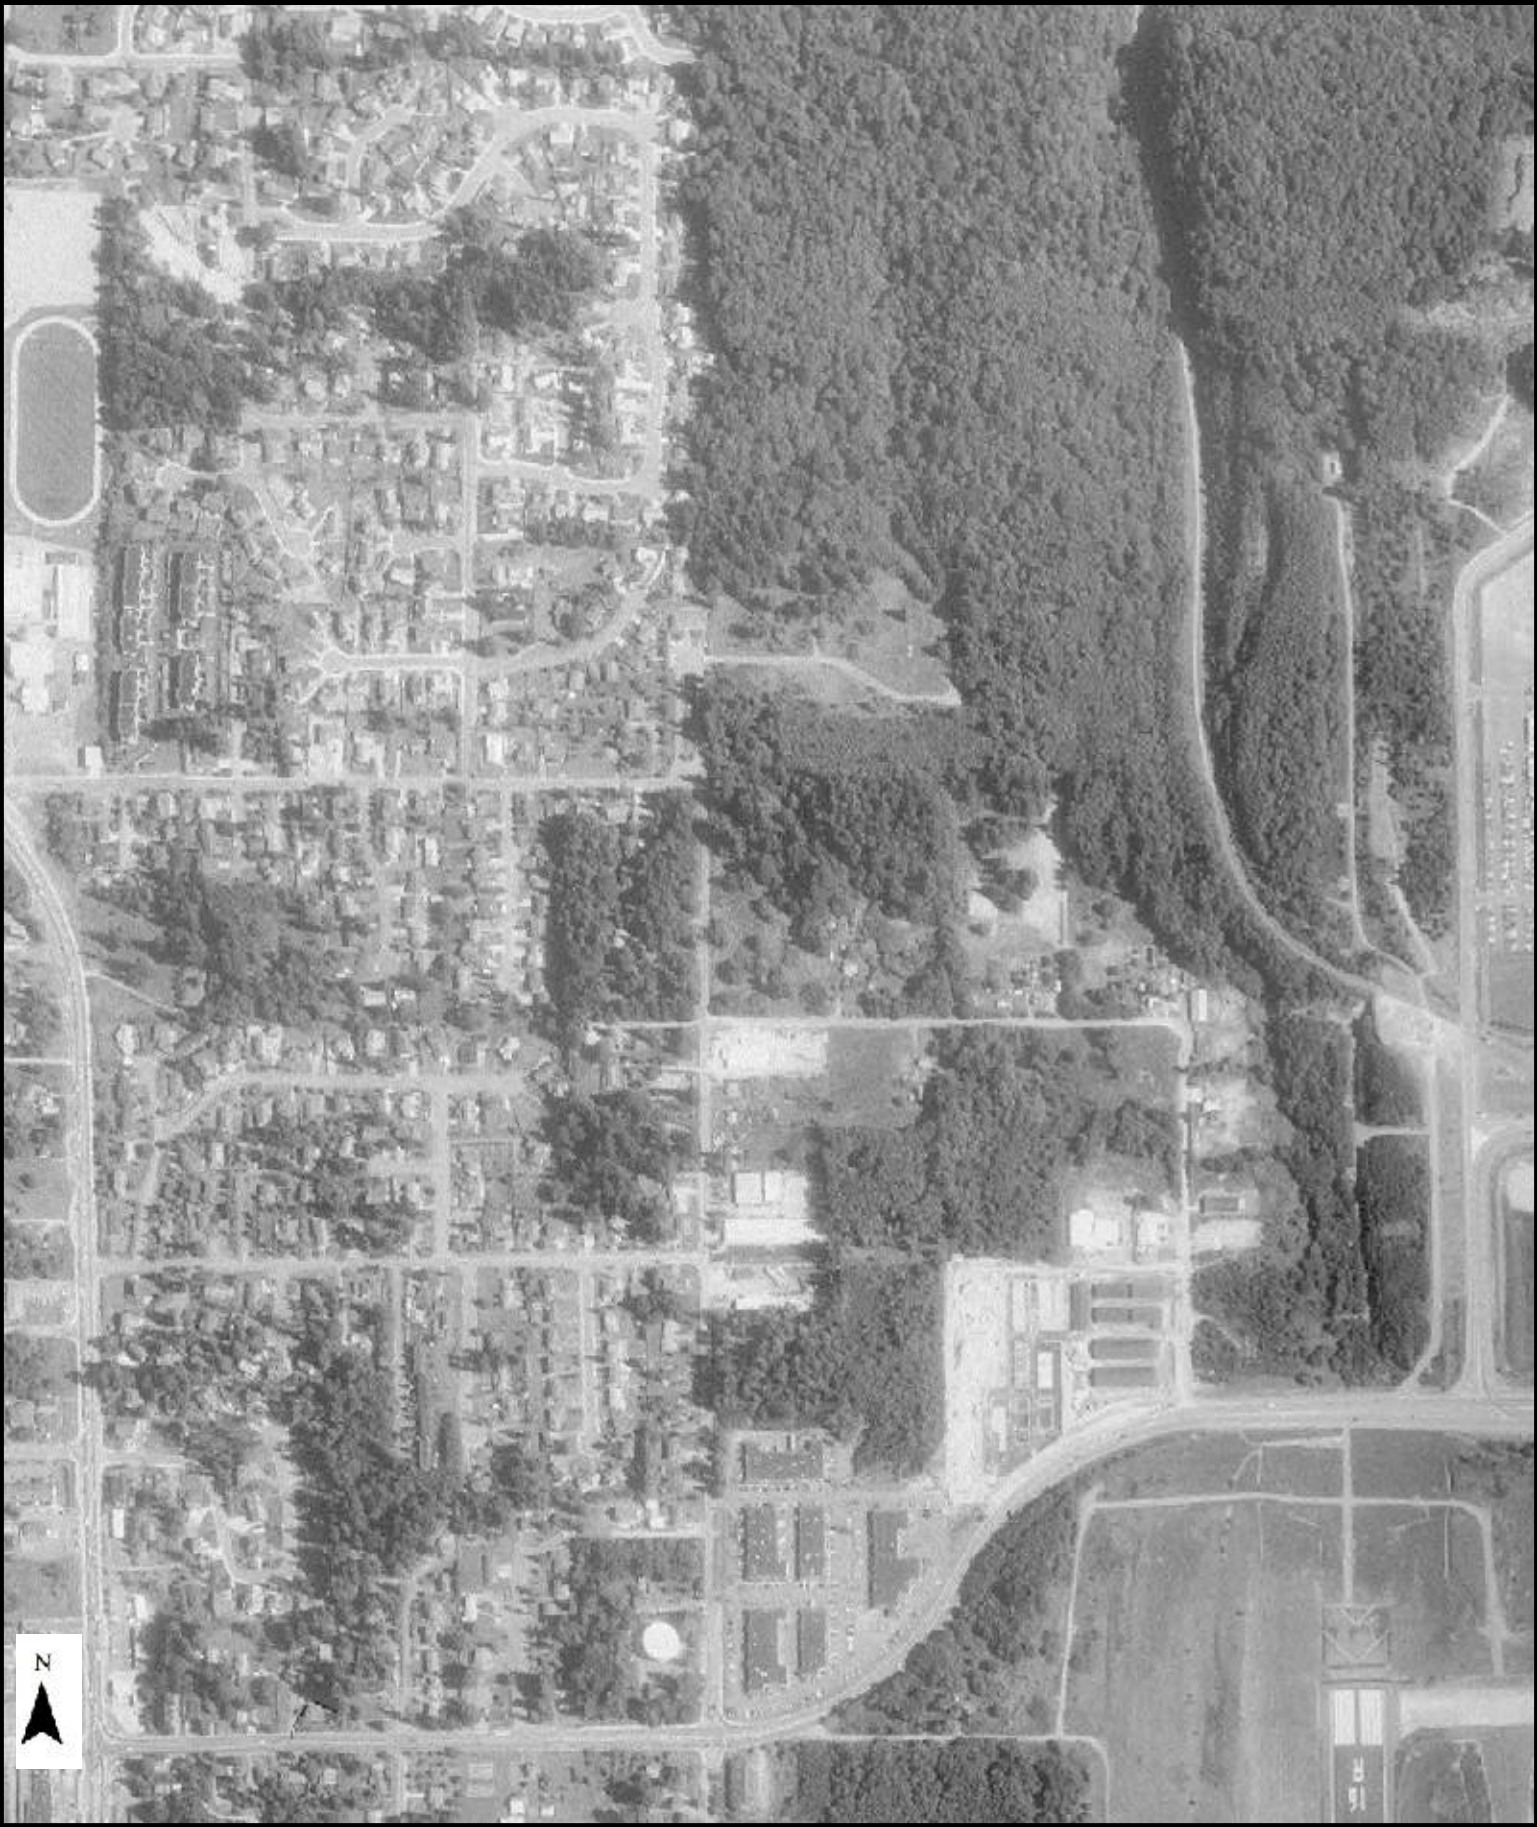
| 1980 | 1"=500' | NHAP | 11/5/2018 | 1186.1962 |

- 1974** No changes to the subject are observed. Residences have been constructed to the southwest of the site.
- 1980** The small “structure” on the southern portion of the property first seen in the 1941 air photo no longer exists. Multiple residential neighborhoods have been constructed west of the site.

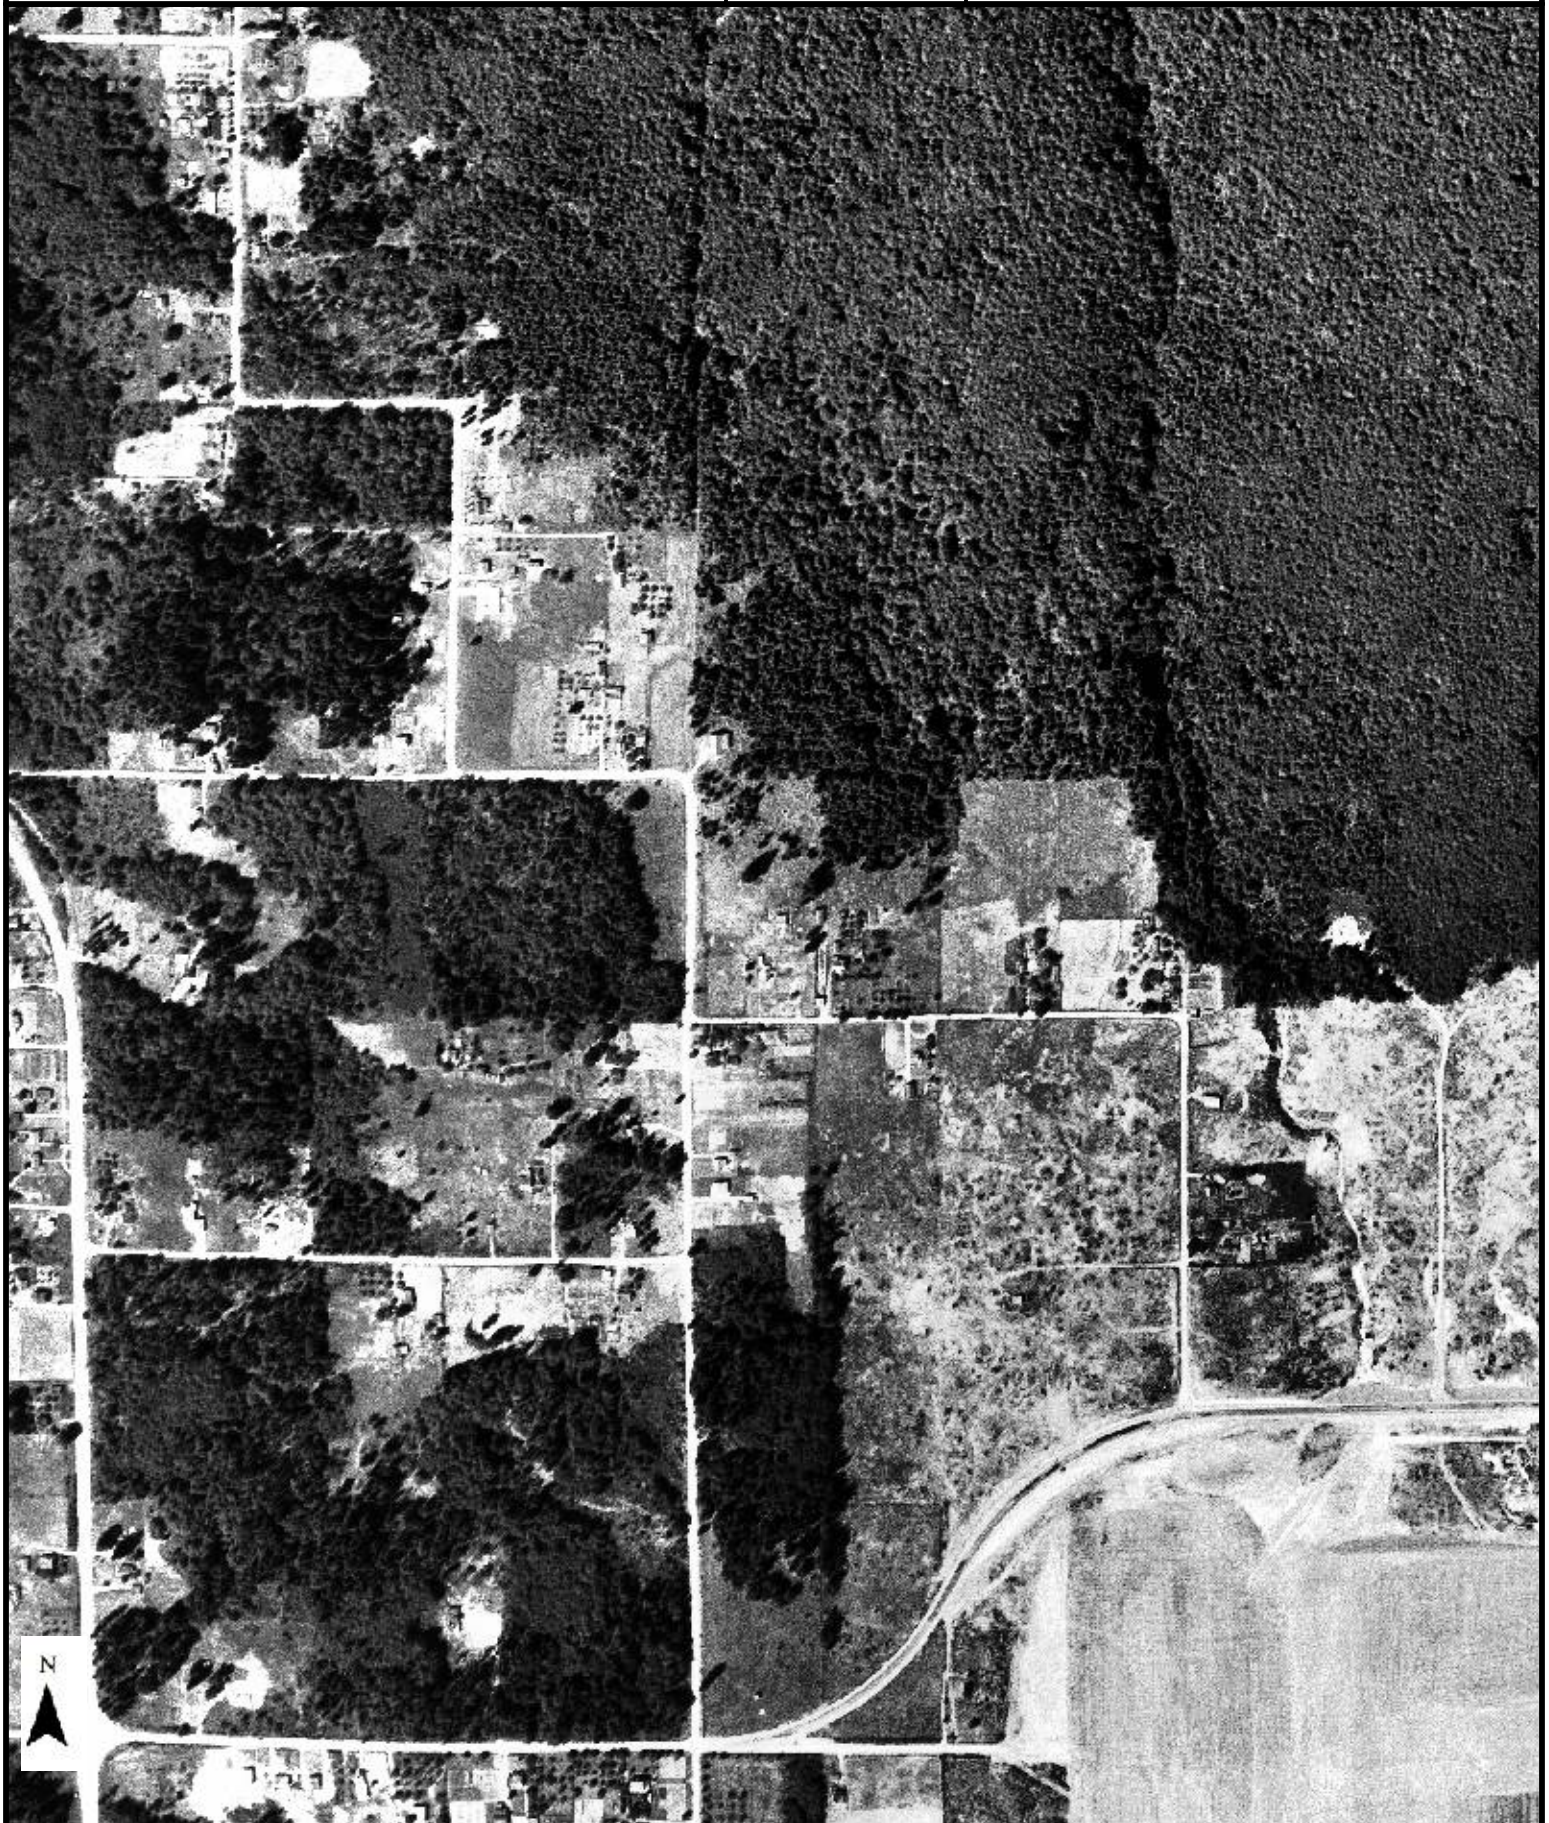
| Date: | Scale: | Source: | Completion Date: | MapPro ID: |
|---|---|---|---|---|
| 1941 | 1"=500' | USGS | 11/5/2018 | 1186.1962 |

- 1941** 44th Avenue West is seen to the west of the property while 78th Street Southwest is observed immediately south. What appears to be a small structure is seen on the southeastern portion of the site. The surrounding parcels are vacant or cleared land with residences.
