CITY OF MUKILTEO

FILE NO.: PPR-2019-002

PROPOSAL NAME: 61st Place Retaining Wall Repair located near the intersection of 61st Place West and 91st Place SW

PROPOSAL DESCRIPTION: Repair and reinforce an existing 90-foot-long soldier pile retaining wall and roadway with associated grading, landscaping, and street improvements.

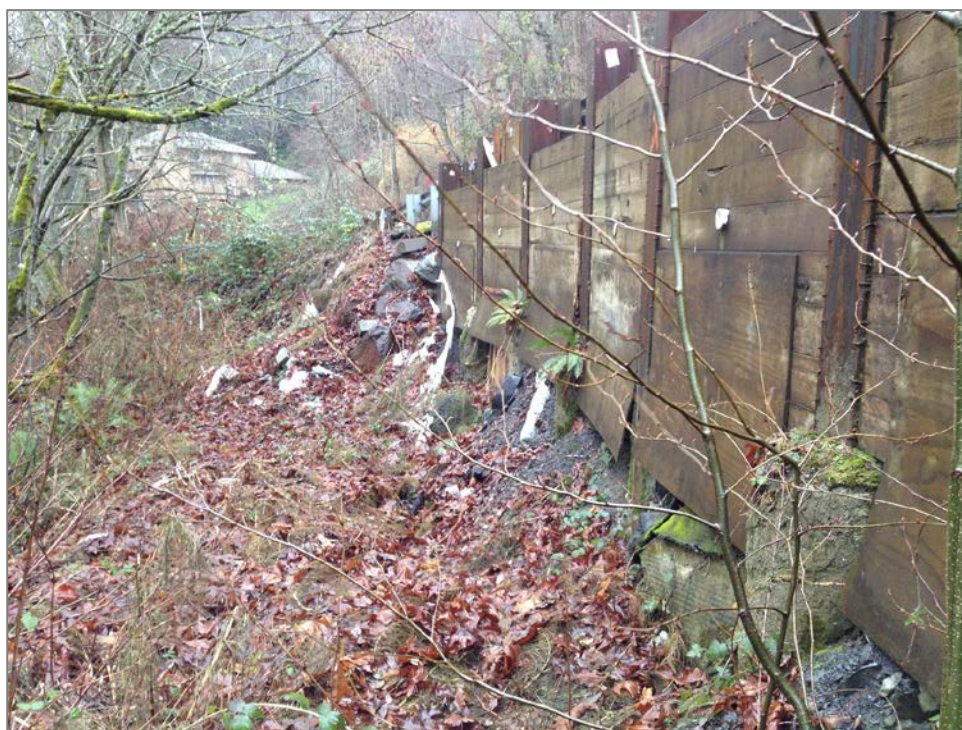
Photo 6. Failing portion of retaining wall, and area of wetland buffer that will be temporarily affected.

The slope in front of the wall slid again in March 2011. The slope appeared to drop an additional 3 to 5 feet exposing up to 14 feet of wall face in the central portion of the wall. The slide undermined the lower level of lagging that had been repaired in 1999 and also resulted in the failure of the MSE wall at the east end of the soldier pile wall. Deformation of the wall soldier piles was also reported. Evidence of surface water erosion was observed on the slope south of the road, below the residential houses. Recommendations were provided to improve short-term stability while long-term stabilization options were being developed.

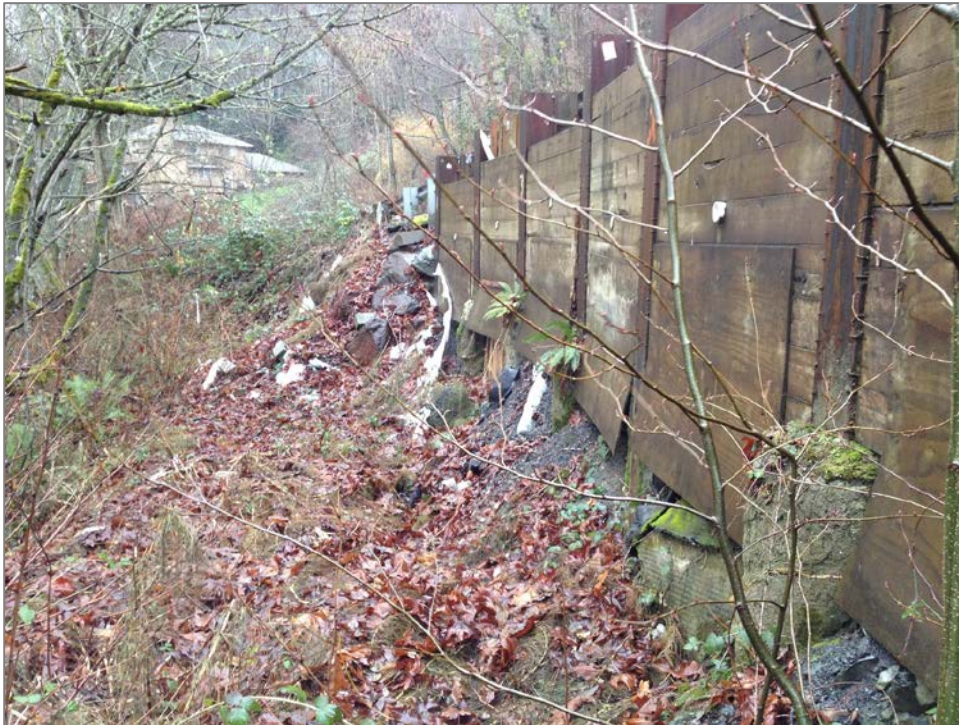
Photo 6. Failing portion of retaining wall, and area of wetland buffer that will be temporarily affected.
