Subject: Revised Japanese Gulch Wetland Delineation
Harbour Pointe Boulevard Widening Project
Mukilteo, Washington
File No. 5790-004-00

INTRODUCTION AND PROJECT UNDERSTANDING

Japanese Gulch Wetland Exhibit

Harbour Pointe Boulevard Widening Project
 Mukilteo, Washington

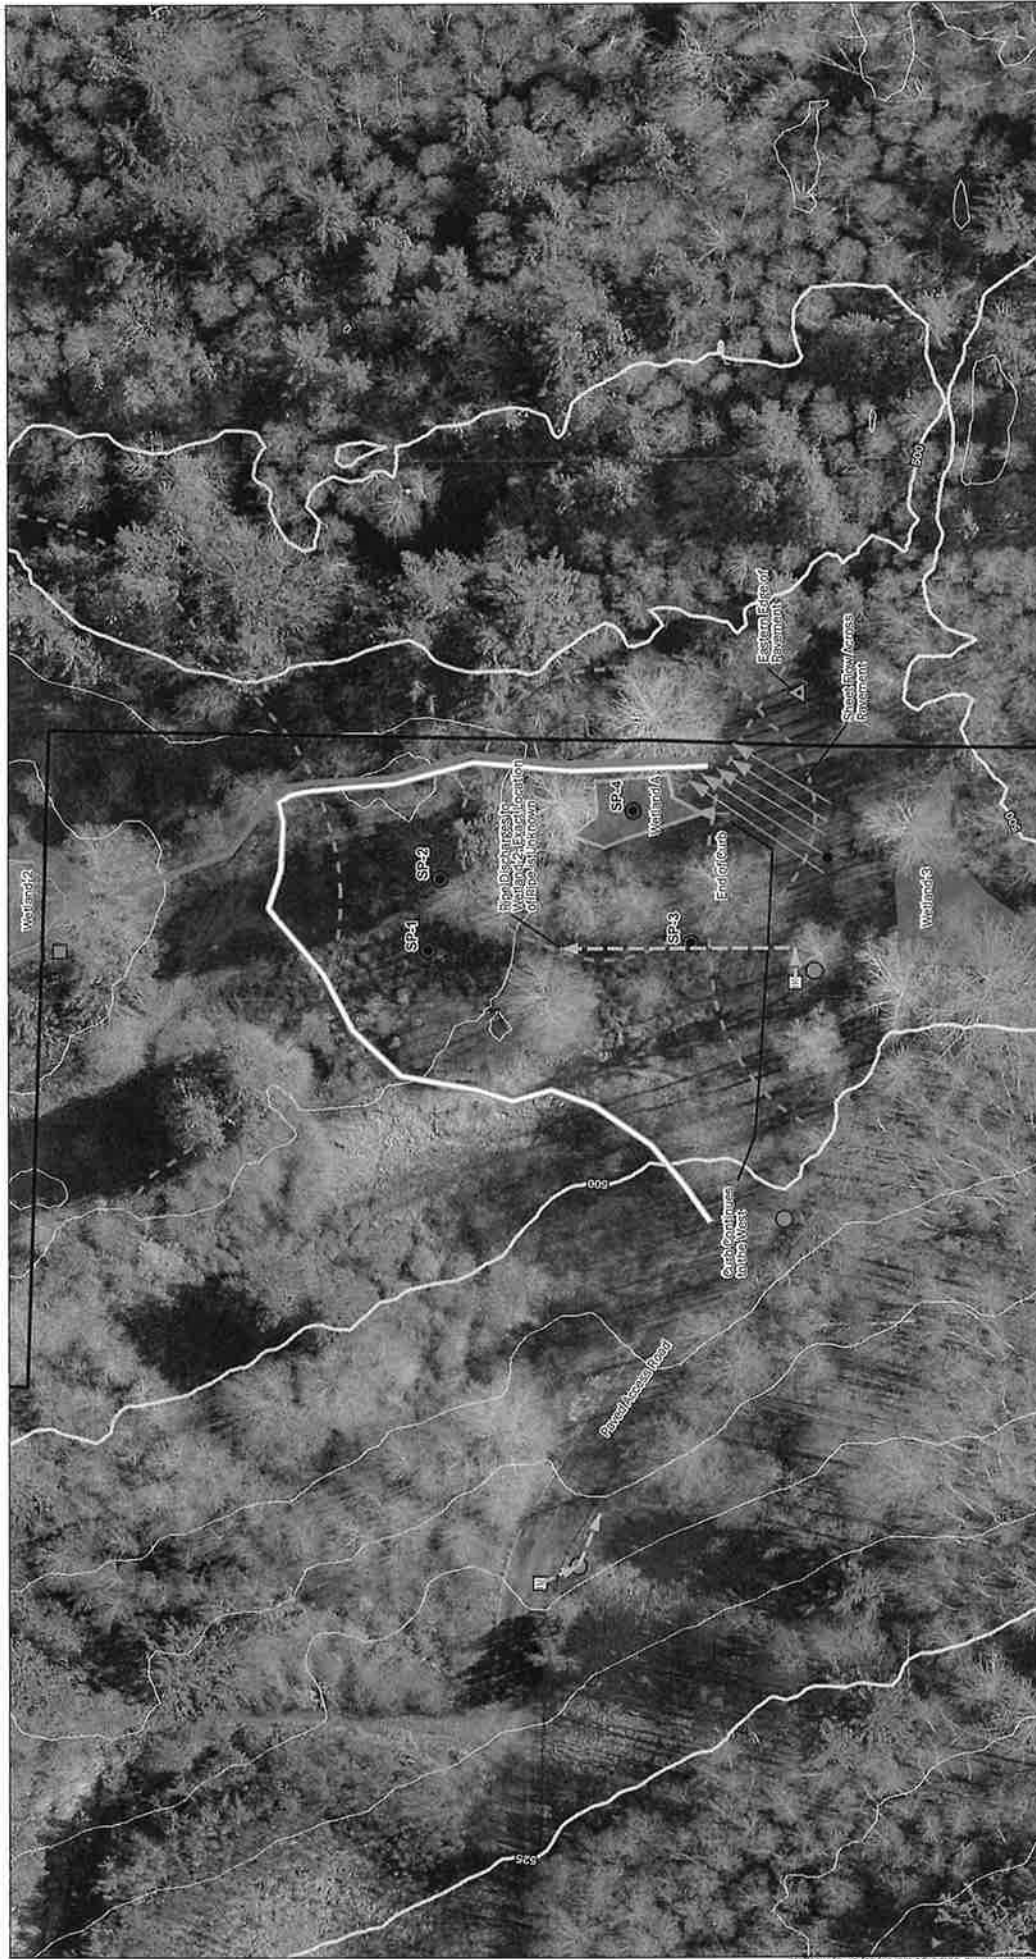
The proposed mitigation site is located in the southeast corner of parcel No. 06314000000001. Figure 2 depicts wetlands identified within the proposed Japanese Gulch mitigation area. The vast majority of the Mukilteo-owned parcels in Japanese Gulch are dominated by a mature mixed coniferous and deciduous forest of western red cedar (*Thuja plicata*) and red alder (*Alnus rubra*) with salmonberry (*Rubus spectabilis*) and sword fern (*Polystichum munitum*) in the understory. The parcels adjacent to the 76th Street SW and 44th Avenue West intersection, that have been identified by Mukilteo for mitigation are dominated by weedy species including Himalayan blackberry (*Rubus armeniacus*) and some reed canary grass with few trees.

GeoEngineers biologists conducted a field assessment on August 2, 2017 to document habitat and delineate potential wetlands within the proposed mitigation site footprint. GeoEngineers biologists identified and delineated one wetland (Wetland A) during the 2017 field investigation. In addition, the previously delineated wetlands were observed north (Wetland 2) and south (Wetland 3) of the mitigation site. No streams were identified within or immediately adjacent to the mitigation site. Representative photographs of the site have been included in Appendix B. Figure 2 depicts the wetlands and the proposed mitigation site.

In general, water on the site flows east and north. The paved road contains multiple catch basins and three manholes. Mukilteo has performed dye tests to determine where water flows within the catch basins and manholes. From the catch basin that is farthest east along the access road, water flows east under the paved roadway and then at an unknown point the underground pipe turns to the north and eventually drains into the northern off-site wetland (Wetland 2). Wetland 3 (off-site to the south) floods during the wet season and water seeps from this wetland and flows north towards the proposed mitigation site and then to a swale that flows north. The swale extends along the eastern parcel boundary and forest edge towards the off-site wetland (Wetland 2). Figure 2 depicts the catch basin and water flow through the site.

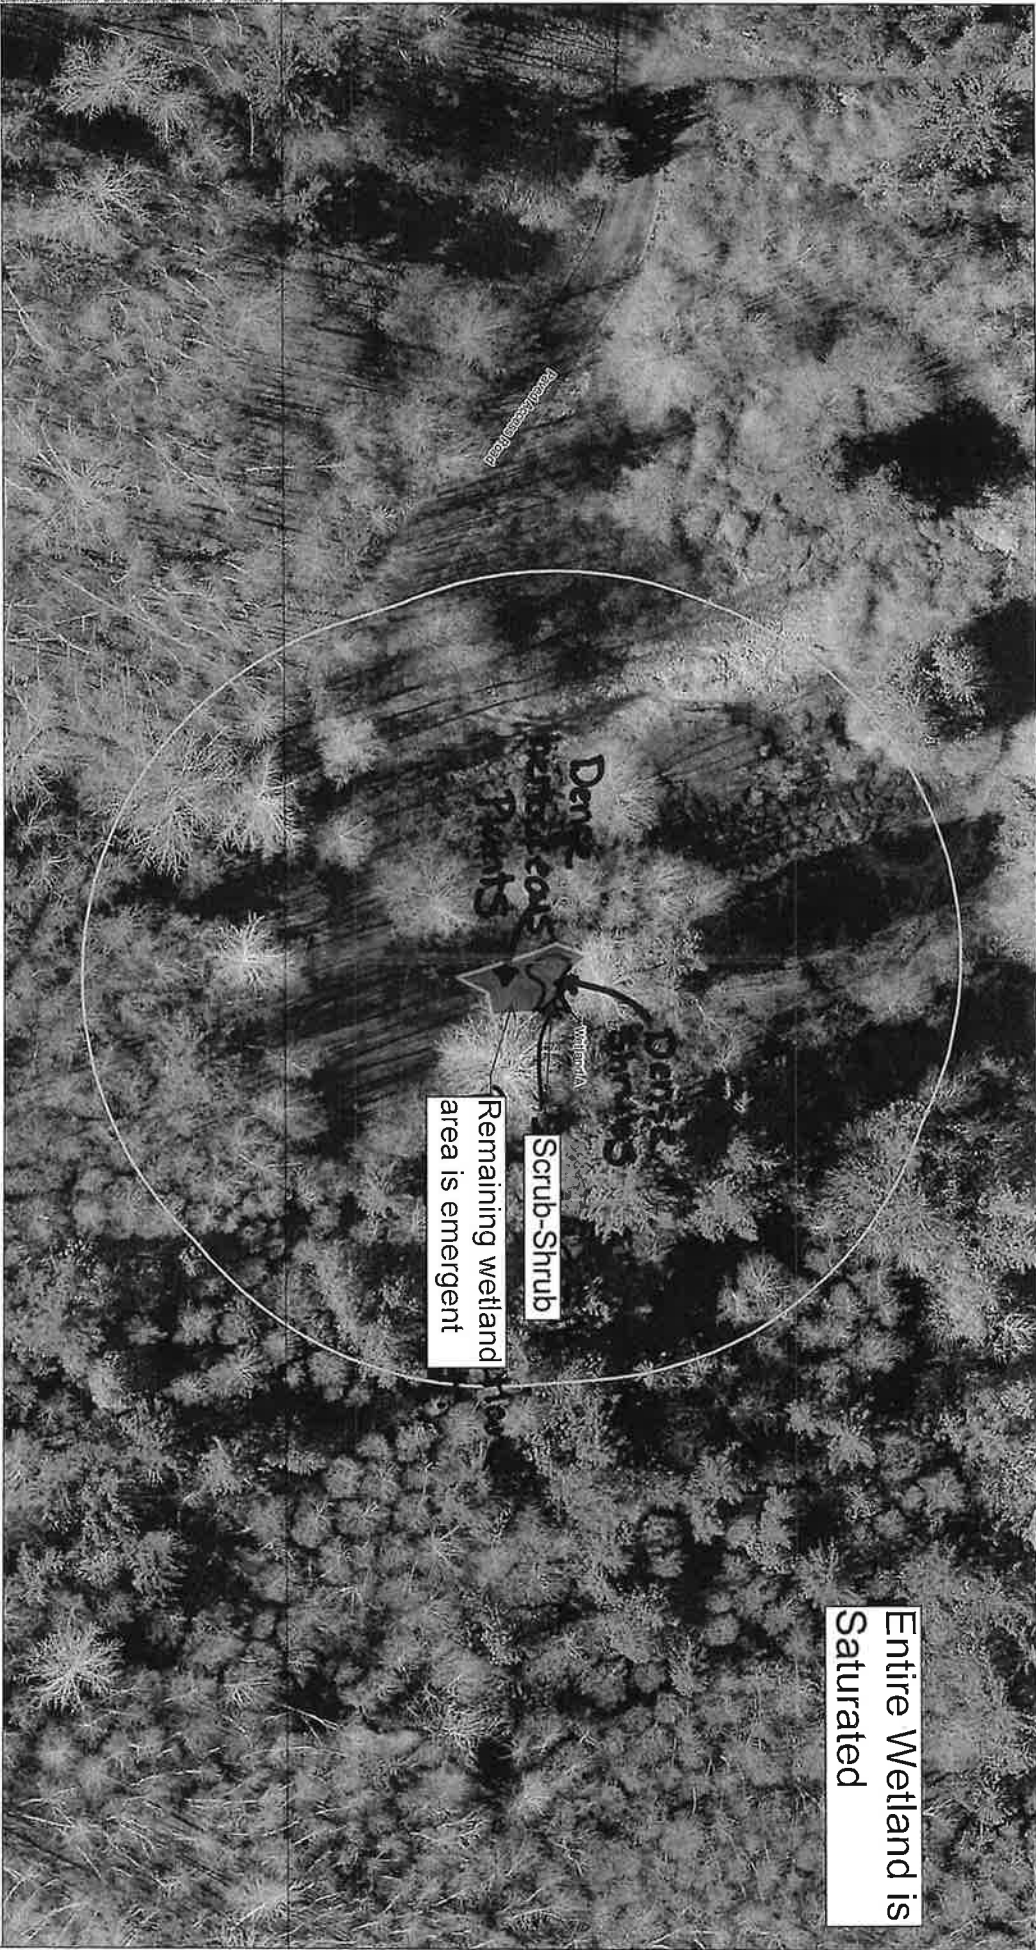
Figure 2

- Wetland (Identified by GeoEngineers)
- 150-foot Boundary Area
