Harbor Grove

Revision Date: April 20th, 2023

Storm Drainage Report

BlueLine Job No. 21-073

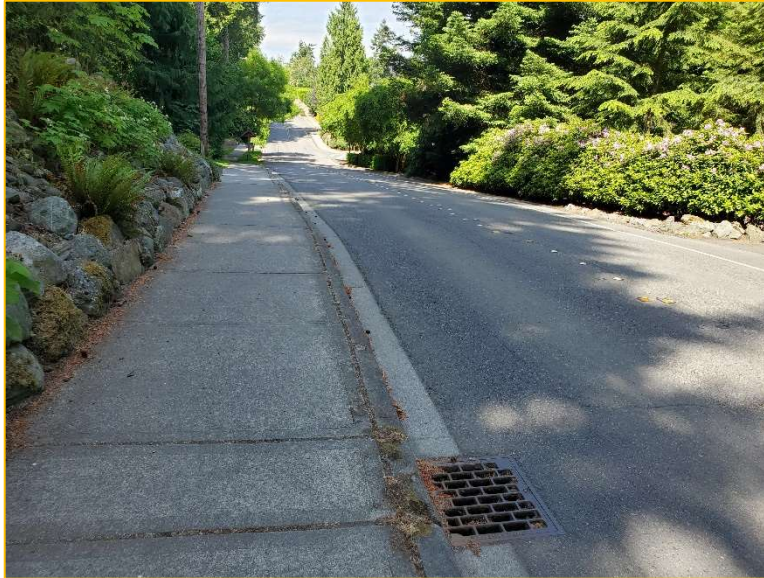
Photo 1 – Facing west from the south side of 92nd St SW. Runoff travels west via the proposed tightlined storm system.

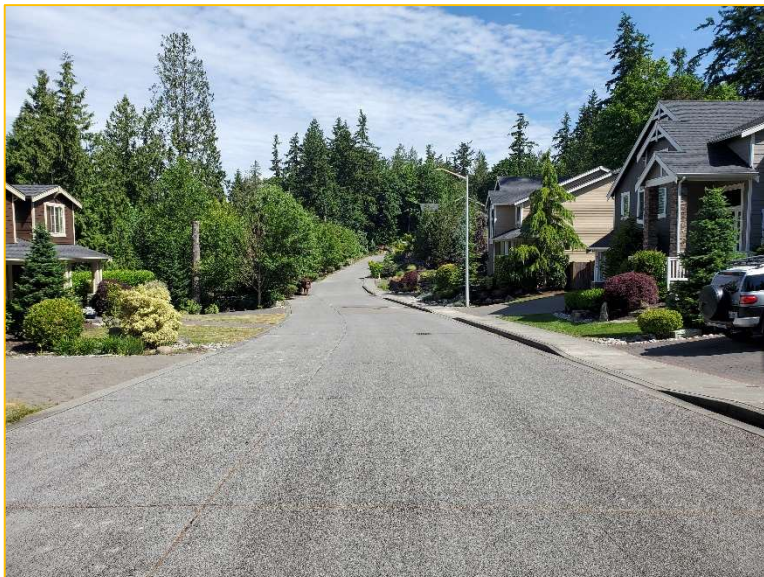
Photo 2 – Facing north on Hargreaves Pl. Runoff combines with the existing system and travels north.

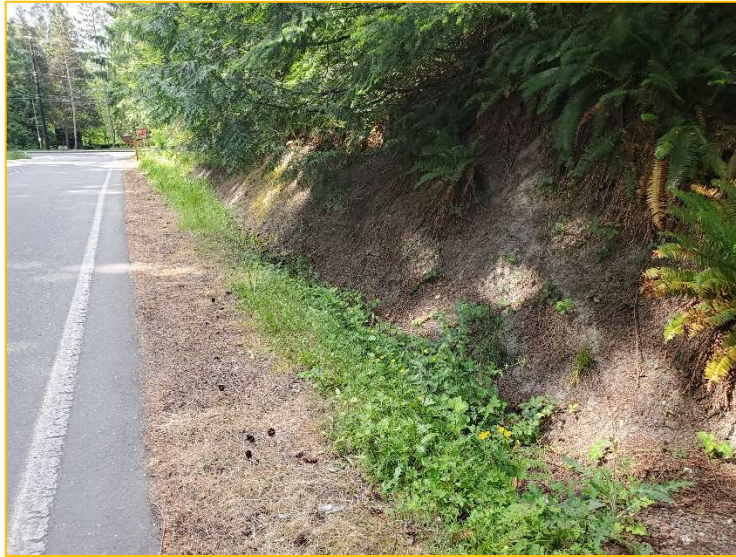
Photo E.1 – Facing south from the eastern property edge. Runoff enters drainage swale adjacent to the west side of 53rd Ave W and is conveyed south.

In the existing condition, portions of runoff from the subject site frontage along 53rd Ave W are collected via drainage swales and routed north along the west side of 53rd Ave W (*Photo E.1*). Flows enter a driveway culvert near the northeast corner of the subject parcel and daylight to a drainage swale that continues north before entering a culvert that directs water to a storm drain manhole (*Photo E.2*). Runoff is conveyed west within the existing tightlined storm system along 92nd St W, before being conveyed north to Hargreaves PI (*Photo E.3-5*). Runoff travels north along Hargreaves PI before outfalling to Smuggler's Gulch Creek (*Photo E.6*). Flows travel

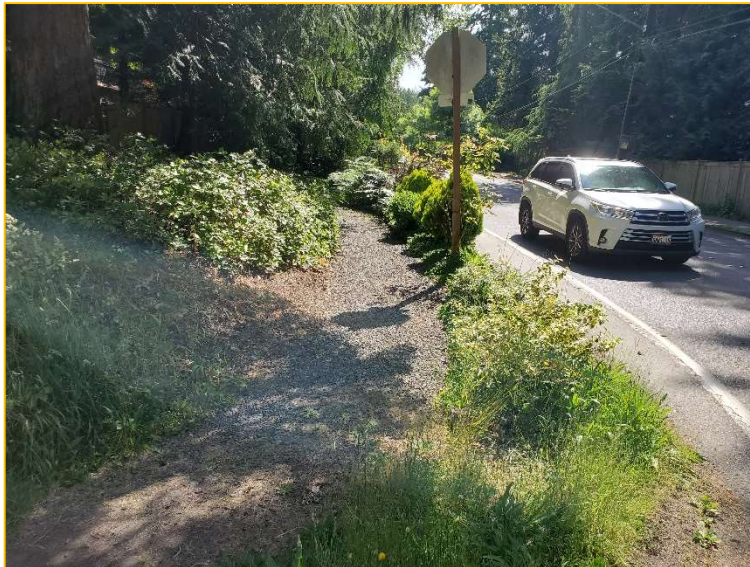
Photo E.2 – Facing north from the east side of 53rd Ave W. Runoff travelling south enters a catch basin and is conveyed west through the existing tightlined storm system.

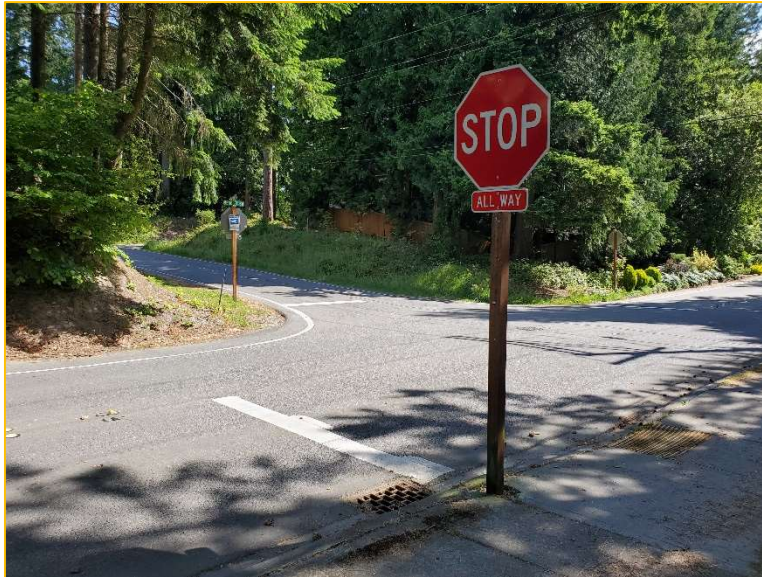
Photo E.3 – Facing northeast from the south side of 92nd St W. Runoff continues west through the existing tightlined storm system.

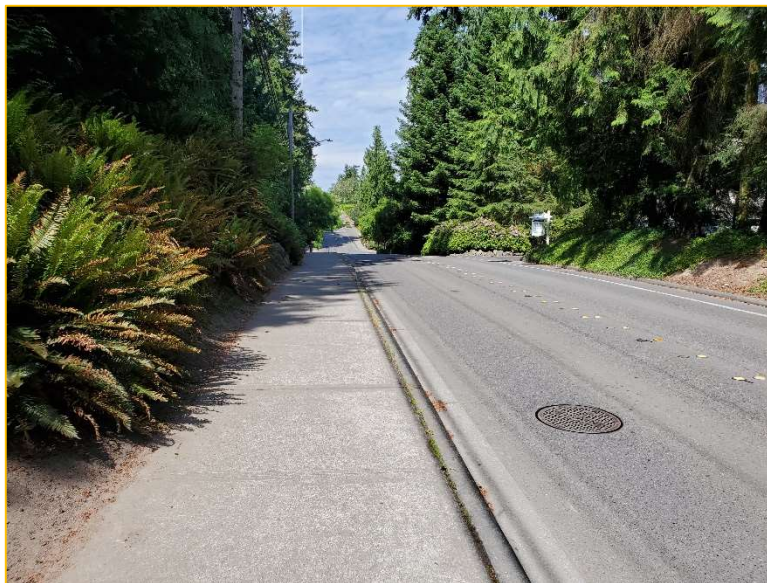
Photo E.4 – Facing west from the south side of 92nd St W. Runoff continues west through the existing tightlined storm system.

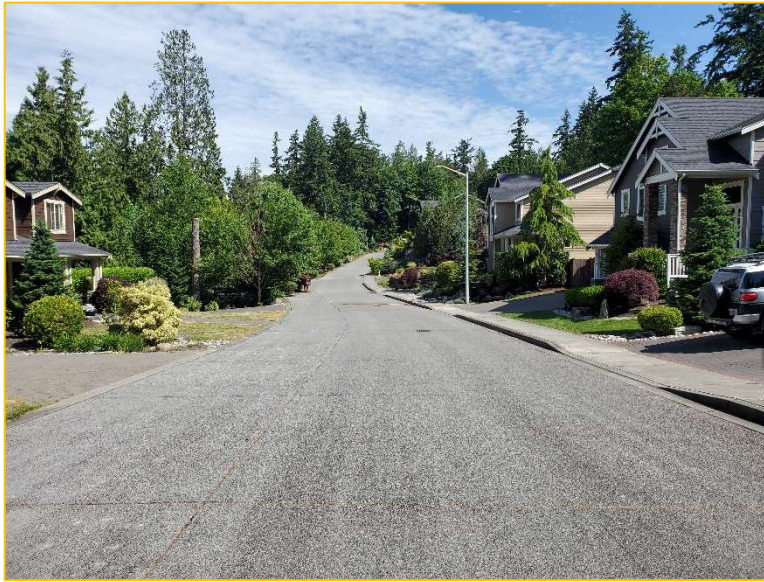
Photo E.5 – Facing north on Hargreaves Pl. Runoff travels north through existing tightlined storm system.

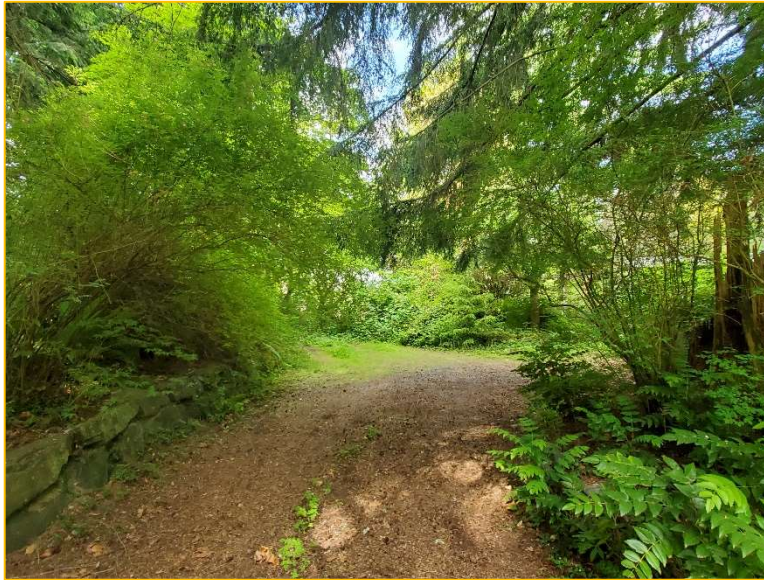
Photo W.1 – Facing west from the western portion of the site. Runoff sheet flows west across vegetated landcover.

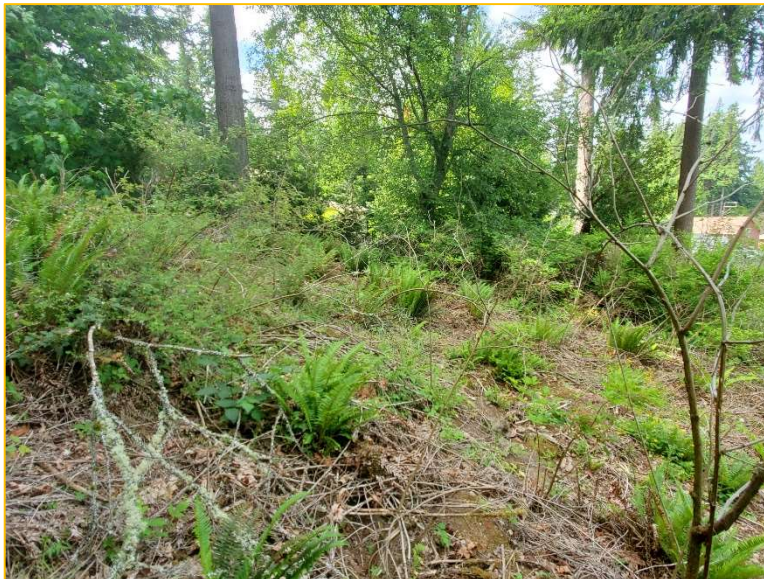
Photo W.2 – Facing south from the western edge of the site. Runoff sheet flows west across sloping terrain.

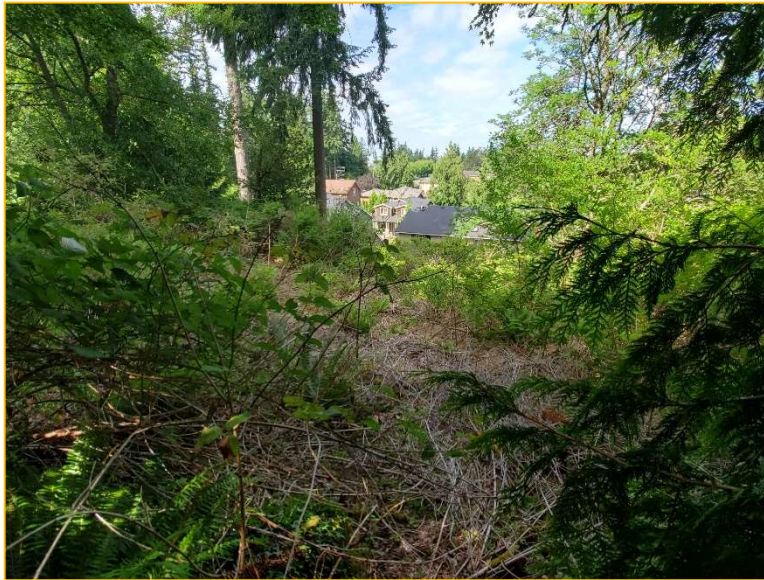
Photo W.3 – Facing west from the western edge of the site. Runoff sheet flows west across vegetated landcover.

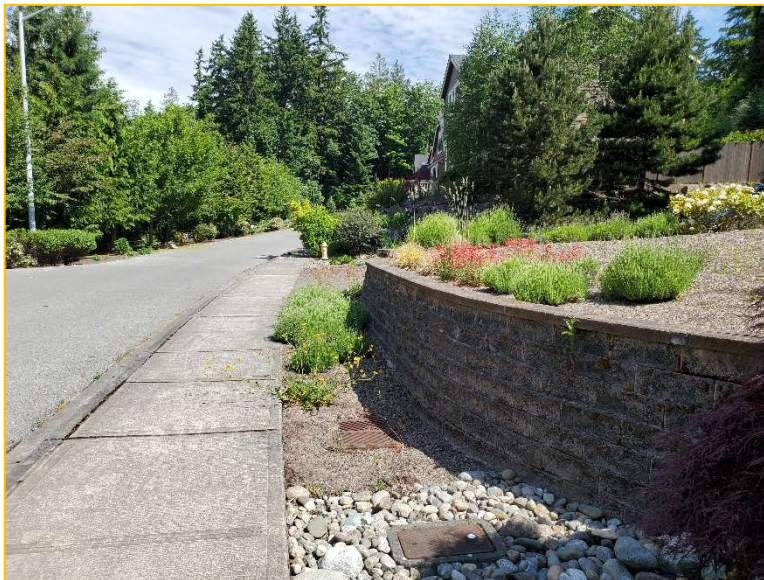
Photo W.4 – Facing north on Hargreaves Pl. Runoff sheet flows west across private residences towards the existing tightlined storm system.

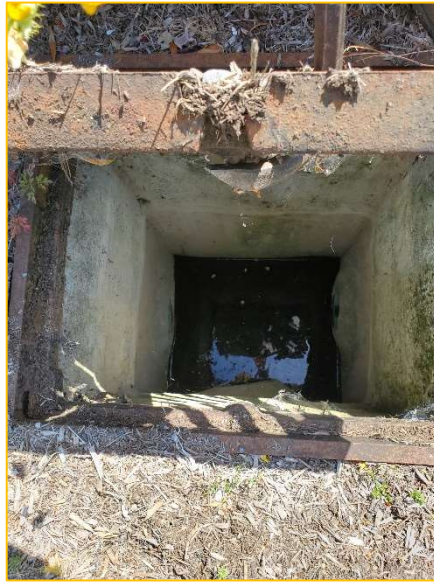
Photo W.5 – Facing east from the east side of Hargreaves Pl. Runoff enters existing catch basin and travels west across Hargreaves Pl.

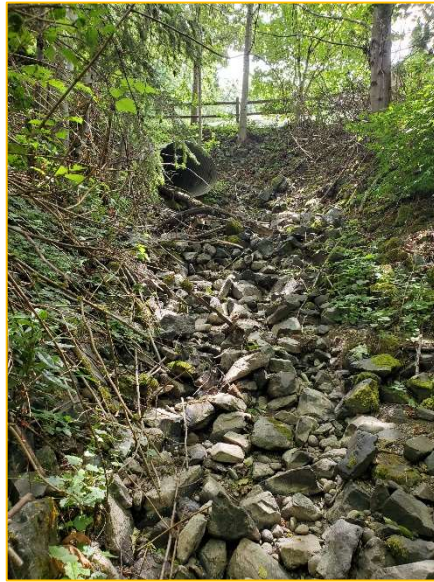
Photo W.7 – Facing east at the downstream end of the culvert just west of Hargreaves Pl. Flows outfall the culvert and continue west through vegetated understory. The downstream flow paths of the east and west subbasin combine at this location.

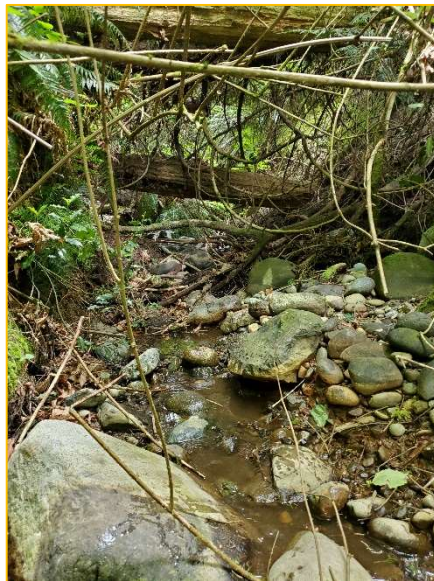
Photo W.8 – Facing east at the quarter-mile downstream location. Flows merge with existing Smuggler's Gulch Creek and continue west.

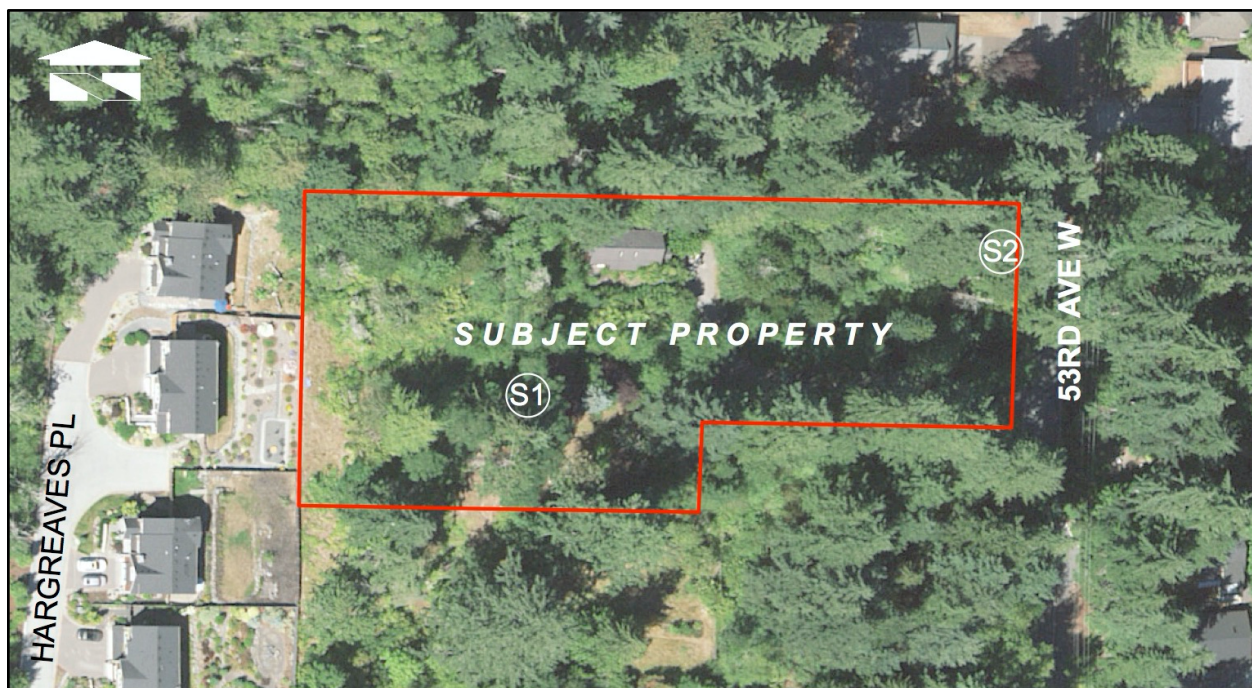
Figure 1 - Aerial photograph of the subject property and data site locations.
