AMERICAN GEOSERVICES

Geotechnical Evaluation Report

Parcel#28040300203200, Mukilteo, Snohomish County,
Washington

Reference: Landslide Evaluation Report, Parcel # 28040300203200, Mukilteo, Snohomish County, WA

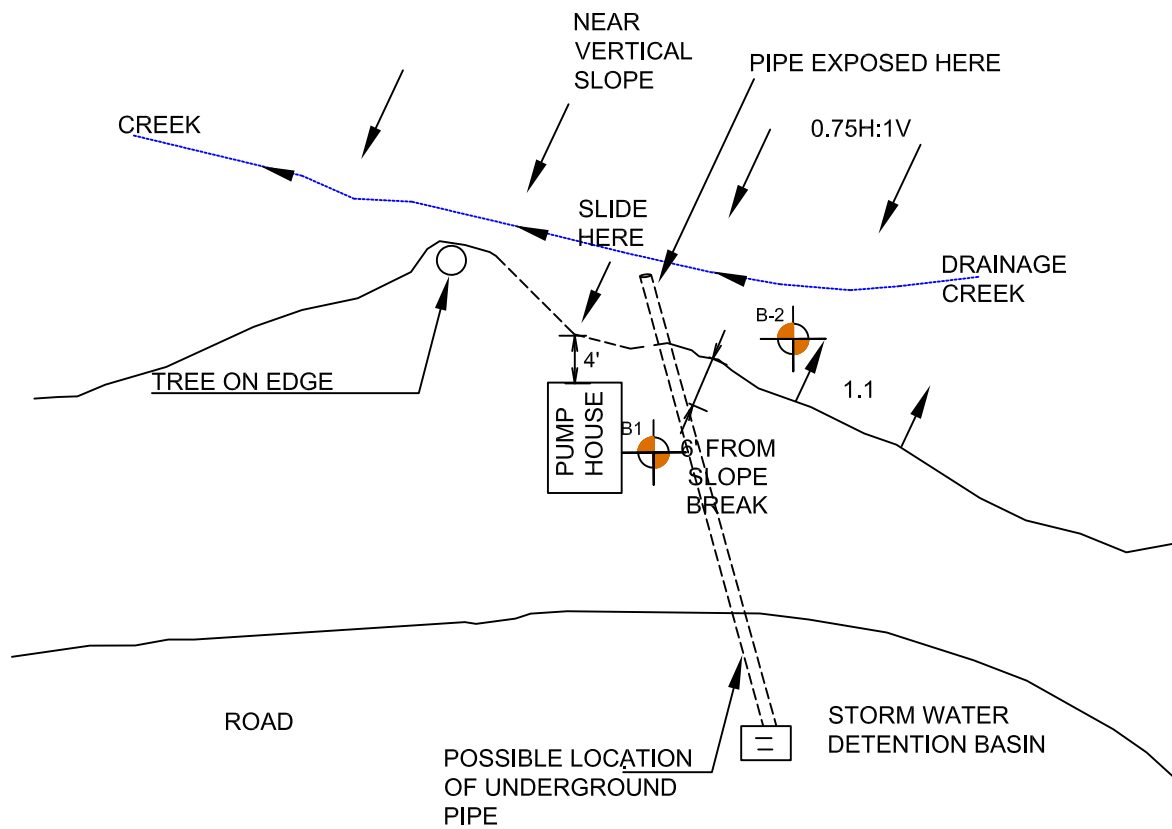
FIGURE 2B: GENERALIZED
CROSS-SECTION

See Figures 2A and 2B for surface conditions and a generalized cross-section of the site. See attached photographs included in an appendix for further details on the surficial site conditions.

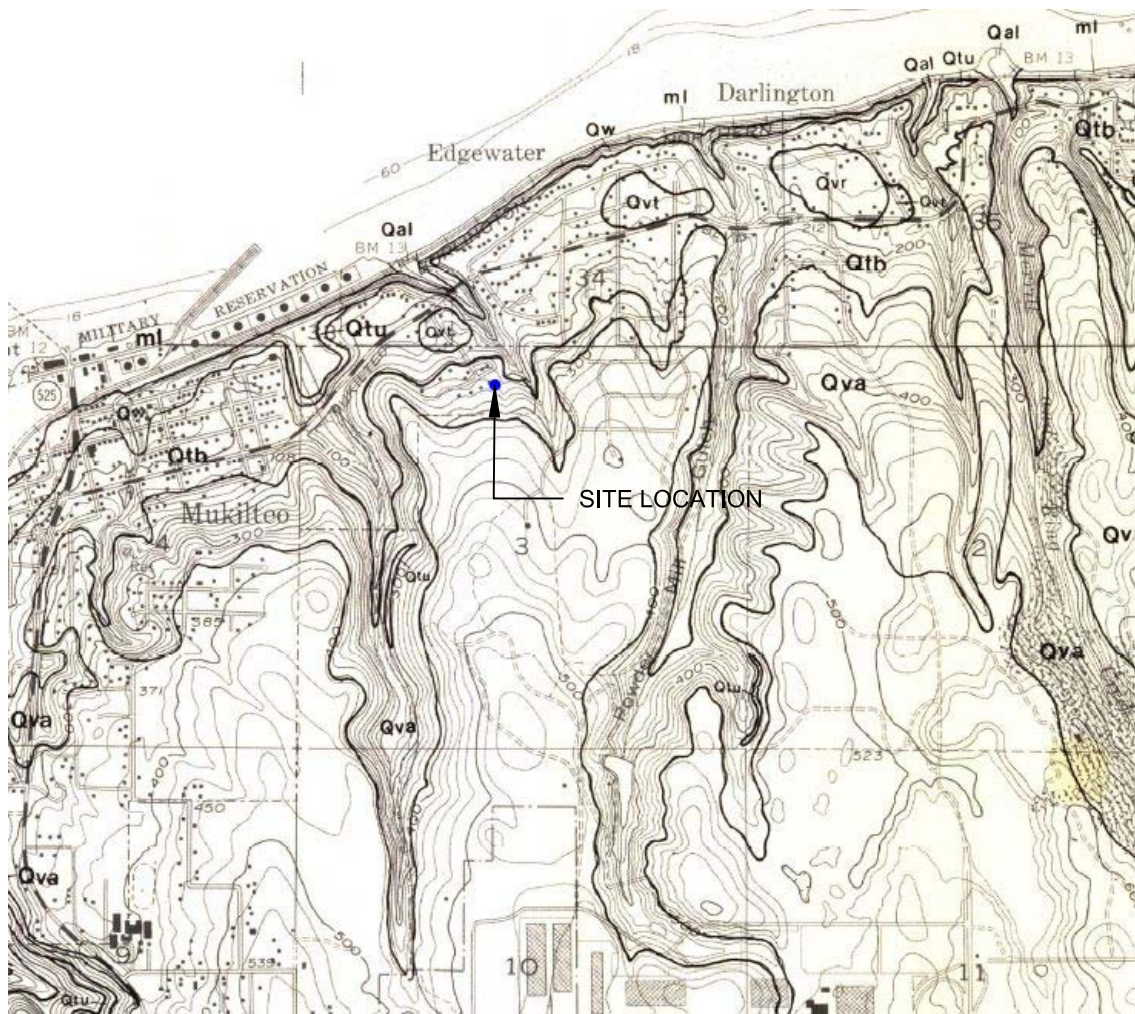
FIGURE 3: GEOLOGIC MAP

Native Sand-Silt Mixtures: The site is primarily underlain by about 11 feet of medium dense sand-silt mixtures (SP, SM,SP/SM) followed by generally dense mixtures of sands, silts, and gravel extending to the maximum explored depth of 25 feet. These soils most likely represent locally known advance outwash deposit, as noted in Figure 3. It appears Vashon till is not present at the site.
