# **GEOSPECTRUM CONSULTANTS, INC.**

November 27, 2017

**SUBJECT: GEOTECHNICAL RECONNAISSANCE**  
Residential Property Development  
Snohomish County Parcel No. 00408600400  
100XX 63<sup>rd</sup> Place West  
Mukilteo, Washington  
Project No. 17-114-01

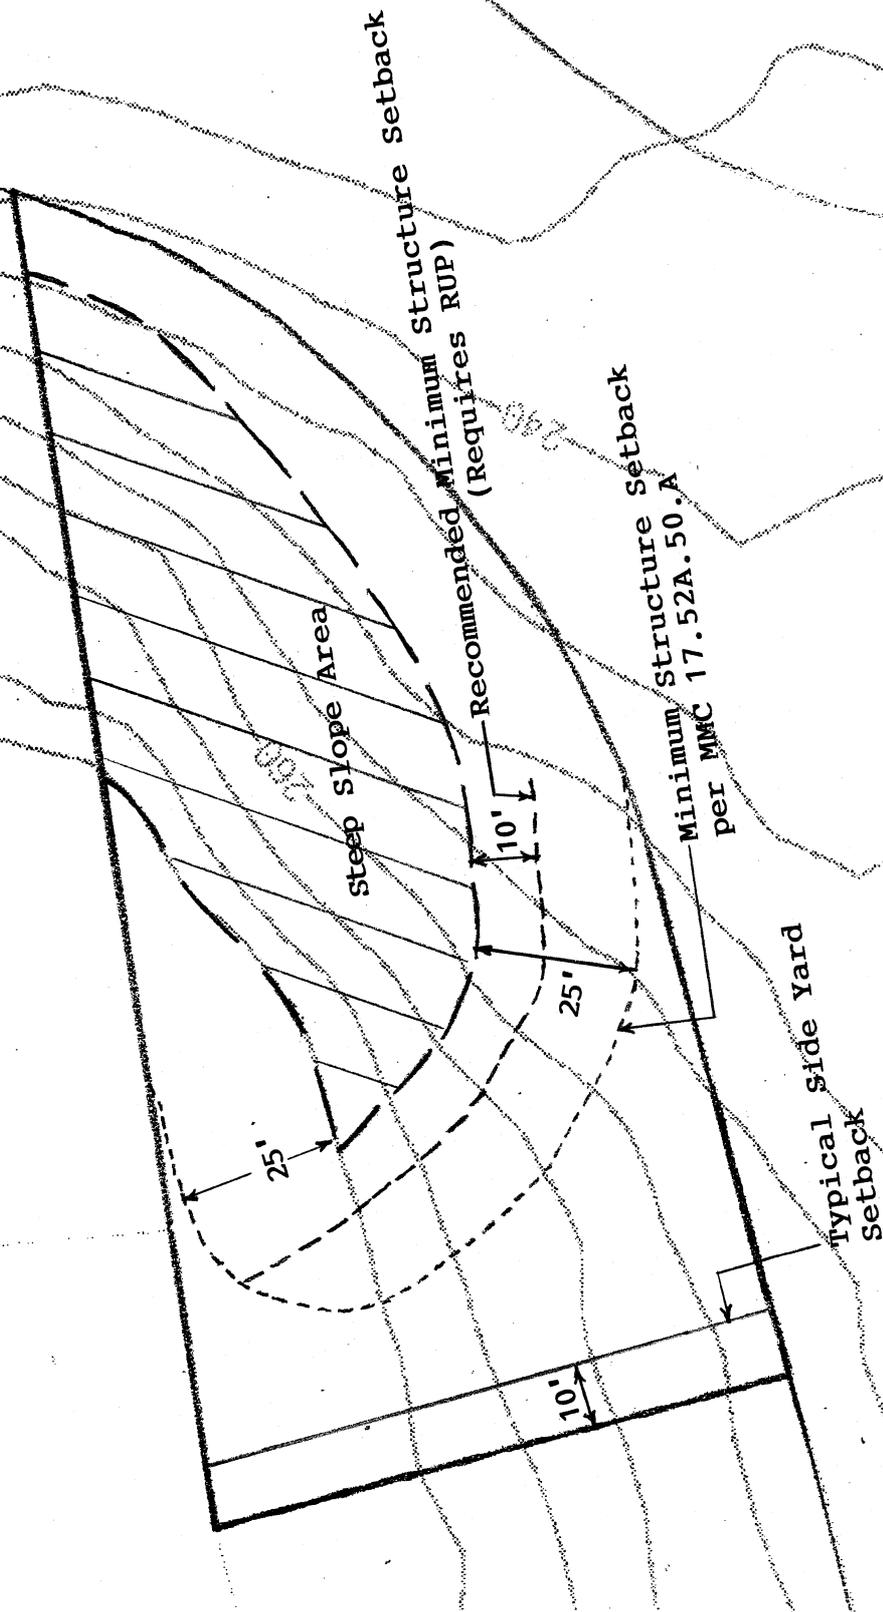
**MINIMUM STRUCTURE-SLOPE SETBACKS**

Our site observations indicate the subject lot is currently stable and most of the smaller trees on the lot are growing relatively straight, but we observed several of the larger Alder trees particularly within the very steep slope area (70 - 100% area shown on Figure 3) that are severely bowed and/or leaning indicating possible past shallow soil movement. The bowed trees are bowed in the downslope direction near the base of the trees indicating that the trees were tilted downslope early in their life (1940's to 1950's).

slope areas is a lateral boundary as approximately shown on Figure 3. Considering that the boundary with the steep slope area is lateral, in our opinion development related site disturbance of the moderately sloped area may extend to the edge of the steep slope area provided the disturbed areas are stabilized after construction, but we recommend that structure foundations be set back at least 10 feet from the edge of the steep slope area or greater as required for temporary construction excavations per our recommendations in this report. Therefore for "Reasonable Use" provision considerations for the subject lot our recommended minimum steep slope buffer would be zero and our recommended minimum buffer setback would be 10 feet.

Slope Buffers and Structure Setbacks: We do not recommend development or disturbance of the steep to very steep slope areas of the site. Development should be limited to the moderately sloped areas of the subject lot (slope gradients less than 40%) which are generally in the western 1/3 of the lot and along the southern boundary as shown in Figure 3. In general to minimize development risk, structures should be set back from the top and toe of steep to very steep slopes as far as possible within the constraints of the development plans.

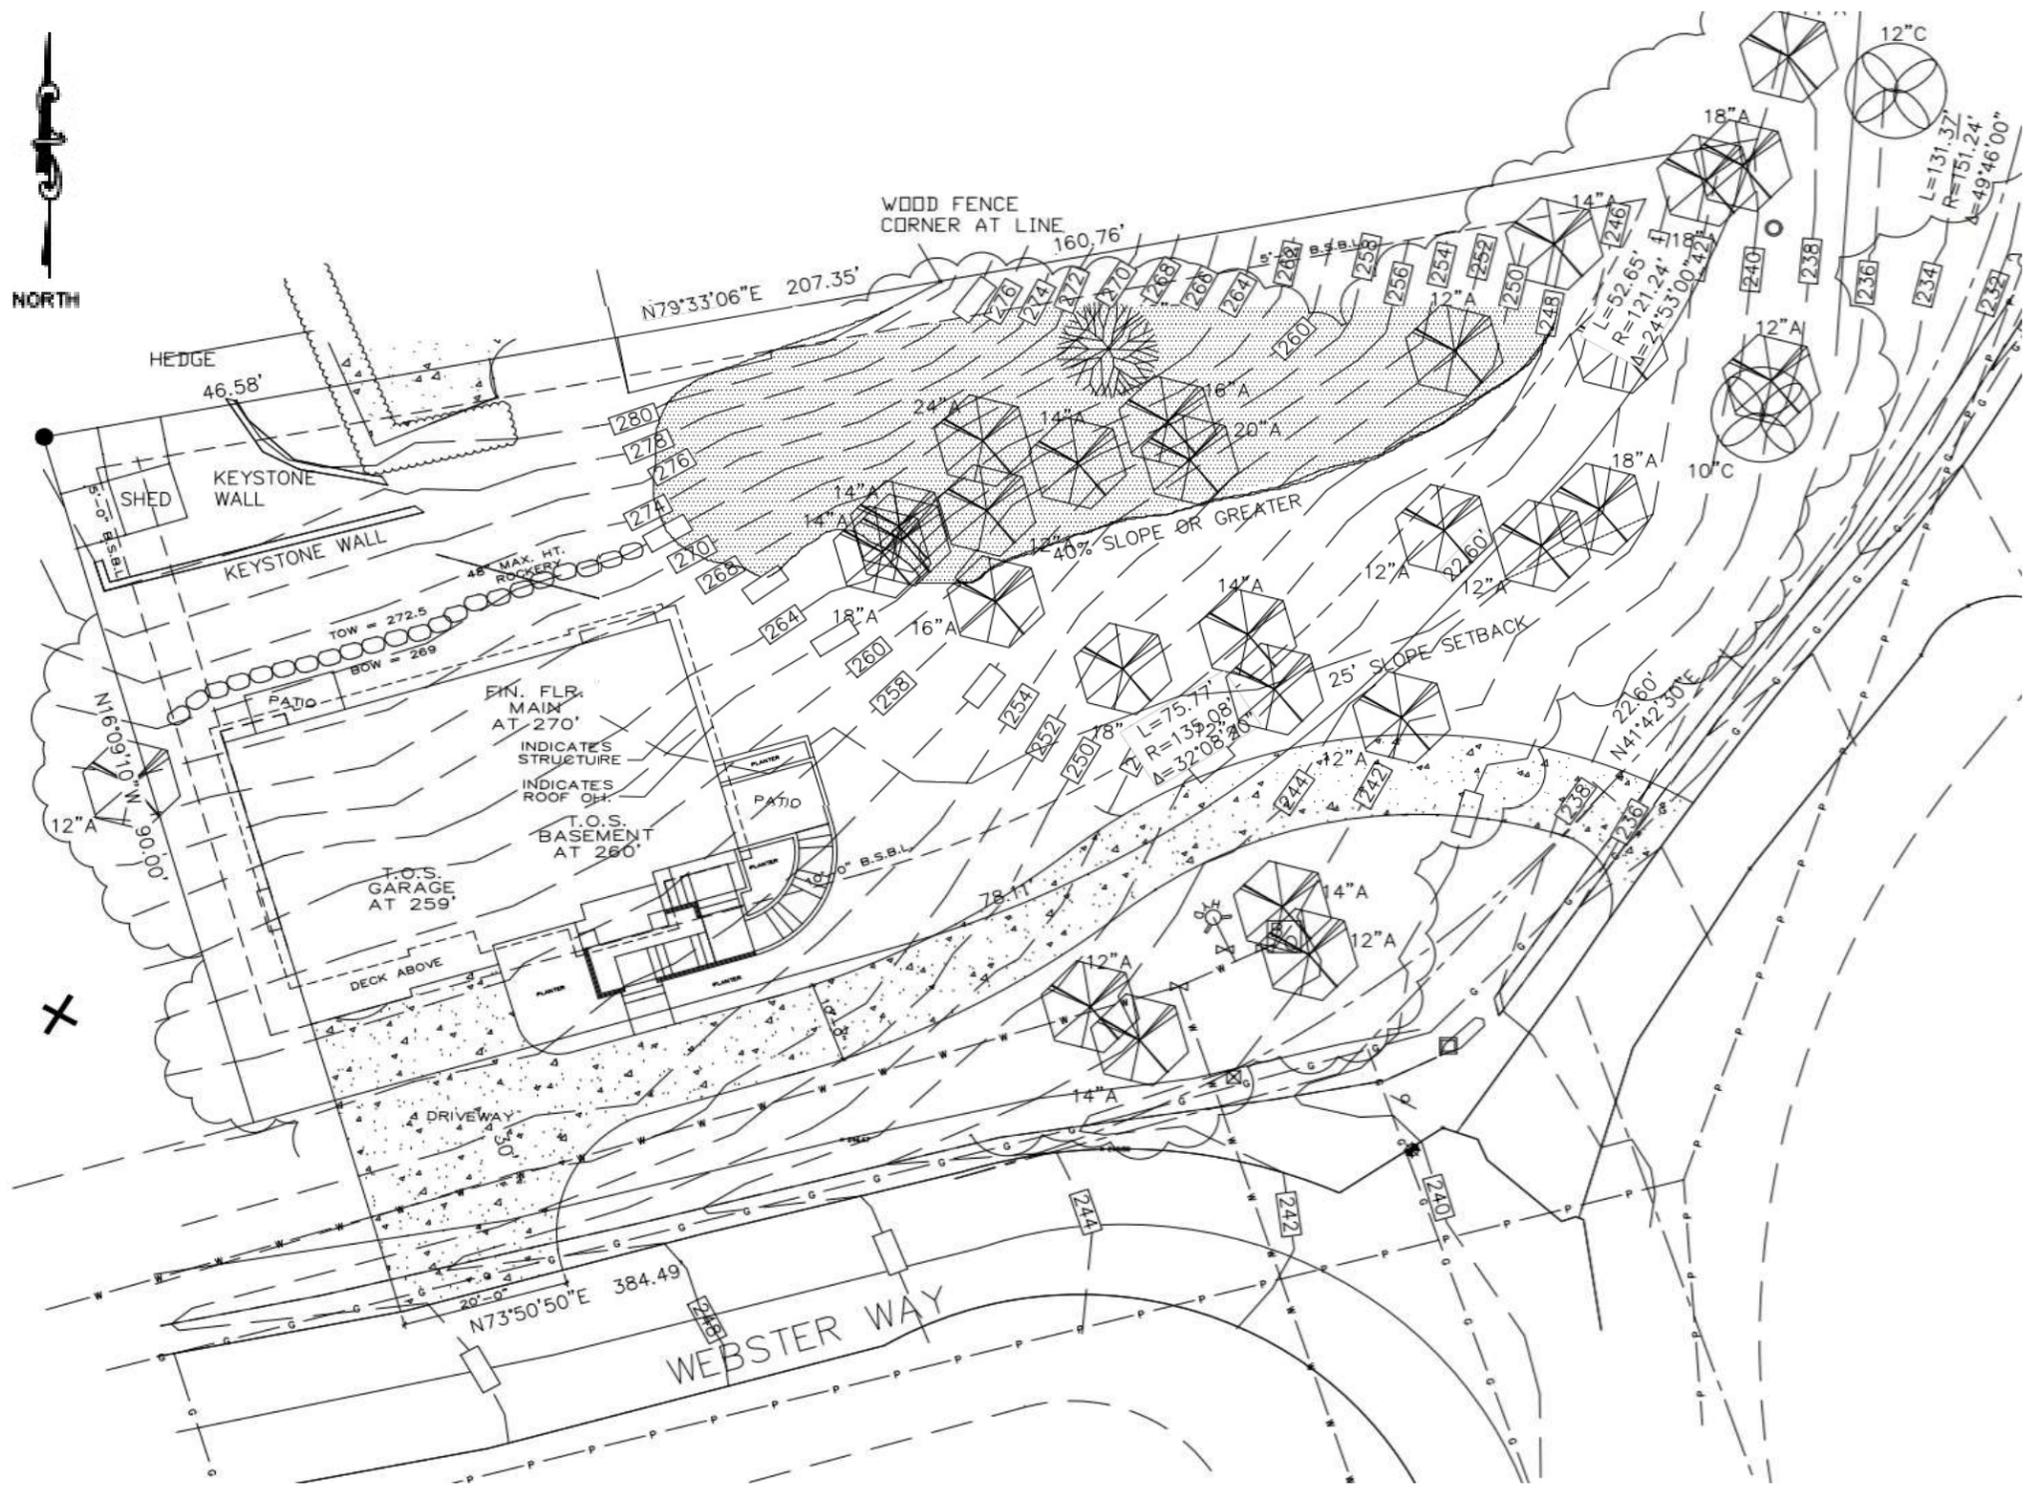
Plate 1 – Site Plan

Based on the information provided, we understand that you are proposing to develop the west section of the existing vacant lot with the construction of a new two-story single-family residence with a south-facing daylight basement and attached garage. The garage will be accessible by a driveway that begins east of the intersection of Webster Way and 63<sup>rd</sup> Place W and runs parallel to the south property line towards the residence along gradually sloped topography. The residence will have a footprint of approximately 1700 square feet, with a total interior living space of 4,000 square feet within the three floors. We understand that excavations into the existing slope at the west section of the property will be required for the construction of the new residence, but this section of the property is not mapped as a steep slope. As noted in the above-referenced geotechnical report, the site contains steep to very steep slopes within the central and northeast areas and therefore is considered a Geologic Sensitive Area. The existing steep slope and the footprint of the proposed residence are illustrated in in Plate 1 – Site Plan.
