DRAINAGE REPORT

ZHANG SHORT PLAT

7908 53rd Ave W

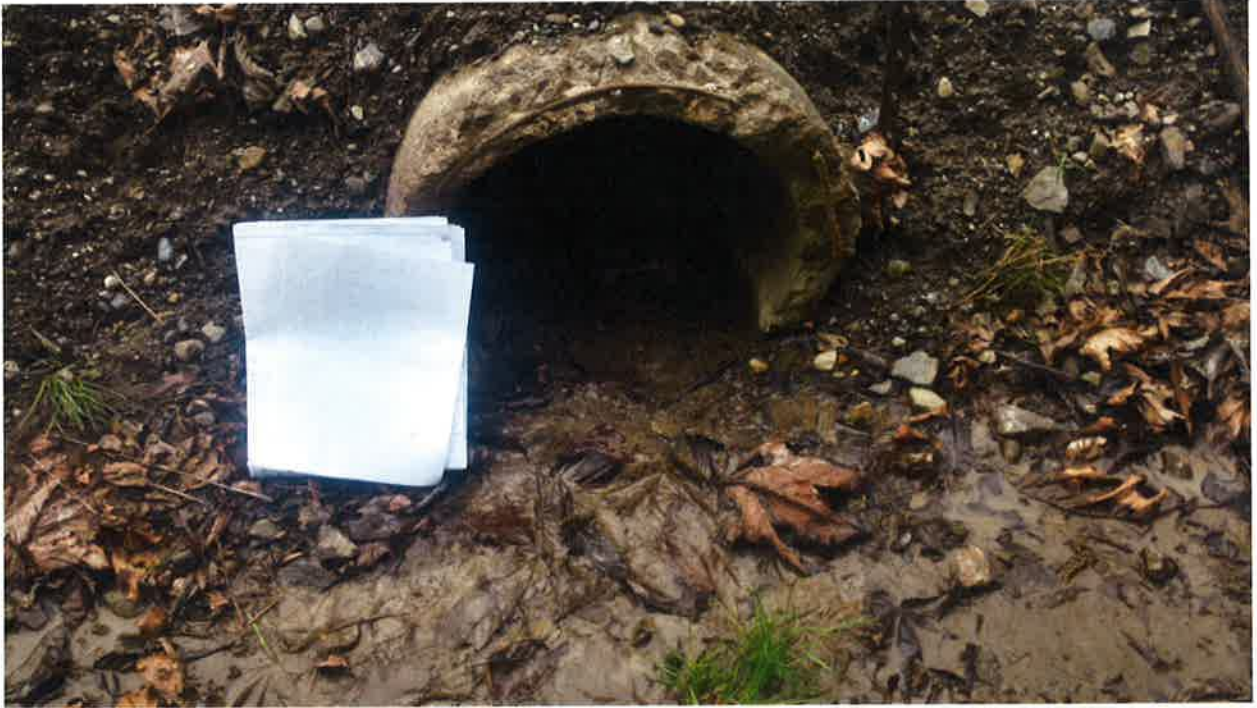
18" CULVERT ENTRANCE FRONTING ZHANGE SITE ON THE WEST

All but 0.09 acres of the developed site will drain down to the west in an HDPE pipe to be laid on the surface. It will discharge into the BNSF ROW through an energy dissipater. This is the same path that any existing sheet flow coming down the hillside follows. A man-made ditch adjacent to the railroad tracks collects the hillside runoff and conveys it to an 18 inch culvert that passes under the tracks and outfall to the Sound. As shown in the Downstream Plath Map" above, there are culverts located about every 200 to 300 feet along the tracks, with one of those culverts located very close to the proposed HDPE pipe. Although the ditch and culverts collect sediment from the hillside, the BNSF maintains them so that they appear to be functioning adequately. No signs of capacity problems were observed. Photos of the BNSF drainage system follow.

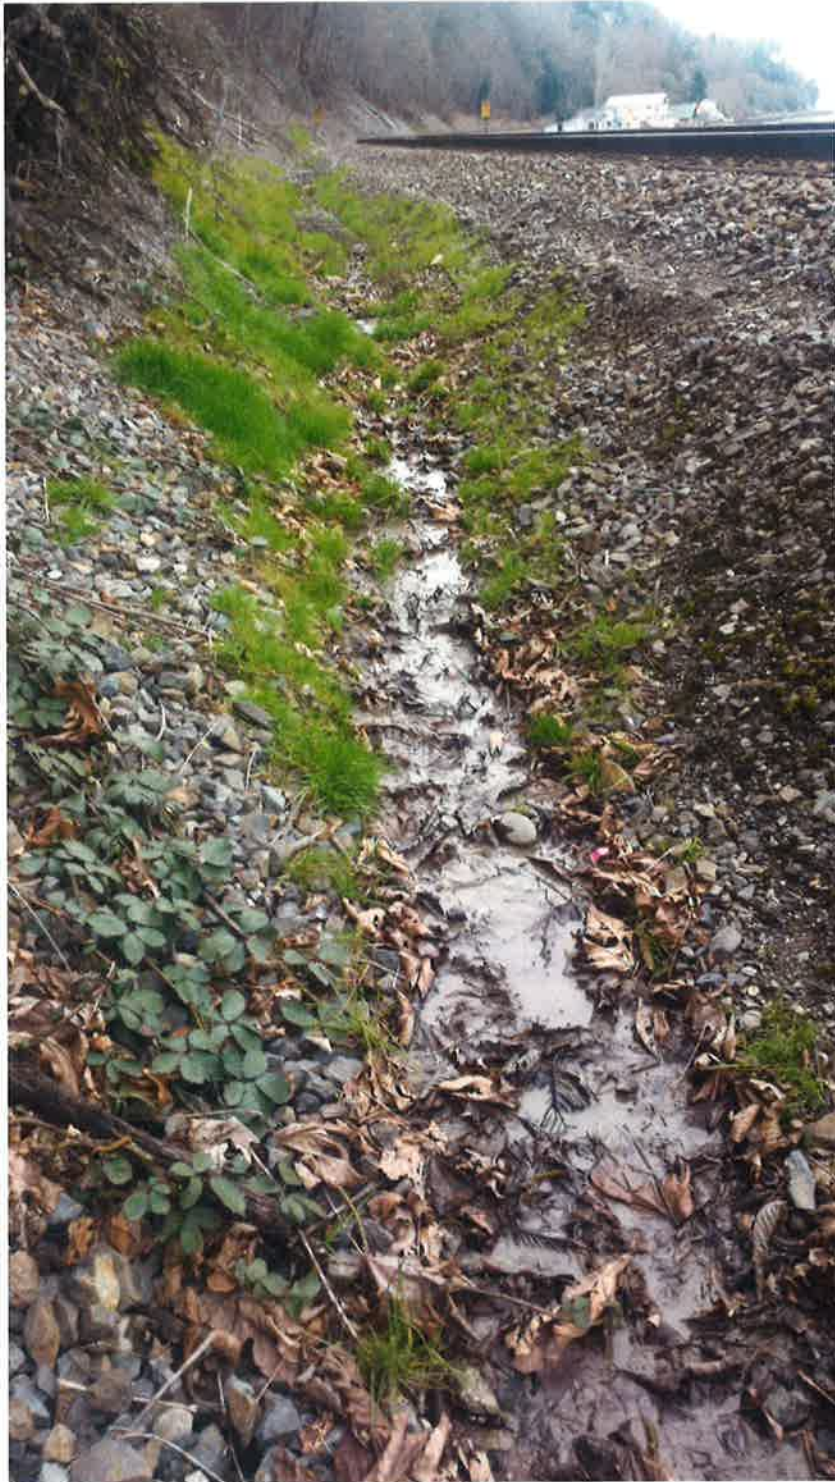
TYPICAL DITCH SECTION

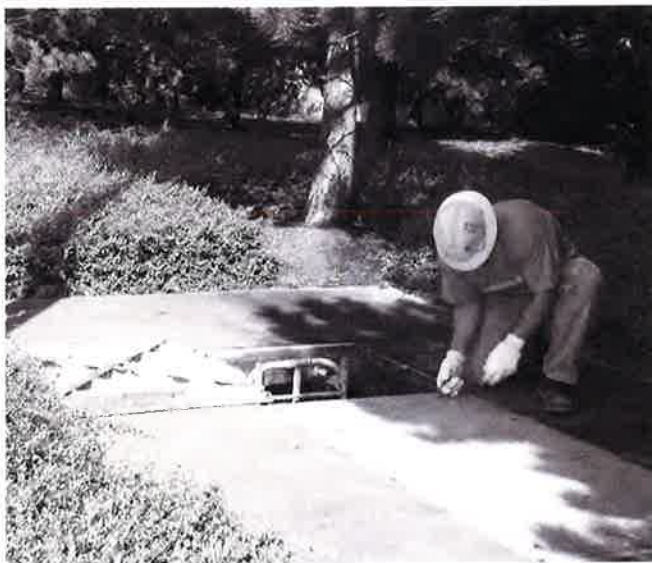
1. If applicable, set up safety equipment to protect and notify surrounding vehicle and pedestrian traffic.
2. Visually inspect the external condition of the unit and take notes concerning defects/problems.

3. Open the access portals to the vault and allow the system vent.
4. Without entering the vault, visually inspect the inside of the unit, and note accumulations of liquids and solids.
5. Be sure to record the level of sediment build-up on the floor of the vault, in the forebay, and on top of the cartridges. If flow is occurring, note the flow of water per drainage pipe. Record all observations. Digital pictures are valuable for historical documentation.
6. Close and fasten the access portals.

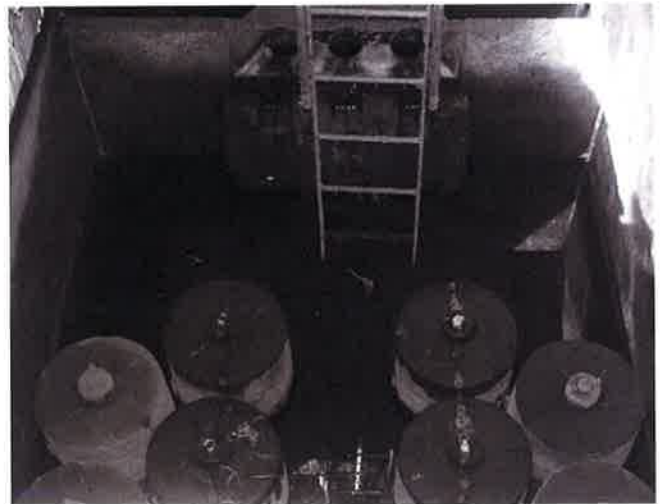
The need for maintenance is typically based on results of the inspection. The following Maintenance Decision Tree should be used as a general guide. (Other factors, such as Regulatory Requirements, may need to be considered)

1. Sediment loading on the vault floor.
 - a. If $>4"$ of accumulated sediment, maintenance is required.
2. Sediment loading on top of the cartridge.
 - a. If $>1/4"$ of accumulation, maintenance is required.

3. Submerged cartridges.
 - a. If $>4"$ of static water in the cartridge bay for more than 24 hours after end of rain event, maintenance is required.
4. Plugged media.

- a. If pore space between media granules is absent, maintenance is required.
5. Bypass condition.
 - a. If inspection is conducted during an average rain fall event and StormFilter remains in bypass condition (water over the internal outlet baffle wall or submerged cartridges), maintenance is required.

6. Hazardous material release.
 - a. If hazardous material release (automotive fluids or other) is reported, maintenance is required.
7. Pronounced scum line.

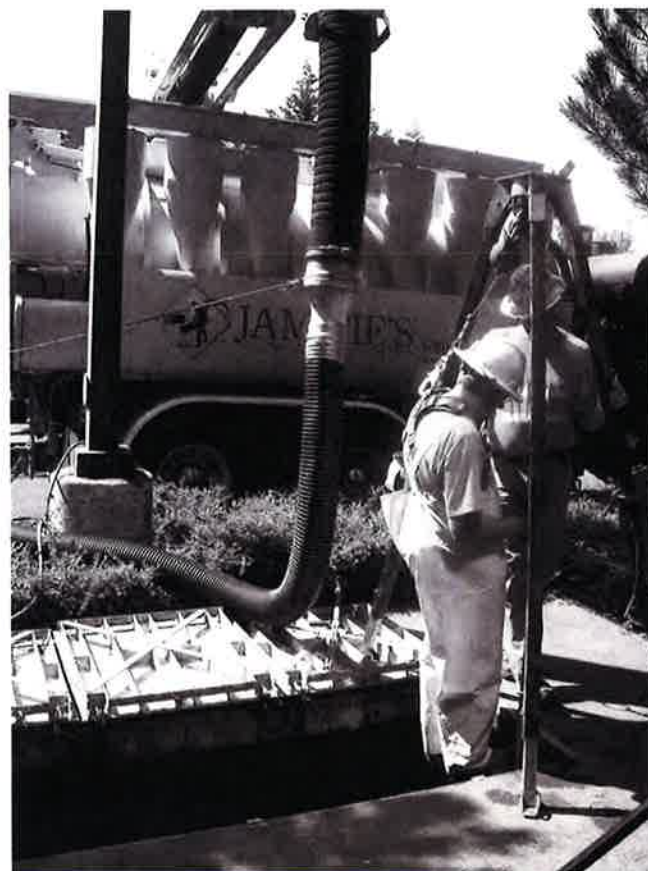
- A. This activity will require that maintenance personnel enter the vault to remove the cartridges from the under drain manifold and place them under the vault opening for lifting (removal). Unscrew (counterclockwise rotations) each filter cartridge from the underdrain connector. Roll the loose cartridge, on edge, to a convenient spot beneath the vault access.

Using appropriate hoisting equipment, attach a cable from the boom, crane, or tripod to the loose cartridge. Contact CONTECH Construction Products for suggested attachment devices.

Important: Note that cartridges containing leaf media (CSF) do not require unscrewing from their connectors. Take care not to damage the manifold connectors. This connector should remain installed in the manifold and could be capped during the maintenance activity to prevent sediments from entering the underdrain manifold.

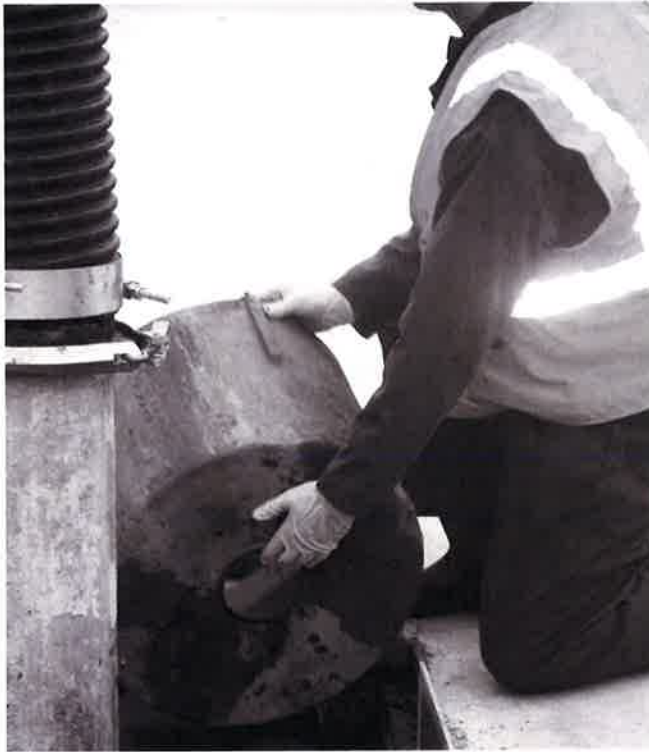
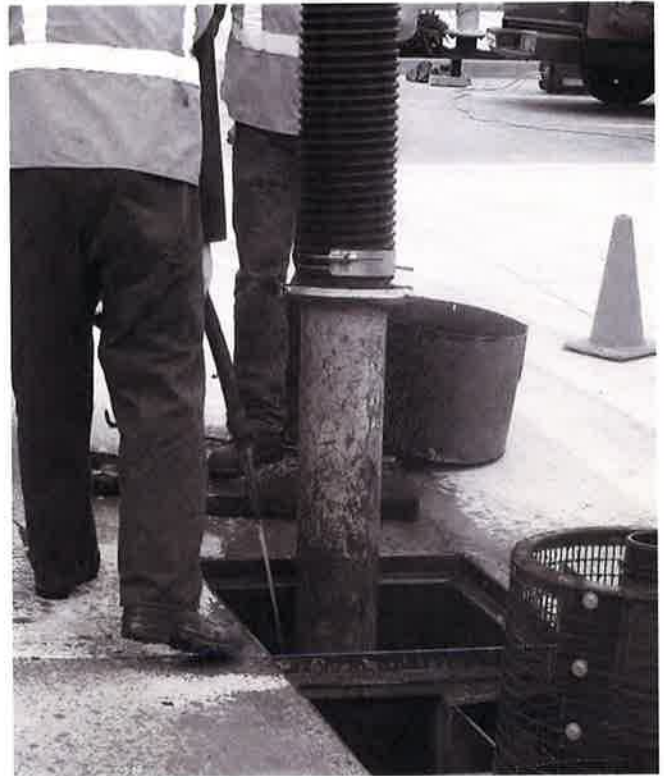
Important: Note that cartridges containing media other than the leaf media require unscrewing from their threaded connectors. Take care not to damage the manifold connectors. This connector should remain installed in the manifold and capped if necessary.

- D. Empty the cartridge onto the vault floor. Reassemble the empty cartridge.
- E. Set the empty, used cartridge aside or load onto the hauling truck.
- F. Continue steps a through e until all cartridges have been removed.

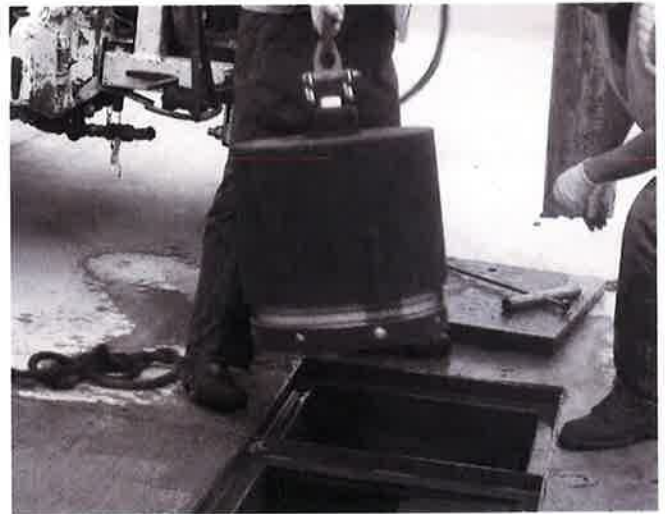
- 8. Remove accumulated sediment from the floor of the vault and from the forebay. This can most effectively be accomplished by use of a vacuum truck.
- 9. Once the sediments are removed, assess the condition of the vault and the condition of the connectors. The connectors are short sections of 2-inch schedule 40 PVC, or threaded schedule 80 PVC that should protrude about 1" above the floor of the vault. Lightly wash down the vault interior.
 - a. Replace any damaged connectors.
- 10. Using the vacuum truck boom, crane, or tripod, lower and install the new cartridges. Once again, take care not to damage connections.
- 11. Close and fasten the door.
- 12. Remove safety equipment.
- 13. Finally, dispose of the accumulated materials in accordance with applicable regulations. Make arrangements to return the used empty cartridges to CONTECH Construction Products.
