**RE: File: SD-2021-001/ENG-2021-019/SEPA-2021-010  
Harbor Grove Subdivision**

Please accept the following comments regarding the Determination of Non-Significance issued on August 30, 2023 for the Harbor Grove preliminary seven-lot subdivision.

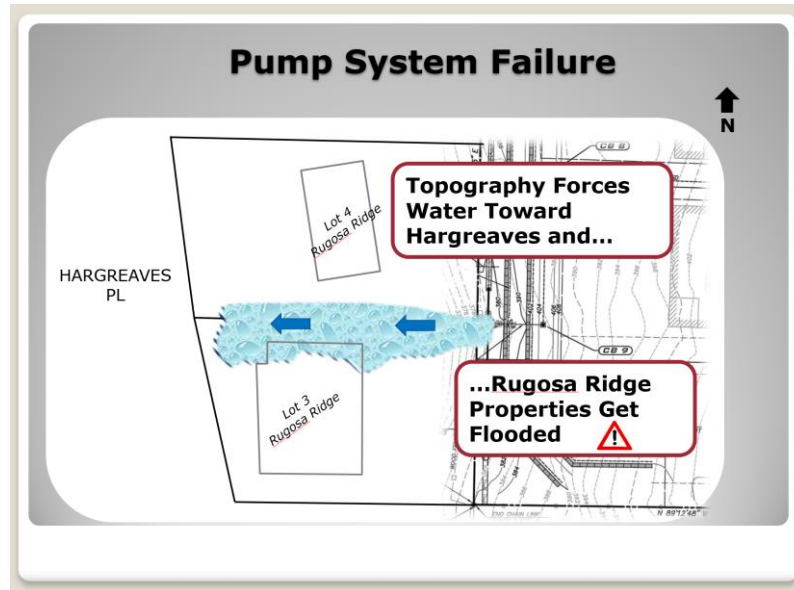
**Figure 1 – Impact of Stormwater Pump System Failure on Rugosa Ridge Properties**

In summary, the City will have no control over how the future HOA conducts its business, which means it will be unable to prevent a pump system failure. There is a possibility the future Harbor Grove HOA will become inactive, meaning that it stops conducting meetings and collecting assessments from its members. Can the City really prevent this scenario and what would be the outcome if this were to occur?

The potential impact of a drainage system failure must be evaluated and avoided or mitigated.

**Analysis:** Possible causes of failure of the Harbor Grove stormwater pump system on the west side of the property include pump failure; debris blockage of the water intake; sediment buildup; power outage; or failure of the force main outlet piping. The conveyance swale, pump and piping would be located at a higher elevation than the adjacent property. A system failure would result in stormwater overflowing off-site in a westerly direction due to the sloping topography. One of the adjacent residences sits directly in the flow path of any surface water exiting the lowest point of the Harbor Grove property (see *Figure 1*). A drainage system failure on the Harbor Grove property would potentially result in direct surface flows onto the neighboring property, causing damage to the structure, yard and landscaping. The DNS does not acknowledge or describe this impact.

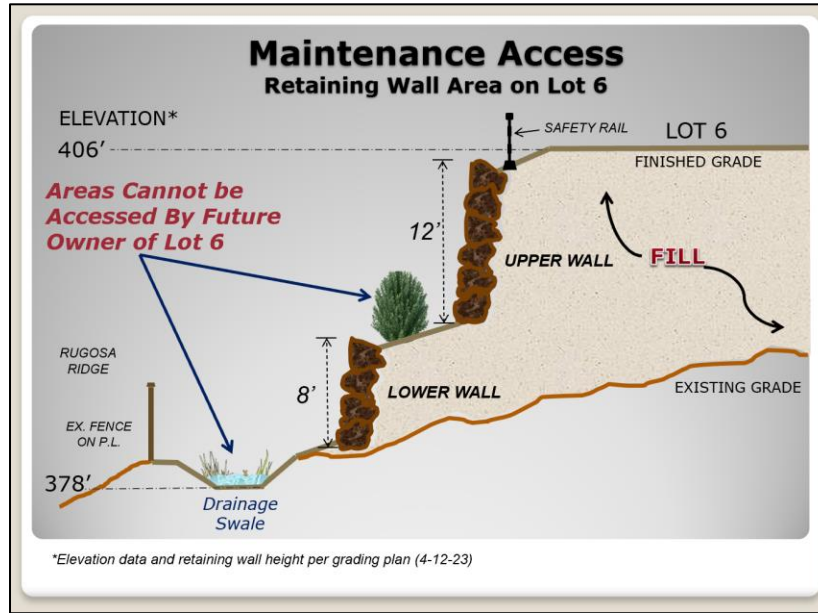
**Figure 2 – Illustration Showing Difficulty of Access to Improvements on Lot 6**

- c. Retaining Walls. The retaining walls along the western boundary of the project will be isolated. Future houses and other improvements will be constructed between the access road and the walls, meaning that any wall failures or damaged areas cannot be accessed for repairs. For example, if a section of the 12' wall on Lot 6 were to fail, it is likely that large equipment would be needed to bring in materials. However, there would be no place for equipment staging. The expectation, therefore, is that the walls will be designed, installed and maintained such that they will last forever. This is a false premise that will lead to erosion and drainage impacts on the adjacent Rugosa properties in the event of a wall failure. Such impacts cannot be addressed because the wall cannot be accessed for repairs. This is a potential unavoidable adverse impact under SEPA.

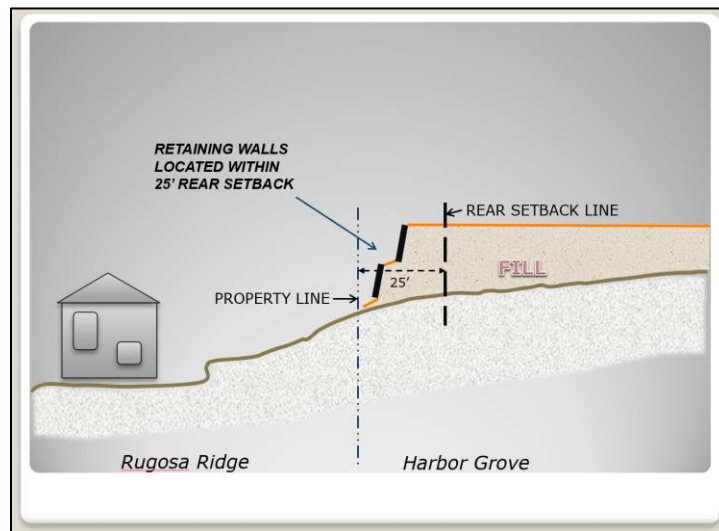
*Figure 3 – Diagram showing location of retaining walls within rear setback*

The proposed retaining walls along the western boundary of the project are located within the 25-foot rear setback required by the zoning code (*Figure 3*). The lower wall would be within 12 feet of the property line, while the upper wall would be within about 20 feet. The total length of the lower wall would be 170 feet, while the upper wall would be 250 feet. The combined height of the walls would be up to 20 feet on Lots 6 and 7, in the southwest corner of the project site. Both walls would exceed six feet in height in places. The purpose of the walls is to enable the grade of the site to be raised and leveled such that it is significantly higher than the surrounding properties.

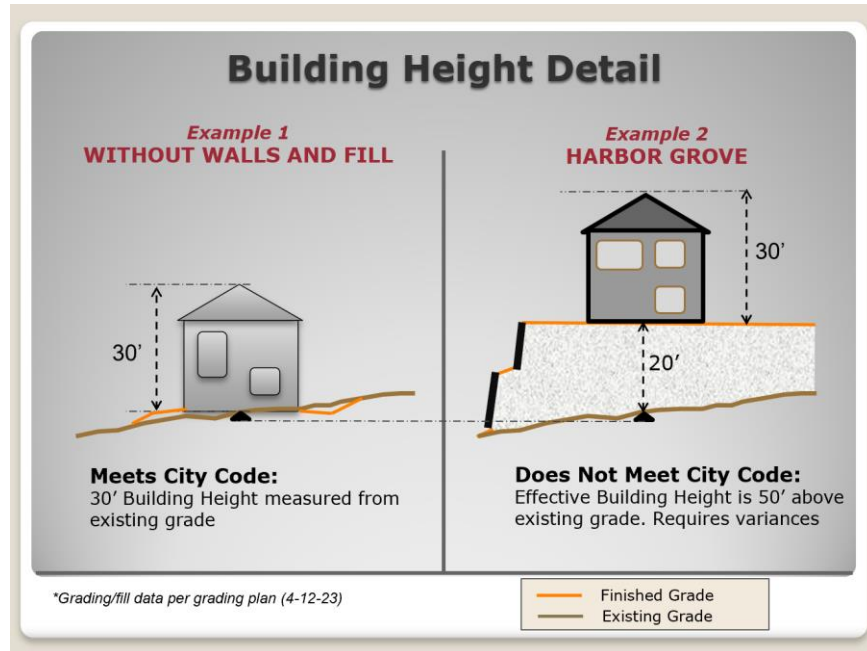
Figure 4 – Building Height examples – with and without project

Under [MMC Section 17.20.020 - Structure bulk matrix](#) – maximum building height in the RD 12.5 zone is 30 feet from *existing grade*, as stated in the City’s requirements for building height calculation. The finished grade on Lots 4 through 7 is proposed to be elevated by up to 20 feet above existing grade. Calculation of building height based on the finished grade would result in future residences being allowed to have 30 feet of building height on top of 20 feet of fill for an overall height of up to 50 feet above the existing ground level (*Figure 4*). Applying the building height standard in this manner would be absurd and would create significant impacts on adjacent properties. It would amount to a building height bonus. Buildings located at or near the 25’ rear setback line would tower over neighboring houses and yards, resulting in light and shadow impacts and loss of privacy, use and enjoyment. These impacts have not been addressed or mitigated.

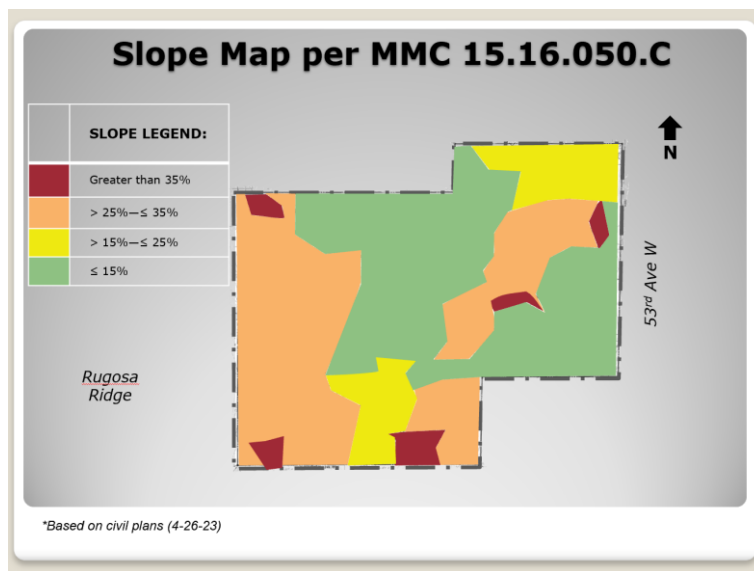
**Figure 5 – Slope Map Showing Approximate Breakdown of Slopes by Percentage**

To meet the standards in Table 1 – Clearing Matrix, the application on file should have included a map showing a breakdown of on-site slopes according to steepness. Such a map can be prepared easily using Autocad or other common engineering software. See Figure 5 below, which shows the site to be anything but flat...

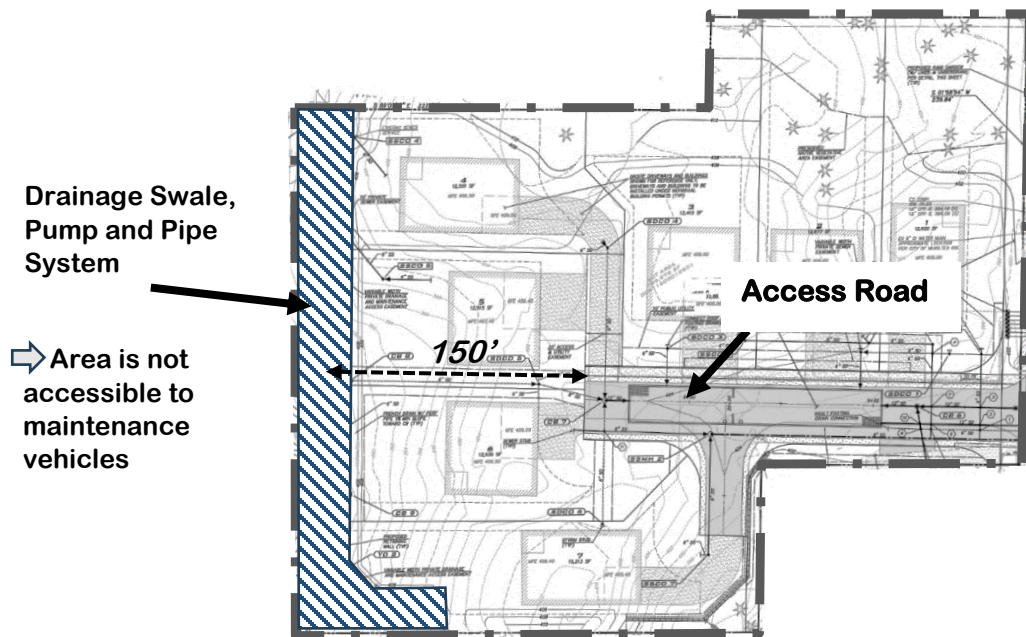
Figure 5 – Map of Project Showing Location of Drainage System and Access Road

**Analysis:** The stormwater drainage swale, pump and pipe system will be located at the base of a large retaining wall and would be inaccessible from any road or driveway. The nearest road would be approximately 150' as the crow flies, and the actual travel distance on foot would be much further (see Figure 5 below). At this location, it would be physically impossible to provide vehicular access to this portion of the drainage system. As a result, all maintenance will need to be performed by hand and all materials and equipment will need to be hand-carried. This will greatly limit the type of work that can be performed and the frequency of maintenance.

The project design does not comply with stormwater facility access and maintenance standards because the stormwater pump system will be inaccessible to maintenance vehicles.
