## DRAINAGE REPORT

# *Rodriguez Commercial Site*

4203 78<sup>th</sup> ST SW  
Mukilteo, WA. 98275  
Tax No. 00611600009300

*BRL Services LLC*

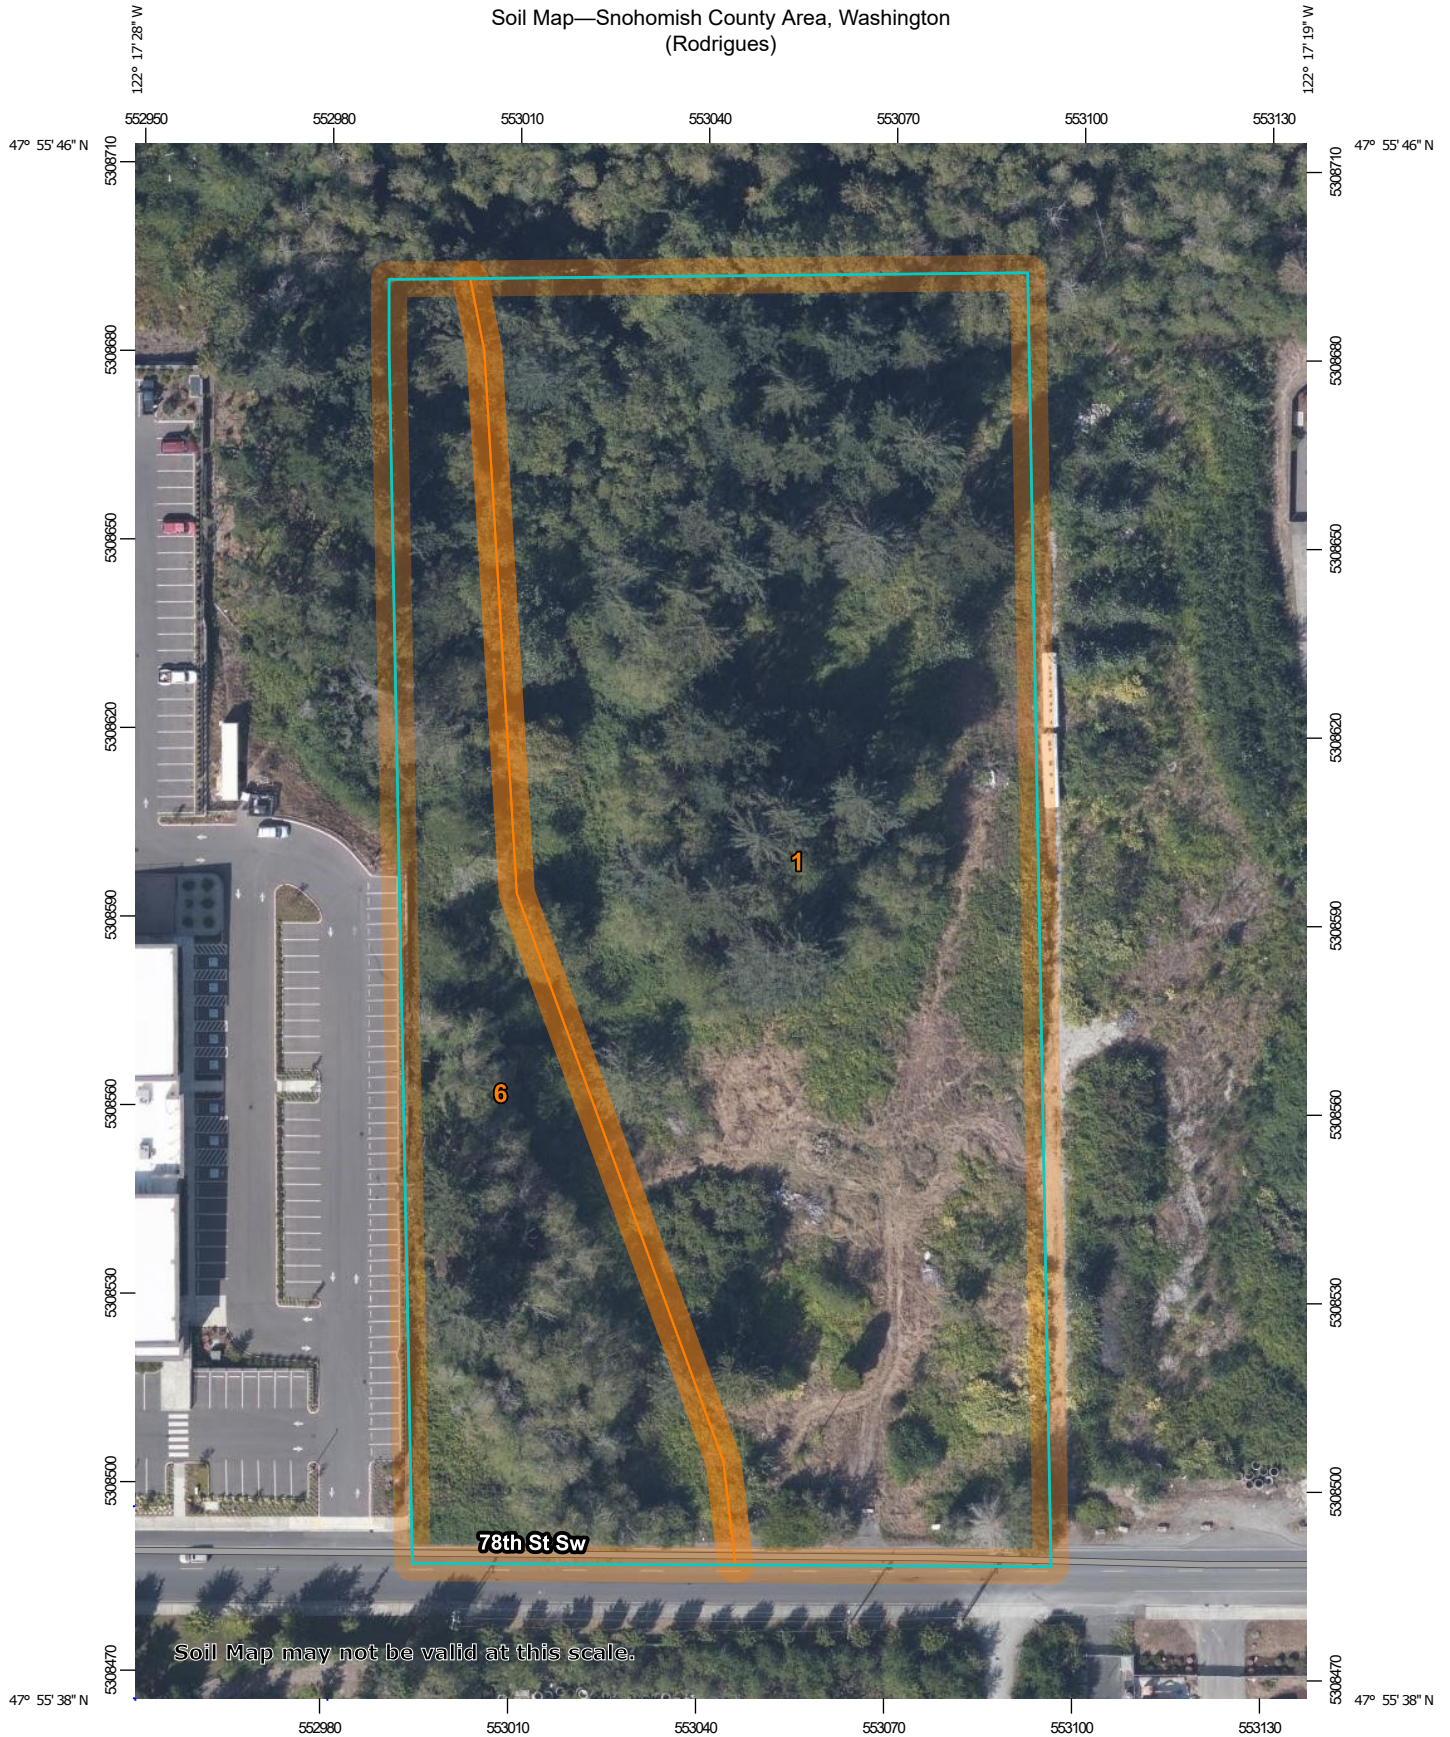
# Soil Map—Snohomish County Area, Washington (Rodrigues)

Soil Map may not be valid at this scale.

The project is for the construction of a construction storage site. Less than 2.8 acre of land disturbance will be required for this development. No existing structures have been found on site an existing drainfield records however has been determined. The soils found onsite are Alderwood Gravelly sandy loam and Alderwood-Urban land complex as identified in the Snohomish County Soil Map. See attached.
