**NELSON GEOTECHNICAL
ASSOCIATES, INC.**

Geotechnical Engineering Evaluation
Rose Hill 12-Unit Mixed-Use Building
730 – 3rd Street
Mukilteo, Washington
NGA File No. 8797B22

We are pleased to submit the attached report titled ***“Geotechnical Engineering Evaluation – Rose Hill 12-Unit Mixed-Use Building – 730 - 3rd Street – Mukilteo, Washington.”*** This report summarizes our observations of the existing surface and subsurface conditions within the site and provides general recommendations for the proposed site development. Our services were completed in general accordance with our proposal, which you signed on December 5, 2022.

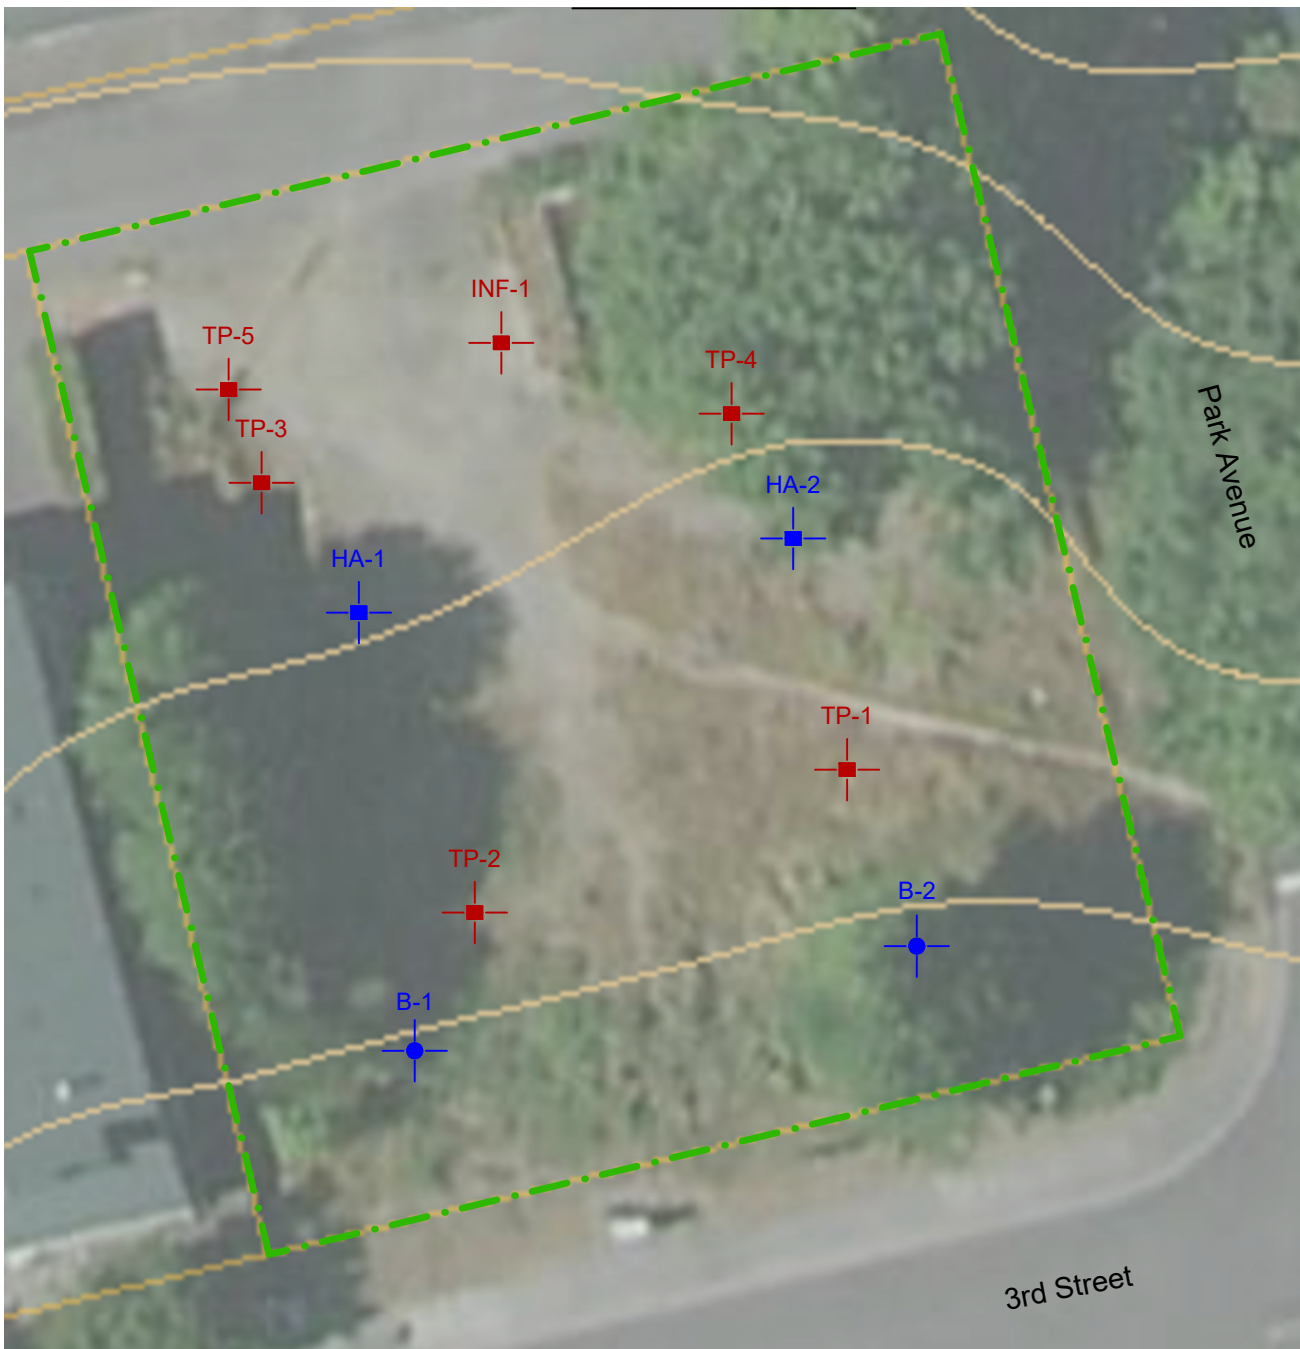
Site Plan

- . - Property line
- TP-1
- Number and approximate location of test pit
- INF-1
- Number and approximate location of infiltration test pit
