DRAINAGE REPORT

Rose Hill Apartments

3rd & Park Ave
Mukilteo, WA 98275

CG Project No.: 22332.20

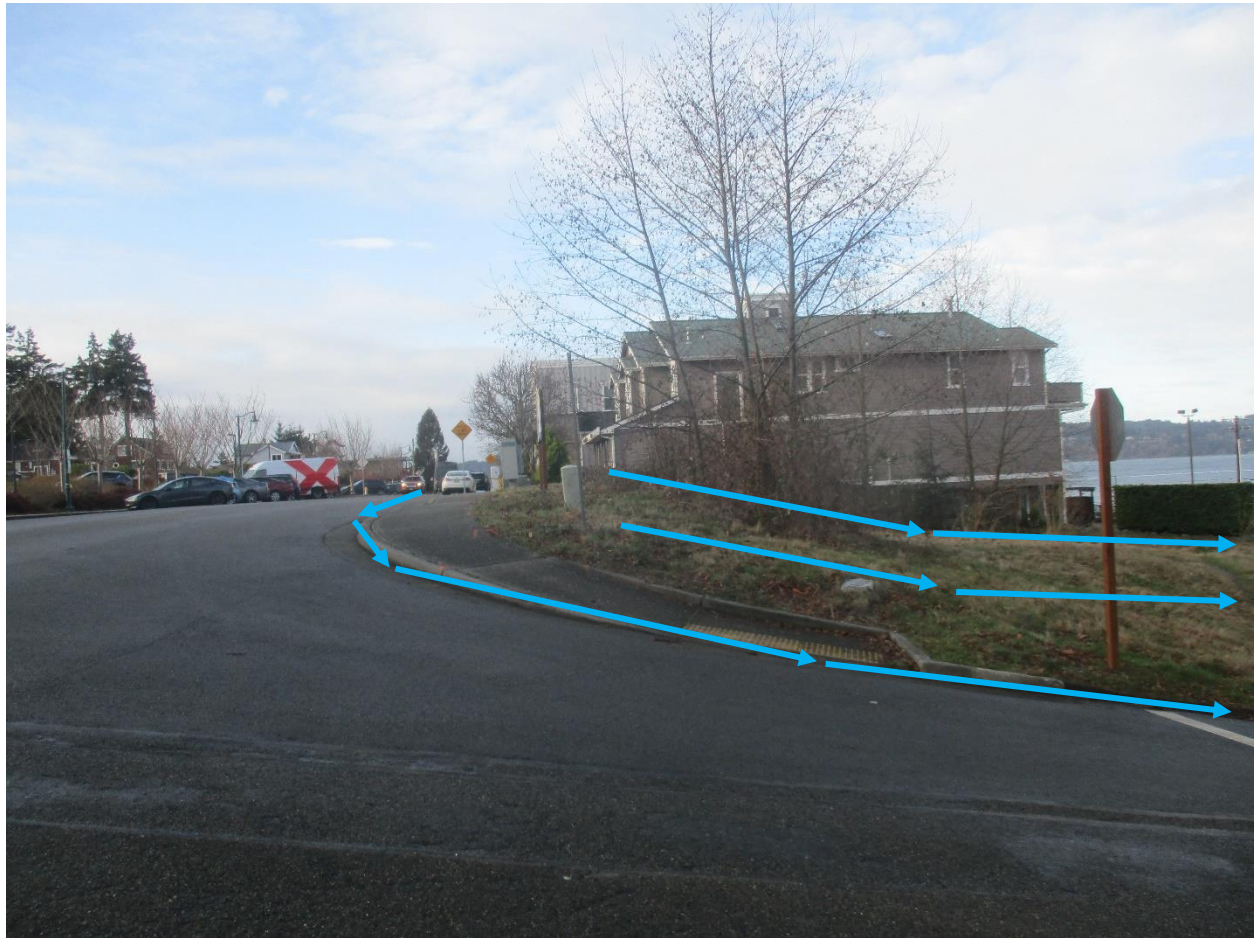
Figure III-2 Looking westerly from the east side of Park Ave

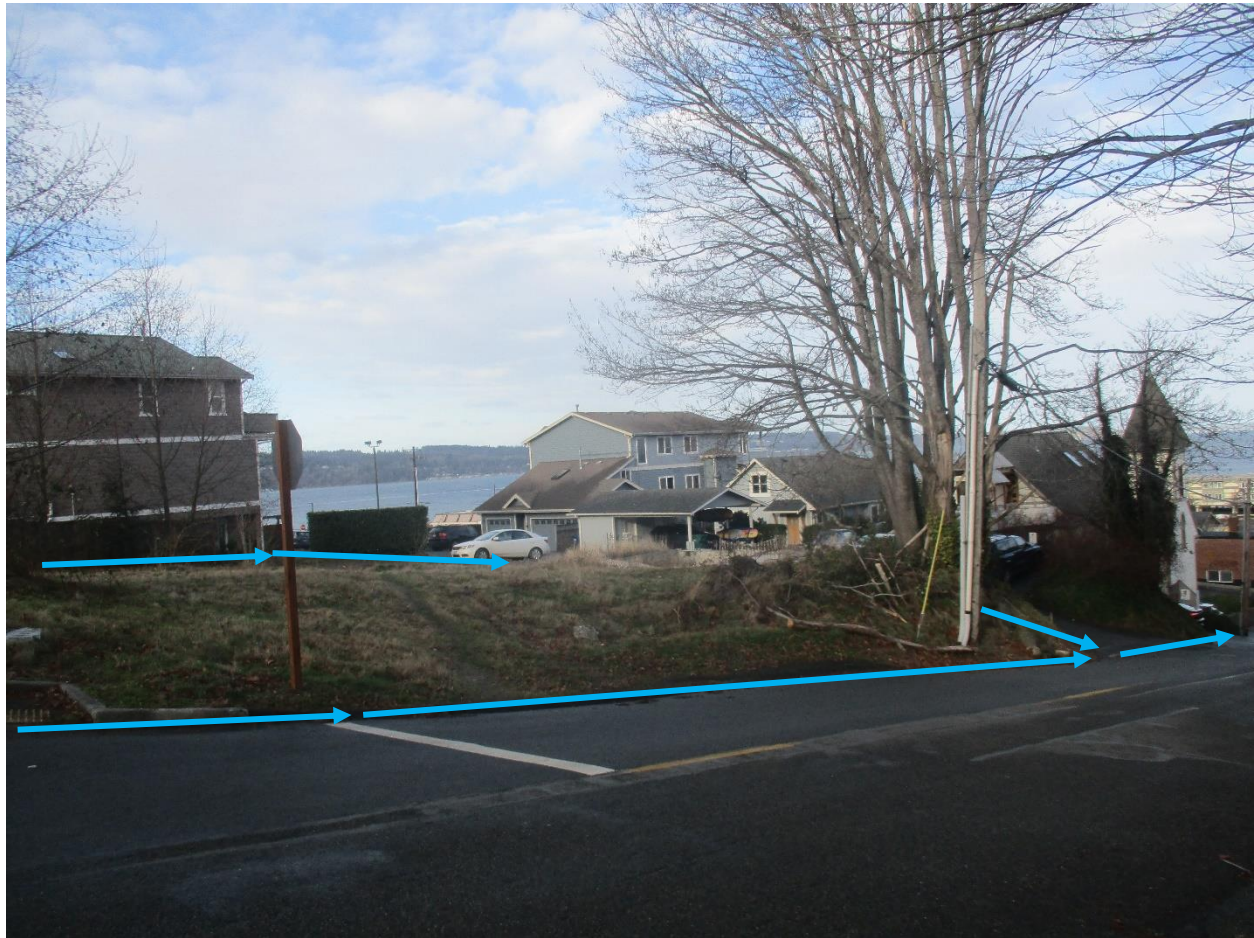
Figure III-3 Looking northwest from the same location as the previous photo

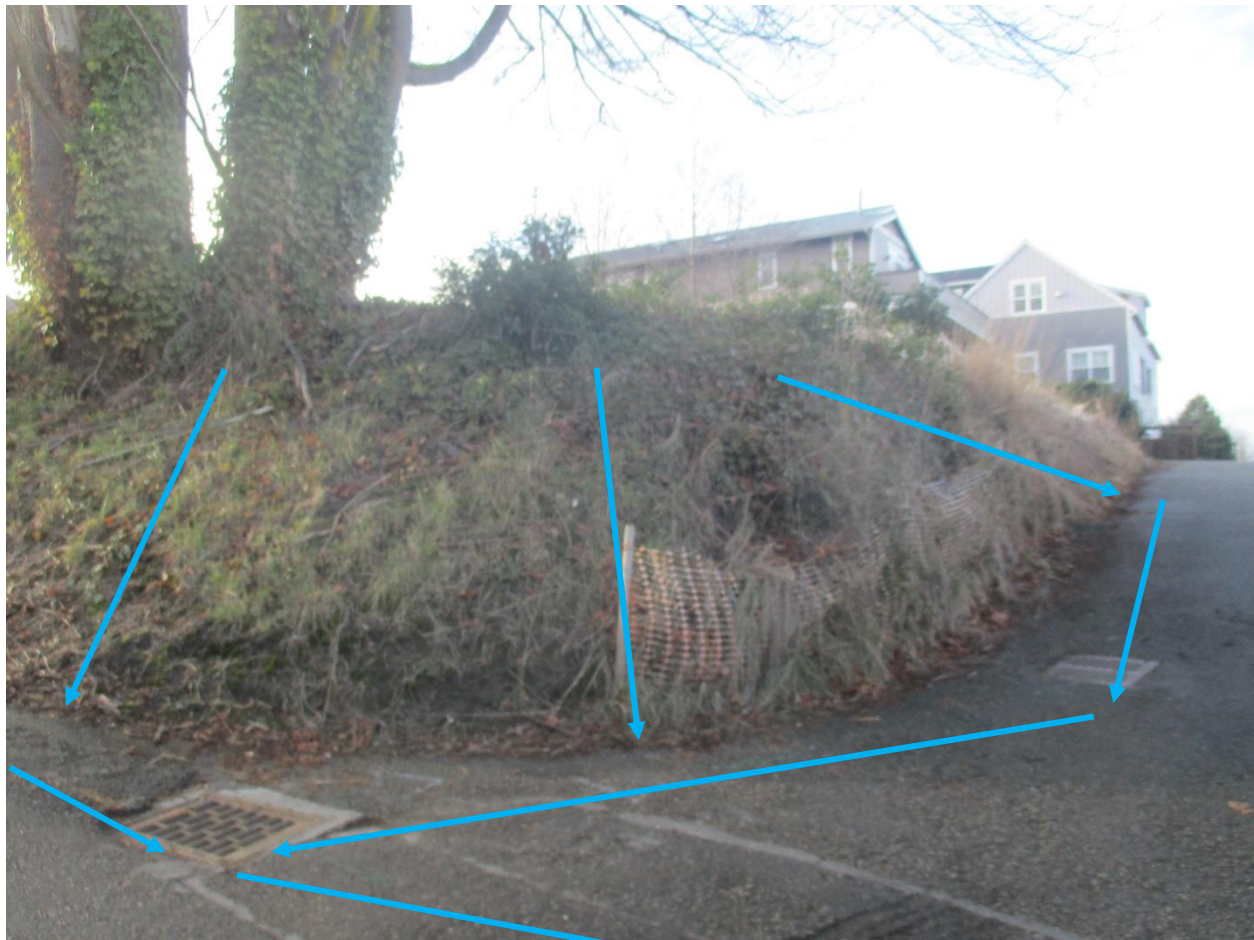
Figure III-4 Looking southwesterly from the intersection of Park Lane and Park Ave

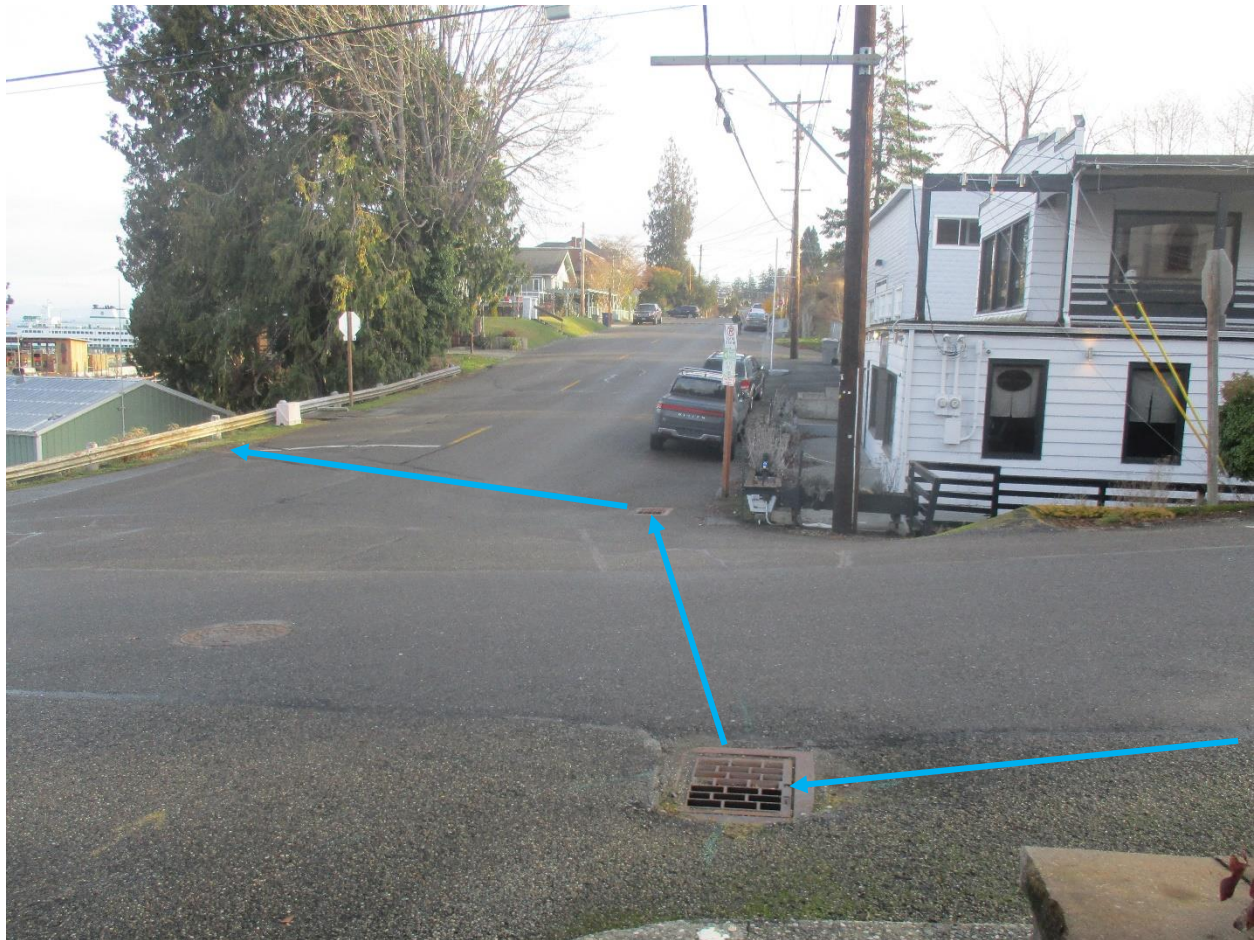
Figure III-5 Looking easterly from the intersection of 2nd Street and Park Ave

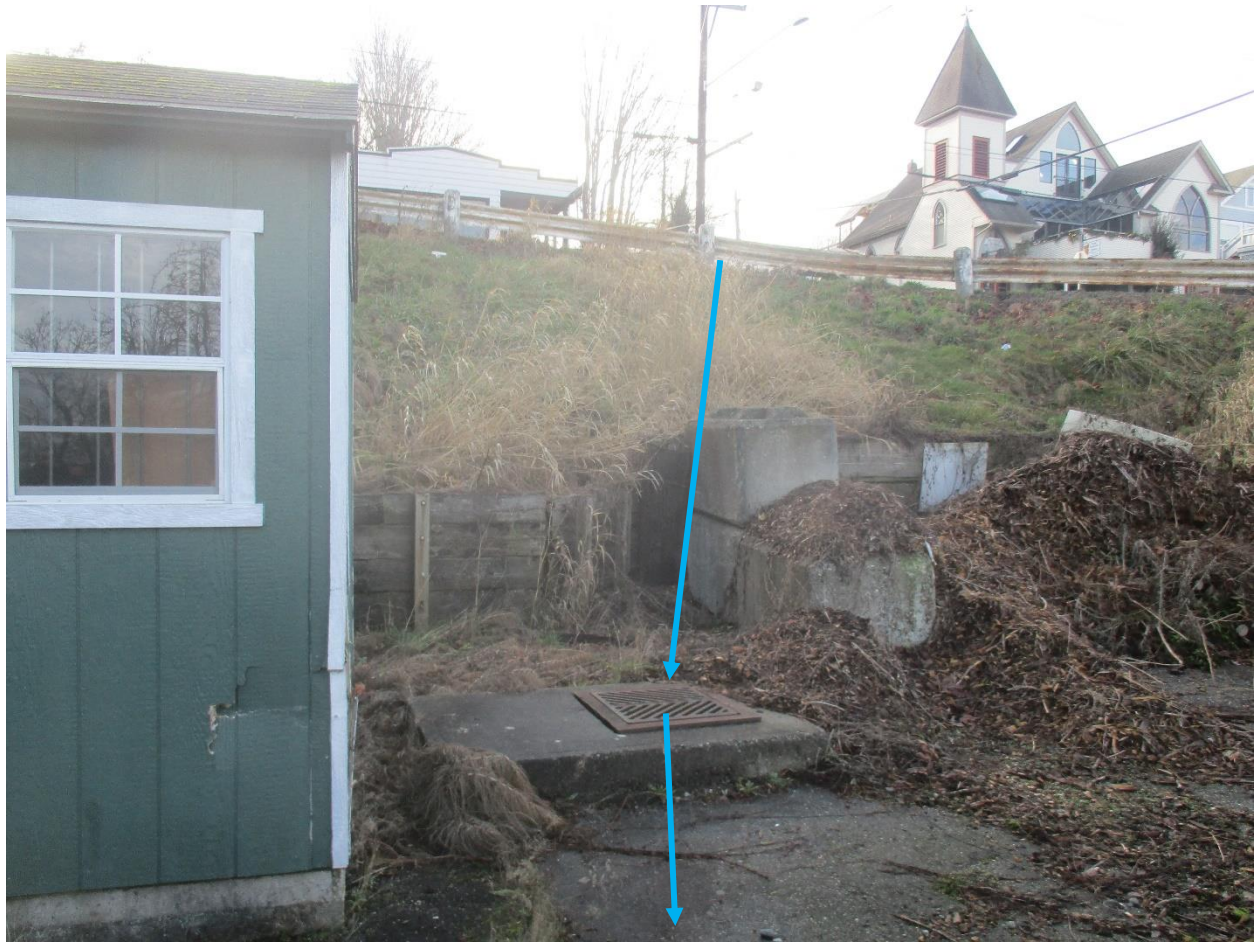
Figure III-6 Looking southerly from 801 Mukilteo Ln

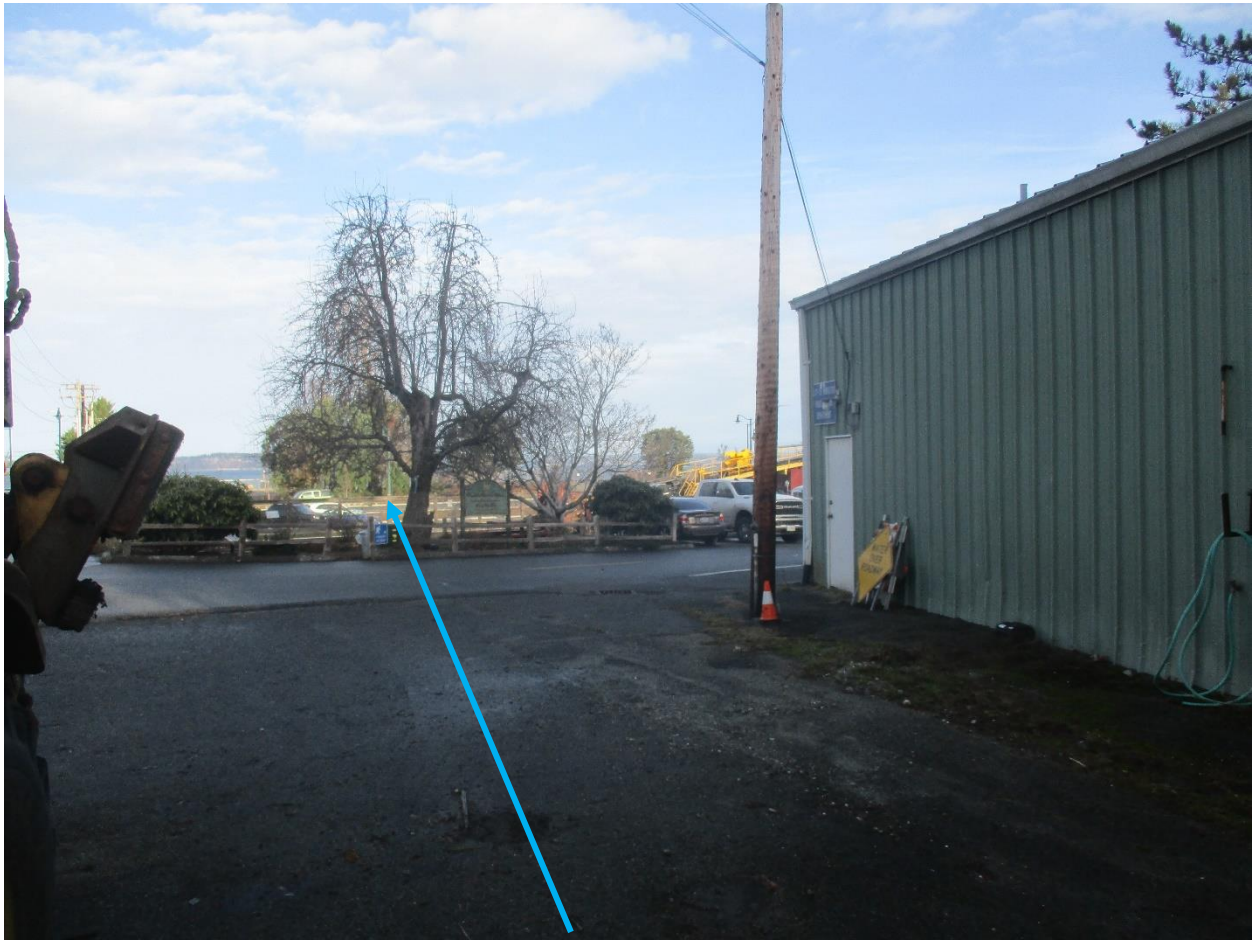
Figure III-7 Looking northerly from the same location as the previous photo

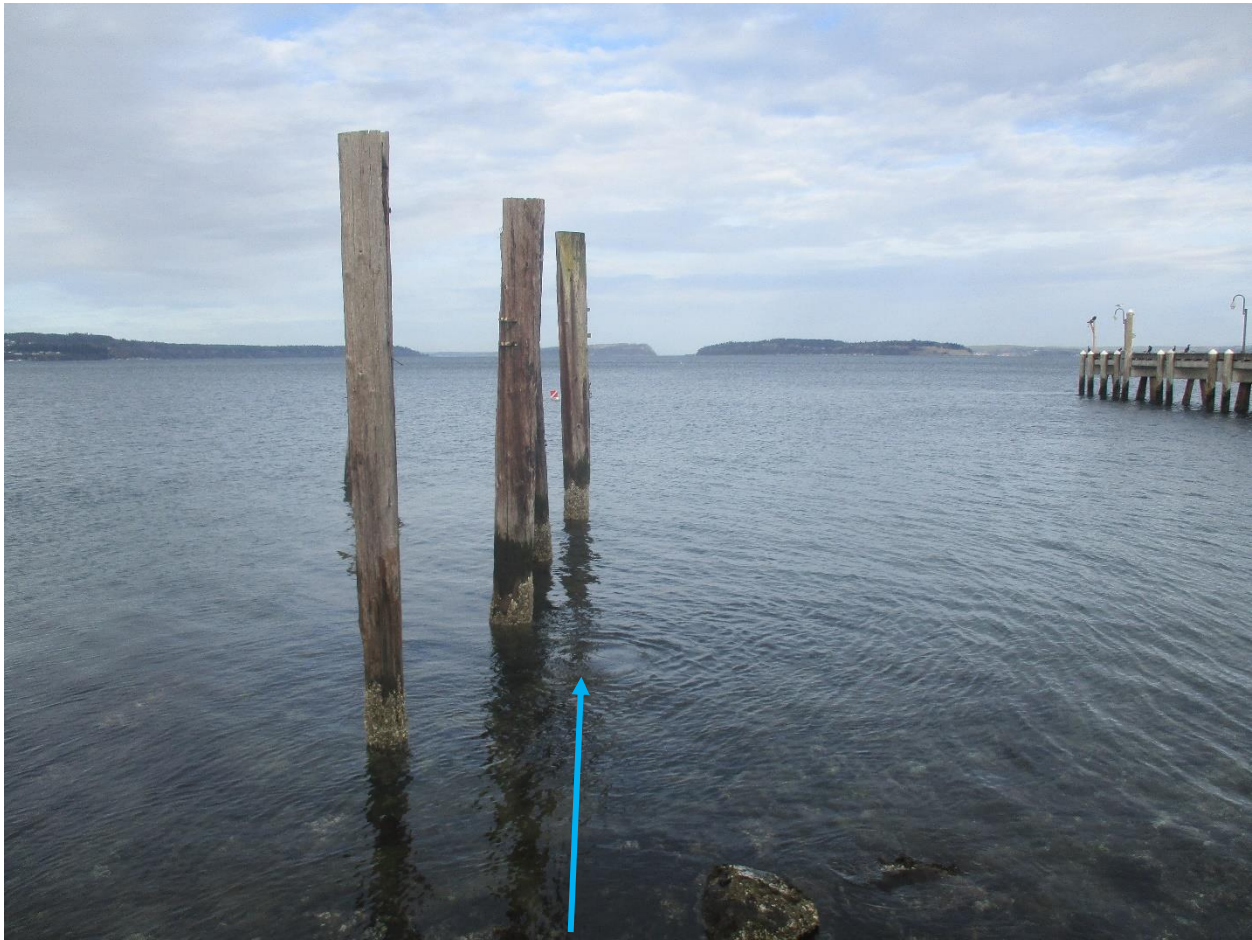
Figure III-8 Looking northerly from the outlet location

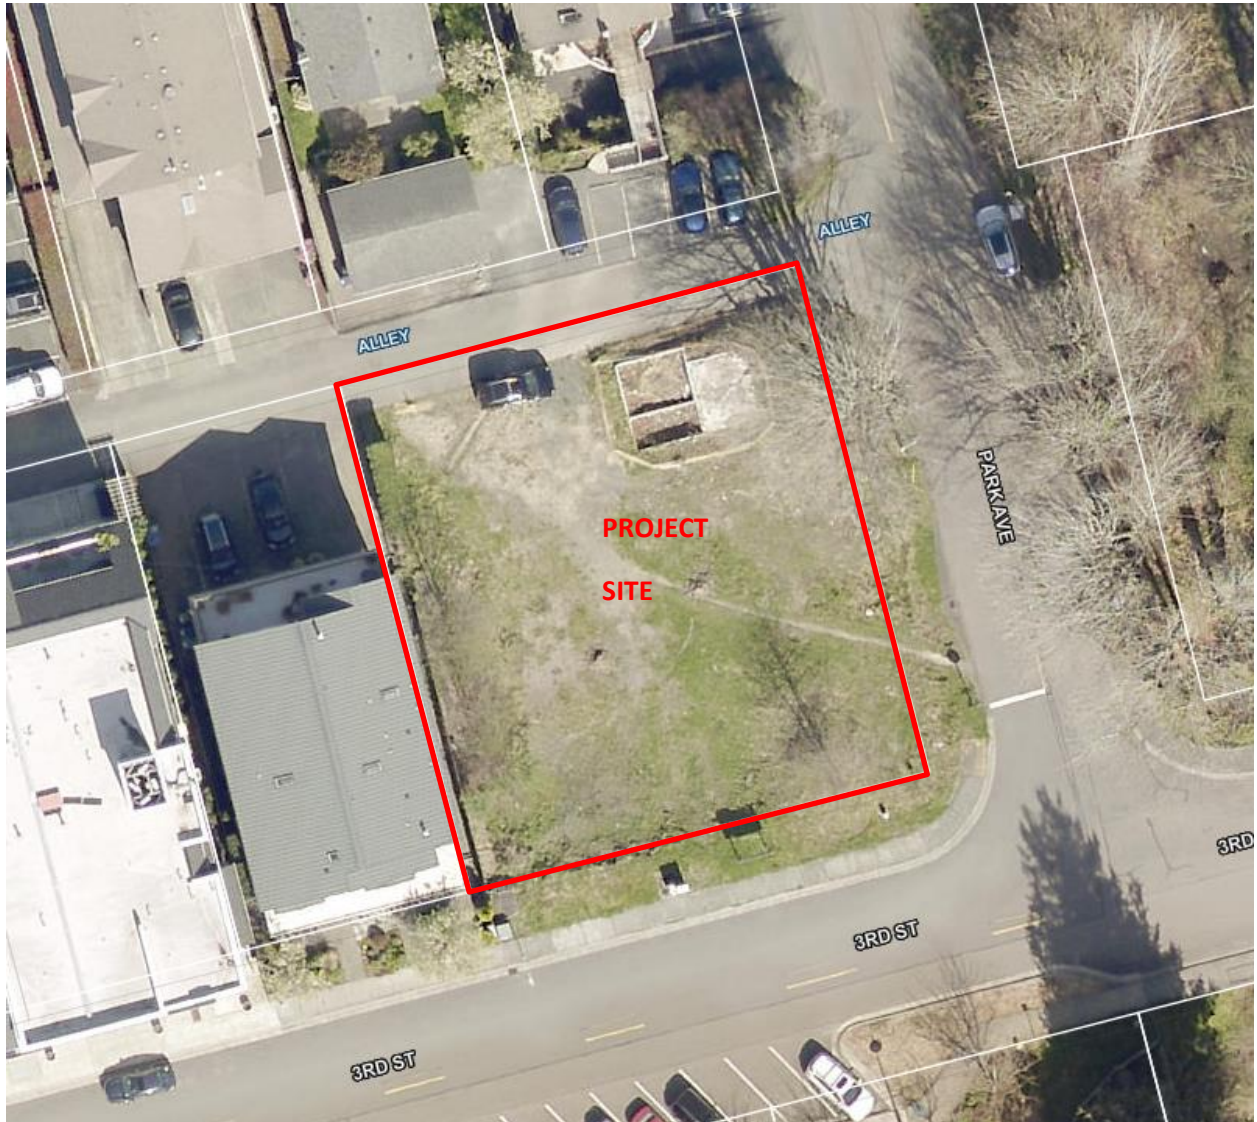
Figure A-1. Site map.

Inlet protection should be provided as shown on the C2.1 Plan. Inlet protection devices will be cleaned, or removed and replaced, when sediment has filled the device by one third (1/3) or as specified by the manufacturer.

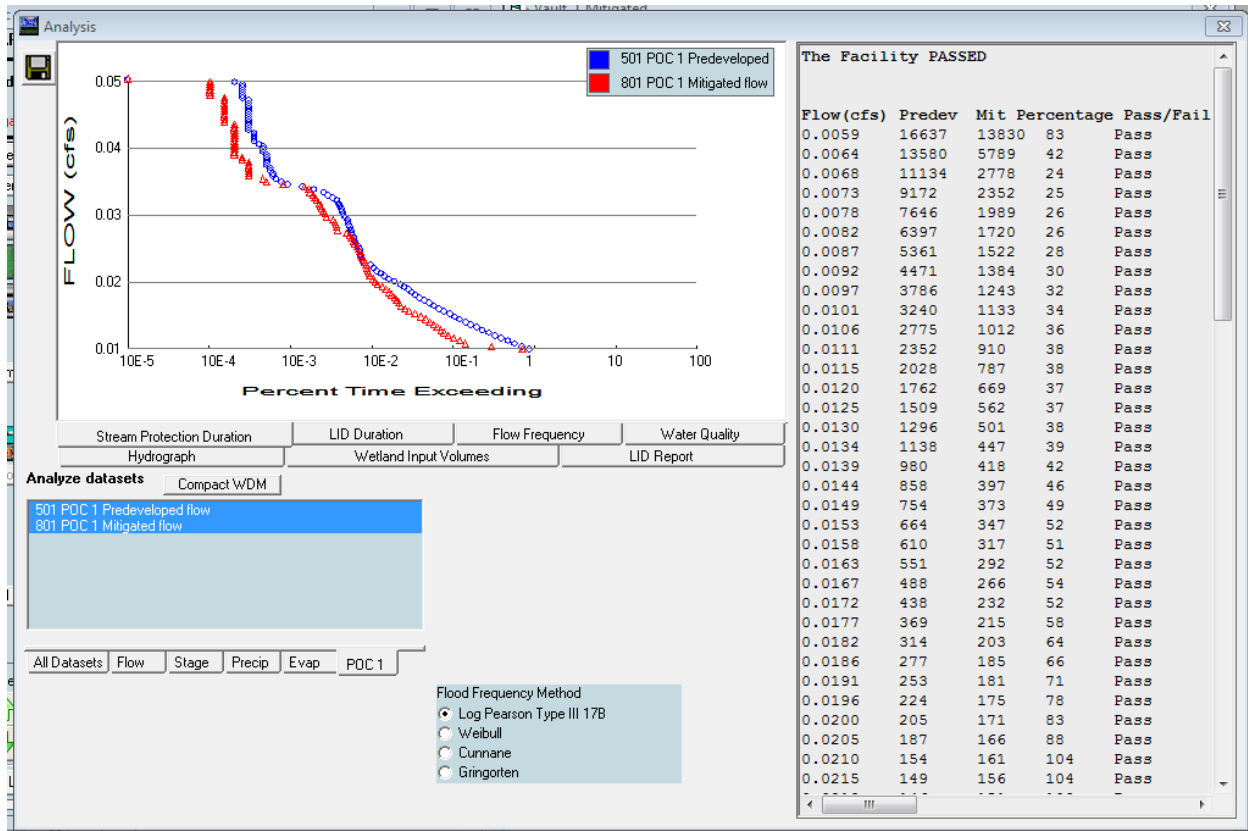
Below is the **Stream Protection Duration** graph for the **Point of Compliance**. This graph shows that the vault configuration meets Ecology's **Flow Control Standard**.

Figure 1: Stream Protection Duration Graph for the Point of Compliance (Auto-Sized)

This is not your final vault size, because the suggested orifice is smaller than Ecology's minimum allowed 0.5".

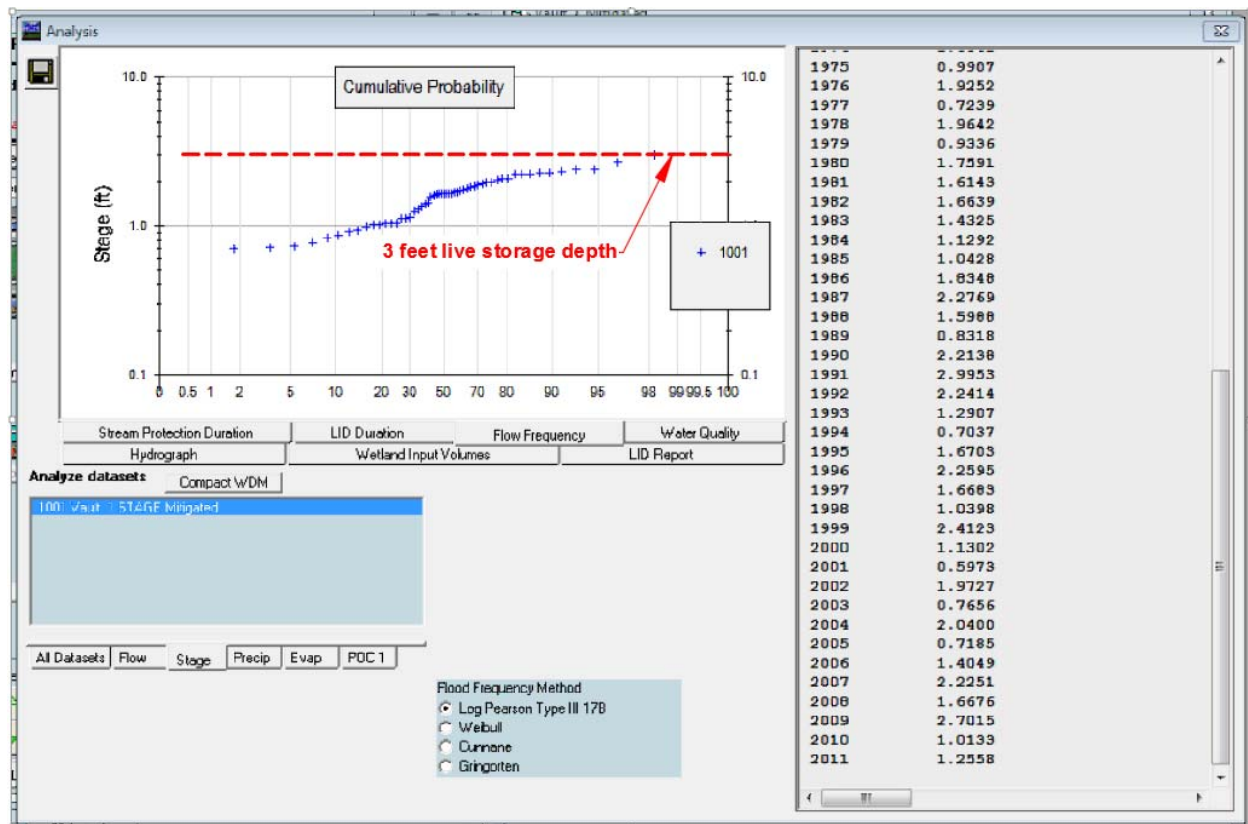
You can verify that the water level is reaching the riser, and therefore utilizing all of the live storage depth, by checking the **Annual Peaks** listed in the **Flow Frequency** analysis output for the **Vault 1 Stage Mitigated** dataset. Below is the graph showing the stage elevation reaching 3 feet, the elevation of the riser.

Figure 2: Flow Frequency Graph for the Vault 1 Stage Mitigated Dataset (Auto-Sized)
