PRELIMINARY
STORMWATER MANAGEMENT REPORT

PITTMAN 2 LOT SHORT PLAT

608 3rd Street
Mukilteo, WA 98275

CSP Engineering PFN 22-024
City PFN _____

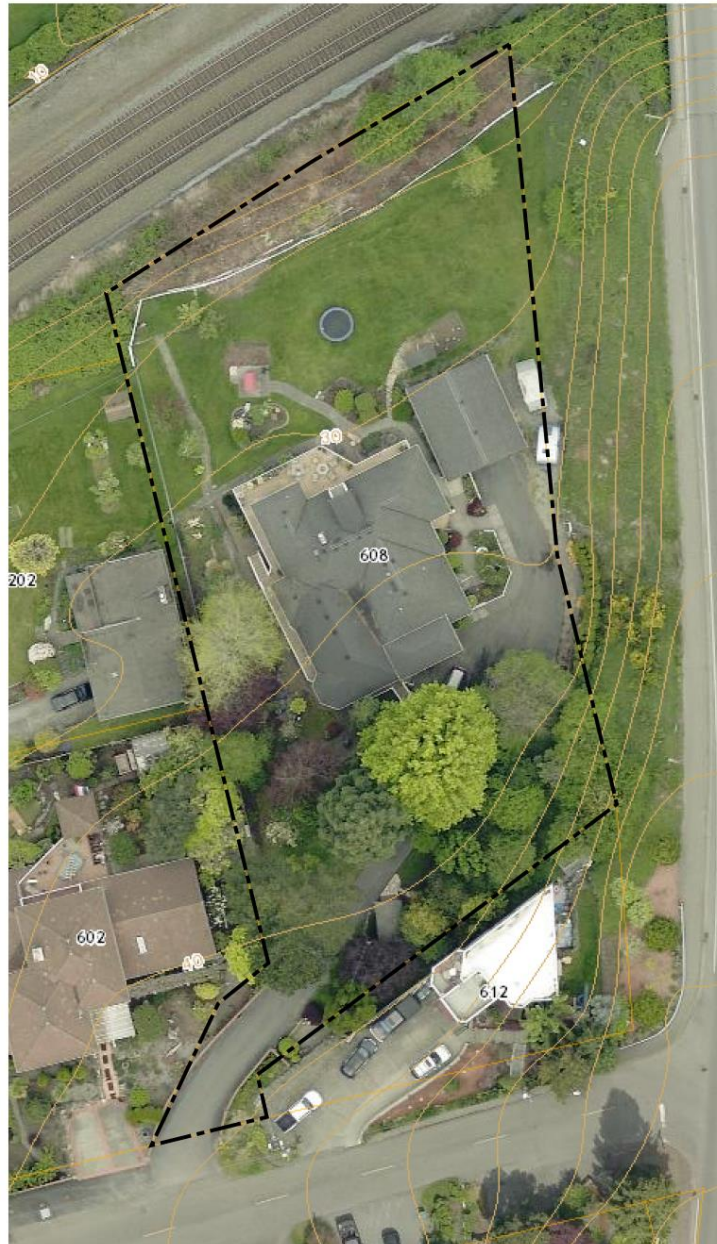
Existing Conditions Map

The subject Site Parcel is situated on a ~10% average north facing slope and is currently developed with a single-family residence. Site ground coverage consists of lawn and deciduous trees. No critical areas, stormwater facilities, surface drainage features, or BMPs are known to exist on the Site Parcel. Stormwater conveyance infrastructure exists in 3rd street south of the Site Parcel and an open conveyance system exists north of the property. Site topography directs stormwater runoff north via surface sheetflow. Developed parcels exist west and south of the Project Site. Surficial Site soils types are identified as SAND.

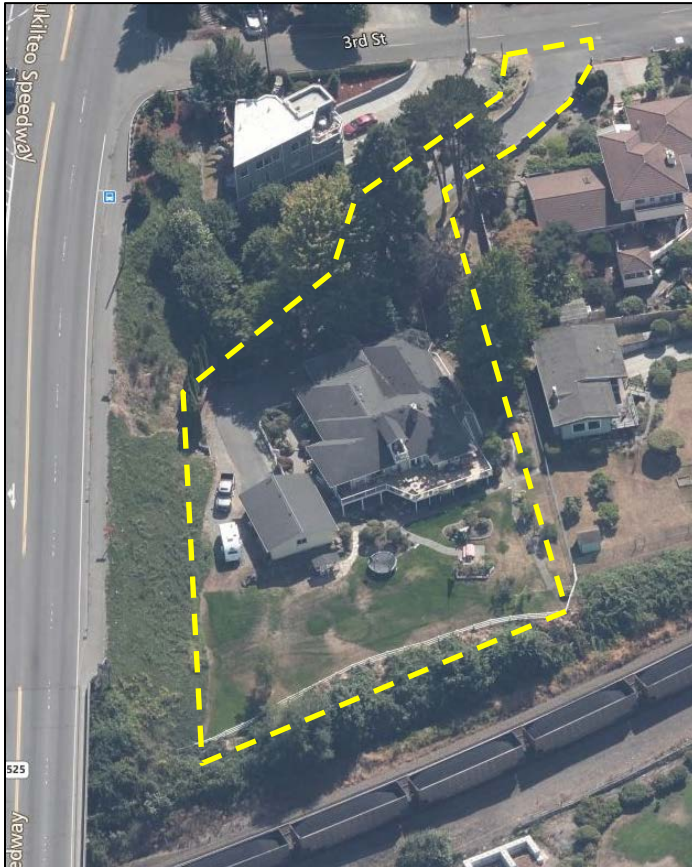
Plate 1: Aerial view of the site looking.

North is at the bottom of the image.

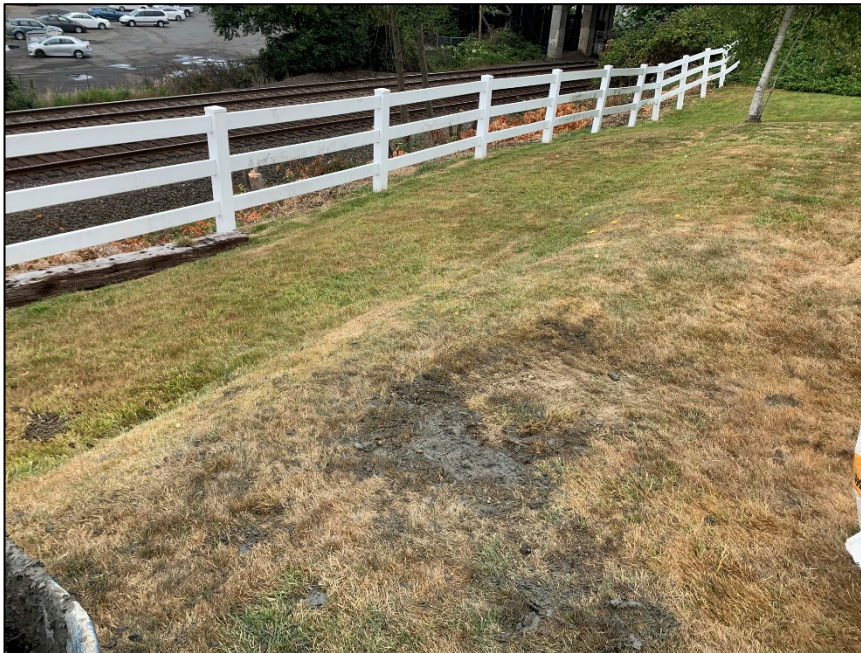
Plate 2: View of the north slope. The Burlington Northern tracks are visible in the upper right corner.

Based on the uniform grade of the slopes and the alignment of the slopes parallel to existing structures, it is our opinion that the east and north slopes are constructed slopes and, as such, would not meet the criteria for a geologically sensitive area.

Construction Setbacks: Although the steep slopes do not appear to meet the City of Mukilteo definition of a geologically sensitive area, in our opinion a setback should still be established from the slopes. We recommend a building setback based on a 2H:1V (Horizontal:Vertical) line extending into the site from the top of the east slope and the toe of the west slope.
